Profile/Photo Observation Report

Date:	04/17/2018	Weather:		Coding:	PACP 6.0
Pipe Length (ft):	281.0	Owner:	NA	Pre Clean:	Not Known
P.O.#:		Surveyor:	Justin Gonzales	PSR:	P-805-042-057
Customer:		Clean Date:	01/01/1900	Shape:	C

Street:	Lillian St.	Flow Control:	Not Controlled
City:	Hobart, IN	Year Renewed:	
Location:	Other	Tape/Media #:	
Purpose:	Not Known	Dia/Height:	8"
Use:	Sanitary	Material:	PVC
Drain Area:	NA	Lining:	
Category:	NA		
Comment:

Location Details:		Direction of Survey:	Downstream
US MH:	M-805-057	DS MH:	M-805-042
		Total Length Surveyed (ft):	157.0

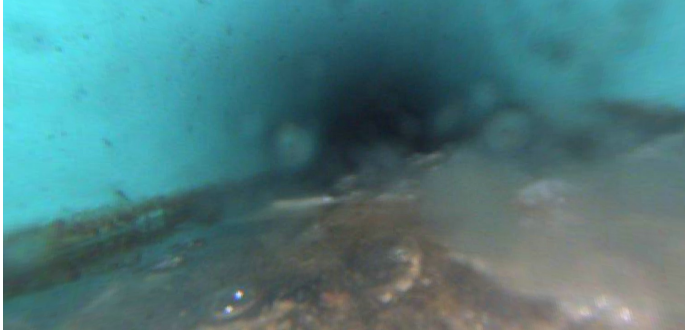
Code: **AMH**
Description: **Manhole**

Distance (ft): **.0**
Structural Grade: **0**
O&M Grade: **0**
Clock Start/From:
Clock To:
1st Value:
2nd Value:
Value Percent:
Continuous Index:
Within 8" of Joint: **NO**
Remarks: **M-805-057**

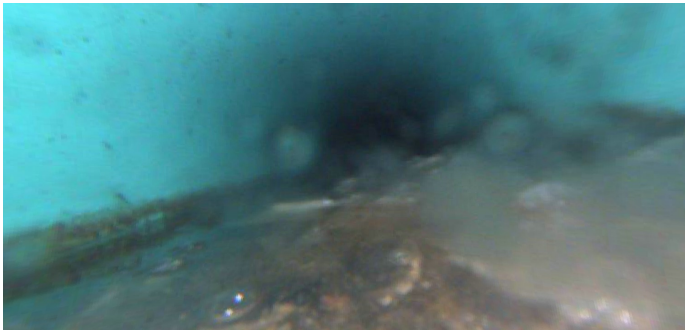
Code: **MWL**
Description: **Water Level**

Distance (ft): **.0**
Structural Grade: **0**
O&M Grade: **0**
Clock Start/From:
Clock To:
1st Value:
2nd Value:
Value Percent: **15.000**
Continuous Index:
Within 8" of Joint: **NO**
Remarks:

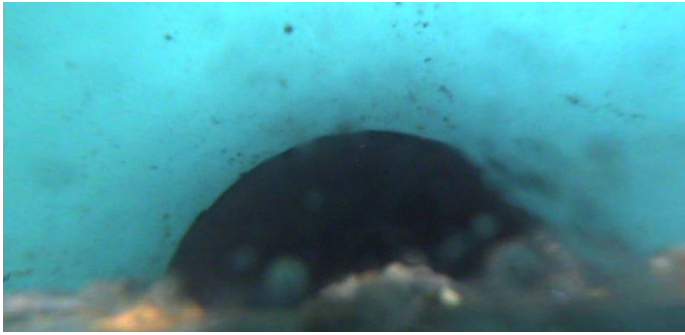
Code: **MMC**
Description: **Material Change**

Distance (ft): **2.7**
Structural Grade: **0**
O&M Grade: **0**
Clock Start/From:
Clock To:
1st Value:
2nd Value:
Value Percent:
Continuous Index:
Within 8" of Joint: **NO**
Remarks: **PVC TO VCP**

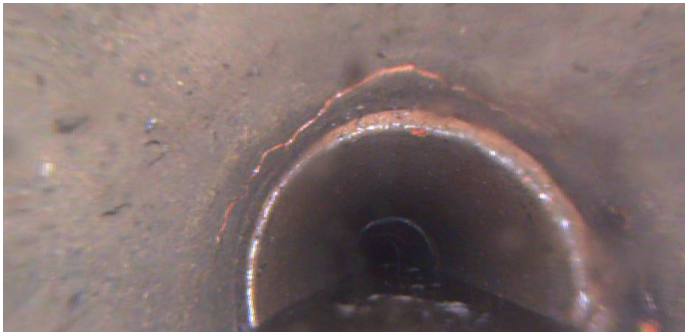
Code: **FC**
Description: **Fracture Circumferential**

Distance (ft): **4.6**
Structural Grade: **2**
O&M Grade: **0**
Clock Start/From: **7**
Clock To: **5**
1st Value:
2nd Value:
Value Percent:
Continuous Index:
Within 8" of Joint:
Remarks:

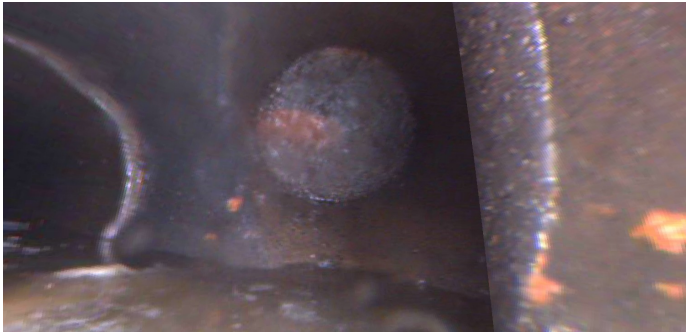
Code: **TFC**
Description: **Tap Factory Capped**

Distance (ft): **10.1**
Structural Grade: **0**
O&M Grade: **0**
Clock Start/From: **3**
Clock To:
1st Value: **4.000**
2nd Value:
Value Percent:
Continuous Index:
Within 8" of Joint:
Remarks:

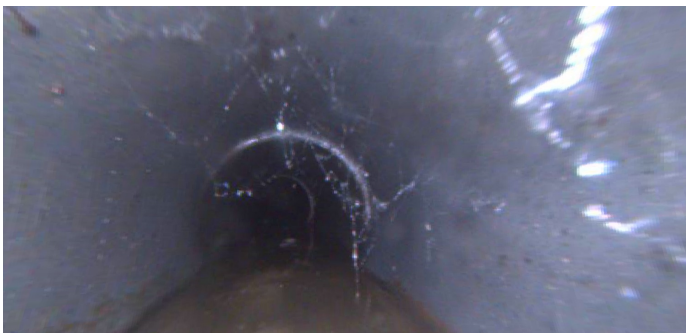
Code: **MGO**
Description: **General Observation**

Distance (ft): **15.9**
Structural Grade: **0**
O&M Grade: **0**
Clock Start/From:
Clock To:
1st Value:
2nd Value:
Value Percent:
Continuous Index:
Within 8" of Joint: **NO**
Remarks: **SPIDER WEBS**

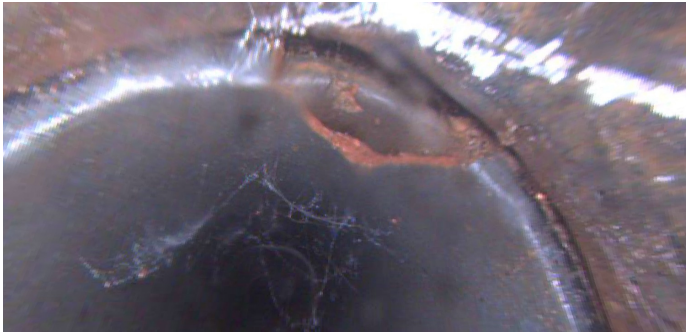
Code: **FC**
Description: **Fracture Circumferential**

Distance (ft): **28.9**
Structural Grade: **2**
O&M Grade: **0**
Clock Start/From: **12**
Clock To: **2**
1st Value:
2nd Value:
Value Percent:
Continuous Index:
Within 8" of Joint: **YES**
Remarks:

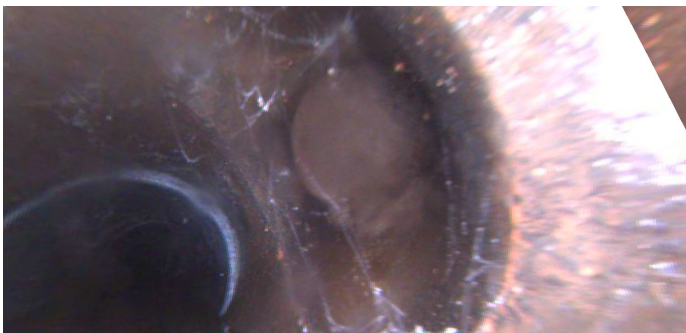
Code: **TFC**
Description: **Tap Factory Capped**

Distance (ft): **36.0**
Structural Grade: **0**
O&M Grade: **0**
Clock Start/From: **2**
Clock To:
1st Value: **4.000**
2nd Value:
Value Percent:
Continuous Index:
Within 8" of Joint:
Remarks:

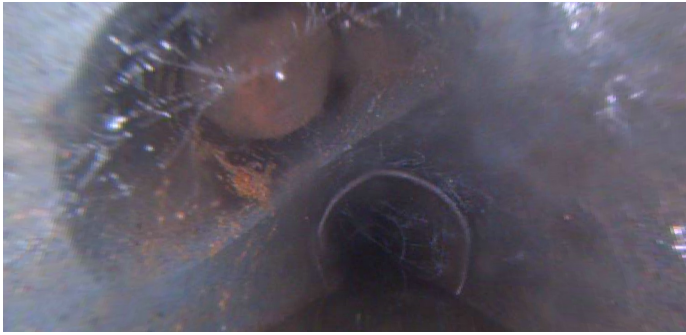
Code: **TFC**
Description: **Tap Factory Capped**

Distance (ft): **37.8**
Structural Grade: **0**
O&M Grade: **0**
Clock Start/From: **10**
Clock To:
1st Value: **4.000**
2nd Value:
Value Percent:
Continuous Index:
Within 8" of Joint:
Remarks:

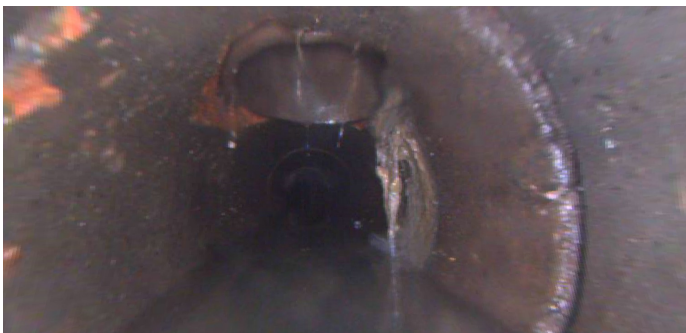
Code: **TBI**
Description: **Tap Break-in Intruding**

Distance (ft): **48.9**
Structural Grade: **0**
O&M Grade: **2**
Clock Start/From: **12**
Clock To:
1st Value: **4.000**
2nd Value: **1.000**
Value Percent:
Continuous Index:
Within 8" of Joint:
Remarks:

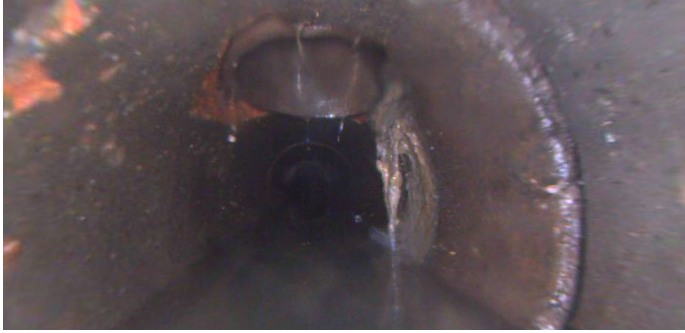
Code: **RFC**
Description: **Roots Fine Connection**

Distance (ft): **48.9**
Structural Grade: **0**
O&M Grade: **1**
Clock Start/From: **1**
Clock To:
1st Value:
2nd Value:
Value Percent:
Continuous Index:
Within 8" of Joint: **NO**
Remarks:

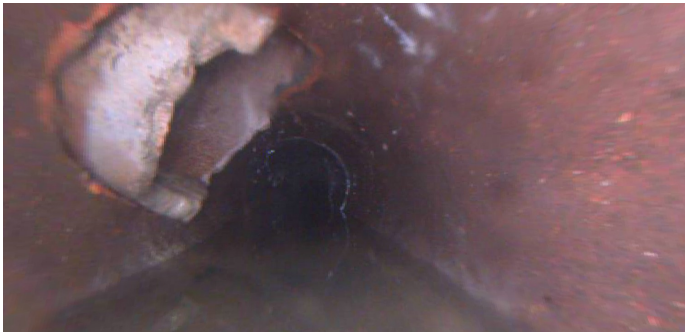
Code: **TBI**
Description: **Tap Break-in Intruding**

Distance (ft): **53.2**
Structural Grade: **0**
O&M Grade: **2**
Clock Start/From: **10**
Clock To:
1st Value: **4.000**
2nd Value: **1.000**
Value Percent:
Continuous Index:
Within 8" of Joint:
Remarks:

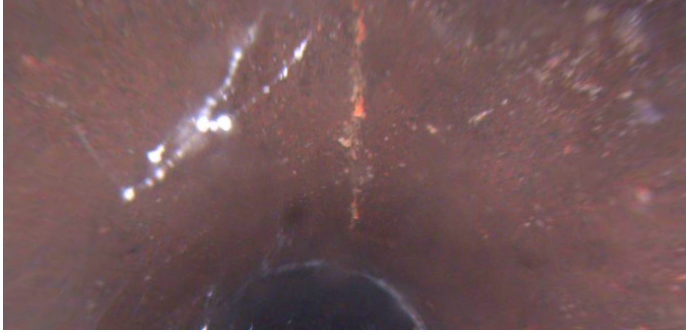
Code: **FL**
Description: **Fracture Longitudinal**

Distance (ft): **54.3**
Structural Grade: **3**
O&M Grade: **0**
Clock Start/From: **12**
Clock To:
1st Value:
2nd Value:
Value Percent:
Continuous Index:
Within 8" of Joint: **YES**
Remarks:

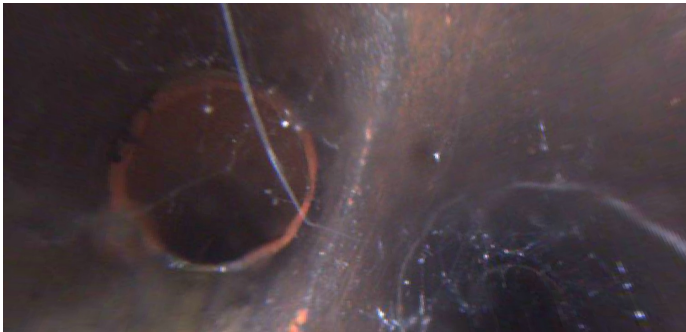
Code: **TF**
Description: **Tap Factory**

Distance (ft): **58.1**
Structural Grade: **0**
O&M Grade: **0**
Clock Start/From: **9**
Clock To:
1st Value: **4.000**
2nd Value:
Value Percent:
Continuous Index:
Within 8" of Joint:
Remarks:

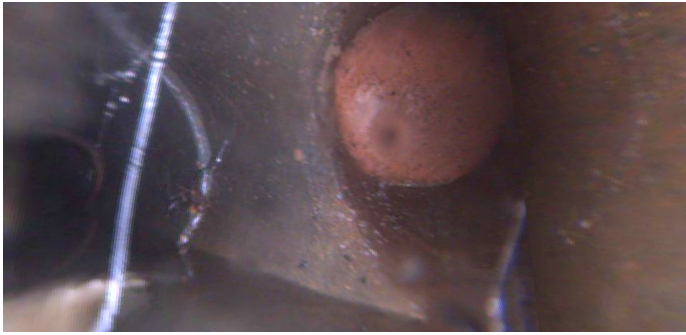
Code: **TFC**
Description: **Tap Factory Capped**

Distance (ft): **65.8**
Structural Grade: **0**
O&M Grade: **0**
Clock Start/From: **2**
Clock To:
1st Value: **4.000**
2nd Value:
Value Percent:
Continuous Index:
Within 8" of Joint:
Remarks:

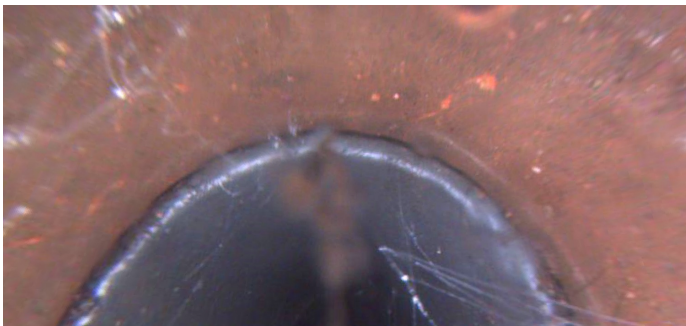
Code: **CM**
Description: **Crack Multiple**

Distance (ft): **70.1**
Structural Grade: **3**
O&M Grade: **0**
Clock Start/From: **10**
Clock To: **1**
1st Value:
2nd Value:
Value Percent:
Continuous Index:
Within 8" of Joint: **YES**
Remarks:

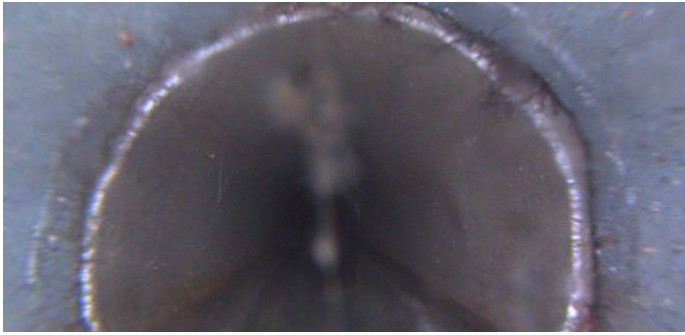
Code: **RFJ**
Description: **Roots Fine Joint**

Distance (ft): **72.2**
Structural Grade: **0**
O&M Grade: **1**
Clock Start/From: **12**
Clock To: **3**
1st Value:
2nd Value:
Value Percent:
Continuous Index:
Within 8" of Joint: **YES**
Remarks:

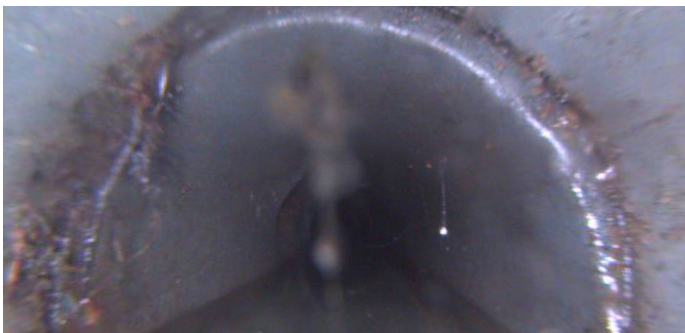
Code: **RFJ**
Description: **Roots Fine Joint**

Distance (ft): **80.3**
Structural Grade: **0**
O&M Grade: **1**
Clock Start/From: **8**
Clock To: **4**
1st Value:
2nd Value:
Value Percent:
Continuous Index:
Within 8" of Joint: **YES**
Remarks:

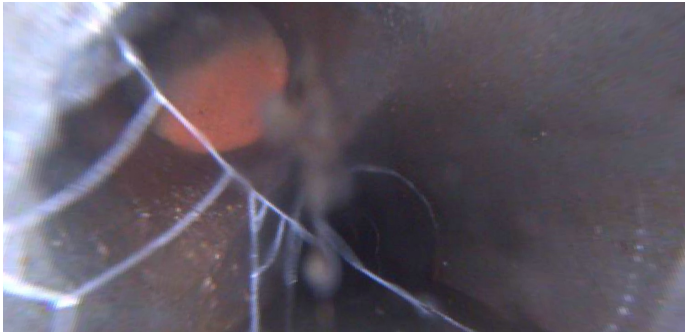
Code: **TFC**
Description: **Tap Factory Capped**

Distance (ft): **81.4**
Structural Grade: **0**
O&M Grade: **0**
Clock Start/From: **10**
Clock To:
1st Value: **4.000**
2nd Value:
Value Percent:
Continuous Index:
Within 8" of Joint:
Remarks:

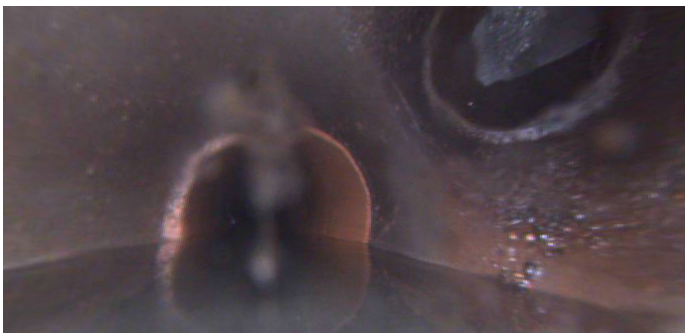
Code: **TF**
Description: **Tap Factory**

Distance (ft): **89.6**
Structural Grade: **0**
O&M Grade: **0**
Clock Start/From: **2**
Clock To:
1st Value: **4.000**
2nd Value:
Value Percent:
Continuous Index:
Within 8" of Joint:
Remarks:

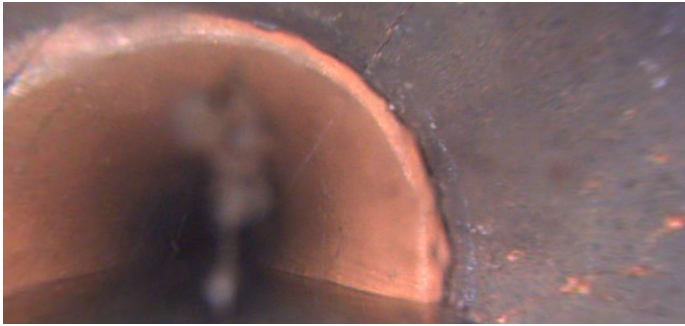
Code: **FM**
Description: **Fracture Multiple**

Distance (ft): **90.2**
Structural Grade: **4**
O&M Grade: **0**
Clock Start/From: **1**
Clock To: **3**
1st Value:
2nd Value:
Value Percent:
Continuous Index:
Within 8" of Joint: **YES**
Remarks:

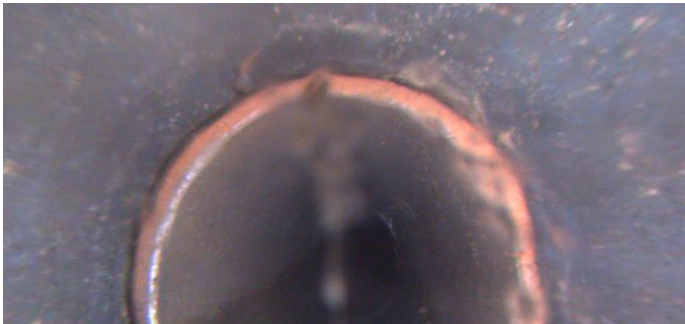
Code: **FM**
Description: **Fracture Multiple**

Distance (ft): **96.3**
Structural Grade: **4**
O&M Grade: **0**
Clock Start/From: **11**
Clock To: **4**
1st Value:
2nd Value:
Value Percent:
Continuous Index:
Within 8" of Joint: **YES**
Remarks:

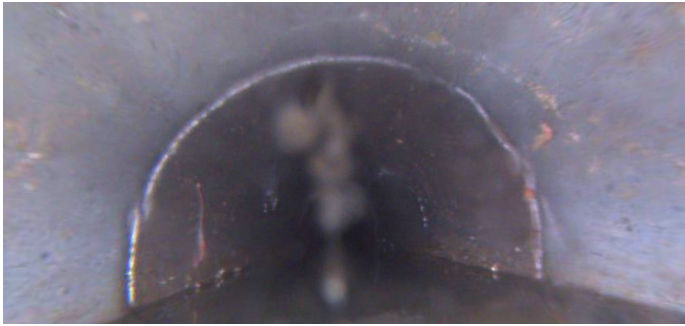
Code: **CM**
Description: **Crack Multiple**

Distance (ft): **100.4**
Structural Grade: **3**
O&M Grade: **0**
Clock Start/From: **12**
Clock To: **3**
1st Value:
2nd Value:
Value Percent:
Continuous Index:
Within 8" of Joint: **YES**
Remarks:

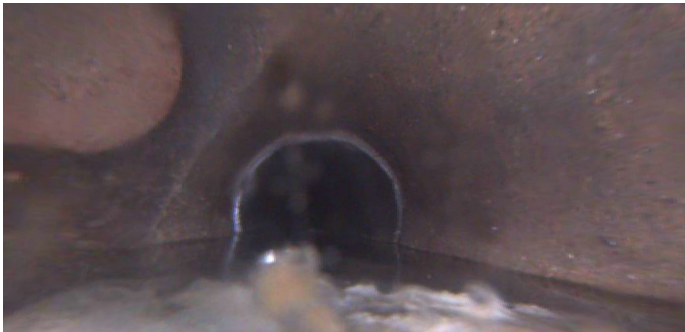
Code: **TFC**
Description: **Tap Factory Capped**

Distance (ft): **113.9**
Structural Grade: **0**
O&M Grade: **0**
Clock Start/From: **10**
Clock To:
1st Value: **4.000**
2nd Value:
Value Percent:
Continuous Index:
Within 8" of Joint:
Remarks:

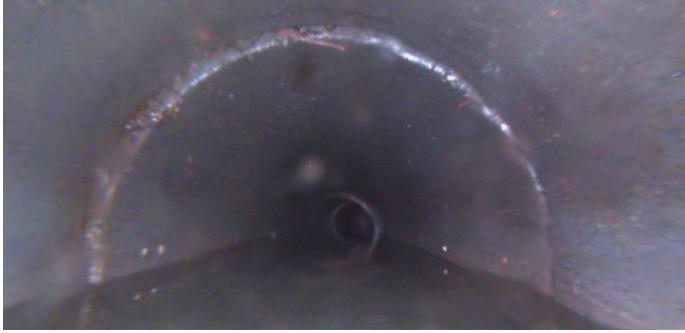
Code: **RFJ**
Description: **Roots Fine Joint**

Distance (ft): **118.6**
Structural Grade: **0**
O&M Grade: **1**
Clock Start/From: **12**
Clock To:
1st Value:
2nd Value:
Value Percent:
Continuous Index:
Within 8" of Joint: **YES**
Remarks:

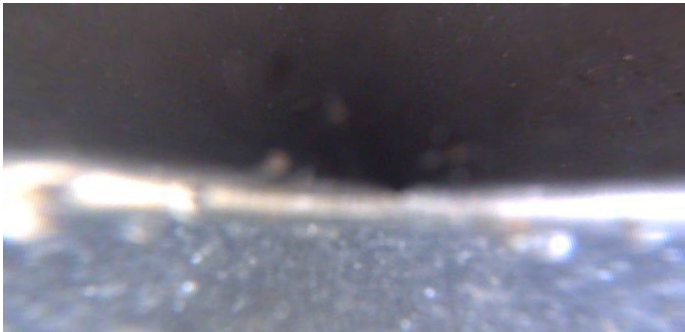
Code: **MCU**
Description: **Camera Underwater**

Distance (ft): **121.0**
Structural Grade: **0**
O&M Grade: **4**
Clock Start/From:
Clock To:
1st Value:
2nd Value:
Value Percent:
Continuous Index:
Within 8" of Joint: **NO**
Remarks:

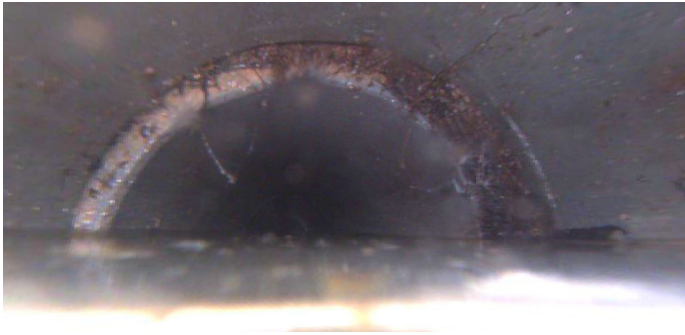
Code: **RFJ**
Description: **Roots Fine Joint**

Distance (ft): **122.7**
Structural Grade: **0**
O&M Grade: **1**
Clock Start/From: **11**
Clock To: **3**
1st Value:
2nd Value:
Value Percent:
Continuous Index:
Within 8" of Joint: **YES**
Remarks:

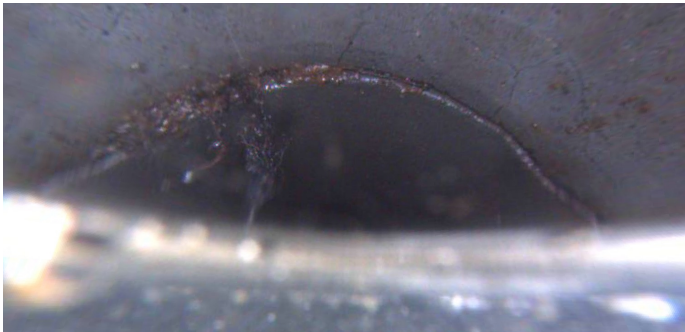
Code: **FM**
Description: **Fracture Multiple**

Distance (ft): **124.8**
Structural Grade: **4**
O&M Grade: **0**
Clock Start/From: **12**
Clock To: **3**
1st Value:
2nd Value:
Value Percent:
Continuous Index:
Within 8" of Joint: **YES**
Remarks:

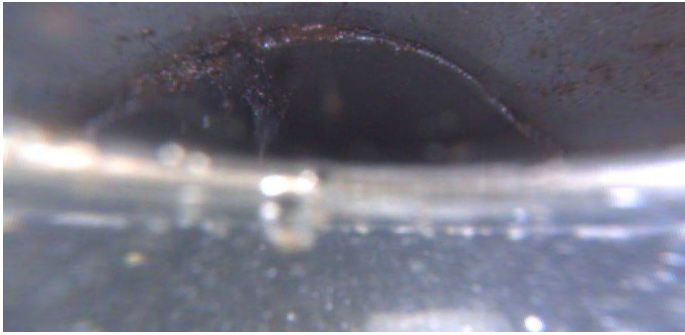
Code: **RFJ**
Description: **Roots Fine Joint**

Distance (ft): **124.8**
Structural Grade: **0**
O&M Grade: **1**
Clock Start/From: **10**
Clock To: **12**
1st Value:
2nd Value:
Value Percent:
Continuous Index:
Within 8" of Joint: **YES**
Remarks:

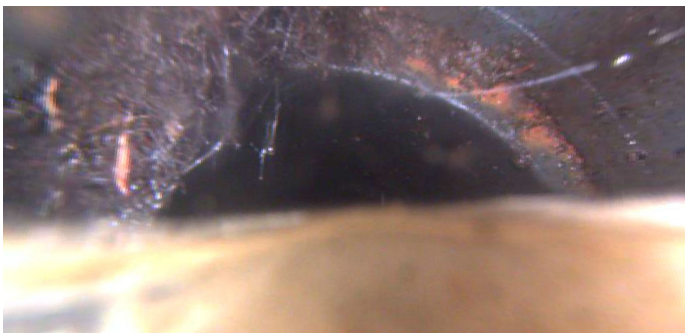
Code: **RFJ**
Description: **Roots Fine Joint**

Distance (ft): **127.0**
Structural Grade: **0**
O&M Grade: **1**
Clock Start/From: **9**
Clock To: **12**
1st Value:
2nd Value:
Value Percent:
Continuous Index:
Within 8" of Joint: **YES**
Remarks:

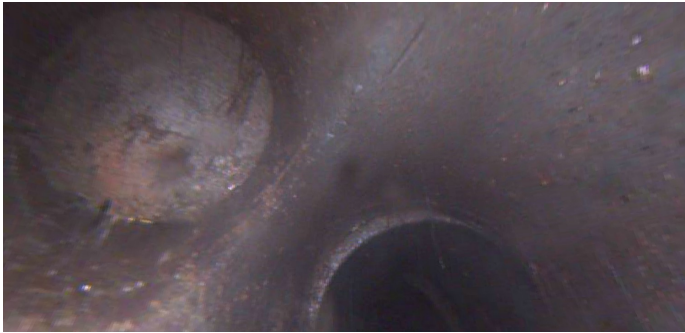
Code: **TFC**
Description: **Tap Factory Capped**

Distance (ft): **130.3**
Structural Grade: **0**
O&M Grade: **0**
Clock Start/From: **10**
Clock To:
1st Value: **4.000**
2nd Value:
Value Percent:
Continuous Index:
Within 8" of Joint:
Remarks:

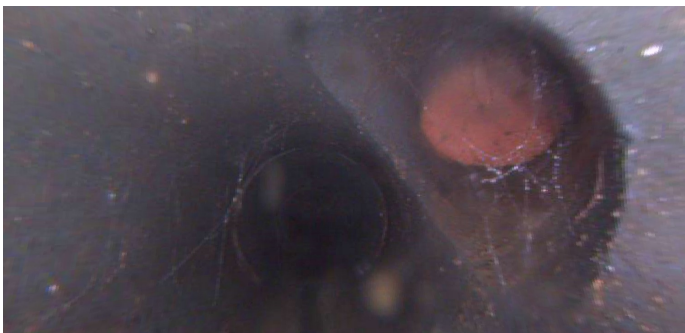
Code: **TFC**
Description: **Tap Factory Capped**

Distance (ft): **131.9**
Structural Grade: **0**
O&M Grade: **0**
Clock Start/From: **2**
Clock To:
1st Value: **4.000**
2nd Value:
Value Percent:
Continuous Index:
Within 8" of Joint:
Remarks:

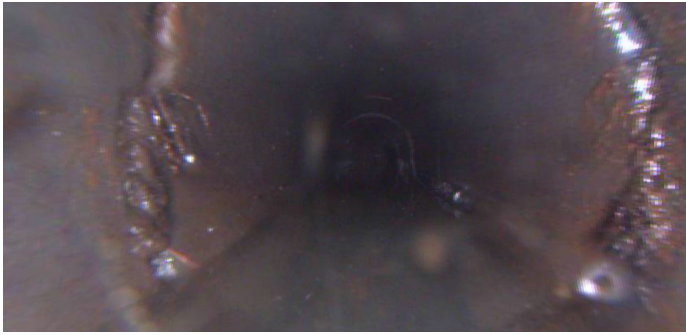
Code: **RFJ**
Description: **Roots Fine Joint**

Distance (ft): **151.1**
Structural Grade: **0**
O&M Grade: **1**
Clock Start/From: **7**
Clock To: **5**
1st Value:
2nd Value:
Value Percent:
Continuous Index:
Within 8" of Joint: **YES**
Remarks:

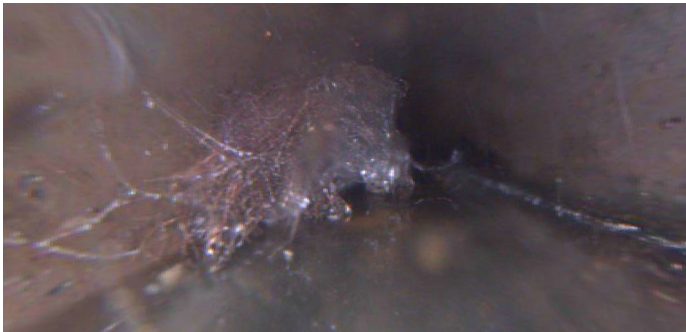
Code: **RBB**
Description: **Roots Ball Barrel**

Distance (ft): **155.4**
Structural Grade: **0**
O&M Grade: **5**
Clock Start/From: **7**
Clock To: **12**
1st Value:
2nd Value:
Value Percent: **60.000**
Continuous Index:
Within 8" of Joint: **NO**
Remarks:

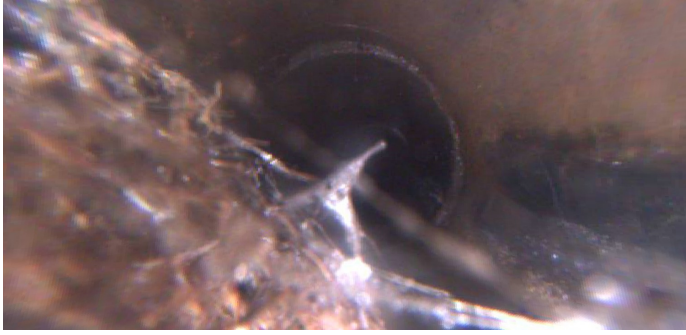
Code:	MSA
Description:	Abandoned Survey
Distance (ft):	157.0
Structural Grade:	0
O&M Grade:	0
Clock Start/From:	
Clock To:	
1st Value:	
2nd Value:	
Value Percent:	
Continuous Index:	
Within 8" of Joint:	NO
Remarks:	CANNOT PASS RBB
