## Profile/Photo Observation Report

Date:	<b>04/19/2018</b>	Weather:		Coding:	<b>PACP 6.0</b>
Pipe Length (ft):	<b>281.0</b>	Owner:	<b>NA</b>	Pre Clean:	<b>Not Known</b>
P.O.#:		Surveyor:	<b>Byrd Fitzgerald</b>	PSR:	<b>P-805-042-057</b>
Customer:		Clean Date:	<b>01/01/1900</b>	Shape:	<b>C</b>

Street:	<b>S OHIO ST &amp; LILLIAN ST</b>	Flow Control:	<b>Not Controlled</b>
City:	<b>Hobart, IN</b>	Year Renewed:	
Location:	<b>Other</b>	Tape/Media #:	
Purpose:	<b>Not Known</b>	Dia/Height:	<b>8"</b>
Use:	<b>Sanitary</b>	Material:	<b>VCP</b>
Drain Area:	<b>NA</b>	Lining:	
Category:	<b>NA</b>		
Comment:

Location Details:		Direction of Survey:	<b>Upstream</b>
US MH:	<b>M-805-057</b>	DS MH:	<b>M-805-042</b>
		Total Length Surveyed (ft):	<b>121.6</b>

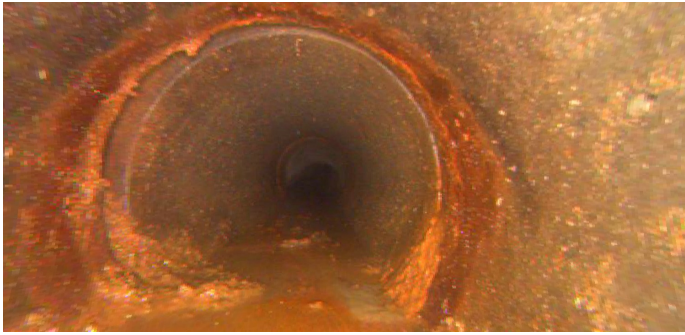
Code: **AMH**  
Description: **Manhole**

Distance (ft): **.0**  
Structural Grade: **0**  
O&M Grade: **0**  
Clock Start/From:  
Clock To:  
1st Value:  
2nd Value:  
Value Percent:  
Continuous Index:  
Within 8" of Joint: **NO**  
Remarks: **M-805-042**

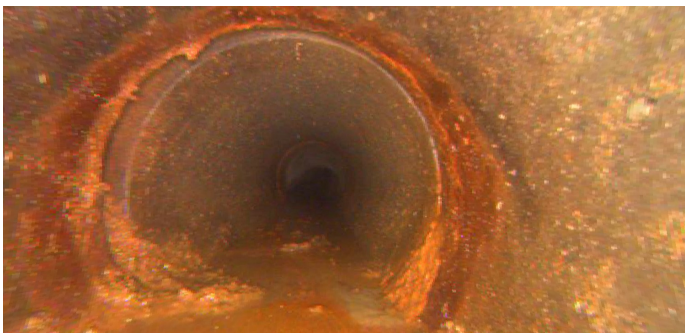
Code: **MWL**  
Description: **Water Level**

Distance (ft): **.0**  
Structural Grade: **0**  
O&M Grade: **0**  
Clock Start/From:  
Clock To:  
1st Value:  
2nd Value:  
Value Percent: **5.000**  
Continuous Index:  
Within 8" of Joint: **NO**  
Remarks:

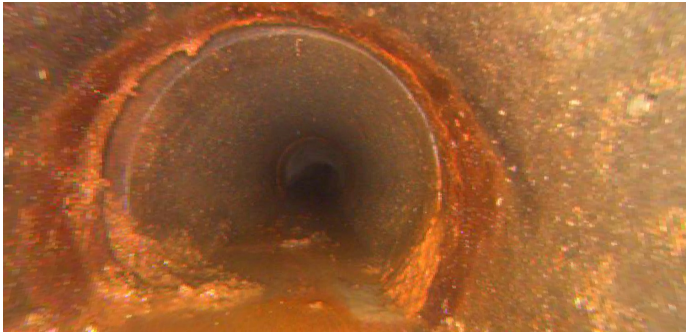
Code: **IS**  
Description: **Infil Stain**

Distance (ft): **.0**  
Structural Grade: **0**  
O&M Grade: **0**  
Clock Start/From: **7**  
Clock To: **5**  
1st Value:  
2nd Value:  
Value Percent:  
Continuous Index: **S01**  
Within 8" of Joint: **YES**  
Remarks:

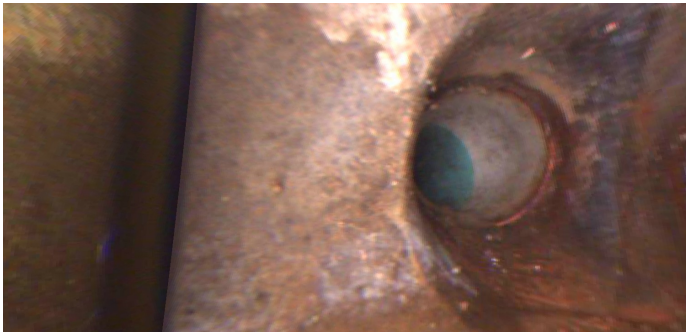
Code: **TF**  
Description: **Tap Factory**

Distance (ft): **5.4**  
Structural Grade: **0**  
O&M Grade: **0**  
Clock Start/From: **3**  
Clock To:  
1st Value: **4.000**  
2nd Value:  
Value Percent:  
Continuous Index:  
Within 8" of Joint: **YES**  
Remarks:

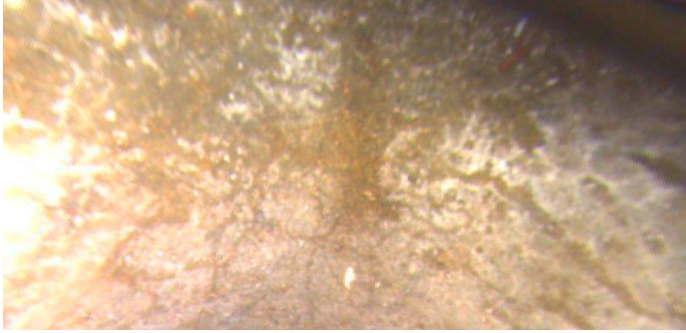
Code: **CM**  
Description: **Crack Multiple**

Distance (ft): **8.2**  
Structural Grade: **3**  
O&M Grade: **0**  
Clock Start/From: **8**  
Clock To: **4**  
1st Value:  
2nd Value:  
Value Percent:  
Continuous Index: **S02**  
Within 8" of Joint: **YES**  
Remarks: **wandering**

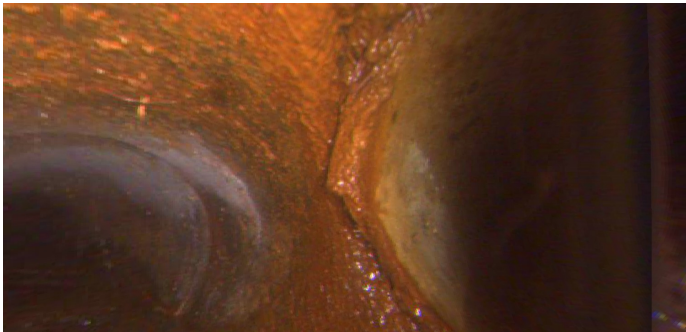
Code: **TB**  
Description: **Tap Break-in**

Distance (ft): **11.2**  
Structural Grade: **0**  
O&M Grade: **0**  
Clock Start/From: **3**  
Clock To:  
1st Value: **6.000**  
2nd Value:  
Value Percent:  
Continuous Index:  
Within 8" of Joint:  
Remarks:

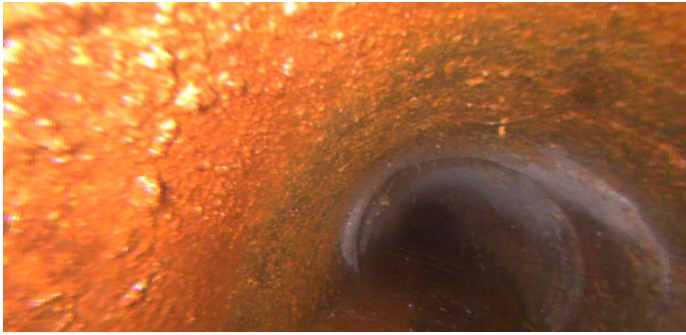
Code: **DAE**  
Description: **Deposits Attached Encrustation**

Distance (ft): **11.2**  
Structural Grade: **0**  
O&M Grade: **2**  
Clock Start/From: **7**  
Clock To: **5**  
1st Value:  
2nd Value:  
Value Percent: **5.000**  
Continuous Index:  
Within 8" of Joint: **NO**  
Remarks:

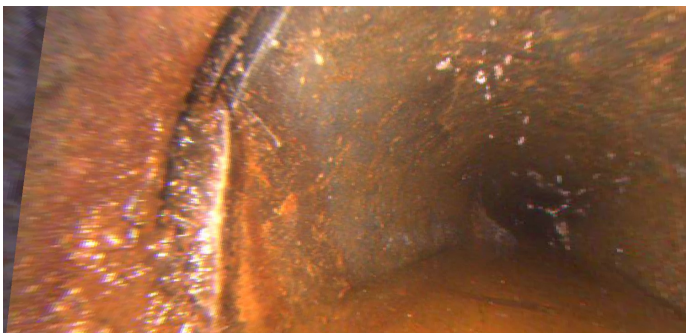
Code: **DAE**  
Description: **Deposits Attached Encrustation**

Distance (ft): **18.1**  
Structural Grade: **0**  
O&M Grade: **2**  
Clock Start/From: **7**  
Clock To: **5**  
1st Value:  
2nd Value:  
Value Percent: **5.000**  
Continuous Index:  
Within 8" of Joint: **YES**  
Remarks:

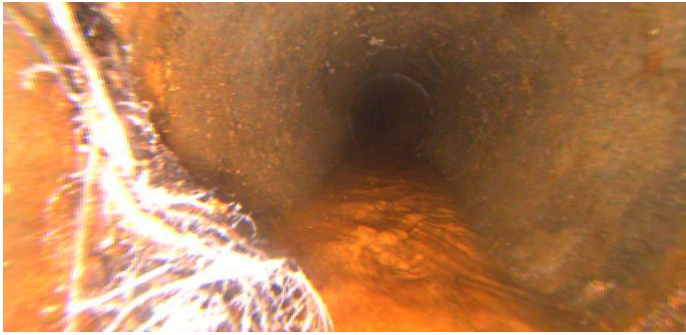
Code: **RFJ**  
Description: **Roots Fine Joint**

Distance (ft): **20.0**  
Structural Grade: **0**  
O&M Grade: **1**  
Clock Start/From: **7**  
Clock To: **9**  
1st Value:  
2nd Value:  
Value Percent:  
Continuous Index: **S03**  
Within 8" of Joint: **YES**  
Remarks: **wandering**

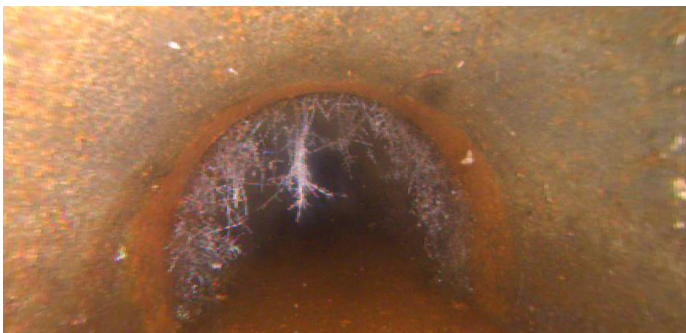
Code: **RMJ**  
Description: **Roots Medium Joint**

Distance (ft): **33.6**  
Structural Grade: **0**  
O&M Grade: **3**  
Clock Start/From: **7**  
Clock To: **5**  
1st Value:  
2nd Value:  
Value Percent: **5.000**  
Continuous Index: **S04**  
Within 8" of Joint: **YES**  
Remarks: **wandering**

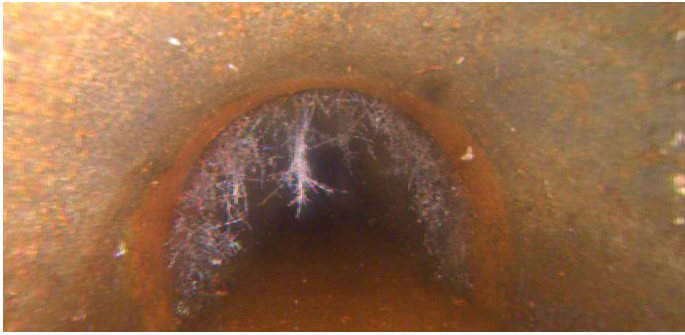
Code: **RFJ**  
Description: **Roots Fine Joint**

Distance (ft): **33.6**  
Structural Grade: **0**  
O&M Grade: **1**  
Clock Start/From: **7**  
Clock To: **9**  
1st Value:  
2nd Value:  
Value Percent:  
Continuous Index: **F03**  
Within 8" of Joint: **YES**  
Remarks: **wandering**

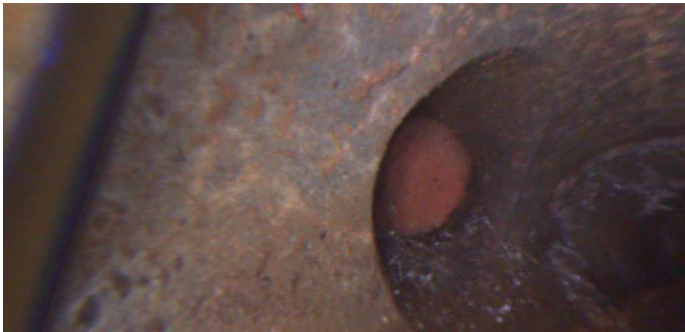
Code: **TFC**  
Description: **Tap Factory Capped**

Distance (ft): **39.8**  
Structural Grade: **0**  
O&M Grade: **0**  
Clock Start/From: **2**  
Clock To:  
1st Value: **4.000**  
2nd Value:  
Value Percent:  
Continuous Index:  
Within 8" of Joint: **YES**  
Remarks:

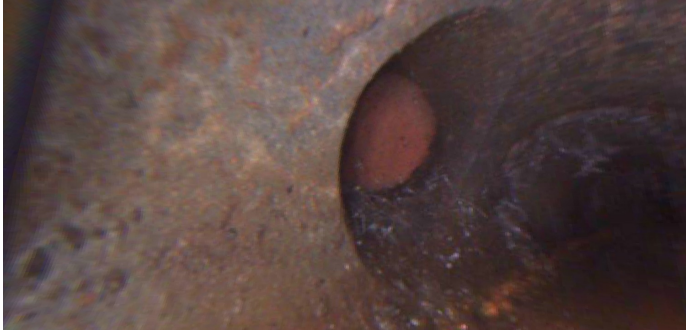
Code: **RFL**  
Description: **Roots Fine Lateral**

Distance (ft): **39.8**  
Structural Grade: **0**  
O&M Grade: **1**  
Clock Start/From: **3**  
Clock To:  
1st Value:  
2nd Value:  
Value Percent:  
Continuous Index:  
Within 8" of Joint: **NO**  
Remarks:

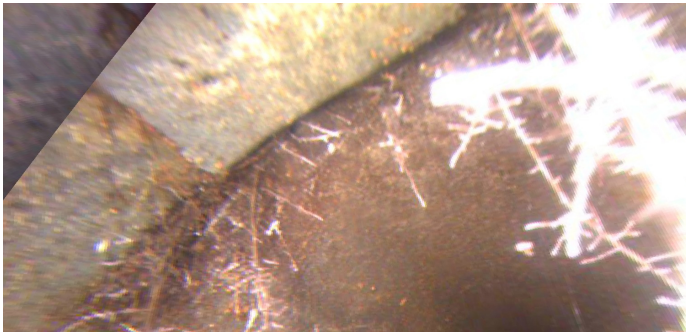
Code: **CM**  
Description: **Crack Multiple**

Distance (ft): **40.2**  
Structural Grade: **3**  
O&M Grade: **0**  
Clock Start/From: **11**  
Clock To: **1**  
1st Value:  
2nd Value:  
Value Percent:  
Continuous Index: **S05**  
Within 8" of Joint: **YES**  
Remarks: **wandering**

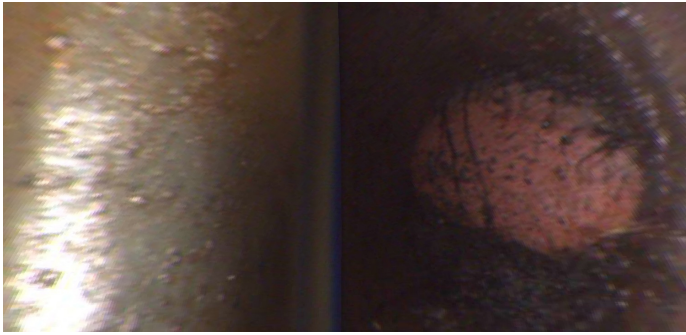
Code: **TFC**  
Description: **Tap Factory Capped**

Distance (ft): **72.4**  
Structural Grade: **0**  
O&M Grade: **0**  
Clock Start/From: **2**  
Clock To:  
1st Value: **4.000**  
2nd Value:  
Value Percent:  
Continuous Index:  
Within 8" of Joint: **YES**  
Remarks:

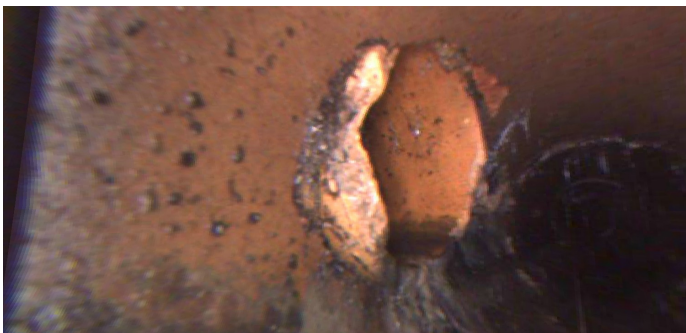
Code: **TB**  
Description: **Tap Break-in**

Distance (ft): **95.6**  
Structural Grade: **0**  
O&M Grade: **0**  
Clock Start/From: **2**  
Clock To:  
1st Value: **4.000**  
2nd Value:  
Value Percent:  
Continuous Index:  
Within 8" of Joint:  
Remarks:

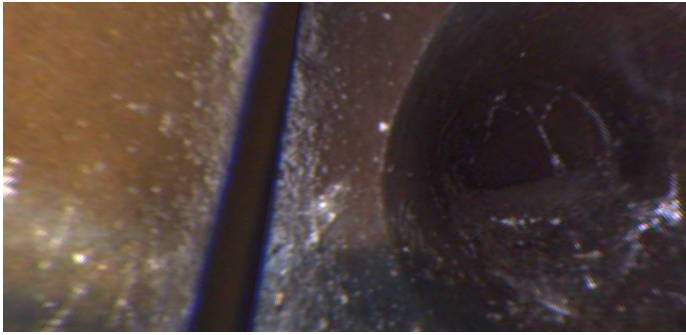
Code: **TFD**  
Description: **Tap Factory Defective**

Distance (ft): **99.2**  
Structural Grade: **0**  
O&M Grade: **2**  
Clock Start/From: **2**  
Clock To:  
1st Value: **4.000**  
2nd Value:  
Value Percent:  
Continuous Index:  
Within 8" of Joint: **YES**  
Remarks: **partially blocked**

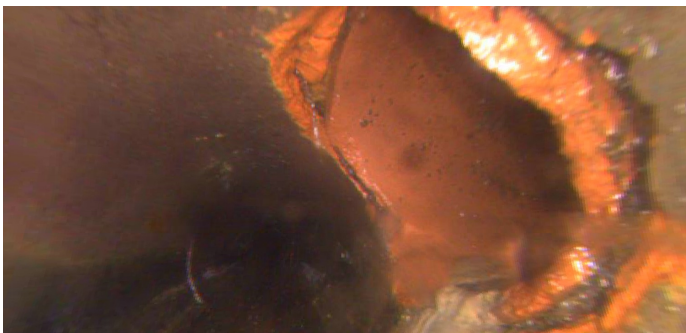
Code: **TB**  
Description: **Tap Break-in**

Distance (ft): **106.5**  
Structural Grade: **0**  
O&M Grade: **0**  
Clock Start/From: **3**  
Clock To:  
1st Value: **6.000**  
2nd Value:  
Value Percent:  
Continuous Index:  
Within 8" of Joint:  
Remarks:

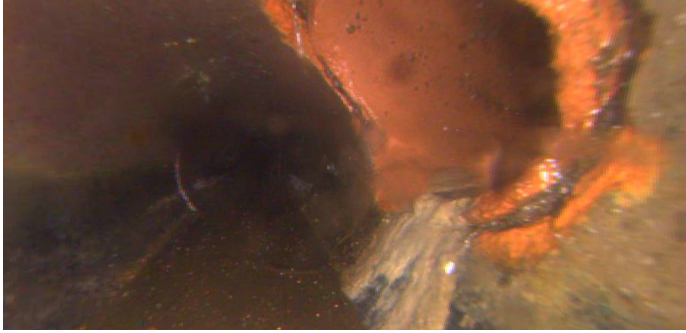
Code: **DAGS**  
Description: **Deposits Attached Grease**

Distance (ft): **106.5**  
Structural Grade: **0**  
O&M Grade: **2**  
Clock Start/From: **4**  
Clock To: **5**  
1st Value:  
2nd Value:  
Value Percent: **5.000**  
Continuous Index:  
Within 8" of Joint: **NO**  
Remarks:

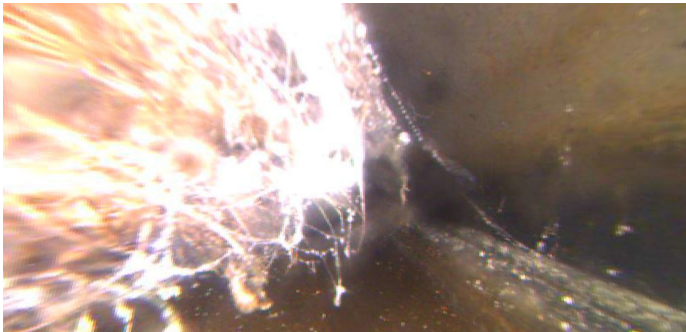
Code: **RBJ**  
Description: **Roots Ball Joint**

Distance (ft): **116.1**  
Structural Grade: **0**  
O&M Grade: **4**  
Clock Start/From: **7**  
Clock To: **12**  
1st Value:  
2nd Value:  
Value Percent: **55.000**  
Continuous Index:  
Within 8" of Joint: **YES**  
Remarks:

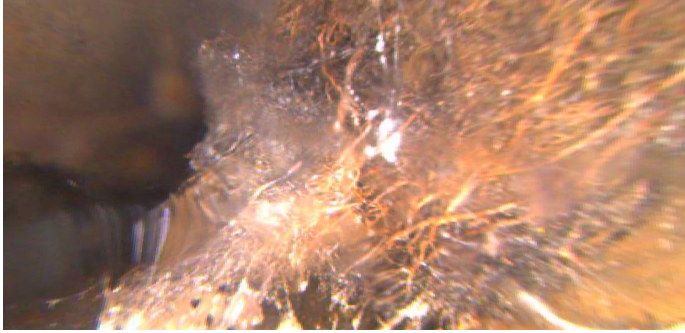
Code: **RBB**  
Description: **Roots Ball Barrel**

Distance (ft): **120.7**  
Structural Grade: **0**  
O&M Grade: **5**  
Clock Start/From: **12**  
Clock To: **5**  
1st Value:  
2nd Value:  
Value Percent: **55.000**  
Continuous Index:  
Within 8" of Joint: **NO**  
Remarks: **possible defective tap**

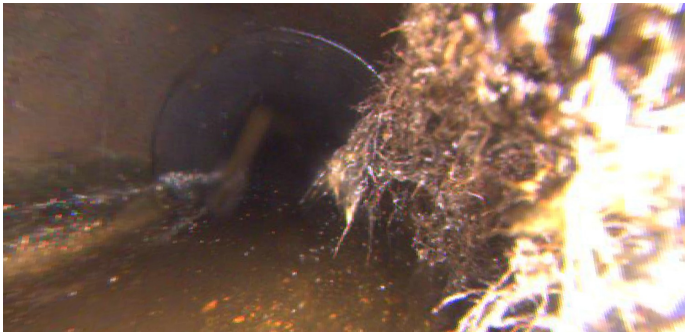
Code: **MSA**  
Description: **Abandoned Survey**

Distance (ft): **121.6**  
Structural Grade: **0**  
O&M Grade: **0**  
Clock Start/From:  
Clock To:  
1st Value:  
2nd Value:  
Value Percent:  
Continuous Index:  
Within 8" of Joint: **NO**  
Remarks: **rbb**

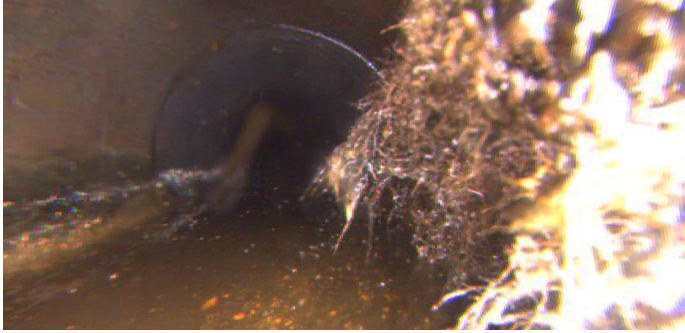
Code: **CM**  
Description: **Crack Multiple**

Distance (ft): **121.6**  
Structural Grade: **3**  
O&M Grade: **0**  
Clock Start/From: **11**  
Clock To: **1**  
1st Value:  
2nd Value:  
Value Percent:  
Continuous Index: **F05**  
Within 8" of Joint: **YES**  
Remarks: **wandering**

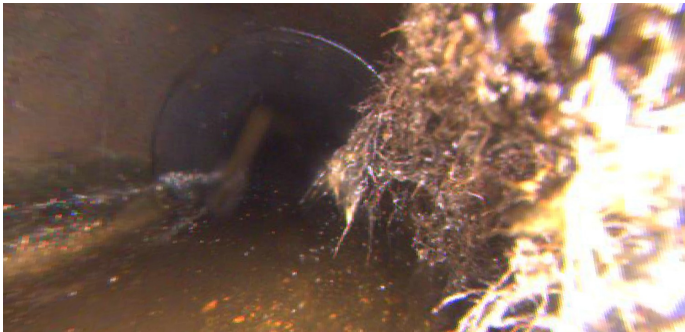
Code: **RMJ**  
Description: **Roots Medium Joint**

Distance (ft): **121.6**  
Structural Grade: **0**  
O&M Grade: **3**  
Clock Start/From: **7**  
Clock To: **5**  
1st Value:  
2nd Value:  
Value Percent: **5.000**  
Continuous Index: **F04**  
Within 8" of Joint: **YES**  
Remarks: **wandering**

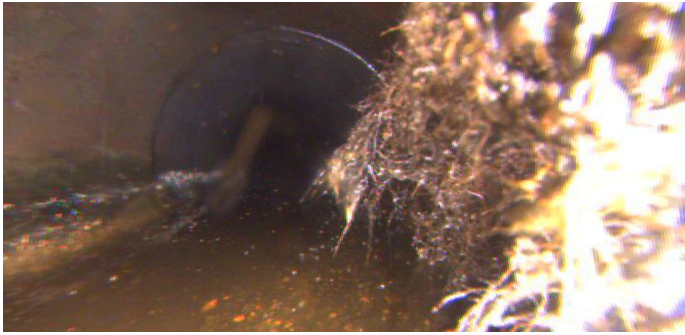
Code: **CM**  
Description: **Crack Multiple**

Distance (ft): **121.6**  
Structural Grade: **3**  
O&M Grade: **0**  
Clock Start/From: **8**  
Clock To: **4**  
1st Value:  
2nd Value:  
Value Percent:  
Continuous Index: **F02**  
Within 8" of Joint: **YES**  
Remarks: **wandering**

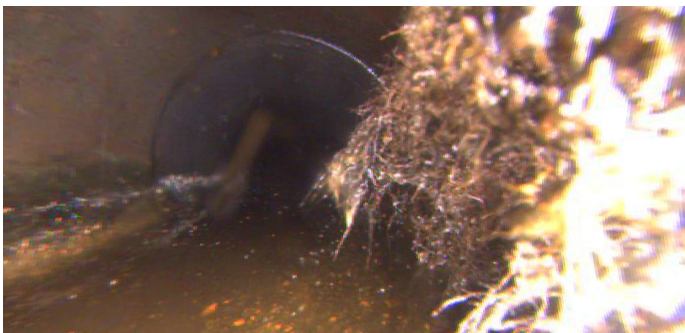
Code: **IS**  
Description: **Infil Stain**

Distance (ft): **121.6**  
Structural Grade: **0**  
O&M Grade: **0**  
Clock Start/From: **7**  
Clock To: **5**  
1st Value:  
2nd Value:  
Value Percent:  
Continuous Index: **F01**  
Within 8" of Joint: **YES**  
Remarks:
