Profile/Photo Observation Report

Street:	LILLIAN ST & S INDIANA ST	Flow Control:	Not Controlled
City:	Hobart, IN	Year Renewed:	
Location:	Other	Tape/Media #:	
Purpose:	Not Known	Dia/Height:	12"
Use:	Sanitary	Material:	VCP
Drain Area:	NA	Lining:	
Category:	NA		
Comment:

Location Details:		Direction of Survey:	Upstream
US MH:	M-805-058	DS MH:	M-805-056
		Total Length Surveyed (ft):	57.1

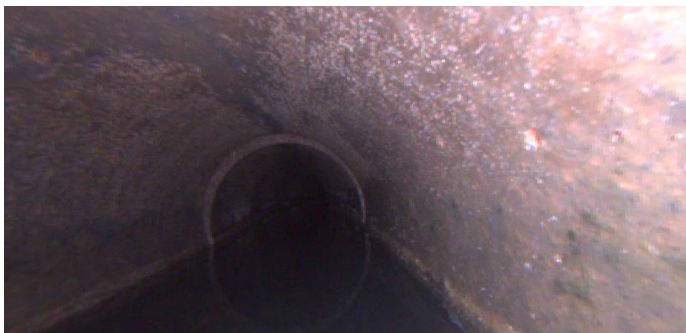
Code: **AMH**
Description: **Manhole**

Distance (ft): **.0**
Structural Grade: **0**
O&M Grade: **0**
Clock Start/From:
Clock To:
1st Value:
2nd Value:
Value Percent:
Continuous Index:
Within 8" of Joint: **NO**
Remarks: **M-805-056**

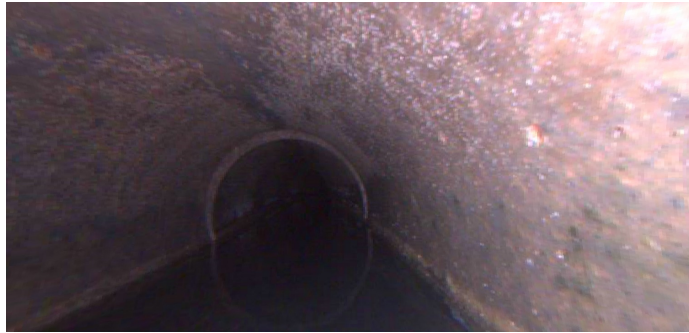
Code: **MWL**
Description: **Water Level**

Distance (ft): **.0**
Structural Grade: **0**
O&M Grade: **0**
Clock Start/From:
Clock To:
1st Value:
2nd Value:
Value Percent: **5.000**
Continuous Index:
Within 8" of Joint: **NO**
Remarks:

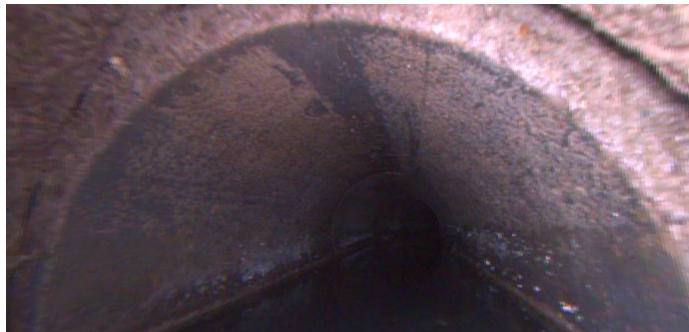
Code: **CM**
Description: **Crack Multiple**

Distance (ft): **.6**
Structural Grade: **3**
O&M Grade: **0**
Clock Start/From: **10**
Clock To: **1**
1st Value:
2nd Value:
Value Percent:
Continuous Index: **S01**
Within 8" of Joint: **YES**
Remarks: **wandering**

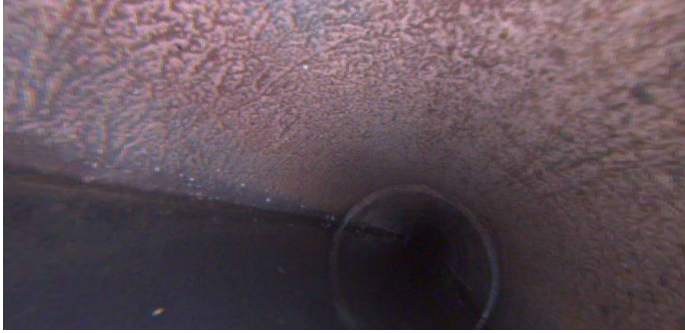
Code: **MSA**
Description: **Abandoned Survey**

Distance (ft): **57.1**
Structural Grade: **0**
O&M Grade: **0**
Clock Start/From:
Clock To:
1st Value:
2nd Value:
Value Percent:
Continuous Index:
Within 8" of Joint: **NO**
Remarks: **cracked pipe**

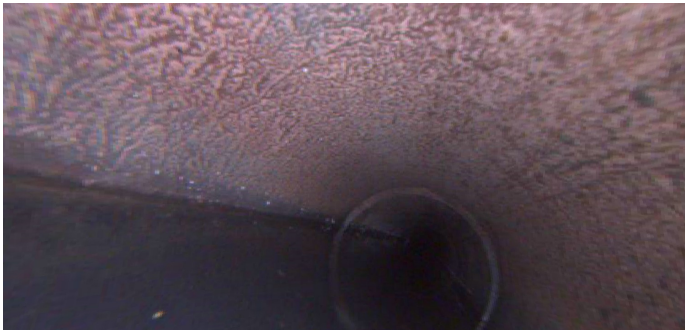
Code: **CM**
Description: **Crack Multiple**

Distance (ft): **57.1**
Structural Grade: **3**
O&M Grade: **0**
Clock Start/From: **10**
Clock To: **1**
1st Value:
2nd Value:
Value Percent:
Continuous Index: **F01**
Within 8" of Joint: **YES**
Remarks: **wandering**
