## Profile/Photo Observation Report

Street:	<b>S Indiana St.</b>	Flow Control:	<b>Not Controlled</b>
City:	<b>Hobart, IN</b>	Year Renewed:	
Location:	<b>Other</b>	Tape/Media #:	
Purpose:	<b>Not Known</b>	Dia/Height:	<b>12"</b>
Use:	<b>Sanitary</b>	Material:	<b>VCP</b>
Drain Area:	<b>NA</b>	Lining:	
Category:	<b>NA</b>		
Comment:

Location Details:		Direction of Survey:	<b>Upstream</b>
US MH:	<b>M-805-058</b>	DS MH:	<b>M-805-056</b>
		Total Length Surveyed (ft):	<b>57.1</b>

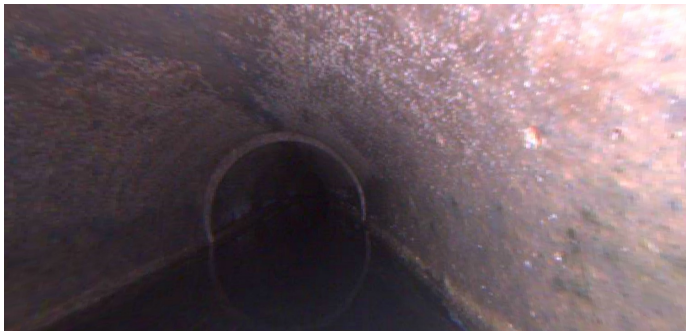
Code: **AMH**  
Description: **Manhole**

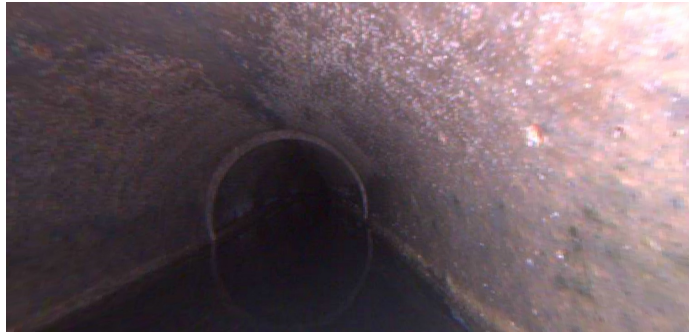
Code: **MWL**  
Description: **Water Level**

Distance (ft): **.0**  
Structural Grade: **0**  
O&M Grade: **0**  
Clock Start/From:  
Clock To:  
1st Value:  
2nd Value:  
Value Percent: **5.000**  
Continuous Index:  
Within 8" of Joint: **NO**  
Remarks:

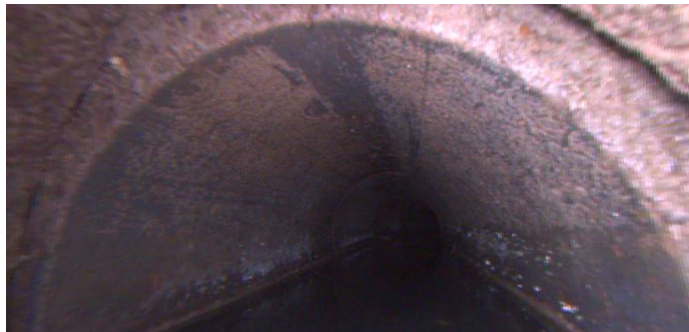
Code: **CM**  
Description: **Crack Multiple**

Distance (ft): **.6**  
Structural Grade: **3**  
O&M Grade: **0**  
Clock Start/From: **10**  
Clock To: **1**  
1st Value:  
2nd Value:  
Value Percent:  
Continuous Index: **S01**  
Within 8" of Joint: **YES**  
Remarks: **wandering**

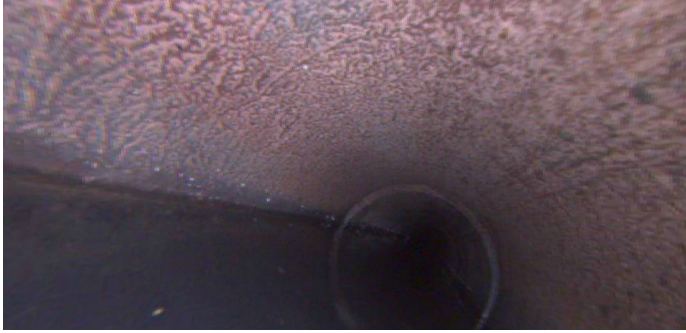
Code: **MSA**  
Description: **Abandoned Survey**

Distance (ft): **57.1**  
Structural Grade: **0**  
O&M Grade: **0**  
Clock Start/From:  
Clock To:  
1st Value:  
2nd Value:  
Value Percent:  
Continuous Index:  
Within 8" of Joint: **NO**  
Remarks: **cracked pipe**

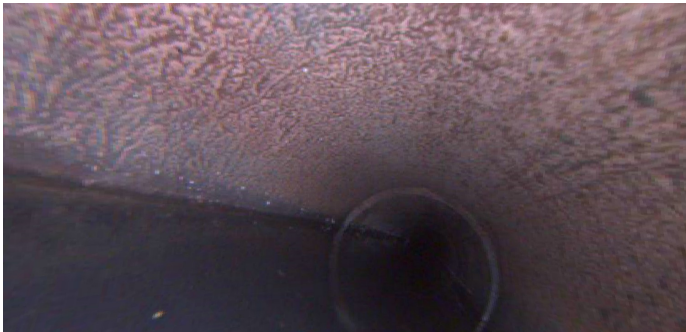
Code: **CM**  
Description: **Crack Multiple**

Distance (ft): **57.1**  
Structural Grade: **3**  
O&M Grade: **0**  
Clock Start/From: **10**  
Clock To: **1**  
1st Value:  
2nd Value:  
Value Percent:  
Continuous Index: **F01**  
Within 8" of Joint: **YES**  
Remarks: **wandering**
