Profile/Photo Observation Report

Street:	S Indiana St.	Flow Control:	Not Controlled
City:	Hobart, IN	Year Renewed:	
Location:	Other	Tape/Media #:	
Purpose:	Not Known	Dia/Height:	12"
Use:	Sanitary	Material:	VCP
Drain Area:	NA	Lining:	
Category:	NA		
Comment:

Location Details:		Direction of Survey:	Downstream
US MH:	M-805-058	DS MH:	M-805-056
		Total Length Surveyed (ft):	3.3

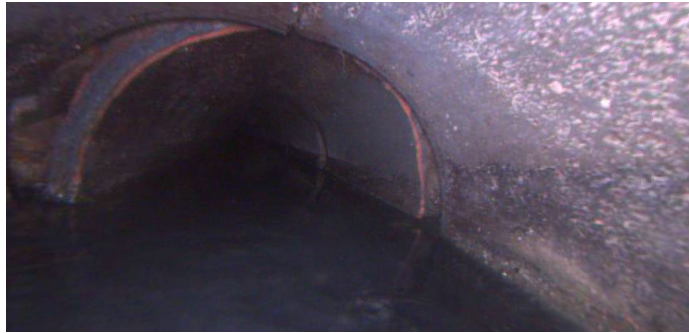
Code: **MWL**
Description: **Water Level**

Distance (ft): **.0**
Structural Grade: **0**
O&M Grade: **0**
Clock Start/From:
Clock To:
1st Value:
2nd Value:
Value Percent: **30.000**
Continuous Index:
Within 8" of Joint: **NO**
Remarks:

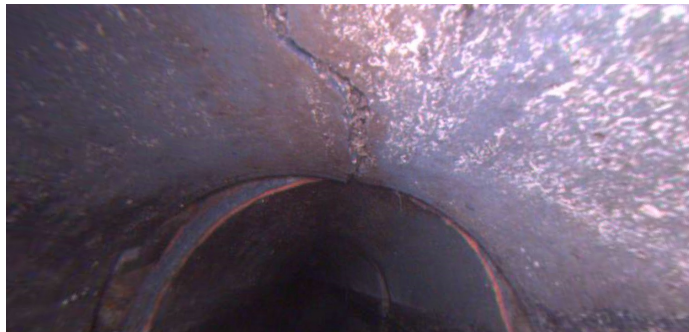
Code: **FL**
Description: **Fracture Longitudinal**

Distance (ft): **.0**
Structural Grade: **3**
O&M Grade: **0**
Clock Start/From: **12**
Clock To:
1st Value:
2nd Value:
Value Percent:
Continuous Index:
Within 8" of Joint: **YES**
Remarks:

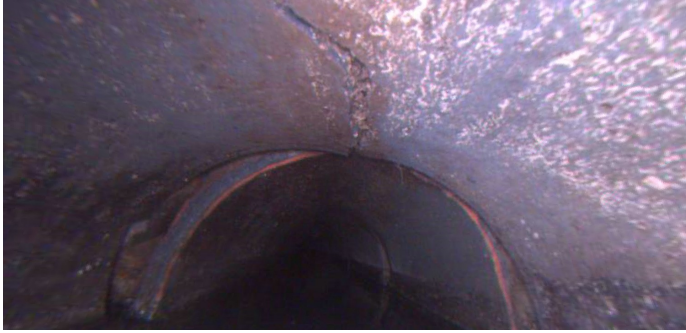
Code: **JOM**
Description: **Joint Offset Medium**

Distance (ft): **.0**
Structural Grade: **1**
O&M Grade: **0**
Clock Start/From:
Clock To:
1st Value:
2nd Value:
Value Percent:
Continuous Index:
Within 8" of Joint: **NO**
Remarks:

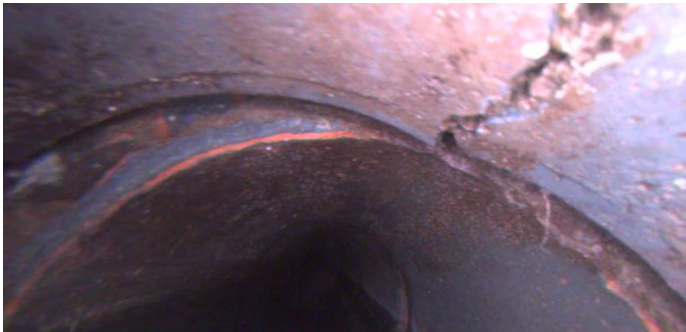
Code: **RFJ**
Description: **Roots Fine Joint**

Distance (ft): **1.2**
Structural Grade: **0**
O&M Grade: **1**
Clock Start/From: **1**
Clock To:
1st Value:
2nd Value:
Value Percent:
Continuous Index:
Within 8" of Joint: **YES**
Remarks:

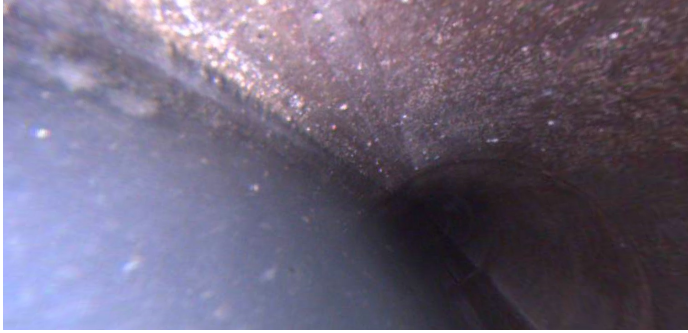
Code:	MSA
Description:	Abandoned Survey
Distance (ft):	2.6
Structural Grade:	0
O&M Grade:	0
Clock Start/From:	
Clock To:	
1st Value:	
2nd Value:	
Value Percent:	
Continuous Index:	
Within 8" of Joint:	NO
Remarks:	debris under water
