Profile/Photo Observation Report

Date:	01/15/2023	Weather:		Coding:	PACP 7.0
Pipe Length (ft):	132.0	Owner:	City of Hobart	Pre Clean:	Heavy Cleaning
P.O.#:	YES502259	Surveyor:	S. Bucklin	PSR:	P-805-058-056
Customer:	City of Hobart	Clean Date:	01/11/2023	Shape:	C

Street:	South Indiana Street	Flow Control:	Not Controlled
City:	Hobart, IN	Year Renewed:	
Location:	Local rural streets with light traffic, t	Tape/Media #:	
Purpose:	Routine Assessment	Dia/Height:	15"
Use:	Sanitary Sewage Pipe	Material:	VCP
Drain Area:		Lining:	None
Category:	NA		
Comment:			
Location Details:		Direction of Survey:	Upstream
US MH:	M-805-058	DS MH:	M-805-056
		Total Length Surveyed (ft):	127.3

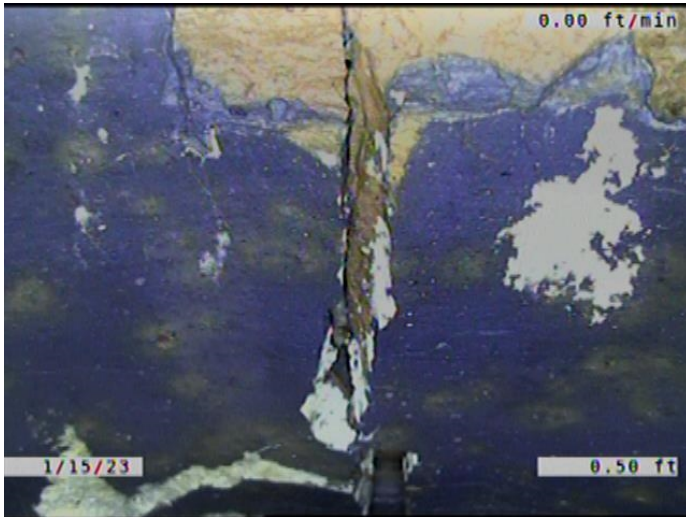
Code: **B**
 Description: **Broken**

Distance (ft): **.5**
 Structural Grade: **4**
 O&M Grade: **0**
 Clock Start/From: **12**
 Clock To: **12**
 1st Value:
 2nd Value:
 Value Percent:
 Continuous Index:
 Within 8" of Joint: **YES**
 Remarks:

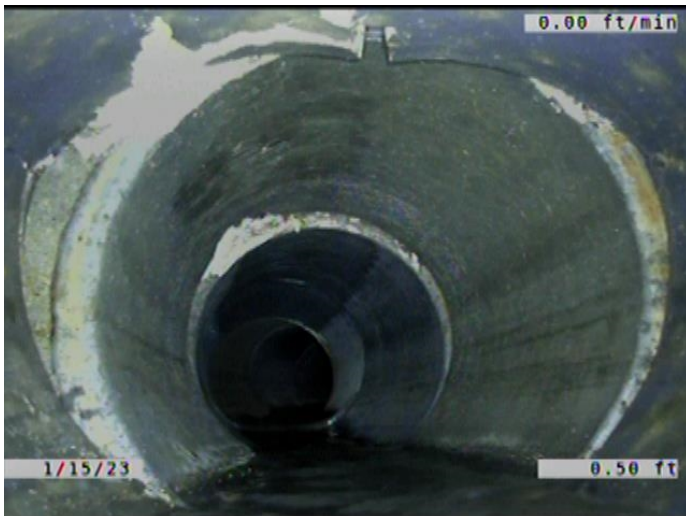
Code: **DR**
 Description: **Deformed Rigid**

Distance (ft): **.5**
 Structural Grade: **5**
 O&M Grade: **0**
 Clock Start/From:
 Clock To:
 1st Value:
 2nd Value:
 Value Percent: **10.000**
 Continuous Index:
 Within 8" of Joint: **NO**
 Remarks:

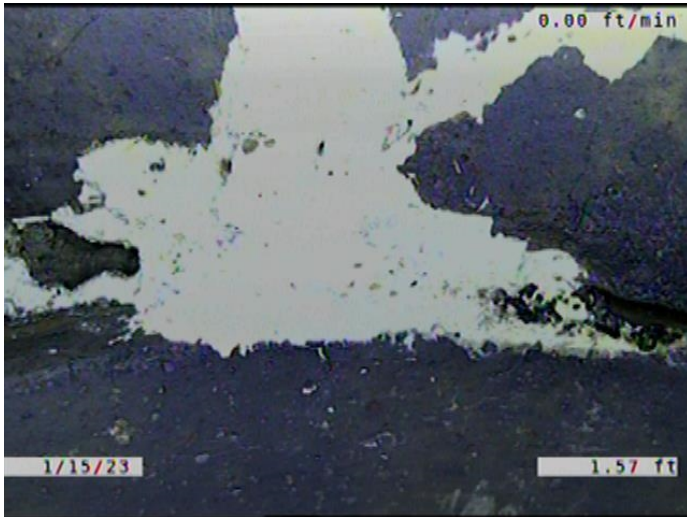
Code: **DAE**
 Description: **Deposits Attached Encrustation**

Distance (ft): **1.6**
 Structural Grade: **0**
 O&M Grade: **2**
 Clock Start/From: **10**
 Clock To: **2**
 1st Value:
 2nd Value:
 Value Percent: **5.000**
 Continuous Index: **S01**
 Within 8" of Joint: **YES**
 Remarks:

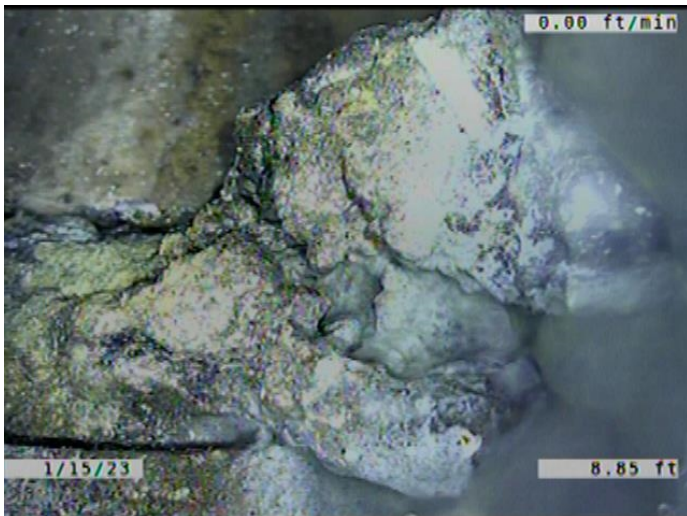
Code: **ISGT**
 Description: **Intruding Sealing Material Grout**

Distance (ft): **8.8**
 Structural Grade: **0**
 O&M Grade: **2**
 Clock Start/From: **7**
 Clock To: **8**
 1st Value:
 2nd Value:
 Value Percent: **5.000**
 Continuous Index:
 Within 8" of Joint: **NO**
 Remarks:

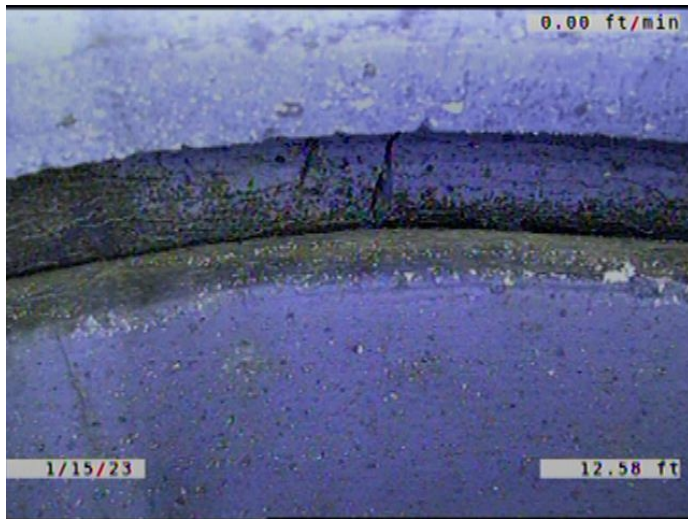
Code: **CM**
 Description: **Crack Multiple**

Distance (ft): **12.6**
 Structural Grade: **3**
 O&M Grade: **0**
 Clock Start/From: **10**
 Clock To: **2**
 1st Value:
 2nd Value:
 Value Percent:
 Continuous Index:
 Within 8" of Joint: **YES**
 Remarks:

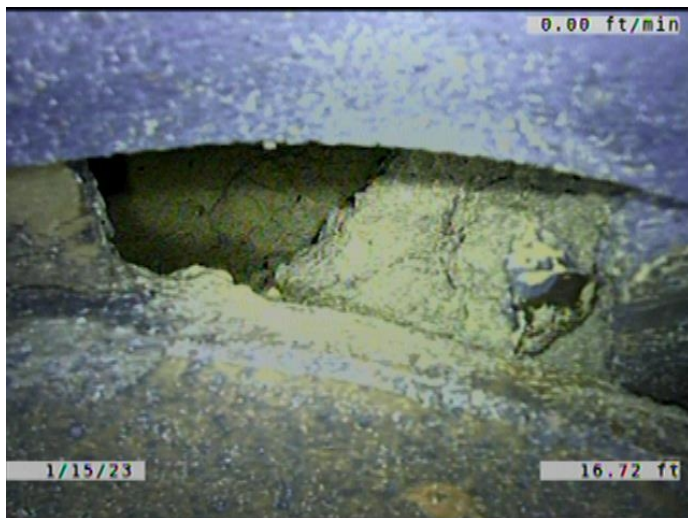
Code: **HVV**
 Description: **Hole Void Visible**

Distance (ft): **16.7**
 Structural Grade: **5**
 O&M Grade: **0**
 Clock Start/From: **1**
 Clock To: **4**
 1st Value:
 2nd Value:
 Value Percent:
 Continuous Index:
 Within 8" of Joint: **YES**
 Remarks: **SOIL AND VOID VISIBLE.**

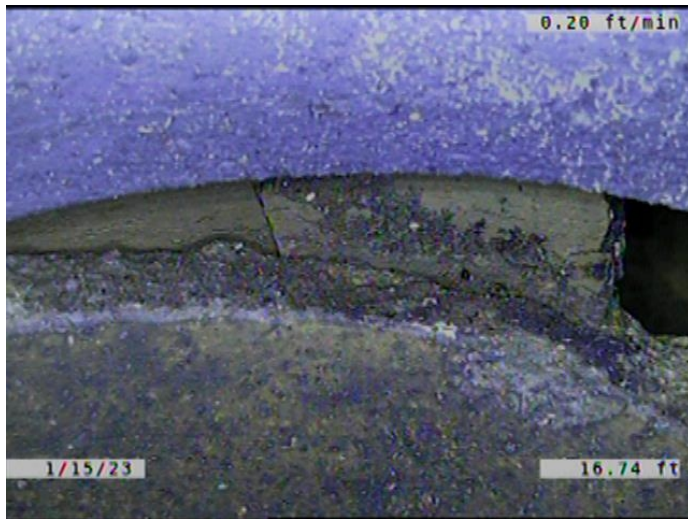
Code: **BVV**
 Description: **Broken Void Visible**

Distance (ft): **16.7**
 Structural Grade: **5**
 O&M Grade: **0**
 Clock Start/From: **11**
 Clock To: **4**
 1st Value:
 2nd Value:
 Value Percent:
 Continuous Index:
 Within 8" of Joint: **YES**
 Remarks:

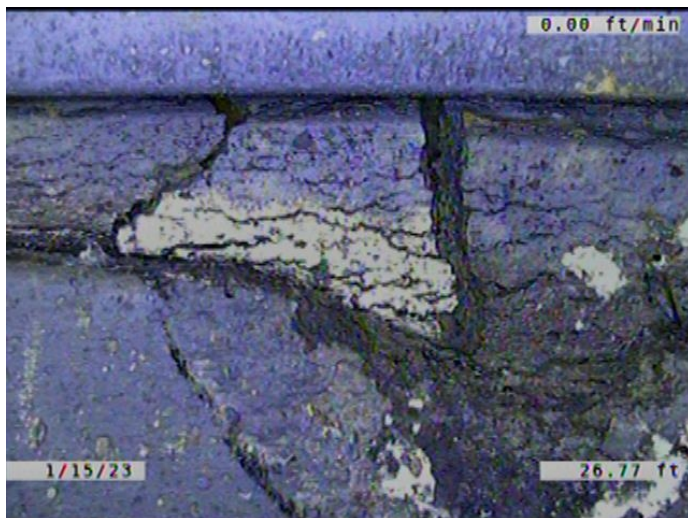
Code: **BSV**
 Description: **Broken Soil Visible**

Distance (ft): **26.8**
 Structural Grade: **5**
 O&M Grade: **0**
 Clock Start/From: **11**
 Clock To: **4**
 1st Value:
 2nd Value:
 Value Percent:
 Continuous Index:
 Within 8" of Joint: **YES**
 Remarks:

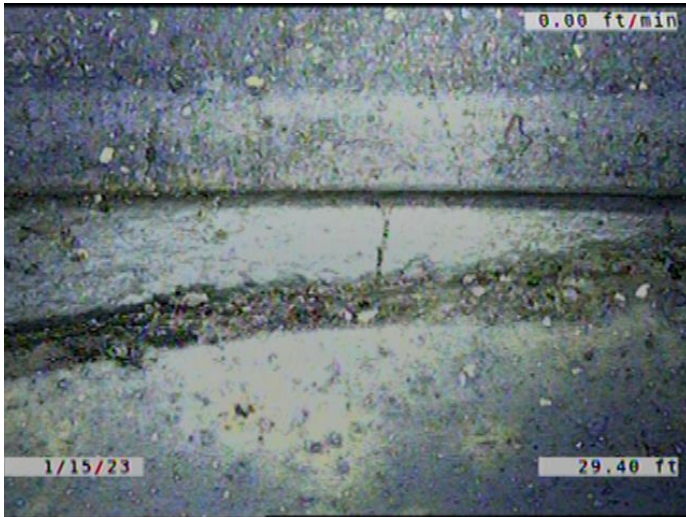
Code: **CL**
 Description: **Crack Longitudinal**

Distance (ft): **29.4**
 Structural Grade: **2**
 O&M Grade: **0**
 Clock Start/From: **12**
 Clock To:
 1st Value:
 2nd Value:
 Value Percent:
 Continuous Index:
 Within 8" of Joint: **YES**
 Remarks:

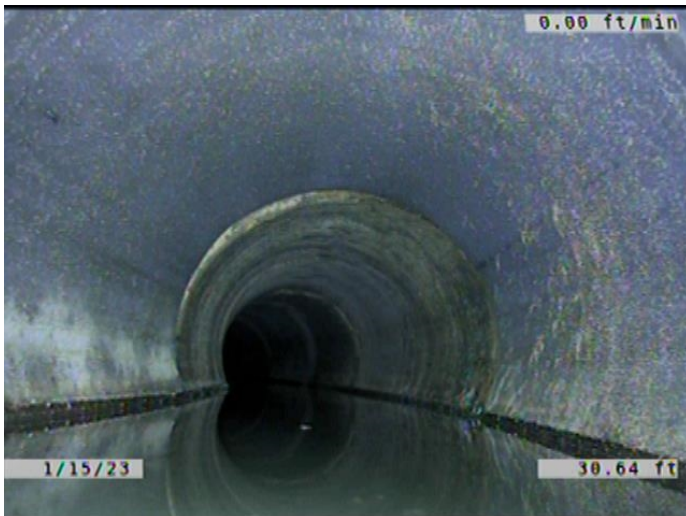
Code: **DAE**
 Description: **Deposits Attached Encrustation**

Distance (ft): **30.6**
 Structural Grade: **0**
 O&M Grade: **2**
 Clock Start/From: **10**
 Clock To: **2**
 1st Value:
 2nd Value:
 Value Percent: **5.000**
 Continuous Index: **F01**
 Within 8" of Joint: **YES**
 Remarks:

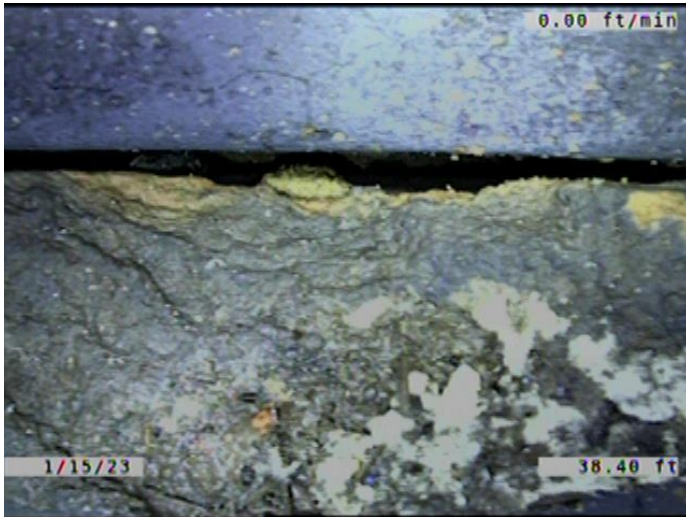
Code:	SZ
Description:	Surface Damage Other
Distance (ft):	38.4
Structural Grade:	0
O&M Grade:	0
Clock Start/From:	11
Clock To:	1
1st Value:	
2nd Value:	
Value Percent:	
Continuous Index:	
Within 8" of Joint:	YES
Remarks:	A PIECE CHIPPED AWAY FROM THE JOINT.

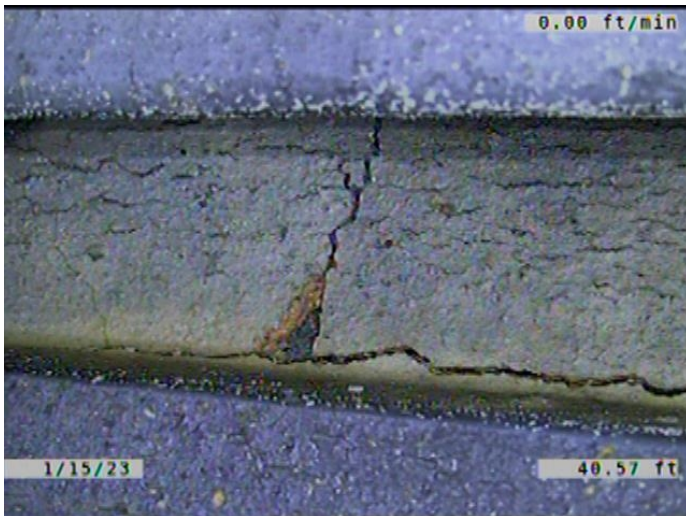
Code:	FM
Description:	Fracture Multiple
Distance (ft):	40.6
Structural Grade:	4
O&M Grade:	0
Clock Start/From:	8
Clock To:	4
1st Value:	
2nd Value:	
Value Percent:	
Continuous Index:	S02
Within 8" of Joint:	YES
Remarks:

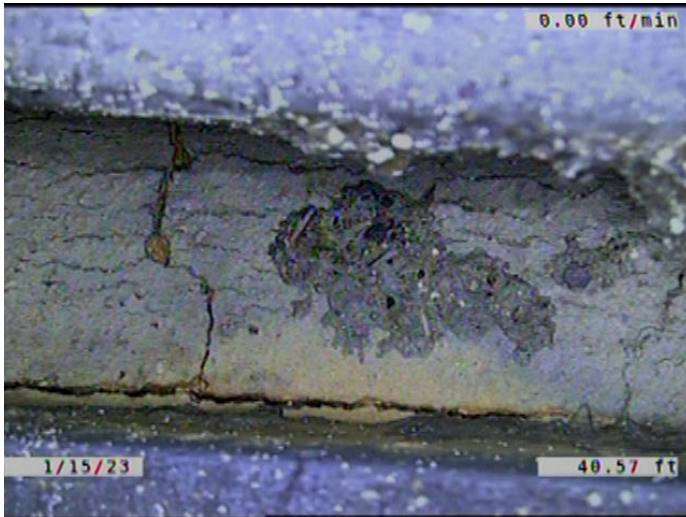
Code: **JAL**
Description: **Joint Angular Large**

Distance (ft): **40.6**
Structural Grade: **4**
O&M Grade: **0**
Clock Start/From:
Clock To:
1st Value:
2nd Value:
Value Percent:
Continuous Index:
Within 8" of Joint: **NO**
Remarks:

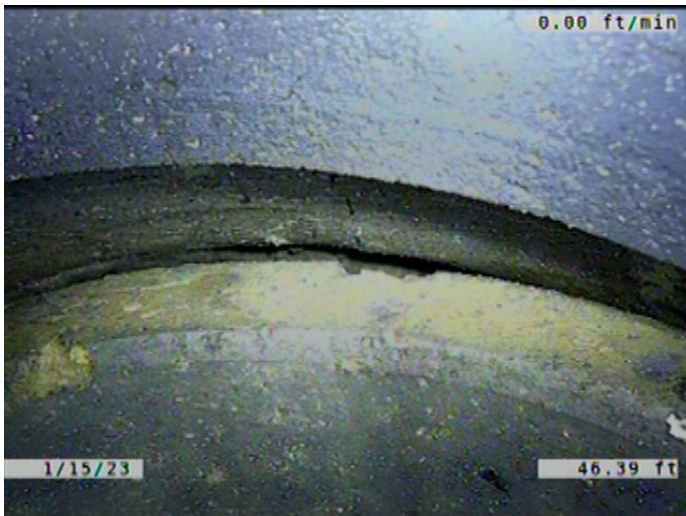
Code: **JAL**
Description: **Joint Angular Large**

Distance (ft): **46.4**
Structural Grade: **4**
O&M Grade: **0**
Clock Start/From:
Clock To:
1st Value:
2nd Value:
Value Percent:
Continuous Index: **S03**
Within 8" of Joint: **NO**
Remarks: **SOIL VISIBLE. WANDERING.**

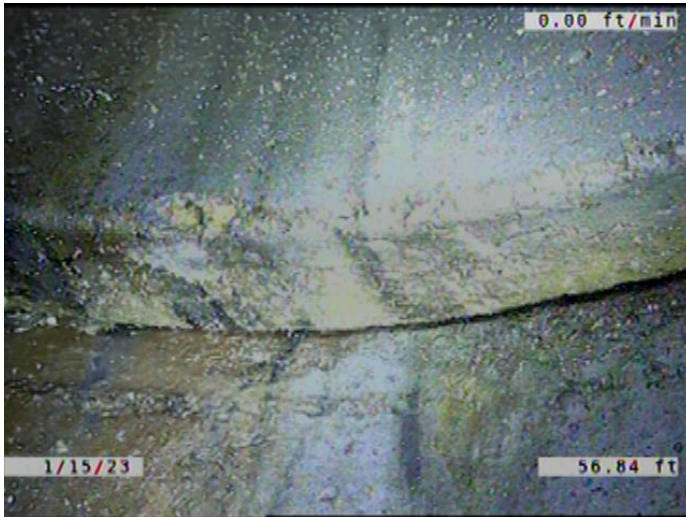
Code: **JOMD**
Description: **Joint Offset Medium Defective**

Distance (ft): **56.8**
Structural Grade: **3**
O&M Grade: **0**
Clock Start/From:
Clock To:
1st Value:
2nd Value:
Value Percent:
Continuous Index:
Within 8" of Joint: **NO**
Remarks:

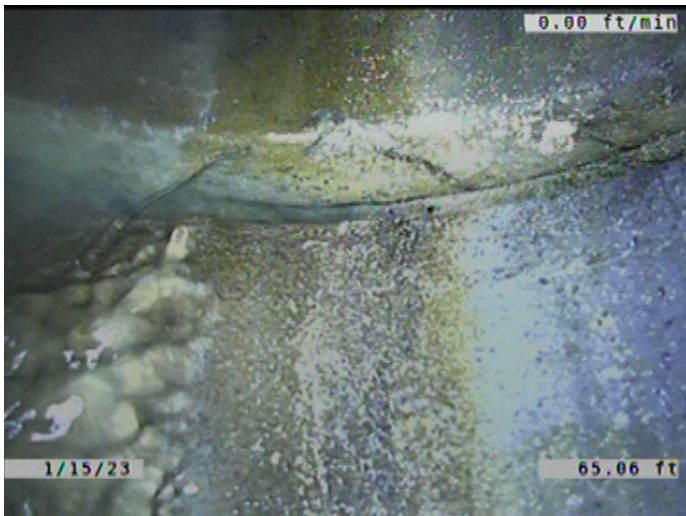
Code: **JOMD**
Description: **Joint Offset Medium Defective**

Distance (ft): **65.1**
Structural Grade: **3**
O&M Grade: **0**
Clock Start/From:
Clock To:
1st Value:
2nd Value:
Value Percent:
Continuous Index:
Within 8" of Joint: **NO**
Remarks:

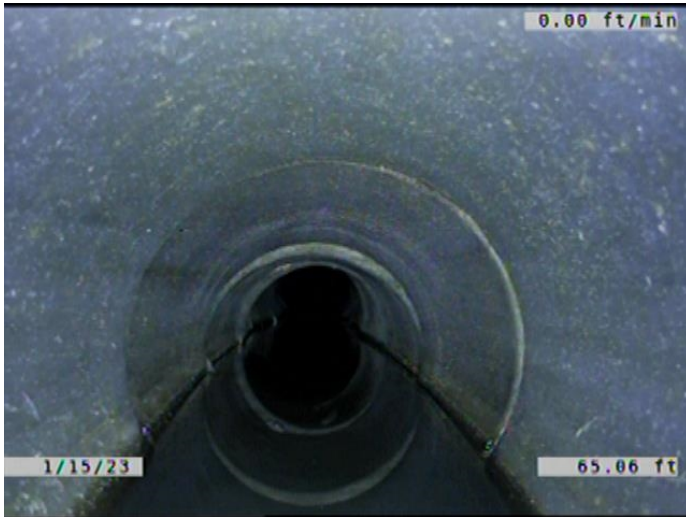
Code: **MWLS**
Description: **Miscellaneous Water Level Sag**

Distance (ft): **65.1**
Structural Grade: **2**
O&M Grade: **0**
Clock Start/From:
Clock To:
1st Value:
2nd Value:
Value Percent: **20.000**
Continuous Index: **S04**
Within 8" of Joint: **NO**
Remarks:

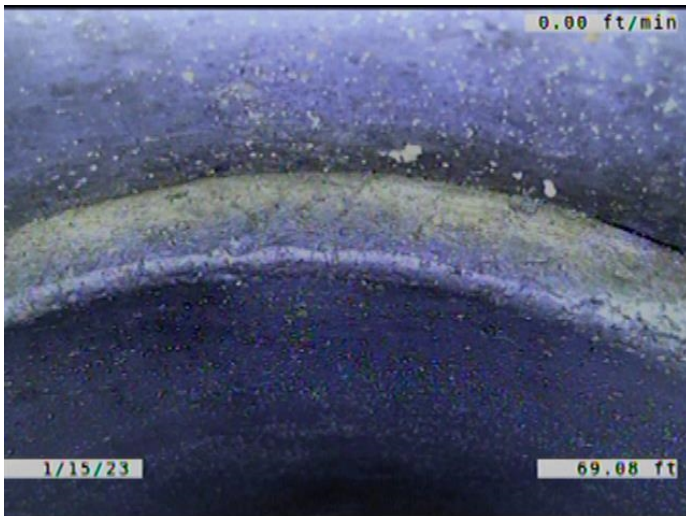
Code: **JOMD**
Description: **Joint Offset Medium Defective**

Distance (ft): **69.1**
Structural Grade: **3**
O&M Grade: **0**
Clock Start/From:
Clock To:
1st Value:
2nd Value:
Value Percent:
Continuous Index:
Within 8" of Joint: **NO**
Remarks:

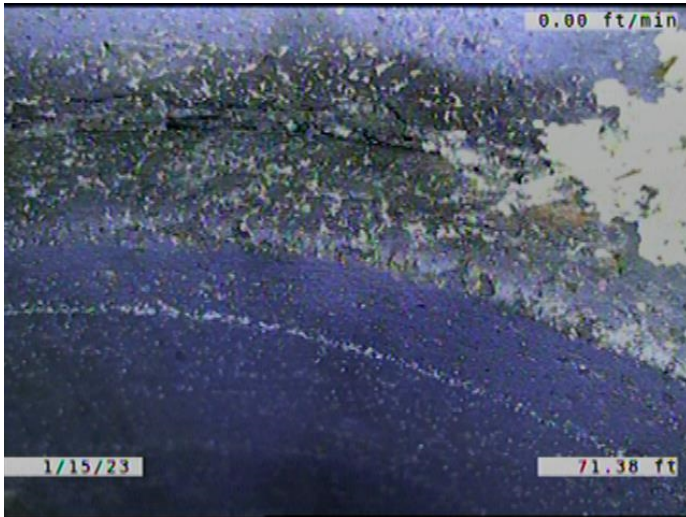
Code: **JOMD**
 Description: **Joint Offset Medium Defective**

Distance (ft): **71.4**
 Structural Grade: **3**
 O&M Grade: **0**
 Clock Start/From:
 Clock To:
 1st Value:
 2nd Value:
 Value Percent:
 Continuous Index:
 Within 8" of Joint: **NO**
 Remarks:

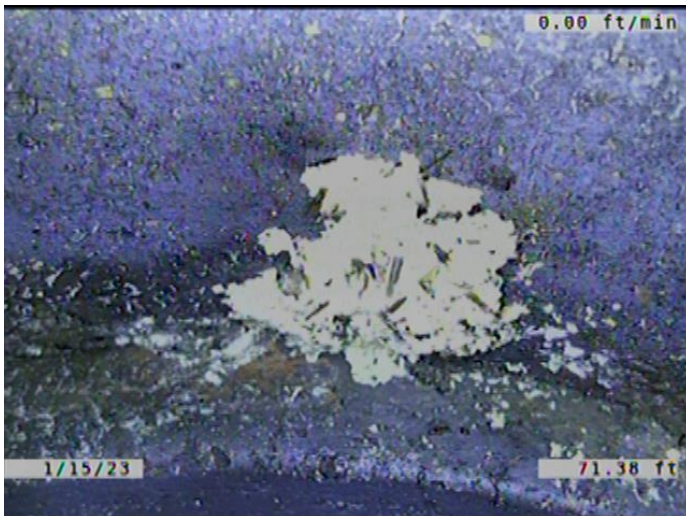
Code: **DAE**
 Description: **Deposits Attached Encrustation**

Distance (ft): **71.4**
 Structural Grade: **0**
 O&M Grade: **2**
 Clock Start/From: **10**
 Clock To: **2**
 1st Value:
 2nd Value:
 Value Percent: **5.000**
 Continuous Index: **S05**
 Within 8" of Joint: **YES**
 Remarks:

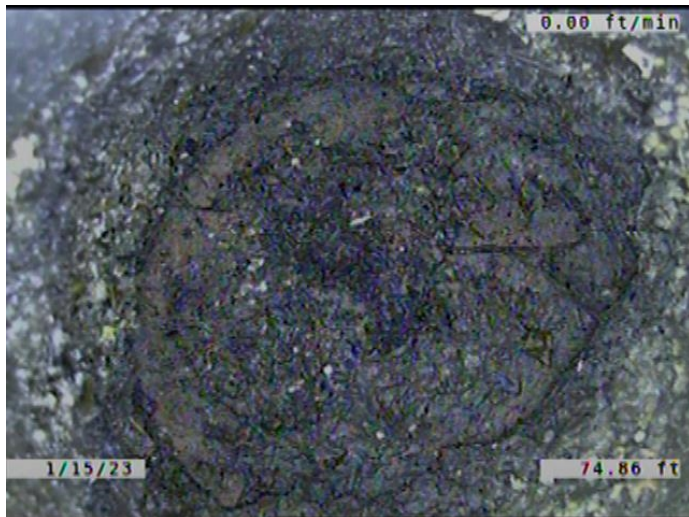
Code: **TFD**
Description: **Tap Factory Defective**

Distance (ft): **74.9**
Structural Grade: **0**
O&M Grade: **3**
Clock Start/From: **1**
Clock To:
1st Value: **6.000**
2nd Value:
Value Percent:
Continuous Index:
Within 8" of Joint: **YES**
Remarks: **CAPPED. CAP BROKEN. SOIL VISIBLE.**

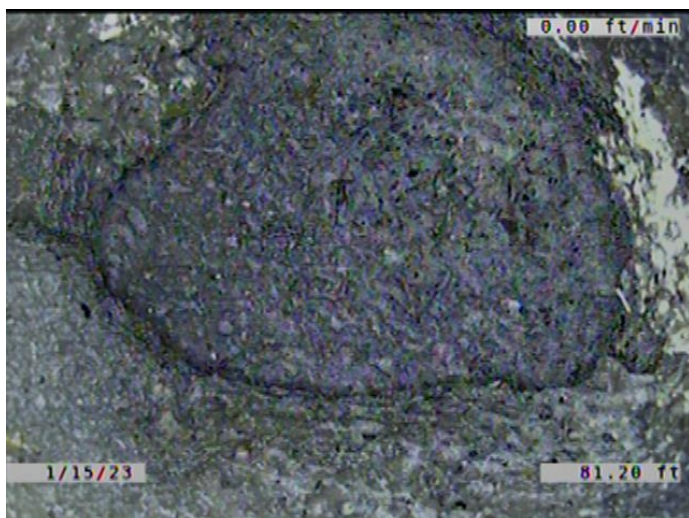
Code: **TFD**
Description: **Tap Factory Defective**

Distance (ft): **81.2**
Structural Grade: **0**
O&M Grade: **3**
Clock Start/From: **11**
Clock To:
1st Value: **6.000**
2nd Value:
Value Percent:
Continuous Index:
Within 8" of Joint: **YES**
Remarks: **100% PLUGGED,**

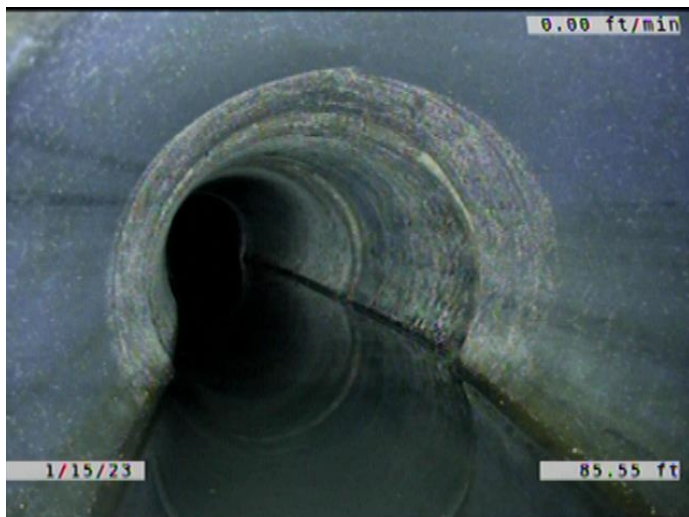
Code: **LL**
 Description: **Line Left**

Distance (ft): **85.6**
 Structural Grade: **0**
 O&M Grade: **1**
 Clock Start/From:
 Clock To:
 1st Value:
 2nd Value:
 Value Percent: **5.000**
 Continuous Index:
 Within 8" of Joint: **NO**
 Remarks:

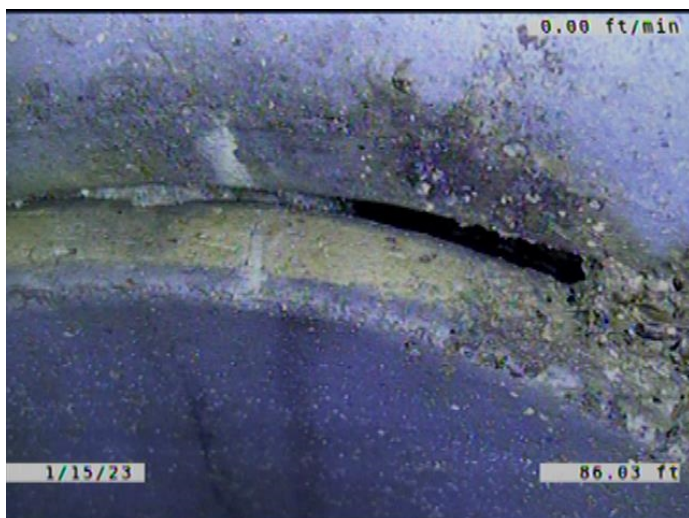
Code: **JOMD**
 Description: **Joint Offset Medium Defective**

Distance (ft): **86.0**
 Structural Grade: **3**
 O&M Grade: **0**
 Clock Start/From:
 Clock To:
 1st Value:
 2nd Value:
 Value Percent:
 Continuous Index:
 Within 8" of Joint: **NO**
 Remarks:

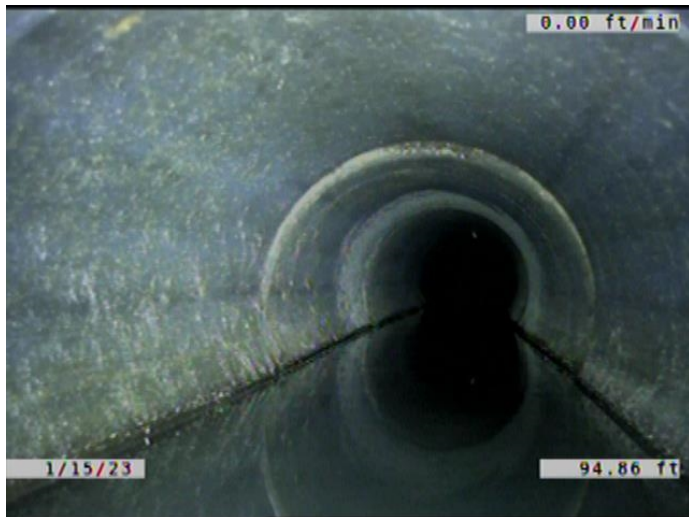
Code: **LR**
 Description: **Line Right**

Distance (ft): **94.9**
 Structural Grade: **0**
 O&M Grade: **1**
 Clock Start/From:
 Clock To:
 1st Value:
 2nd Value:
 Value Percent: **5.000**
 Continuous Index:
 Within 8" of Joint: **NO**
 Remarks:

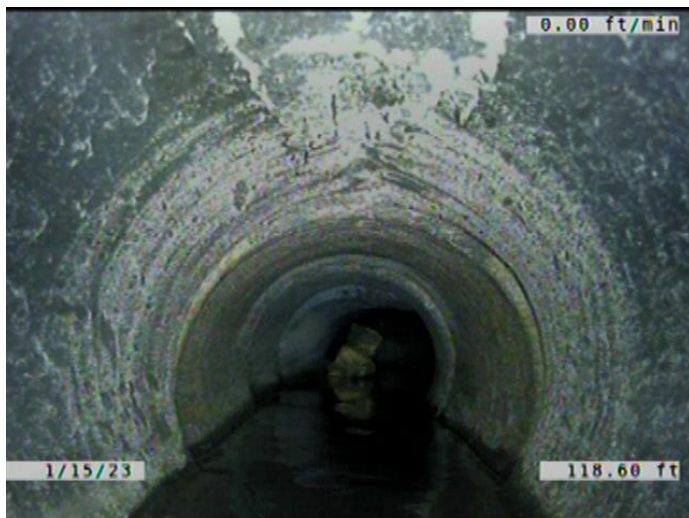
Code: **MWLS**
 Description: **Miscellaneous Water Level Sag**

Distance (ft): **118.6**
 Structural Grade: **2**
 O&M Grade: **0**
 Clock Start/From:
 Clock To:
 1st Value:
 2nd Value:
 Value Percent: **20.000**
 Continuous Index: **F04**
 Within 8" of Joint: **NO**
 Remarks:

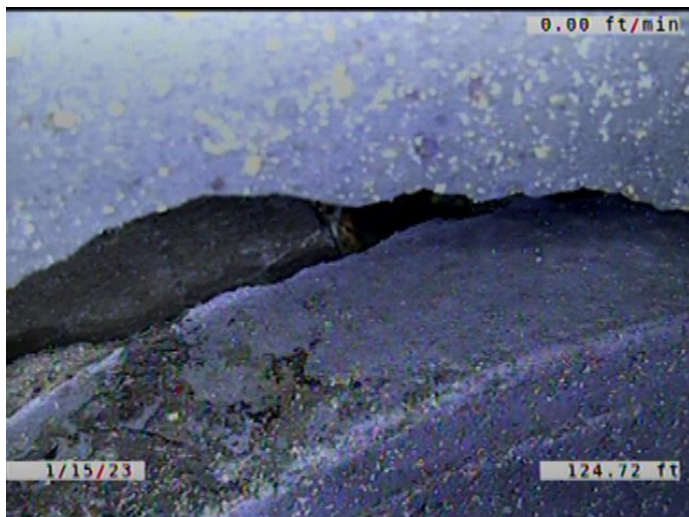
Code: **BSV**
 Description: **Broken Soil Visible**

Distance (ft): **124.7**
 Structural Grade: **5**
 O&M Grade: **0**
 Clock Start/From: **8**
 Clock To: **4**
 1st Value:
 2nd Value:
 Value Percent:
 Continuous Index:
 Within 8" of Joint: **YES**
 Remarks:

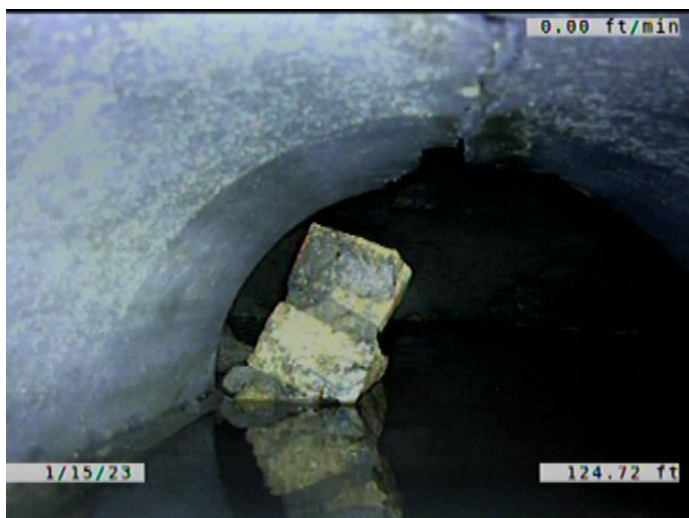
Code: **DR**
 Description: **Deformed Rigid**

Distance (ft): **124.7**
 Structural Grade: **4**
 O&M Grade: **0**
 Clock Start/From:
 Clock To:
 1st Value:
 2nd Value:
 Value Percent: **5.000**
 Continuous Index:
 Within 8" of Joint: **NO**
 Remarks:

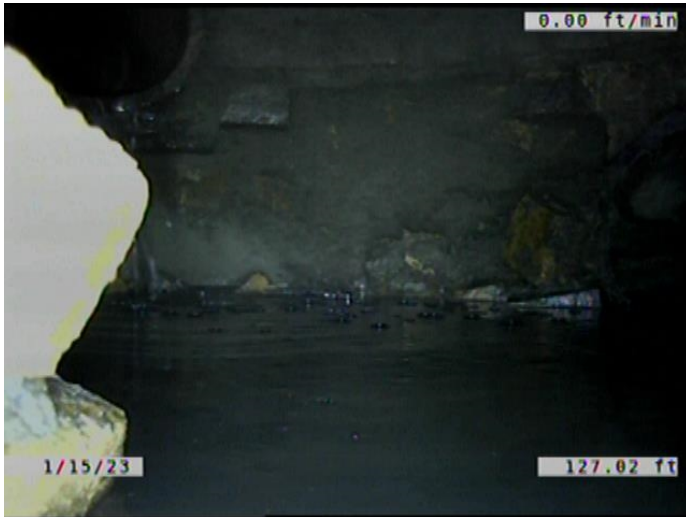
Code: **FM**
Description: **Fracture Multiple**

Distance (ft): **127.0**
Structural Grade: **4**
O&M Grade: **0**
Clock Start/From: **8**
Clock To: **4**
1st Value:
2nd Value:
Value Percent:
Continuous Index: **F02**
Within 8" of Joint: **YES**
Remarks:

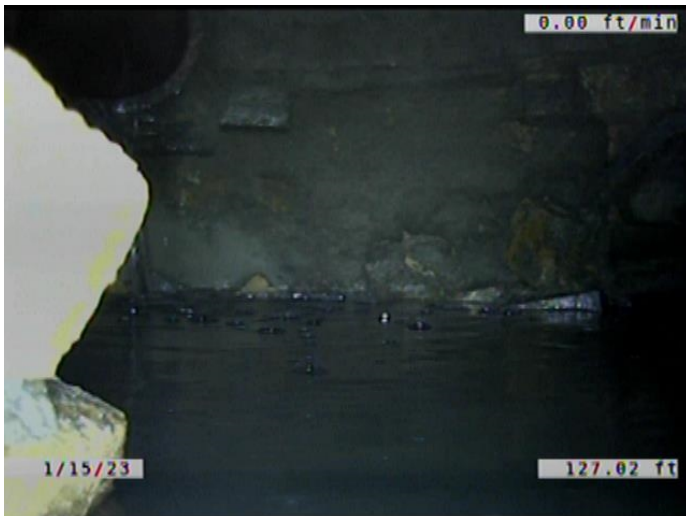
Code: **JAL**
Description: **Joint Angular Large**

Distance (ft): **127.0**
Structural Grade: **4**
O&M Grade: **0**
Clock Start/From:
Clock To:
1st Value:
2nd Value:
Value Percent:
Continuous Index: **F03**
Within 8" of Joint: **NO**
Remarks: **SOIL VISIBLE. WANDERING**

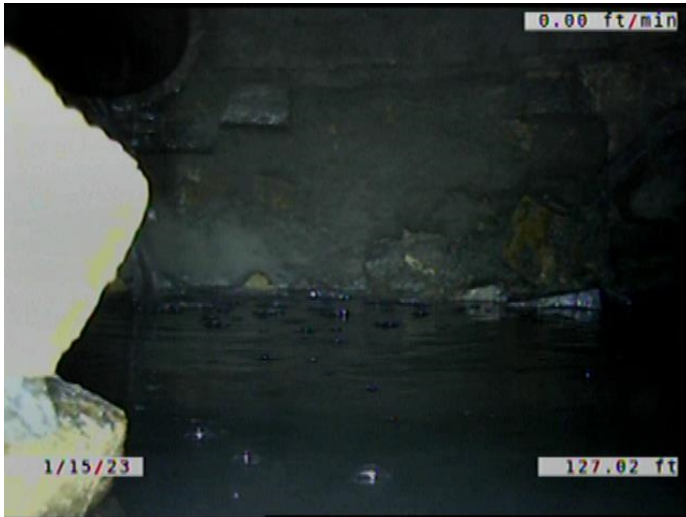
Code: **DAE**
 Description: **Deposits Attached Encrustation**

Distance (ft): **127.0**
 Structural Grade: **0**
 O&M Grade: **2**
 Clock Start/From: **10**
 Clock To: **2**
 1st Value:
 2nd Value:
 Value Percent: **5.000**
 Continuous Index: **F05**
 Within 8" of Joint: **YES**
 Remarks:
