Profile/Photo Observation Report

Street:	DEVONSHIRE ST & S INDIANA ST	Flow Control:	Not Controlled
City:	Hobart, IN	Year Renewed:	
Location:	Other	Tape/Media #:	
Purpose:	Not Known	Dia/Height:	12"
Use:	Sanitary	Material:	VCP
Drain Area:	NA	Lining:	
Category:	NA		
Comment:

Location Details:		Direction of Survey:	Upstream
US MH:	M-805-059	DS MH:	M-805-058
		Total Length Surveyed (ft):	27.3

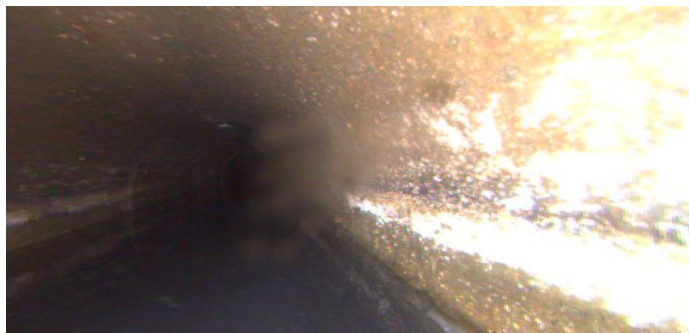
Code: **AMH**
Description: **Manhole**

Distance (ft): **.0**
Structural Grade: **0**
O&M Grade: **0**
Clock Start/From:
Clock To:
1st Value:
2nd Value:
Value Percent:
Continuous Index:
Within 8" of Joint: **NO**
Remarks: **M-805-058**

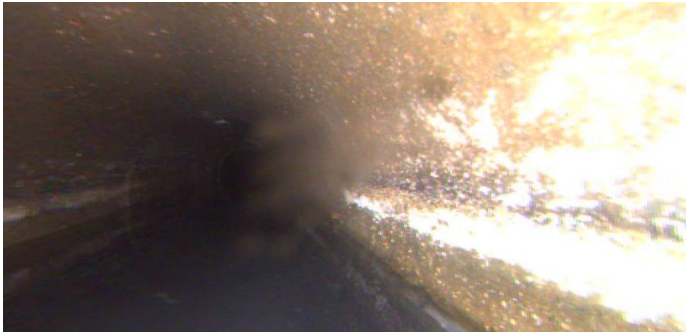
Code:	MWL
Description:	Water Level

Distance (ft):	.0
Structural Grade:	0
O&M Grade:	0
Clock Start/From:	
Clock To:	
1st Value:	
2nd Value:	
Value Percent:	5.000
Continuous Index:	
Within 8" of Joint:	NO
Remarks:

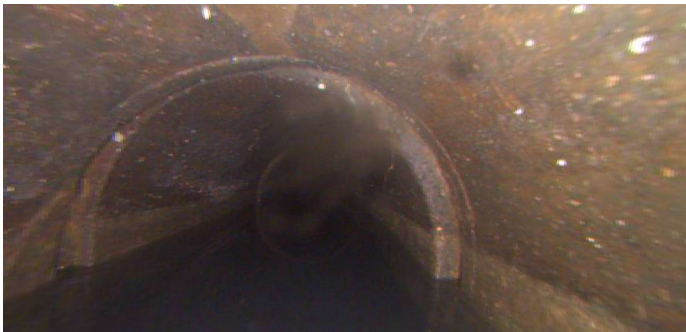
Code:	CM
Description:	Crack Multiple

Distance (ft):	4.4
Structural Grade:	3
O&M Grade:	0
Clock Start/From:	9
Clock To:	3
1st Value:	
2nd Value:	
Value Percent:	
Continuous Index:	S01
Within 8" of Joint:	YES
Remarks:	wandering

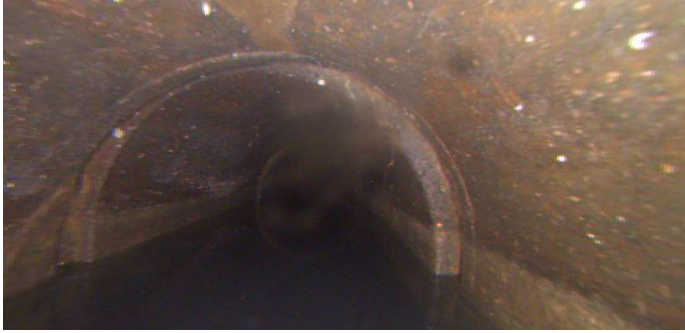
Code: **MWL**
Description: **Water Level**

Distance (ft): **4.4**
Structural Grade: **0**
O&M Grade: **0**
Clock Start/From:
Clock To:
1st Value:
2nd Value:
Value Percent: **35.000**
Continuous Index:
Within 8" of Joint: **NO**
Remarks:

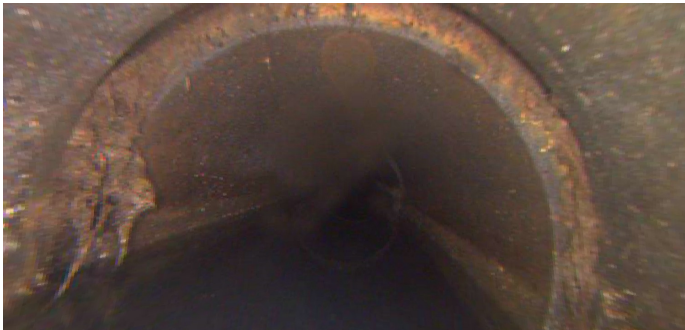
Code: **RFJ**
Description: **Roots Fine Joint**

Distance (ft): **14.6**
Structural Grade: **0**
O&M Grade: **1**
Clock Start/From: **9**
Clock To:
1st Value:
2nd Value:
Value Percent:
Continuous Index: **S02**
Within 8" of Joint: **YES**
Remarks: **wandering**

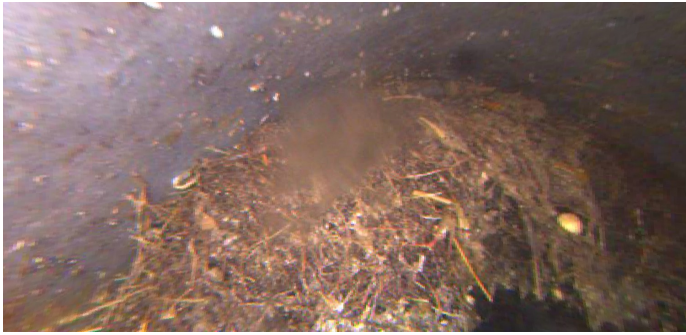
Code: **RBJ**
Description: **Roots Ball Joint**

Distance (ft): **24.4**
Structural Grade: **0**
O&M Grade: **4**
Clock Start/From: **9**
Clock To: **3**
1st Value:
2nd Value:
Value Percent: **55.000**
Continuous Index:
Within 8" of Joint: **YES**
Remarks:

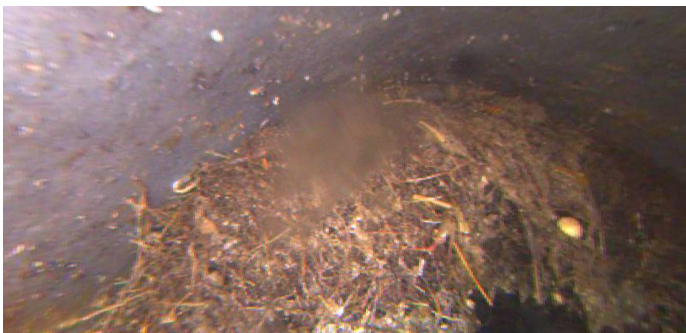
Code: **RFJ**
Description: **Roots Fine Joint**

Distance (ft): **24.4**
Structural Grade: **0**
O&M Grade: **1**
Clock Start/From: **9**
Clock To:
1st Value:
2nd Value:
Value Percent:
Continuous Index: **F02**
Within 8" of Joint: **YES**
Remarks: **wandering**

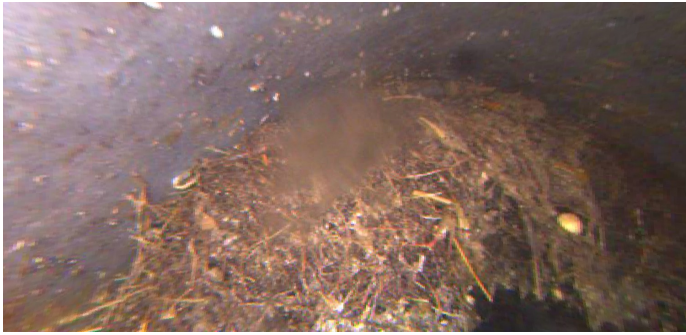
Code: **CM**
Description: **Crack Multiple**

Distance (ft): **24.4**
Structural Grade: **3**
O&M Grade: **0**
Clock Start/From: **9**
Clock To: **3**
1st Value:
2nd Value:
Value Percent:
Continuous Index: **F01**
Within 8" of Joint: **YES**
Remarks: **wandering**
