## Profile/Photo Observation Report

Date:	<b>04/19/2018</b>	Weather:		Coding:	<b>PACP 6.0</b>
Pipe Length (ft):	<b>196.7</b>	Owner:	<b>NA</b>	Pre Clean:	<b>Not Known</b>
P.O.#:		Surveyor:	<b>Byrd Fitzgerald</b>	PSR:	<b>P-805-059-058</b>
Customer:		Clean Date:	<b>01/01/1900</b>	Shape:	<b>C</b>

Street:	<b>Devonshire St.</b>	Flow Control:	<b>Not Controlled</b>
City:	<b>Hobart, IN</b>	Year Renewed:	
Location:	<b>Other</b>	Tape/Media #:	
Purpose:	<b>Not Known</b>	Dia/Height:	<b>12"</b>
Use:	<b>Sanitary</b>	Material:	<b>VCP</b>
Drain Area:	<b>NA</b>	Lining:	
Category:	<b>NA</b>		
Comment:

Location Details:		Direction of Survey:	<b>Upstream</b>
US MH:	<b>M-805-059</b>	DS MH:	<b>M-805-058</b>
		Total Length Surveyed (ft):	<b>27.3</b>

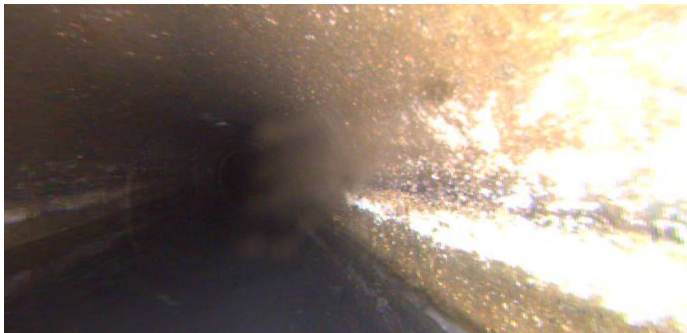
Code: **AMH**  
Description: **Manhole**

Distance (ft): **.0**  
Structural Grade: **0**  
O&M Grade: **0**  
Clock Start/From:  
Clock To:  
1st Value:  
2nd Value:  
Value Percent:  
Continuous Index:  
Within 8" of Joint: **NO**  
Remarks: **M-805-058**

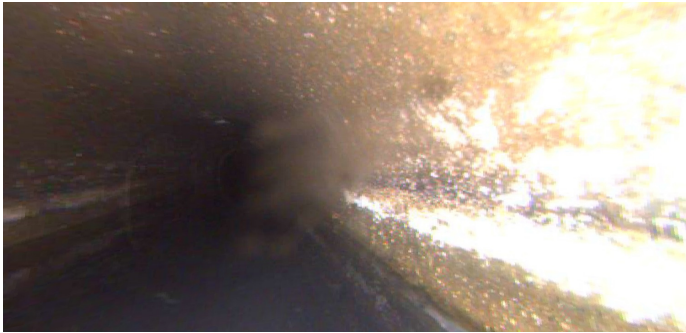
Code:	<b>MWL</b>
Description:	<b>Water Level</b>

Distance (ft):	<b>.0</b>
Structural Grade:	<b>0</b>
O&M Grade:	<b>0</b>
Clock Start/From:	
Clock To:	
1st Value:	
2nd Value:	
Value Percent:	<b>5.000</b>
Continuous Index:	
Within 8" of Joint:	<b>NO</b>
Remarks:

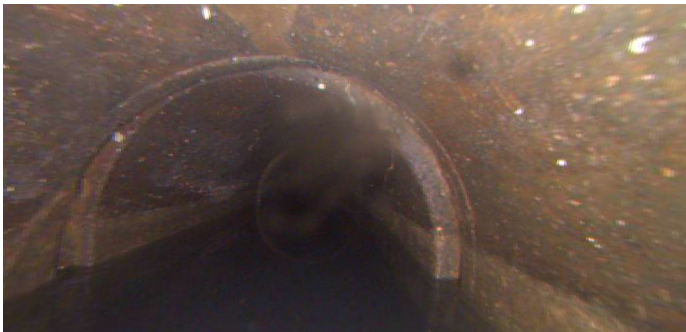
Code:	<b>CM</b>
Description:	<b>Crack Multiple</b>

Distance (ft):	<b>4.4</b>
Structural Grade:	<b>3</b>
O&M Grade:	<b>0</b>
Clock Start/From:	<b>9</b>
Clock To:	<b>3</b>
1st Value:	
2nd Value:	
Value Percent:	
Continuous Index:	<b>S01</b>
Within 8" of Joint:	<b>YES</b>
Remarks:	<b>wandering</b>

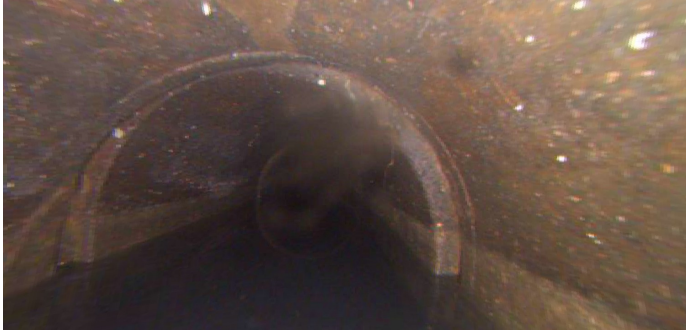
Code: **MWL**  
Description: **Water Level**

Distance (ft): **4.4**  
Structural Grade: **0**  
O&M Grade: **0**  
Clock Start/From:  
Clock To:  
1st Value:  
2nd Value:  
Value Percent: **35.000**  
Continuous Index:  
Within 8" of Joint: **NO**  
Remarks:

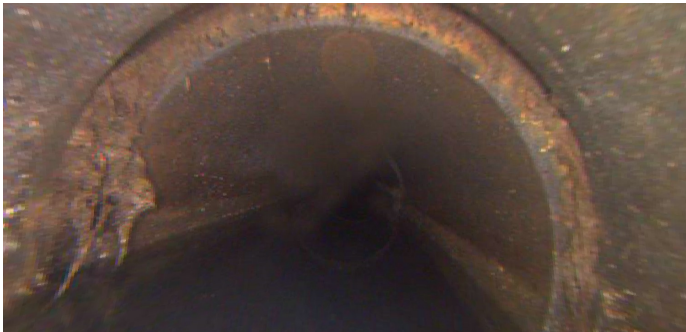
Code: **RFJ**  
Description: **Roots Fine Joint**

Distance (ft): **14.6**  
Structural Grade: **0**  
O&M Grade: **1**  
Clock Start/From: **9**  
Clock To:  
1st Value:  
2nd Value:  
Value Percent:  
Continuous Index: **S02**  
Within 8" of Joint: **YES**  
Remarks: **wandering**

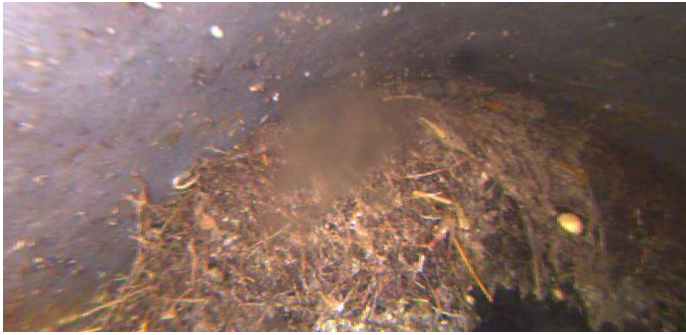
Code: **RBJ**  
Description: **Roots Ball Joint**

Distance (ft): **24.4**  
Structural Grade: **0**  
O&M Grade: **4**  
Clock Start/From: **9**  
Clock To: **3**  
1st Value:  
2nd Value:  
Value Percent: **55.000**  
Continuous Index:  
Within 8" of Joint: **YES**  
Remarks:

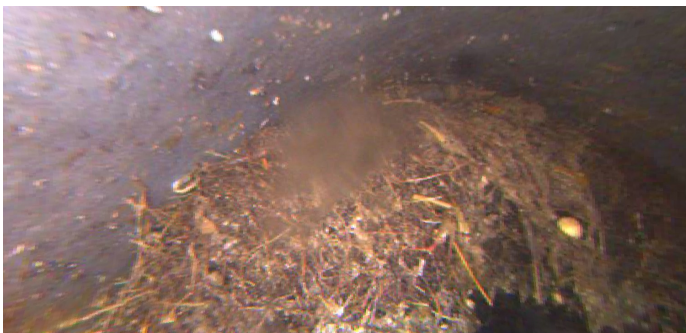
Code: **RFJ**  
Description: **Roots Fine Joint**

Distance (ft): **24.4**  
Structural Grade: **0**  
O&M Grade: **1**  
Clock Start/From: **9**  
Clock To:  
1st Value:  
2nd Value:  
Value Percent:  
Continuous Index: **F02**  
Within 8" of Joint: **YES**  
Remarks: **wandering**

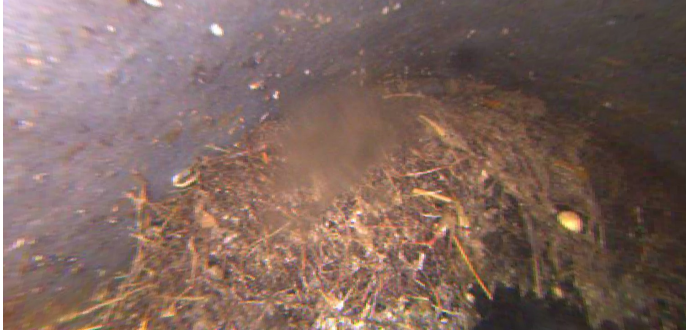
Code: **CM**  
Description: **Crack Multiple**

Distance (ft): **24.4**  
Structural Grade: **3**  
O&M Grade: **0**  
Clock Start/From: **9**  
Clock To: **3**  
1st Value:  
2nd Value:  
Value Percent:  
Continuous Index: **F01**  
Within 8" of Joint: **YES**  
Remarks: **wandering**
