# Profile/Photo Observation Report

Date:	<b>01/24/2023</b>	Weather:		Coding:	<b>PACP 7.0</b>
Pipe Length (ft):	<b>197.0</b>	Owner:	<b>City of Hobart</b>	Pre Clean:	<b>Heavy Cleaning</b>
P.O.#:	<b>YES502259</b>	Surveyor:	<b>Steven Bucklin</b>	PSR:	<b>P-805-059-058</b>
Customer:	<b>City of Hobart</b>	Clean Date:	<b>01/20/2023</b>	Shape:	<b>C</b>

Street:	<b>Devanshire Street</b>	Flow Control:	<b>Not Controlled</b>
City:	<b>Hobart, IN</b>	Year Renewed:	
Location:	<b>Local rural streets with light traffic, t</b>	Tape/Media #:	
Purpose:	<b>Routine Assessment</b>	Dia/Height:	<b>12"</b>
Use:	<b>Sanitary Sewage Pipe</b>	Material:	<b>VCP</b>
Drain Area:		Lining:	<b>None</b>
Category:	<b>NA</b>		
Comment:			
Location Details:		Direction of Survey:	<b>Downstream</b>
US MH:	<b>M-805-059</b>	DS MH:	<b>M-805-058</b>
		Total Length Surveyed (ft):	<b>193.9</b>

O&M Index:	<b>1.42</b>	O&M Quick:	<b>3824</b>	O&M Rating:	<b>68.00</b>
Structural Index:	<b>2.90</b>	Structural Quick:	<b>514A</b>	Structural Rating:	<b>122.00</b>
Overall Index:	<b>2.11</b>	Overall Quick:	<b>514A</b>	Overall Rating:	<b>190.00</b>

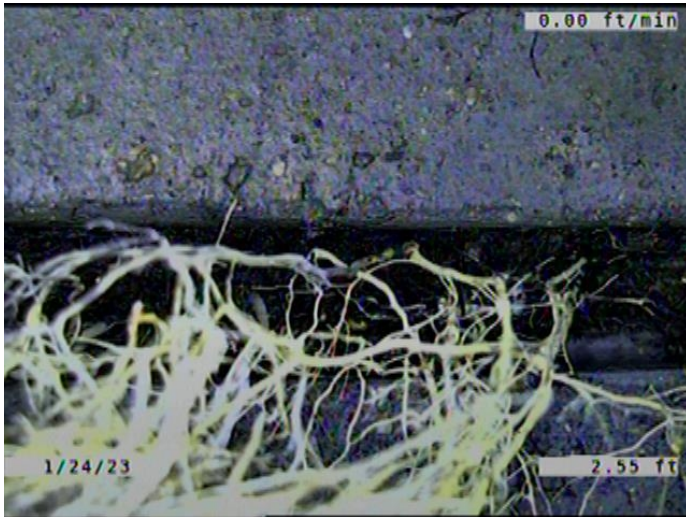
Code: **RMJ**  
 Description: **Roots Medium Joint**

Distance (ft): **2.5**  
 Structural Grade: **0**  
 O&M Grade: **3**  
 Clock Start/From: **10**  
 Clock To: **2**  
 1st Value:  
 2nd Value:  
 Value Percent: **5.000**  
 Continuous Index:  
 Within 8" of Joint: **YES**  
 Remarks:

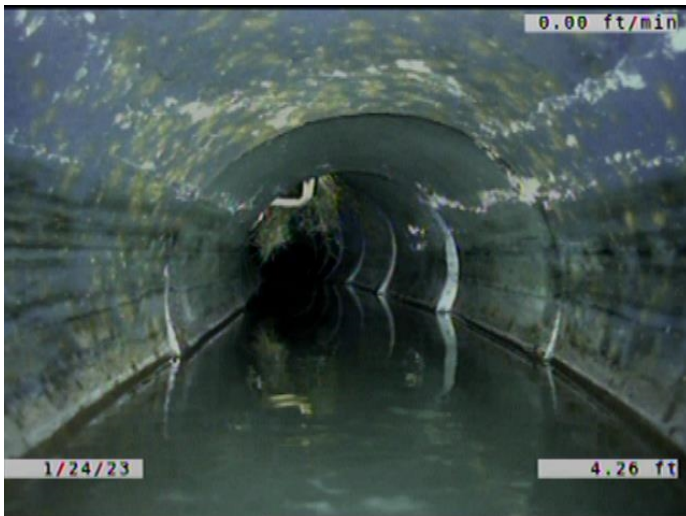
Code: **MWLS**  
 Description: **Miscellaneous Water Level Sag**

Distance (ft): **4.3**  
 Structural Grade: **2**  
 O&M Grade: **0**  
 Clock Start/From:  
 Clock To:  
 1st Value:  
 2nd Value:  
 Value Percent: **20.000**  
 Continuous Index: **S01**  
 Within 8" of Joint: **NO**  
 Remarks:

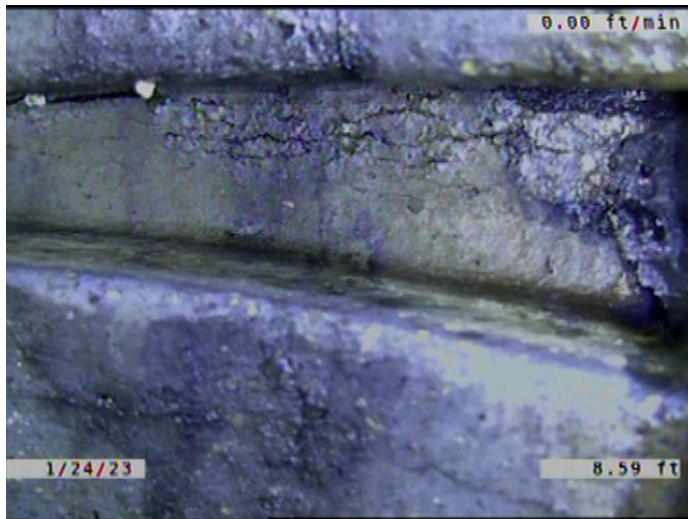
Code: **JAL**  
 Description: **Joint Angular Large**

Distance (ft): **8.6**  
 Structural Grade: **4**  
 O&M Grade: **0**  
 Clock Start/From:  
 Clock To:  
 1st Value:  
 2nd Value:  
 Value Percent:  
 Continuous Index:  
 Within 8" of Joint: **NO**  
 Remarks:

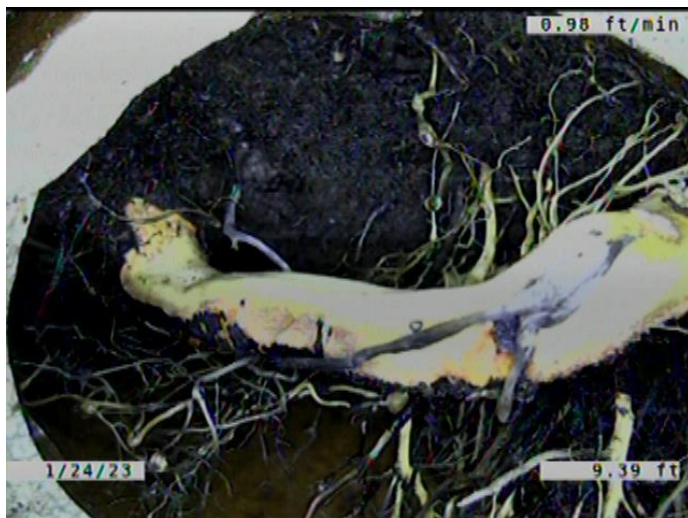
Code: **TBI**  
 Description: **Tap Break-in Intruding**

Distance (ft): **9.4**  
 Structural Grade: **0**  
 O&M Grade: **2**  
 Clock Start/From: **11**  
 Clock To:  
 1st Value: **6.000**  
 2nd Value: **1.000**  
 Value Percent:  
 Continuous Index:  
 Within 8" of Joint: **YES**  
 Remarks: **ROOTS GROWING IN THE SERVICE AND FROM THE SERVICE TO MAIN C**

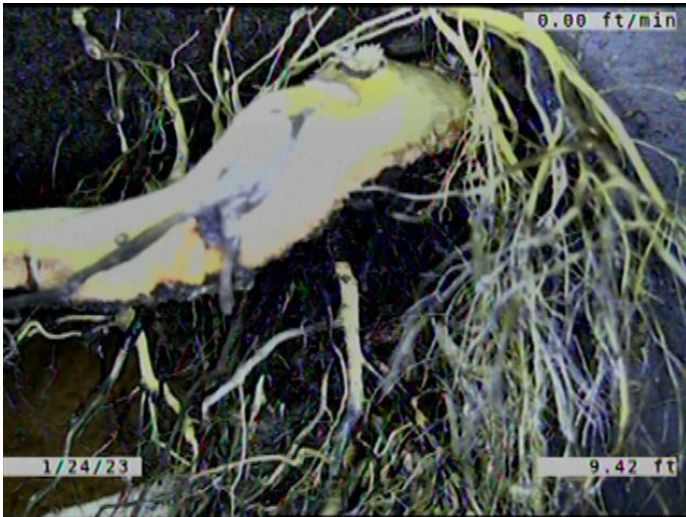
Code: **RTC**  
 Description: **Roots Tap Connection**

Distance (ft): **9.4**  
 Structural Grade: **0**  
 O&M Grade: **2**  
 Clock Start/From: **10**  
 Clock To: **12**  
 1st Value:  
 2nd Value:  
 Value Percent: **20.000**  
 Continuous Index:  
 Within 8" of Joint: **NO**  
 Remarks:

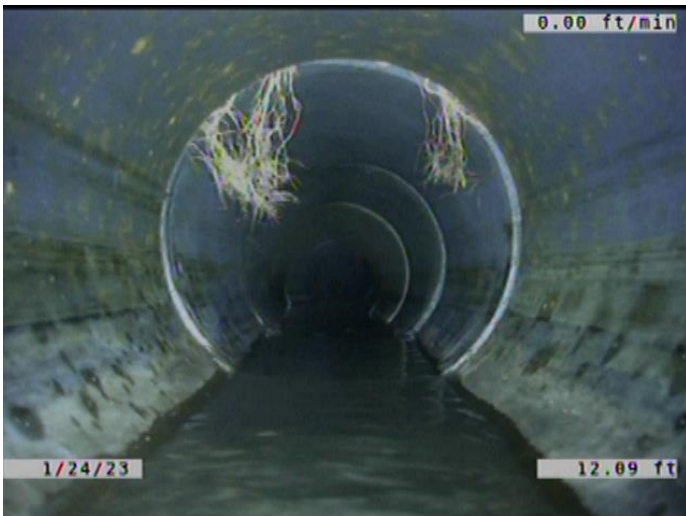
Code: **MWLS**  
 Description: **Miscellaneous Water Level Sag**

Distance (ft): **12.1**  
 Structural Grade: **2**  
 O&M Grade: **0**  
 Clock Start/From:  
 Clock To:  
 1st Value:  
 2nd Value:  
 Value Percent: **20.000**  
 Continuous Index: **F01**  
 Within 8" of Joint: **NO**  
 Remarks:

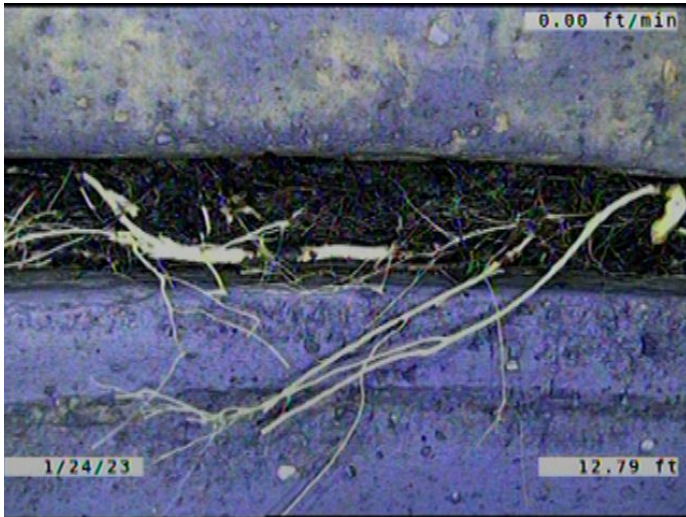
Code: **RFJ**  
Description: **Roots Fine Joint**

Distance (ft): **12.8**  
Structural Grade: **0**  
O&M Grade: **1**  
Clock Start/From: **10**  
Clock To: **2**  
1st Value:  
2nd Value:  
Value Percent:  
Continuous Index:  
Within 8" of Joint: **YES**  
Remarks:

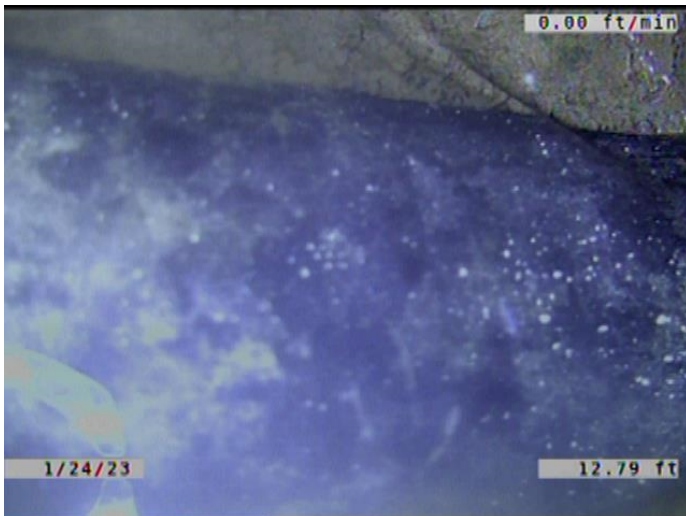
Code: **ISGT**  
Description: **Intruding Sealing Material Grout**

Distance (ft): **12.8**  
Structural Grade: **0**  
O&M Grade: **2**  
Clock Start/From: **4**  
Clock To: **8**  
1st Value:  
2nd Value:  
Value Percent: **5.000**  
Continuous Index:  
Within 8" of Joint: **NO**  
Remarks:

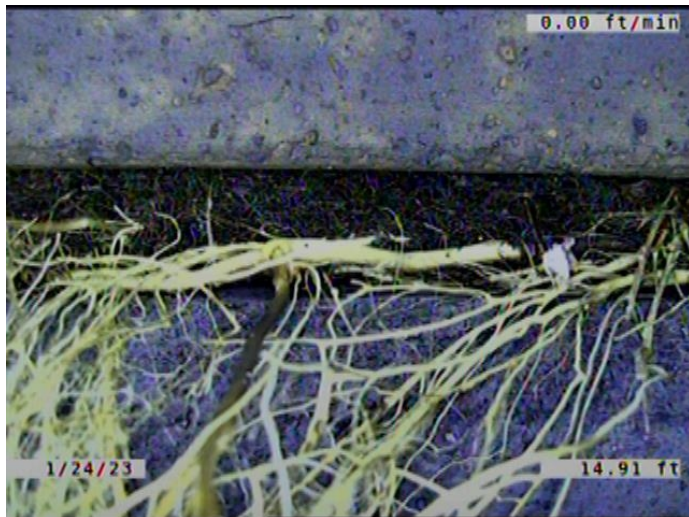
Code: **RMJ**  
 Description: **Roots Medium Joint**

Distance (ft): **14.9**  
 Structural Grade: **0**  
 O&M Grade: **3**  
 Clock Start/From: **10**  
 Clock To: **2**  
 1st Value:  
 2nd Value:  
 Value Percent: **5.000**  
 Continuous Index:  
 Within 8" of Joint: **YES**  
 Remarks:

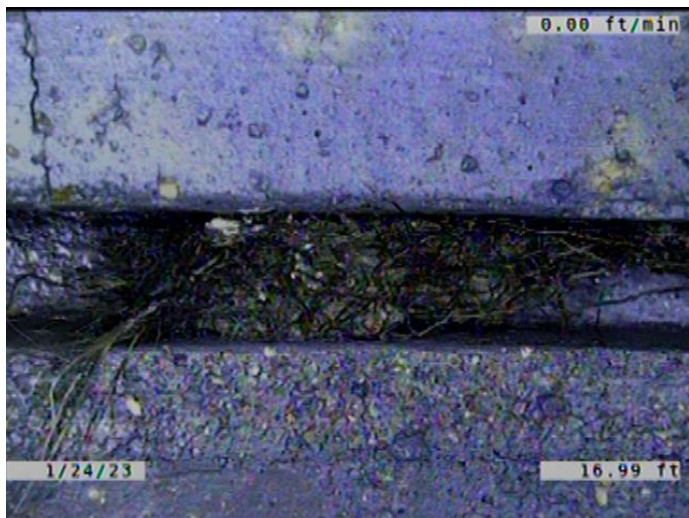
Code: **RFJ**  
 Description: **Roots Fine Joint**

Distance (ft): **17.0**  
 Structural Grade: **0**  
 O&M Grade: **1**  
 Clock Start/From: **10**  
 Clock To: **12**  
 1st Value:  
 2nd Value:  
 Value Percent:  
 Continuous Index:  
 Within 8" of Joint: **YES**  
 Remarks:

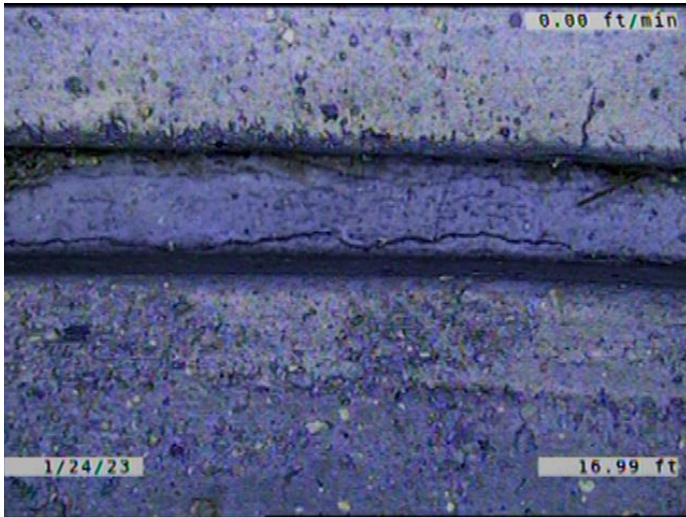
Code: **CM**  
 Description: **Crack Multiple**

Distance (ft): **17.0**  
 Structural Grade: **3**  
 O&M Grade: **0**  
 Clock Start/From: **10**  
 Clock To: **3**  
 1st Value:  
 2nd Value:  
 Value Percent:  
 Continuous Index:  
 Within 8" of Joint: **YES**  
 Remarks:

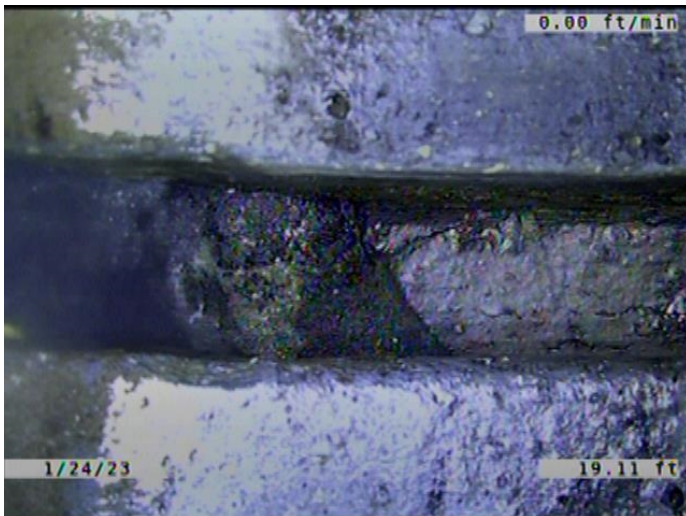
Code: **JAM**  
 Description: **Joint Angular Medium**

Distance (ft): **19.1**  
 Structural Grade: **3**  
 O&M Grade: **0**  
 Clock Start/From:  
 Clock To:  
 1st Value:  
 2nd Value:  
 Value Percent:  
 Continuous Index:  
 Within 8" of Joint: **NO**  
 Remarks:

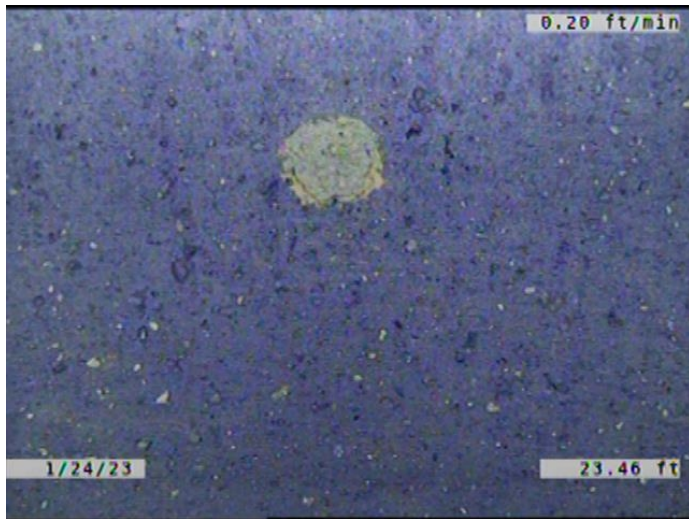
Code: **SSS**  
 Description: **Surface Damage Surface Spalling**

Distance (ft): **23.5**  
 Structural Grade: **2**  
 O&M Grade: **0**  
 Clock Start/From: **12**  
 Clock To:  
 1st Value:  
 2nd Value:  
 Value Percent:  
 Continuous Index:  
 Within 8" of Joint: **NO**  
 Remarks:

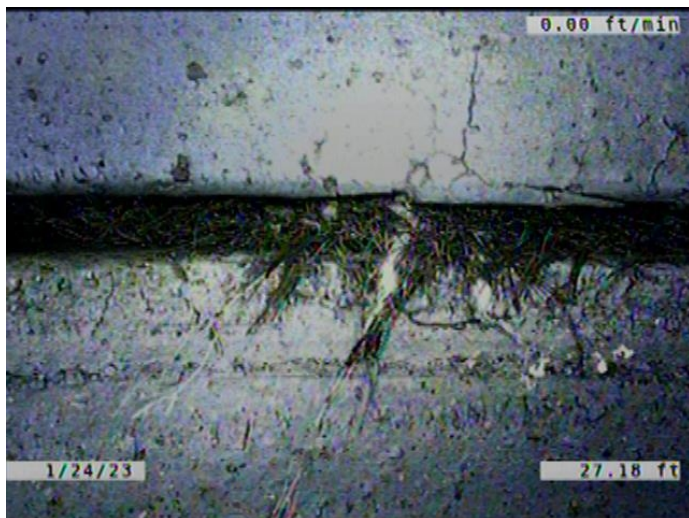
Code: **RFJ**  
 Description: **Roots Fine Joint**

Distance (ft): **27.2**  
 Structural Grade: **0**  
 O&M Grade: **1**  
 Clock Start/From: **9**  
 Clock To: **3**  
 1st Value:  
 2nd Value:  
 Value Percent:  
 Continuous Index: **S02**  
 Within 8" of Joint: **YES**  
 Remarks:

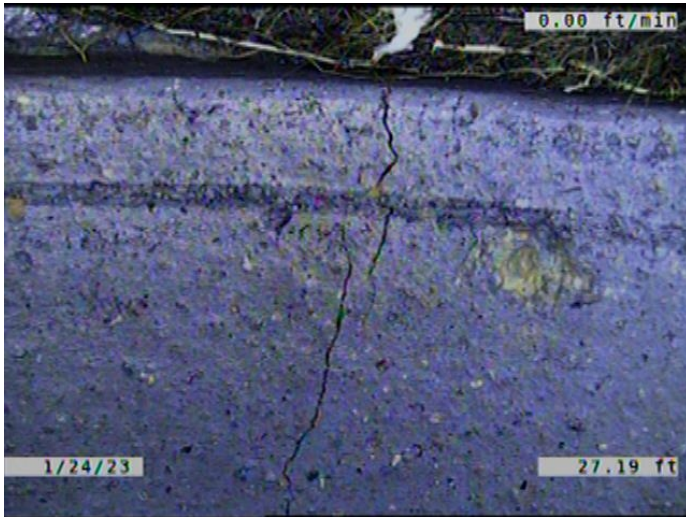
Code: **CL**  
 Description: **Crack Longitudinal**

Distance (ft): **27.2**  
 Structural Grade: **2**  
 O&M Grade: **0**  
 Clock Start/From: **1**  
 Clock To:  
 1st Value:  
 2nd Value:  
 Value Percent:  
 Continuous Index:  
 Within 8" of Joint: **YES**  
 Remarks:

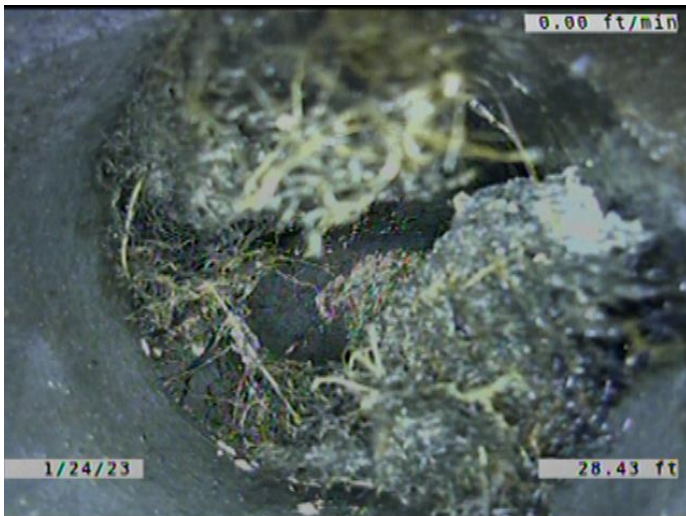
Code: **TF**  
 Description: **Tap Factory**

Distance (ft): **28.4**  
 Structural Grade: **0**  
 O&M Grade: **0**  
 Clock Start/From: **1**  
 Clock To:  
 1st Value: **6.000**  
 2nd Value:  
 Value Percent:  
 Continuous Index:  
 Within 8" of Joint: **YES**  
 Remarks: **ROOTS GROWING FROM THE  
SERVICE TO MAIN CONNECTION INT**

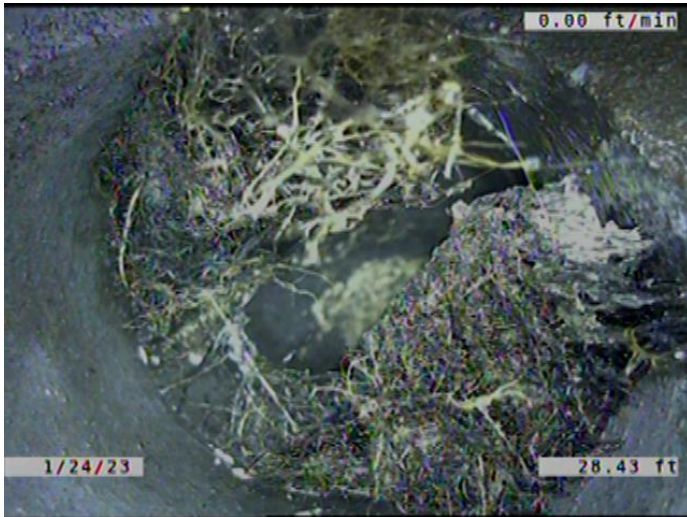
Code:	<b>RMC</b>
Description:	<b>Roots Medium Connection</b>
Distance (ft):	<b>28.4</b>
Structural Grade:	<b>0</b>
O&M Grade:	<b>3</b>
Clock Start/From:	<b>1</b>
Clock To:	
1st Value:	
2nd Value:	
Value Percent:	<b>5.000</b>
Continuous Index:	
Within 8" of Joint:	<b>NO</b>
Remarks:

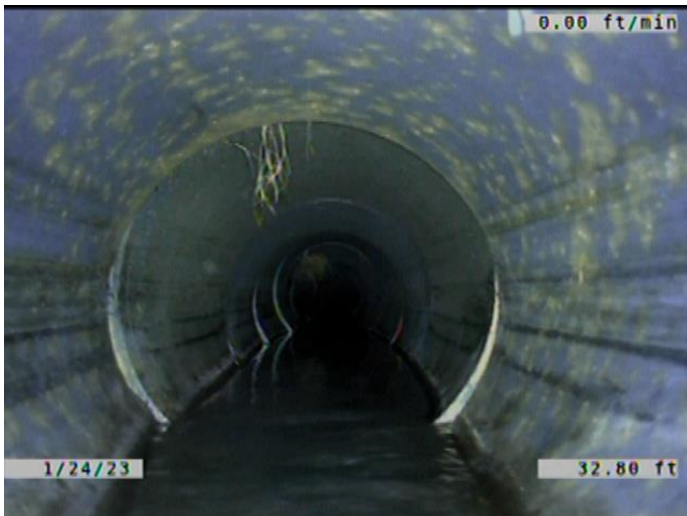
Code:	<b>MWLS</b>
Description:	<b>Miscellaneous Water Level Sag</b>
Distance (ft):	<b>32.8</b>
Structural Grade:	<b>2</b>
O&M Grade:	<b>0</b>
Clock Start/From:	
Clock To:	
1st Value:	
2nd Value:	
Value Percent:	<b>15.000</b>
Continuous Index:	<b>S03</b>
Within 8" of Joint:	<b>NO</b>
Remarks:

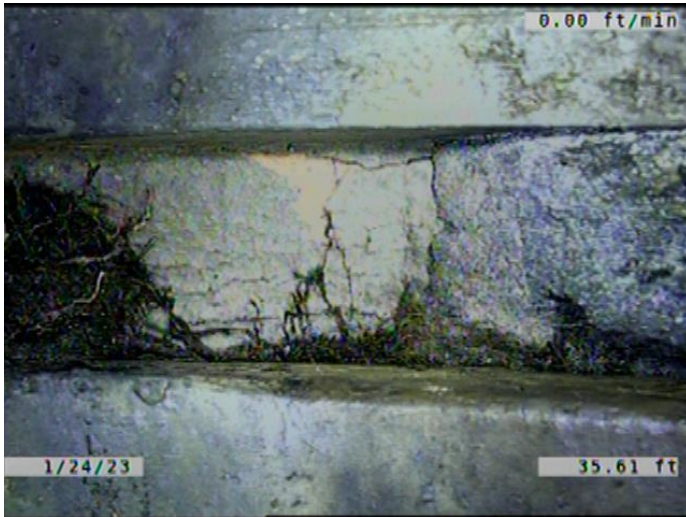
Code: **JAL**  
Description: **Joint Angular Large**

Distance (ft): **35.6**  
Structural Grade: **4**  
O&M Grade: **0**  
Clock Start/From:  
Clock To:  
1st Value:  
2nd Value:  
Value Percent:  
Continuous Index:  
Within 8" of Joint: **NO**  
Remarks:

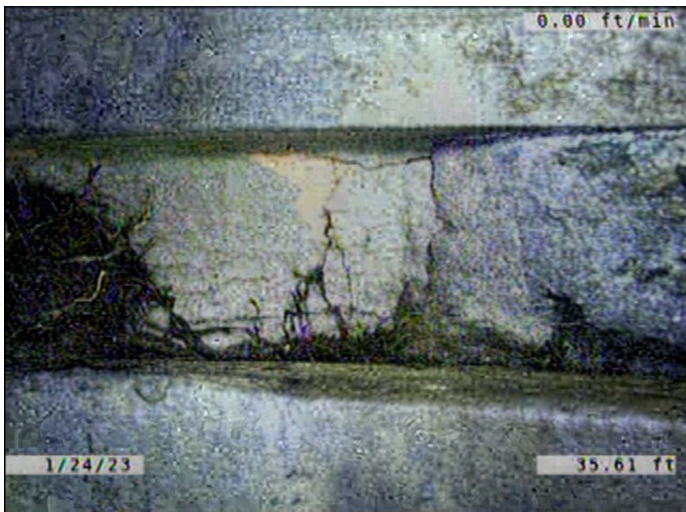
Code: **B**  
Description: **Broken**

Distance (ft): **35.6**  
Structural Grade: **4**  
O&M Grade: **0**  
Clock Start/From: **2**  
Clock To: **4**  
1st Value:  
2nd Value:  
Value Percent:  
Continuous Index:  
Within 8" of Joint: **YES**  
Remarks:

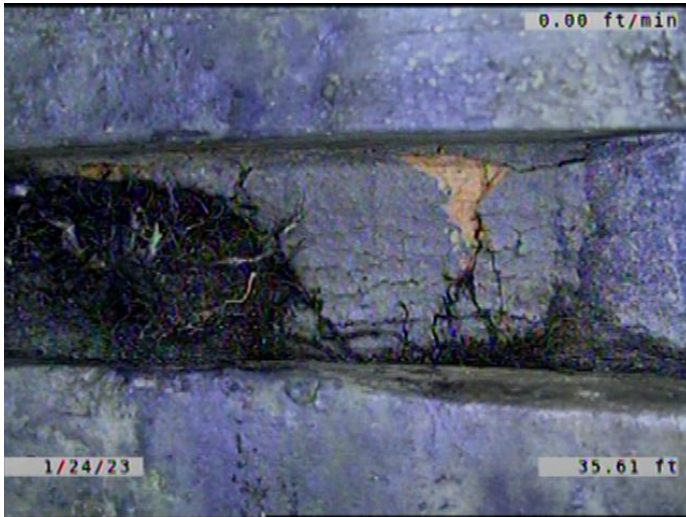
Code: **CM**  
 Description: **Crack Multiple**

Distance (ft): **35.6**  
 Structural Grade: **3**  
 O&M Grade: **0**  
 Clock Start/From: **8**  
 Clock To: **10**  
 1st Value:  
 2nd Value:  
 Value Percent:  
 Continuous Index:  
 Within 8" of Joint: **YES**  
 Remarks:

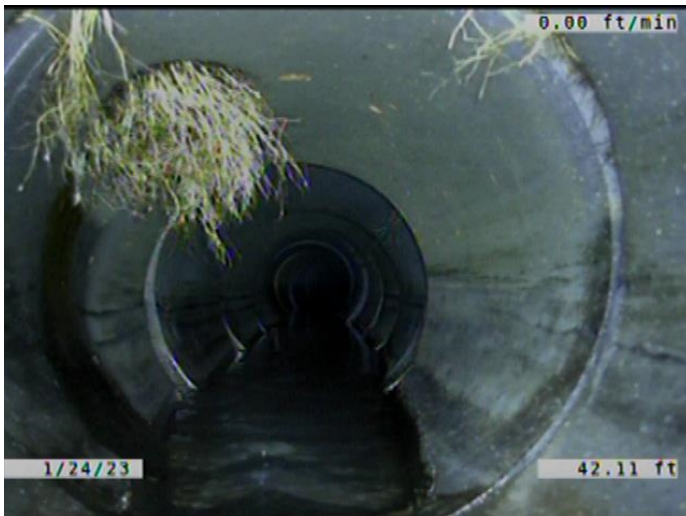
Code: **MWLS**  
 Description: **Miscellaneous Water Level Sag**

Distance (ft): **42.1**  
 Structural Grade: **2**  
 O&M Grade: **0**  
 Clock Start/From:  
 Clock To:  
 1st Value:  
 2nd Value:  
 Value Percent: **15.000**  
 Continuous Index: **F03**  
 Within 8" of Joint: **NO**  
 Remarks:

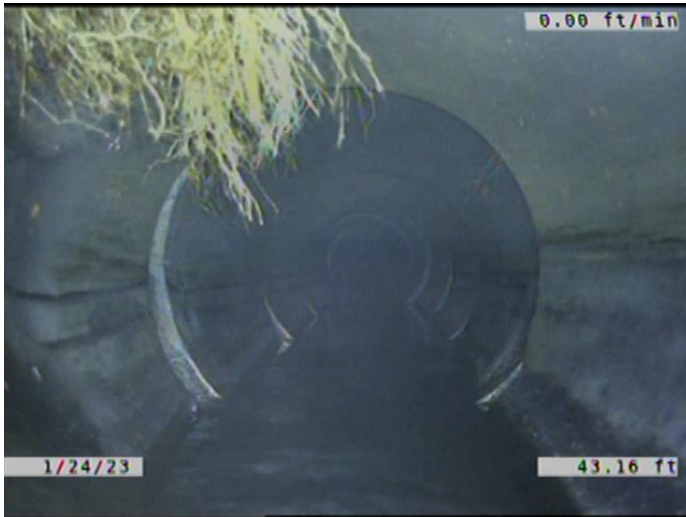
Code: **MWLS**  
 Description: **Miscellaneous Water Level Sag**

Distance (ft): **43.2**  
 Structural Grade: **2**  
 O&M Grade: **0**  
 Clock Start/From:  
 Clock To:  
 1st Value:  
 2nd Value:  
 Value Percent: **15.000**  
 Continuous Index: **S04**  
 Within 8" of Joint: **NO**  
 Remarks:

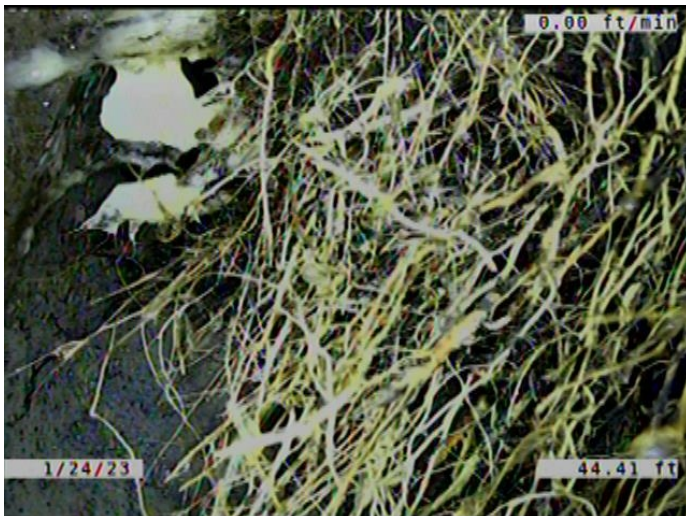
Code: **TFD**  
 Description: **Tap Factory Defective**

Distance (ft): **44.4**  
 Structural Grade: **0**  
 O&M Grade: **3**  
 Clock Start/From: **11**  
 Clock To:  
 1st Value: **6.000**  
 2nd Value:  
 Value Percent:  
 Continuous Index:  
 Within 8" of Joint: **YES**  
 Remarks: **99% PLUGGED WITH ROOTS.  
 CONSTANTLY RUNNING WATER.**

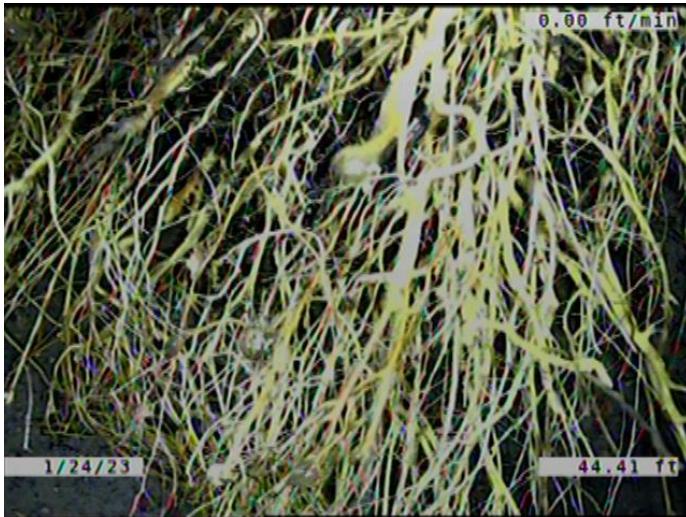
Code: **RML**  
 Description: **Roots Medium Lateral**

Distance (ft): **44.4**  
 Structural Grade: **0**  
 O&M Grade: **3**  
 Clock Start/From: **10**  
 Clock To: **12**  
 1st Value:  
 2nd Value:  
 Value Percent: **10.000**  
 Continuous Index:  
 Within 8" of Joint: **NO**  
 Remarks:

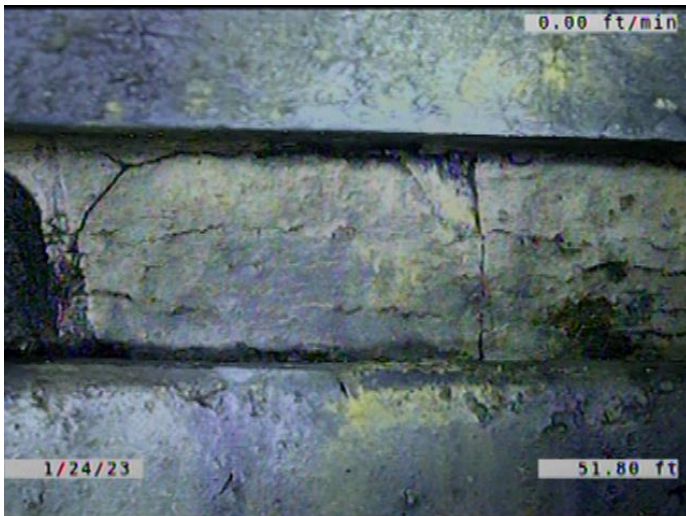
Code: **JAM**  
 Description: **Joint Angular Medium**

Distance (ft): **51.8**  
 Structural Grade: **3**  
 O&M Grade: **0**  
 Clock Start/From:  
 Clock To:  
 1st Value:  
 2nd Value:  
 Value Percent:  
 Continuous Index:  
 Within 8" of Joint: **NO**  
 Remarks:

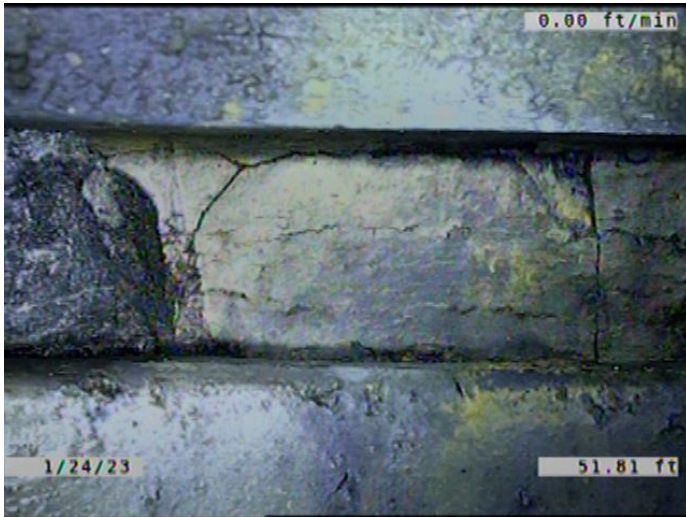
Code: **CM**  
Description: **Crack Multiple**

Distance (ft): **51.8**  
Structural Grade: **3**  
O&M Grade: **0**  
Clock Start/From: **2**  
Clock To: **4**  
1st Value:  
2nd Value:  
Value Percent:  
Continuous Index:  
Within 8" of Joint: **YES**  
Remarks:

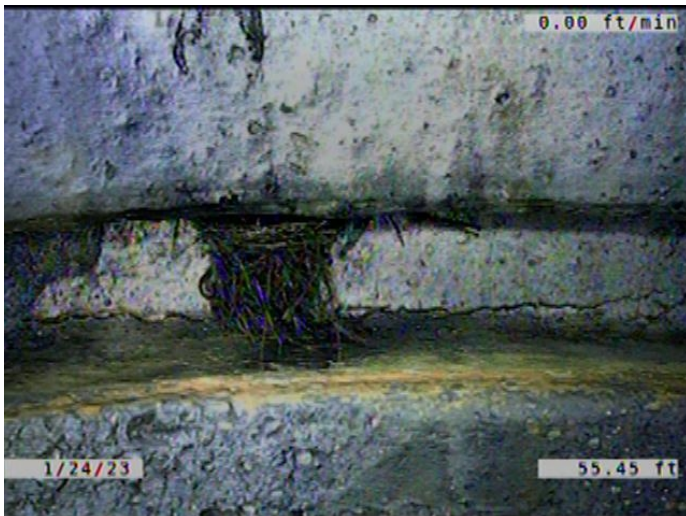
Code: **JAM**  
Description: **Joint Angular Medium**

Distance (ft): **55.4**  
Structural Grade: **3**  
O&M Grade: **0**  
Clock Start/From:  
Clock To:  
1st Value:  
2nd Value:  
Value Percent:  
Continuous Index:  
Within 8" of Joint: **NO**  
Remarks:

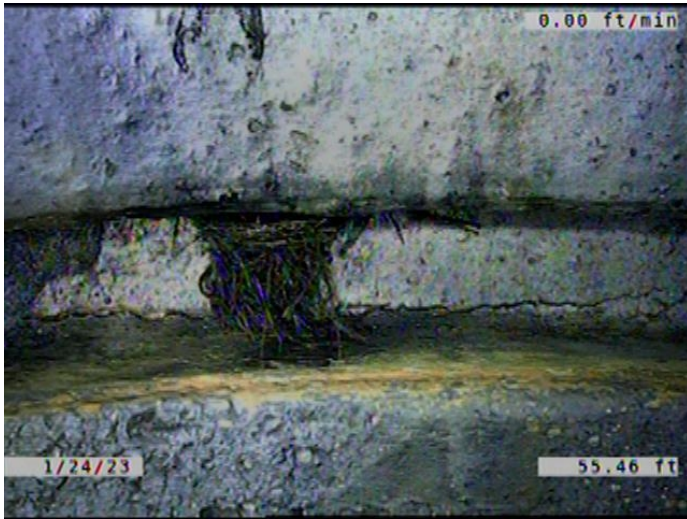
Code: **FM**  
Description: **Fracture Multiple**

Distance (ft): **55.5**  
Structural Grade: **4**  
O&M Grade: **0**  
Clock Start/From: **9**  
Clock To: **11**  
1st Value:  
2nd Value:  
Value Percent:  
Continuous Index:  
Within 8" of Joint: **YES**  
Remarks:

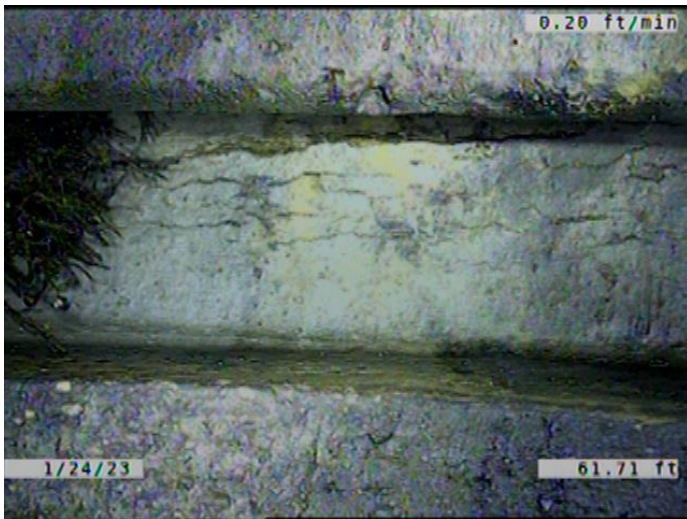
Code: **JAL**  
Description: **Joint Angular Large**

Distance (ft): **61.7**  
Structural Grade: **4**  
O&M Grade: **0**  
Clock Start/From:  
Clock To:  
1st Value:  
2nd Value:  
Value Percent:  
Continuous Index:  
Within 8" of Joint: **NO**  
Remarks:

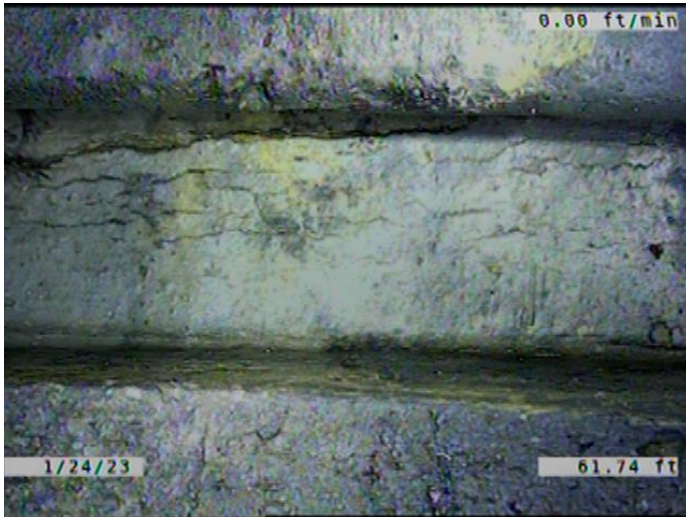
Code: **FM**  
 Description: **Fracture Multiple**

Distance (ft): **61.7**  
 Structural Grade: **4**  
 O&M Grade: **0**  
 Clock Start/From: **3**  
 Clock To: **4**  
 1st Value:  
 2nd Value:  
 Value Percent:  
 Continuous Index:  
 Within 8" of Joint: **YES**  
 Remarks:

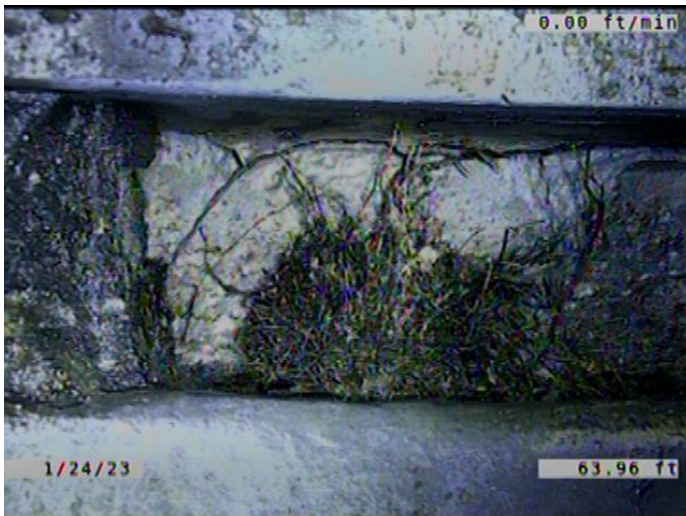
Code: **FM**  
 Description: **Fracture Multiple**

Distance (ft): **64.0**  
 Structural Grade: **4**  
 O&M Grade: **0**  
 Clock Start/From: **3**  
 Clock To: **5**  
 1st Value:  
 2nd Value:  
 Value Percent:  
 Continuous Index:  
 Within 8" of Joint: **YES**  
 Remarks:

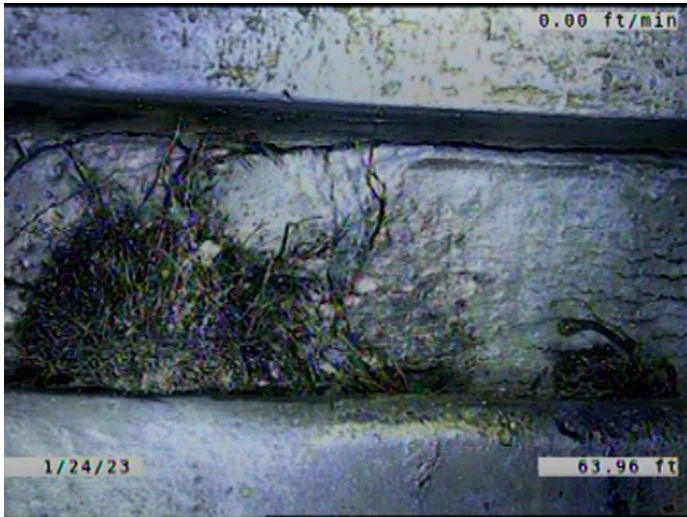
Code: **JAM**  
 Description: **Joint Angular Medium**

Distance (ft): **64.0**  
 Structural Grade: **3**  
 O&M Grade: **0**  
 Clock Start/From:  
 Clock To:  
 1st Value:  
 2nd Value:  
 Value Percent:  
 Continuous Index:  
 Within 8" of Joint: **NO**  
 Remarks:

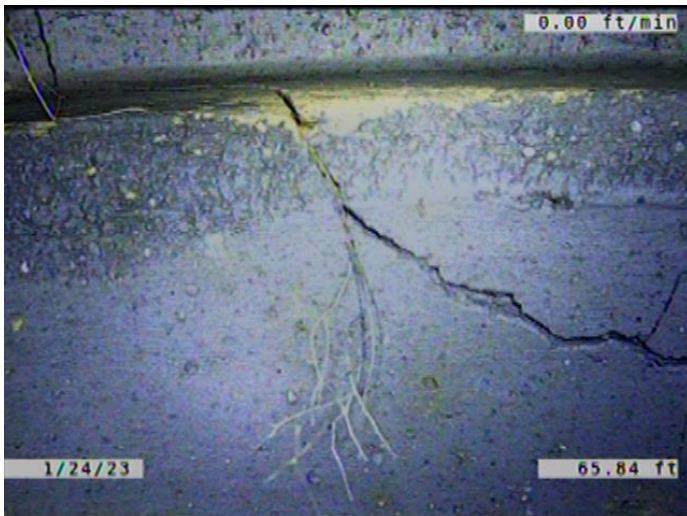
Code: **FM**  
 Description: **Fracture Multiple**

Distance (ft): **65.8**  
 Structural Grade: **4**  
 O&M Grade: **0**  
 Clock Start/From: **12**  
 Clock To: **4**  
 1st Value:  
 2nd Value:  
 Value Percent:  
 Continuous Index:  
 Within 8" of Joint: **YES**  
 Remarks:

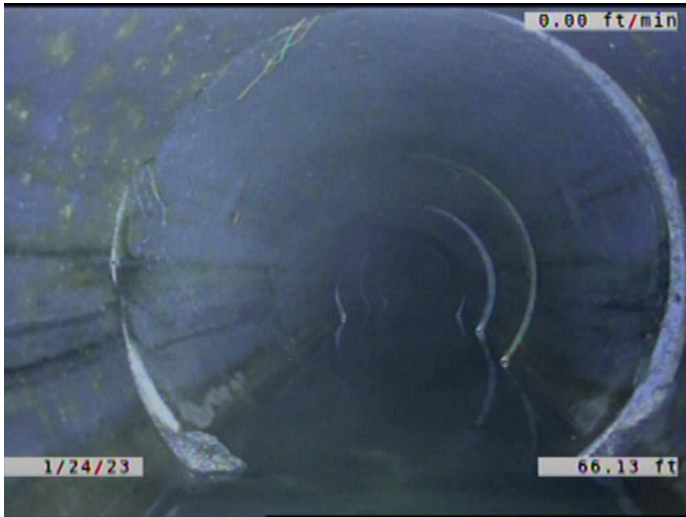
Code: **MWLS**  
Description: **Miscellaneous Water Level Sag**

Distance (ft): **66.1**  
Structural Grade: **2**  
O&M Grade: **0**  
Clock Start/From:  
Clock To:  
1st Value:  
2nd Value:  
Value Percent: **15.000**  
Continuous Index: **F04**  
Within 8" of Joint: **NO**  
Remarks:

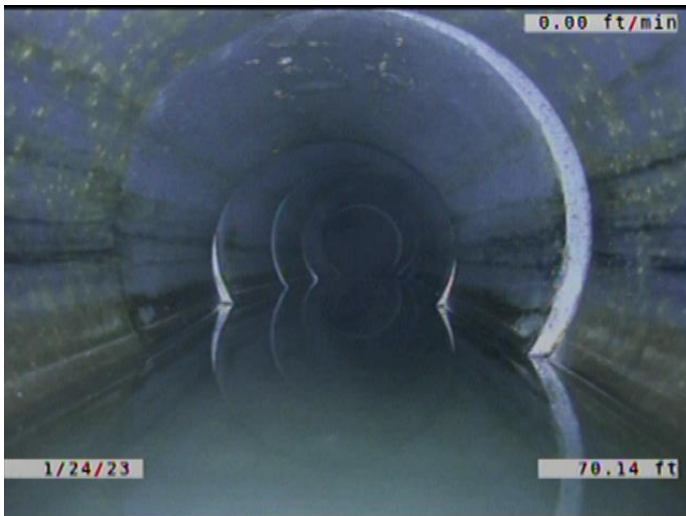
Code: **MWLS**  
Description: **Miscellaneous Water Level Sag**

Distance (ft): **70.1**  
Structural Grade: **2**  
O&M Grade: **0**  
Clock Start/From:  
Clock To:  
1st Value:  
2nd Value:  
Value Percent: **15.000**  
Continuous Index: **S05**  
Within 8" of Joint: **NO**  
Remarks:

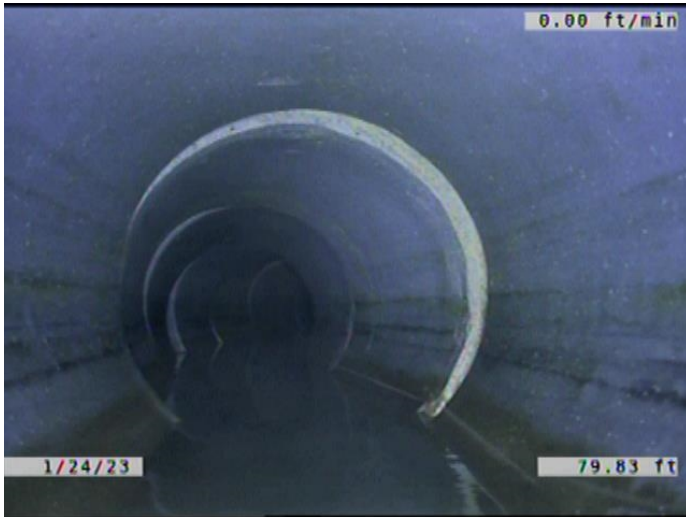
Code: **MWLS**  
Description: **Miscellaneous Water Level Sag**

Distance (ft): **79.8**  
Structural Grade: **2**  
O&M Grade: **0**  
Clock Start/From:  
Clock To:  
1st Value:  
2nd Value:  
Value Percent: **15.000**  
Continuous Index: **F05**  
Within 8" of Joint: **NO**  
Remarks:

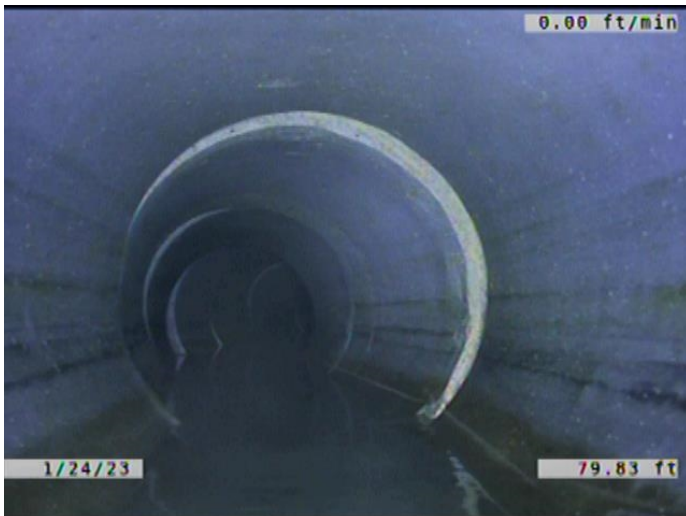
Code: **LL**  
Description: **Line Left**

Distance (ft): **79.8**  
Structural Grade: **0**  
O&M Grade: **1**  
Clock Start/From:  
Clock To:  
1st Value:  
2nd Value:  
Value Percent: **10.000**  
Continuous Index:  
Within 8" of Joint: **NO**  
Remarks:

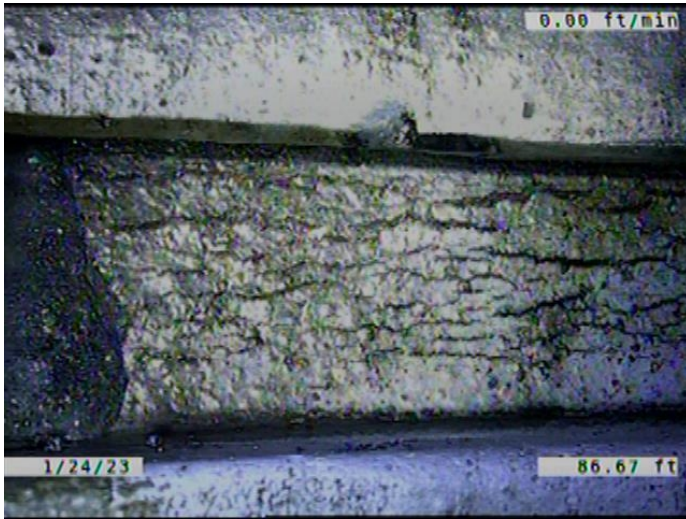
Code: **JAL**  
 Description: **Joint Angular Large**

Distance (ft): **86.7**  
 Structural Grade: **4**  
 O&M Grade: **0**  
 Clock Start/From:  
 Clock To:  
 1st Value:  
 2nd Value:  
 Value Percent:  
 Continuous Index:  
 Within 8" of Joint: **NO**  
 Remarks:

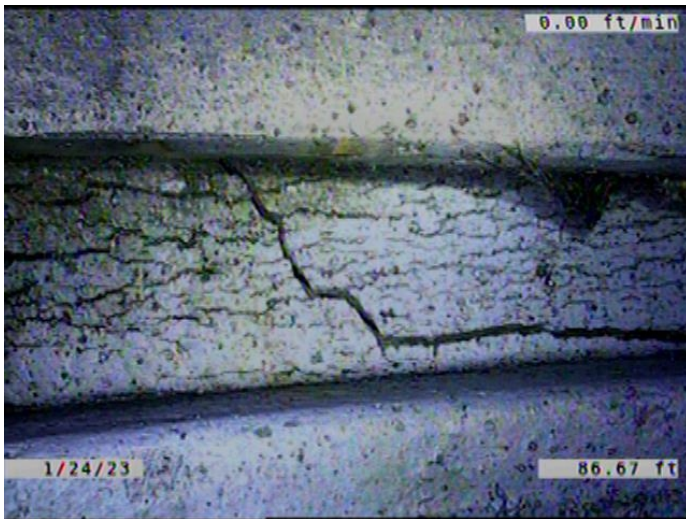
Code: **FM**  
 Description: **Fracture Multiple**

Distance (ft): **86.7**  
 Structural Grade: **4**  
 O&M Grade: **0**  
 Clock Start/From: **8**  
 Clock To: **12**  
 1st Value:  
 2nd Value:  
 Value Percent:  
 Continuous Index:  
 Within 8" of Joint: **YES**  
 Remarks:

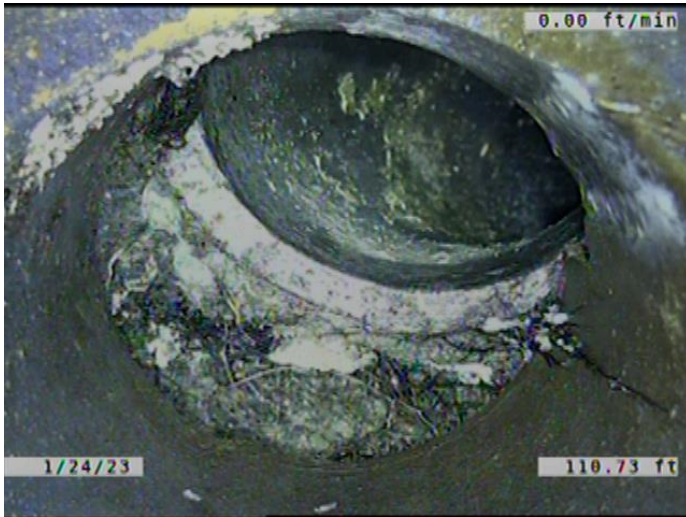
Code:	<b>TFD</b>
Description:	<b>Tap Factory Defective</b>
Distance (ft):	<b>110.7</b>
Structural Grade:	<b>0</b>
O&M Grade:	<b>3</b>
Clock Start/From:	<b>1</b>
Clock To:	
1st Value:	<b>6.000</b>
2nd Value:	
Value Percent:	
Continuous Index:	
Within 8" of Joint:	<b>YES</b>
Remarks:	<b>TAP BROKEN. SERVICE LARGE OFFSET. SOIL VISIBLE. ROOTS GROW</b>

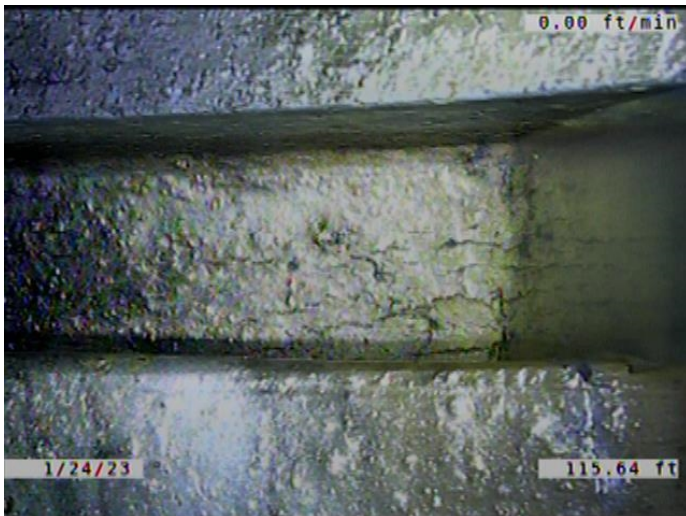
Code:	<b>JAM</b>
Description:	<b>Joint Angular Medium</b>
Distance (ft):	<b>115.6</b>
Structural Grade:	<b>3</b>
O&M Grade:	<b>0</b>
Clock Start/From:	
Clock To:	
1st Value:	
2nd Value:	
Value Percent:	
Continuous Index:	
Within 8" of Joint:	<b>NO</b>
Remarks:

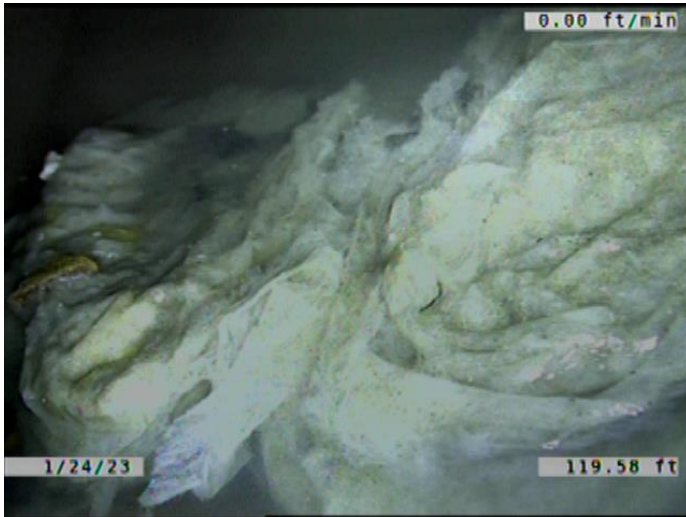
Code: **DAR**  
Description: **Deposits Attached Ragging**

Distance (ft): **119.6**  
Structural Grade: **0**  
O&M Grade: **2**  
Clock Start/From: **6**  
Clock To: **7**  
1st Value:  
2nd Value:  
Value Percent: **5.000**  
Continuous Index:  
Within 8" of Joint: **YES**  
Remarks:

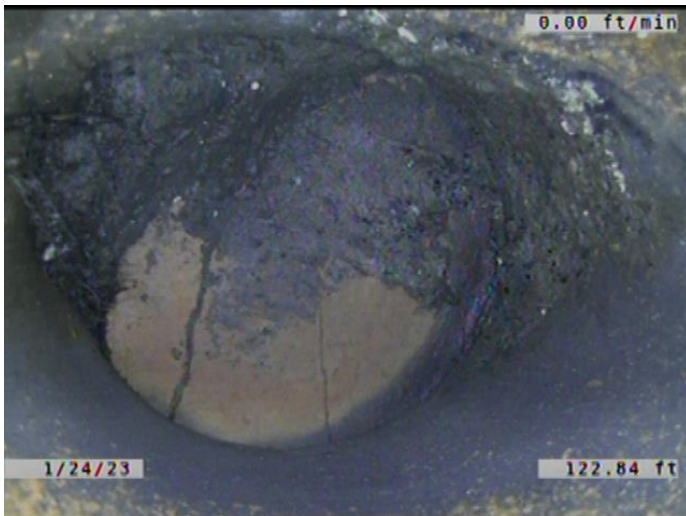
Code: **TFD**  
Description: **Tap Factory Defective**

Distance (ft): **122.8**  
Structural Grade: **0**  
O&M Grade: **3**  
Clock Start/From: **11**  
Clock To:  
1st Value: **6.000**  
2nd Value:  
Value Percent:  
Continuous Index:  
Within 8" of Joint: **YES**  
Remarks: **CAPPED. CAP BROKEN. ROOTS GROWING AROUND THE CAP.**

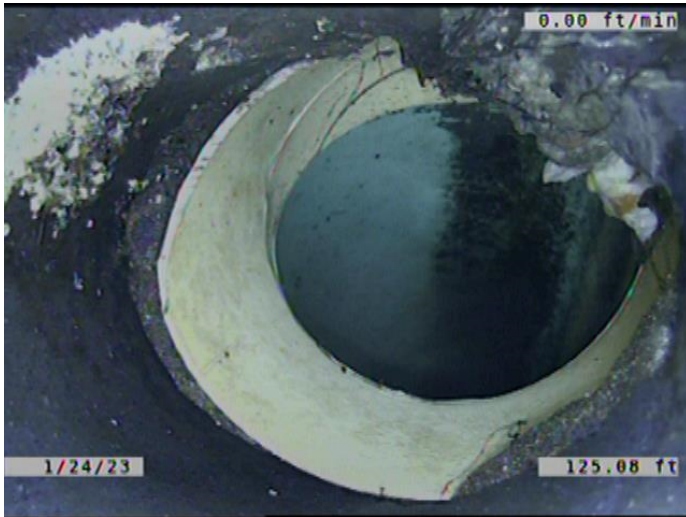
Code:	<b>TF</b>
Description:	<b>Tap Factory</b>
Distance (ft):	<b>125.1</b>
Structural Grade:	<b>0</b>
O&M Grade:	<b>0</b>
Clock Start/From:	<b>1</b>
Clock To:	
1st Value:	<b>6.000</b>
2nd Value:	
Value Percent:	
Continuous Index:	
Within 8" of Joint:	<b>YES</b>
Remarks:	<b>ROOTS GROWING FROM THE SERVICE TO MAIN CONNECTION INT</b>

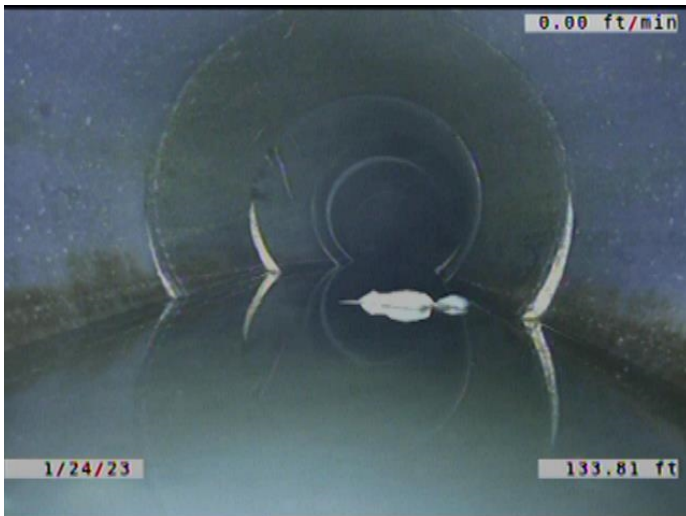
Code:	<b>MWLS</b>
Description:	<b>Miscellaneous Water Level Sag</b>
Distance (ft):	<b>133.8</b>
Structural Grade:	<b>2</b>
O&M Grade:	<b>0</b>
Clock Start/From:	
Clock To:	
1st Value:	
2nd Value:	
Value Percent:	<b>15.000</b>
Continuous Index:	<b>S06</b>
Within 8" of Joint:	<b>NO</b>
Remarks:

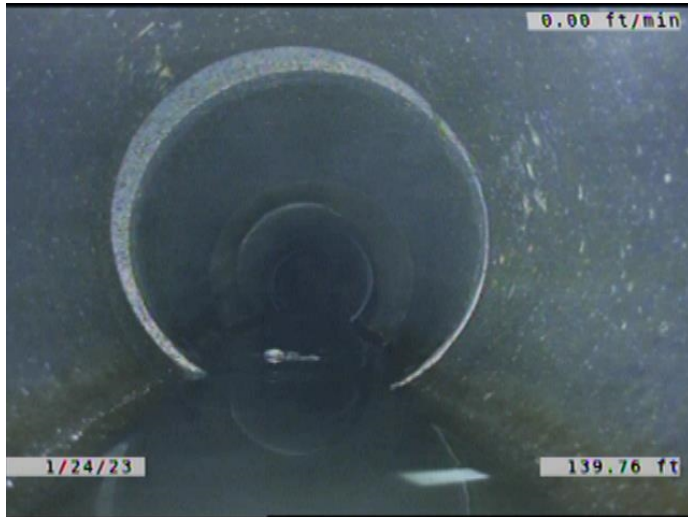
Code: **MWLS**  
Description: **Miscellaneous Water Level Sag**

Distance (ft): **139.8**  
Structural Grade: **2**  
O&M Grade: **0**  
Clock Start/From:  
Clock To:  
1st Value:  
2nd Value:  
Value Percent: **15.000**  
Continuous Index: **F06**  
Within 8" of Joint: **NO**  
Remarks:

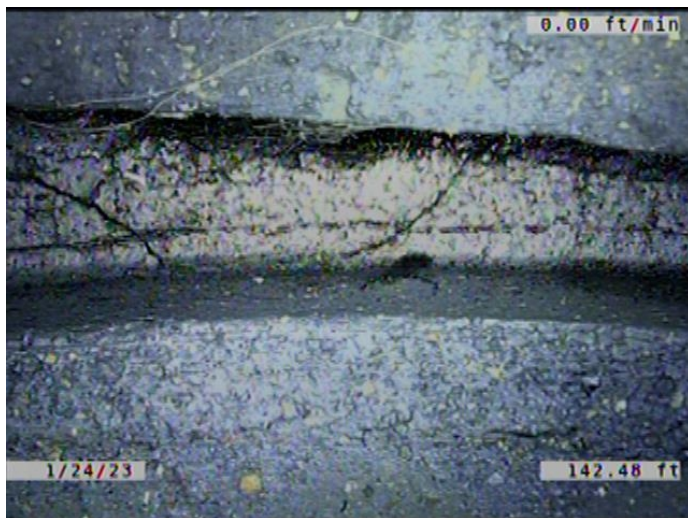
Code: **CM**  
Description: **Crack Multiple**

Distance (ft): **142.5**  
Structural Grade: **3**  
O&M Grade: **0**  
Clock Start/From: **1**  
Clock To: **3**  
1st Value:  
2nd Value:  
Value Percent:  
Continuous Index:  
Within 8" of Joint: **YES**  
Remarks:

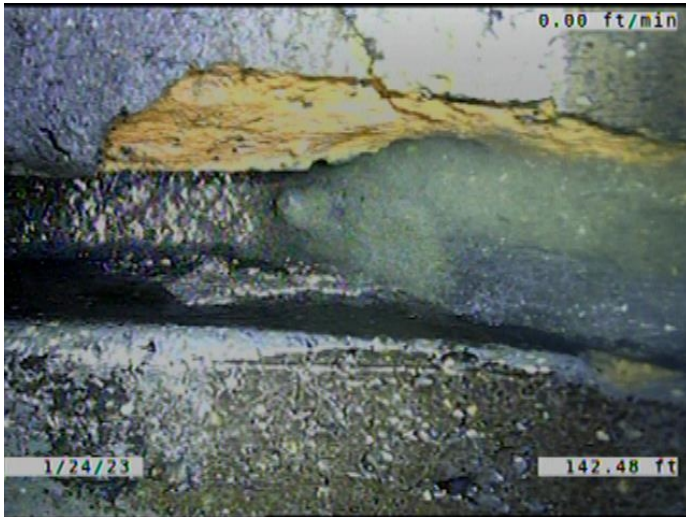
Code: **SZ**  
Description: **Surface Damage Other**

Distance (ft): **142.5**  
Structural Grade: **0**  
O&M Grade: **0**  
Clock Start/From: **4**  
Clock To: **5**  
1st Value:  
2nd Value:  
Value Percent:  
Continuous Index:  
Within 8" of Joint: **YES**  
Remarks: **A PIECE CHIPPED AWAY FROM THE JOINT.**

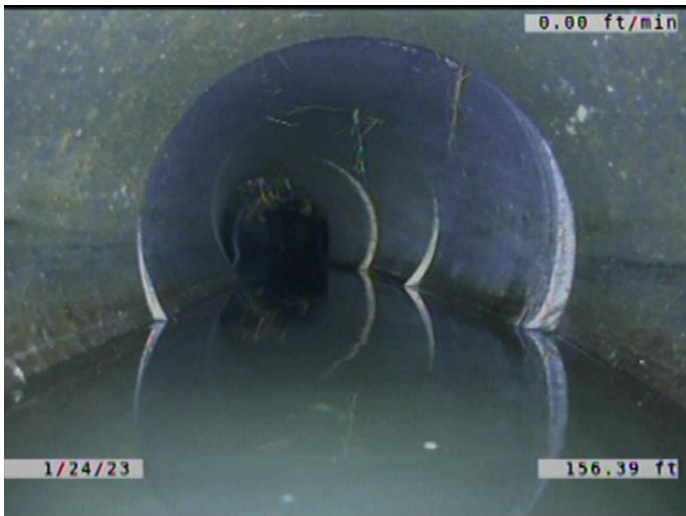
Code: **MWLS**  
Description: **Miscellaneous Water Level Sag**

Distance (ft): **156.4**  
Structural Grade: **2**  
O&M Grade: **0**  
Clock Start/From:  
Clock To:  
1st Value:  
2nd Value:  
Value Percent: **20.000**  
Continuous Index: **S07**  
Within 8" of Joint: **NO**  
Remarks:

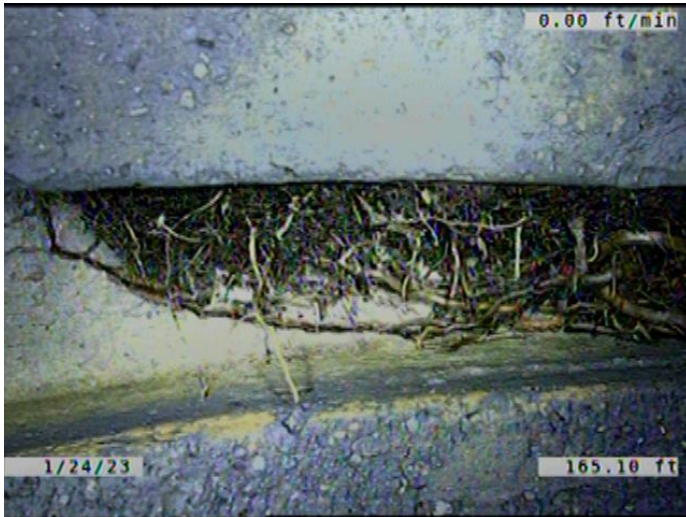
Code: **FM**  
 Description: **Fracture Multiple**

Distance (ft): **165.1**  
 Structural Grade: **4**  
 O&M Grade: **0**  
 Clock Start/From: **10**  
 Clock To: **11**  
 1st Value:  
 2nd Value:  
 Value Percent:  
 Continuous Index:  
 Within 8" of Joint: **YES**  
 Remarks:
