# Profile/Photo Observation Report

Date:	<b>01/24/2023</b>	Weather:		Coding:	<b>PACP 7.0</b>
Pipe Length (ft):	<b>197.0</b>	Owner:	<b>City of Hobart</b>	Pre Clean:	<b>Heavy Cleaning</b>
P.O.#:	<b>YES502259</b>	Surveyor:	<b>Steven Bucklin</b>	PSR:	<b>P-805-059-058</b>
Customer:	<b>City of Hobart</b>	Clean Date:	<b>01/20/2023</b>	Shape:	<b>C</b>

Street:	<b>Devanshire Street</b>	Flow Control:	<b>Not Controlled</b>
City:	<b>Hobart, IN</b>	Year Renewed:	
Location:	<b>Local rural streets with light traffic, t</b>	Tape/Media #:	
Purpose:	<b>Routine Assessment</b>	Dia/Height:	<b>12"</b>
Use:	<b>Sanitary Sewage Pipe</b>	Material:	<b>VCP</b>
Drain Area:		Lining:	<b>None</b>
Category:	<b>NA</b>		
Comment:			
Location Details:		Direction of Survey:	<b>Downstream</b>
US MH:	<b>M-805-059</b>	DS MH:	<b>M-805-058</b>
		Total Length Surveyed (ft):	<b>193.9</b>

O&M Index:	<b>1.42</b>	O&M Quick:	<b>3824</b>	O&M Rating:	<b>68.00</b>
Structural Index:	<b>2.90</b>	Structural Quick:	<b>514A</b>	Structural Rating:	<b>122.00</b>
Overall Index:	<b>2.11</b>	Overall Quick:	<b>514A</b>	Overall Rating:	<b>190.00</b>

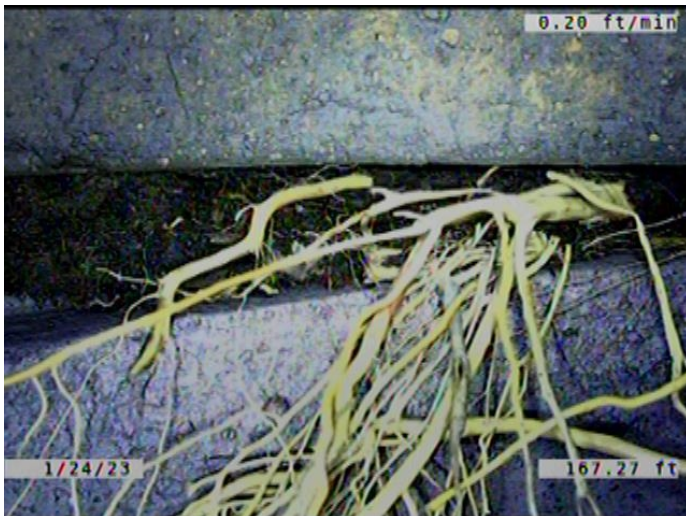
Code: **RMJ**  
 Description: **Roots Medium Joint**

Distance (ft): **167.2**  
 Structural Grade: **0**  
 O&M Grade: **3**  
 Clock Start/From: **9**  
 Clock To: **3**  
 1st Value:  
 2nd Value:  
 Value Percent: **5.000**  
 Continuous Index:  
 Within 8" of Joint: **YES**  
 Remarks:

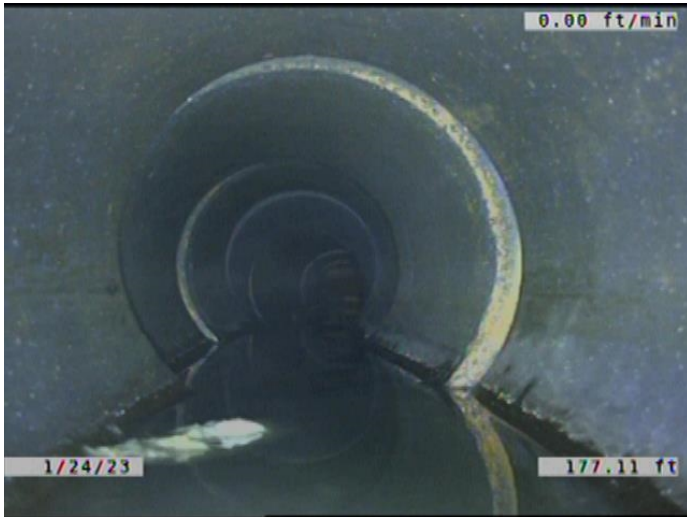
Code: **MWLS**  
Description: **Miscellaneous Water Level Sag**

Distance (ft): **177.1**  
Structural Grade: **2**  
O&M Grade: **0**  
Clock Start/From:  
Clock To:  
1st Value:  
2nd Value:  
Value Percent: **20.000**  
Continuous Index: **F07**  
Within 8" of Joint: **NO**  
Remarks:

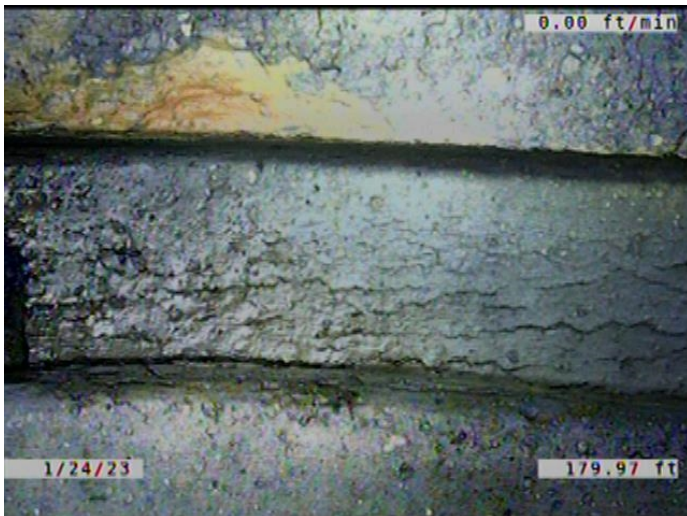
Code: **JAM**  
Description: **Joint Angular Medium**

Distance (ft): **180.0**  
Structural Grade: **3**  
O&M Grade: **0**  
Clock Start/From:  
Clock To:  
1st Value:  
2nd Value:  
Value Percent:  
Continuous Index:  
Within 8" of Joint: **NO**  
Remarks:

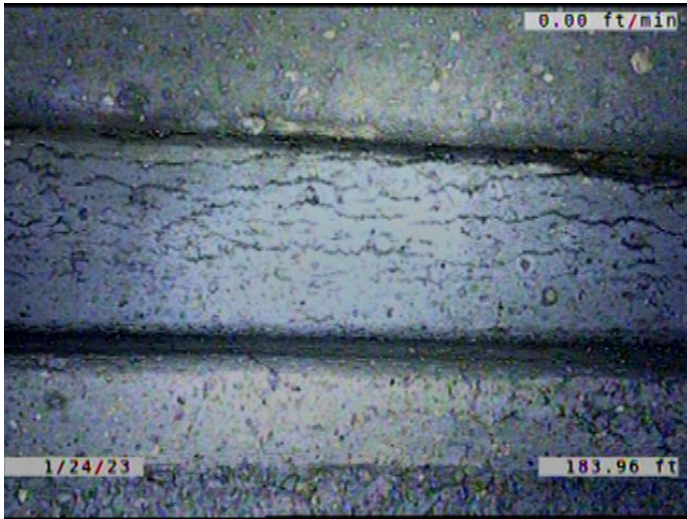
Code: **JAM**  
 Description: **Joint Angular Medium**

Distance (ft): **184.0**  
 Structural Grade: **3**  
 O&M Grade: **0**  
 Clock Start/From:  
 Clock To:  
 1st Value:  
 2nd Value:  
 Value Percent:  
 Continuous Index:  
 Within 8" of Joint: **NO**  
 Remarks:

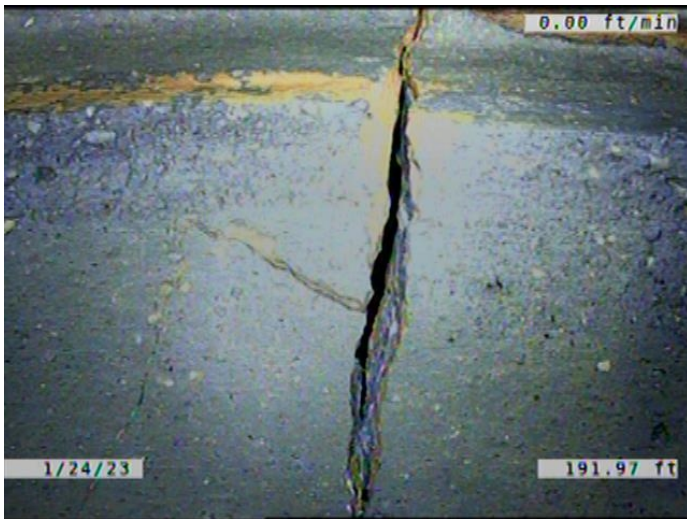
Code: **BVV**  
 Description: **Broken Void Visible**

Distance (ft): **192.0**  
 Structural Grade: **5**  
 O&M Grade: **0**  
 Clock Start/From: **9**  
 Clock To: **4**  
 1st Value:  
 2nd Value:  
 Value Percent:  
 Continuous Index:  
 Within 8" of Joint: **YES**  
 Remarks:

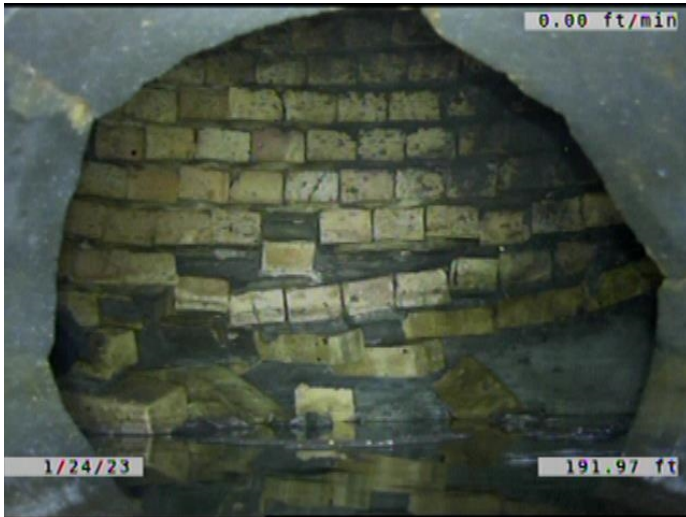
Code: **DR**  
 Description: **Deformed Rigid**

Distance (ft): **192.0**  
 Structural Grade: **4**  
 O&M Grade: **0**  
 Clock Start/From:  
 Clock To:  
 1st Value:  
 2nd Value:  
 Value Percent: **5.000**  
 Continuous Index:  
 Within 8" of Joint: **NO**  
 Remarks:

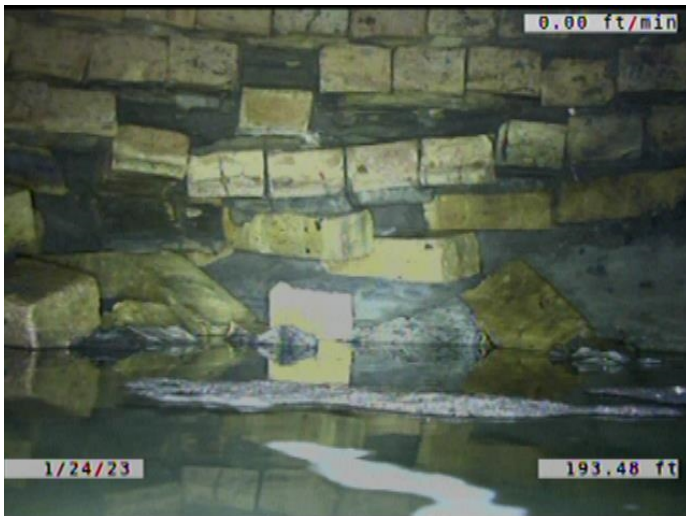
Code: **RFJ**  
 Description: **Roots Fine Joint**

Distance (ft): **193.5**  
 Structural Grade: **0**  
 O&M Grade: **1**  
 Clock Start/From: **9**  
 Clock To: **3**  
 1st Value:  
 2nd Value:  
 Value Percent:  
 Continuous Index: **F02**  
 Within 8" of Joint: **YES**  
 Remarks:
