## Profile/Photo Observation Report

Date:	<b>04/20/2018</b>	Weather:		Coding:	<b>PACP 6.0</b>
Pipe Length (ft):	<b>211.4</b>	Owner:	<b>NA</b>	Pre Clean:	<b>Not Known</b>
P.O.#:		Surveyor:	<b>Byrd Fitzgerald</b>	PSR:	<b>P-805-060-059</b>
Customer:		Clean Date:	<b>01/01/1900</b>	Shape:	<b>C</b>

Street:	<b>DEVONSHIRE ST &amp; S OHIO ST</b>	Flow Control:	<b>Not Controlled</b>
City:	<b>Hobart, IN</b>	Year Renewed:	
Location:	<b>Other</b>	Tape/Media #:	
Purpose:	<b>Not Known</b>	Dia/Height:	<b>12"</b>
Use:	<b>Sanitary</b>	Material:	<b>VCP</b>
Drain Area:	<b>NA</b>	Lining:	
Category:	<b>NA</b>		
Comment:

Location Details:		Direction of Survey:	<b>Downstream</b>
US MH:	<b>M-805-059</b>	DS MH:	<b>M-805-060</b>
		Total Length Surveyed (ft):	<b>45.2</b>

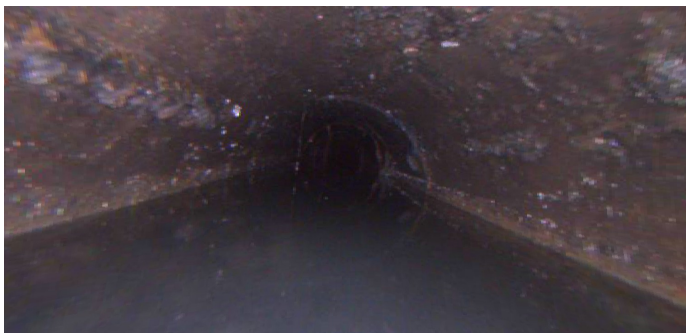
Code: **AMH**  
Description: **Manhole**

Distance (ft): **.0**  
Structural Grade: **0**  
O&M Grade: **0**  
Clock Start/From:  
Clock To:  
1st Value:  
2nd Value:  
Value Percent:  
Continuous Index:  
Within 8" of Joint: **NO**  
Remarks: **M-805-059**

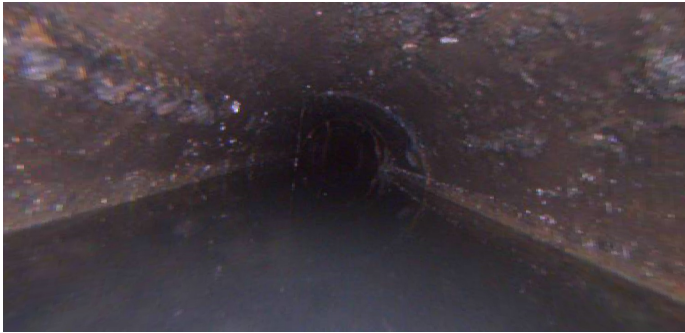
Code:	<b>MWL</b>
Description:	<b>Water Level</b>

Distance (ft):	<b>.0</b>
Structural Grade:	<b>0</b>
O&M Grade:	<b>0</b>
Clock Start/From:	
Clock To:	
1st Value:	
2nd Value:	
Value Percent:	<b>25.000</b>
Continuous Index:	
Within 8" of Joint:	<b>NO</b>
Remarks:

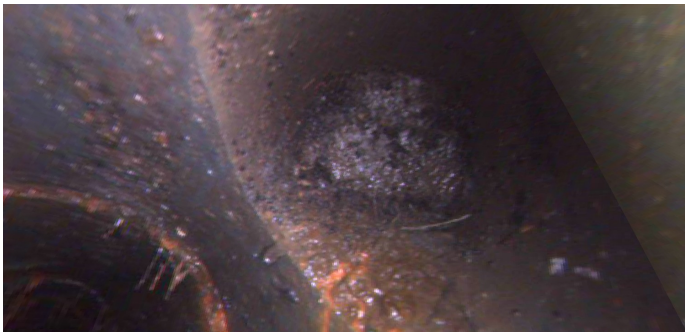
Code:	<b>TFD</b>
Description:	<b>Tap Factory Defective</b>

Distance (ft):	<b>3.8</b>
Structural Grade:	<b>0</b>
O&M Grade:	<b>2</b>
Clock Start/From:	<b>2</b>
Clock To:	
1st Value:	<b>4.000</b>
2nd Value:	
Value Percent:	
Continuous Index:	
Within 8" of Joint:	<b>YES</b>
Remarks:	<b>blocked by roots/capped?</b>

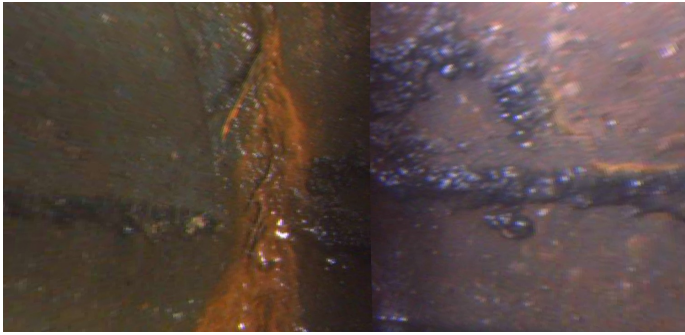
Code: **RFJ**  
Description: **Roots Fine Joint**

Distance (ft): **5.0**  
Structural Grade: **0**  
O&M Grade: **1**  
Clock Start/From: **8**  
Clock To: **4**  
1st Value:  
2nd Value:  
Value Percent:  
Continuous Index: **S01**  
Within 8" of Joint: **YES**  
Remarks: **wandering**

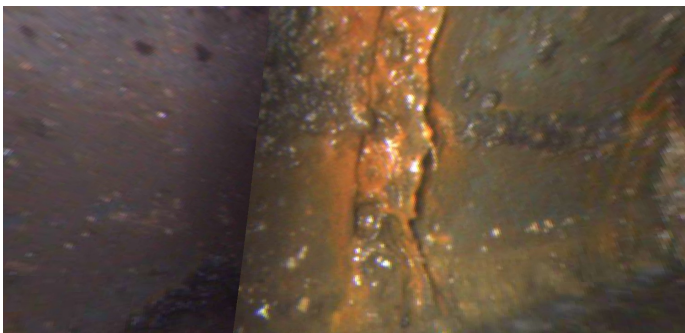
Code: **IS**  
Description: **Infil Stain**

Distance (ft): **5.0**  
Structural Grade: **0**  
O&M Grade: **0**  
Clock Start/From: **8**  
Clock To: **4**  
1st Value:  
2nd Value:  
Value Percent:  
Continuous Index: **S02**  
Within 8" of Joint: **YES**  
Remarks:

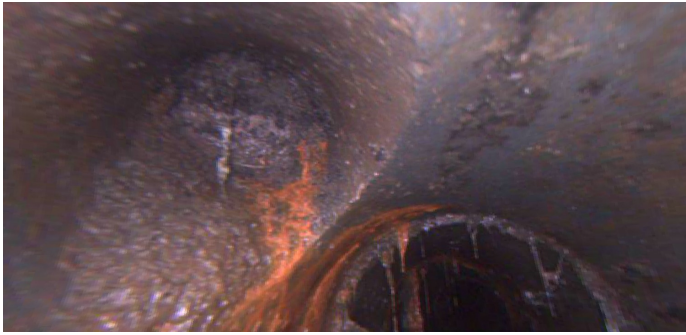
Code: **TFD**  
Description: **Tap Factory Defective**

Distance (ft): **5.6**  
Structural Grade: **0**  
O&M Grade: **2**  
Clock Start/From: **10**  
Clock To:  
1st Value: **4.000**  
2nd Value:  
Value Percent:  
Continuous Index:  
Within 8" of Joint: **YES**  
Remarks: **blocked/capped?**

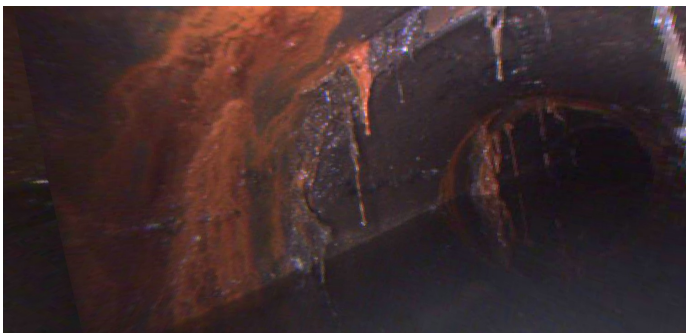
Code: **IS**  
Description: **Infil Stain**

Distance (ft): **6.3**  
Structural Grade: **0**  
O&M Grade: **0**  
Clock Start/From: **8**  
Clock To: **11**  
1st Value:  
2nd Value:  
Value Percent:  
Continuous Index:  
Within 8" of Joint:  
Remarks:

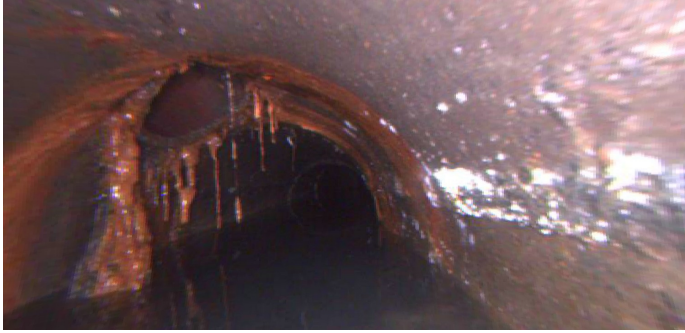
Code: **TB**  
Description: **Tap Break-in**

Distance (ft): **7.5**  
Structural Grade: **0**  
O&M Grade: **0**  
Clock Start/From: **11**  
Clock To:  
1st Value: **4.000**  
2nd Value:  
Value Percent:  
Continuous Index:  
Within 8" of Joint:  
Remarks:

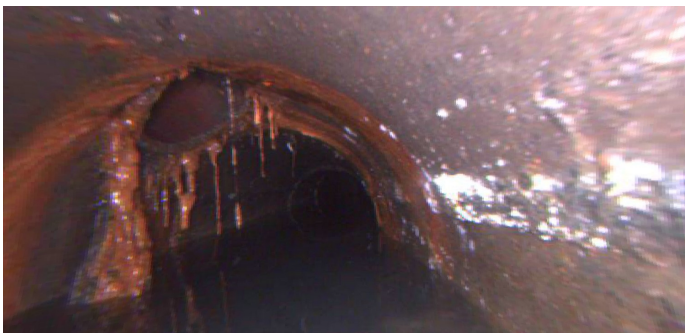
Code: **DAE**  
Description: **Deposits Attached Encrustation**

Distance (ft): **7.5**  
Structural Grade: **0**  
O&M Grade: **2**  
Clock Start/From: **8**  
Clock To: **12**  
1st Value:  
2nd Value:  
Value Percent: **5.000**  
Continuous Index:  
Within 8" of Joint: **NO**  
Remarks:

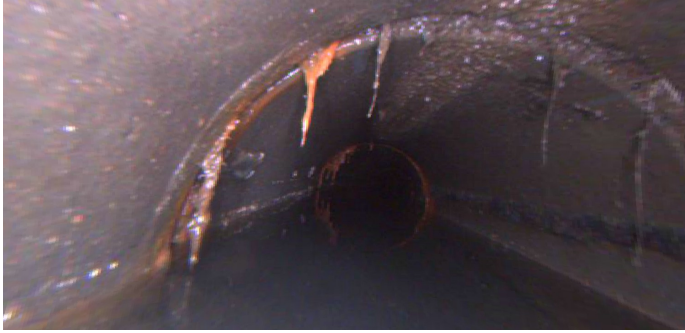
Code: **MWL**  
Description: **Water Level**

Distance (ft): **14.5**  
Structural Grade: **0**  
O&M Grade: **0**  
Clock Start/From:  
Clock To:  
1st Value:  
2nd Value:  
Value Percent: **40.000**  
Continuous Index:  
Within 8" of Joint: **NO**  
Remarks:

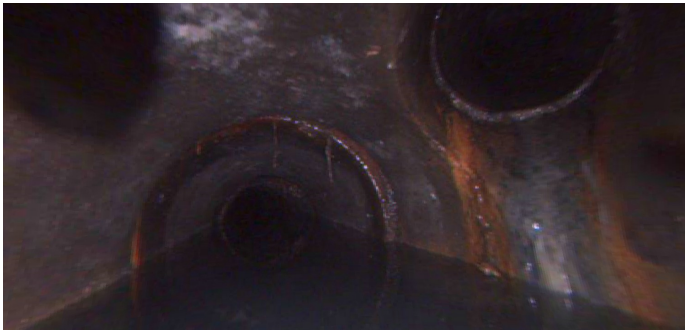
Code: **TF**  
Description: **Tap Factory**

Distance (ft): **38.3**  
Structural Grade: **0**  
O&M Grade: **0**  
Clock Start/From: **2**  
Clock To:  
1st Value: **4.000**  
2nd Value:  
Value Percent:  
Continuous Index:  
Within 8" of Joint: **YES**  
Remarks:

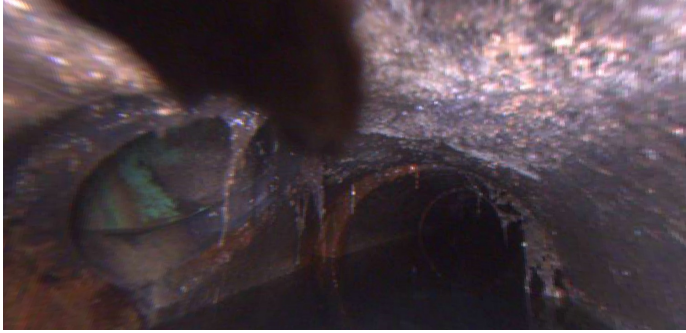
Code: **TF**  
Description: **Tap Factory**

Distance (ft): **44.4**  
Structural Grade: **0**  
O&M Grade: **0**  
Clock Start/From: **11**  
Clock To:  
1st Value: **4.000**  
2nd Value:  
Value Percent:  
Continuous Index:  
Within 8" of Joint: **YES**  
Remarks:

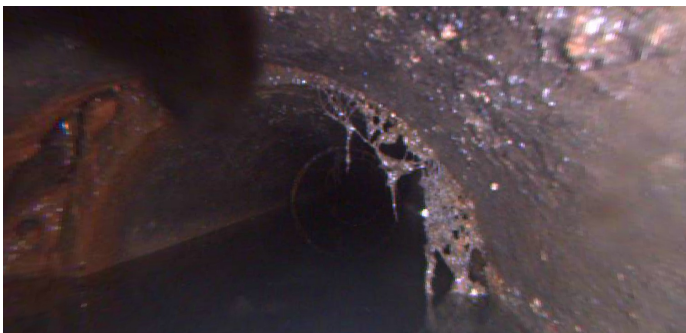
Code: **MSA**  
Description: **Abandoned Survey**

Distance (ft): **45.2**  
Structural Grade: **0**  
O&M Grade: **0**  
Clock Start/From:  
Clock To:  
1st Value:  
2nd Value:  
Value Percent:  
Continuous Index:  
Within 8" of Joint: **NO**  
Remarks: **no blockage**

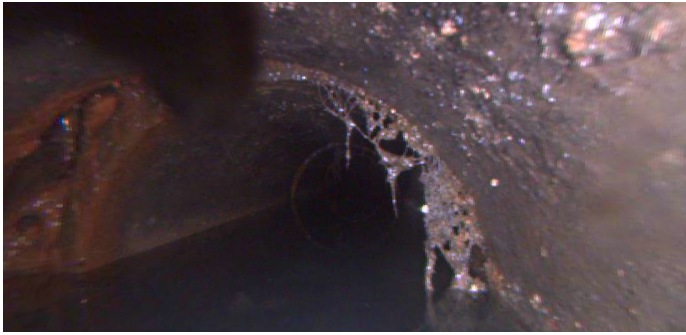
Code: **IS**  
Description: **Infil Stain**

Distance (ft): **45.2**  
Structural Grade: **0**  
O&M Grade: **0**  
Clock Start/From: **8**  
Clock To: **4**  
1st Value:  
2nd Value:  
Value Percent:  
Continuous Index: **F02**  
Within 8" of Joint: **YES**  
Remarks:

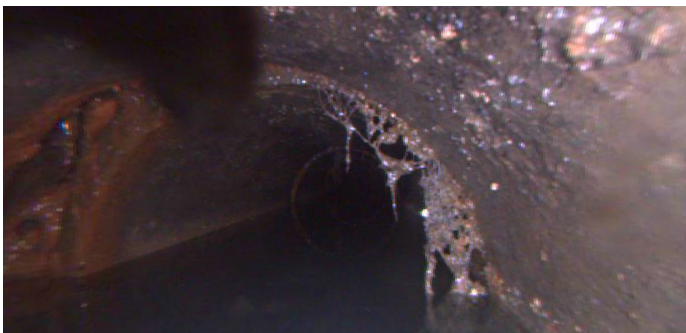
Code: **RFJ**  
Description: **Roots Fine Joint**

Distance (ft): **45.2**  
Structural Grade: **0**  
O&M Grade: **1**  
Clock Start/From: **8**  
Clock To: **4**  
1st Value:  
2nd Value:  
Value Percent:  
Continuous Index: **F01**  
Within 8" of Joint: **YES**  
Remarks: **wandering**
