Profile/Photo Observation Report

Date:	04/20/2018	Weather:		Coding:	PACP 6.0
Pipe Length (ft):	211.4	Owner:	NA	Pre Clean:	Not Known
P.O.#:		Surveyor:	Byrd Fitzgerald	PSR:	P-805-060-059
Customer:		Clean Date:	01/01/1900	Shape:	C

Street:	Devonshire St.	Flow Control:	Not Controlled
City:	Hobart, IN	Year Renewed:	
Location:	Other	Tape/Media #:	
Purpose:	Not Known	Dia/Height:	12"
Use:	Sanitary	Material:	VCP
Drain Area:	NA	Lining:	
Category:	NA		
Comment:

Location Details:		Direction of Survey:	Downstream
US MH:	M-805-059	DS MH:	M-805-060
		Total Length Surveyed (ft):	45.2

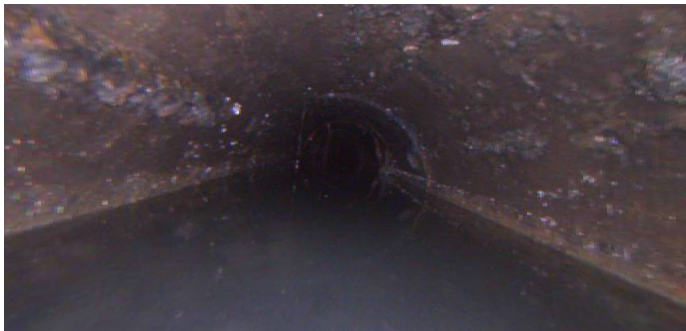
Code: **AMH**
Description: **Manhole**

Distance (ft): **.0**
Structural Grade: **0**
O&M Grade: **0**
Clock Start/From:
Clock To:
1st Value:
2nd Value:
Value Percent:
Continuous Index:
Within 8" of Joint: **NO**
Remarks: **M-805-059**

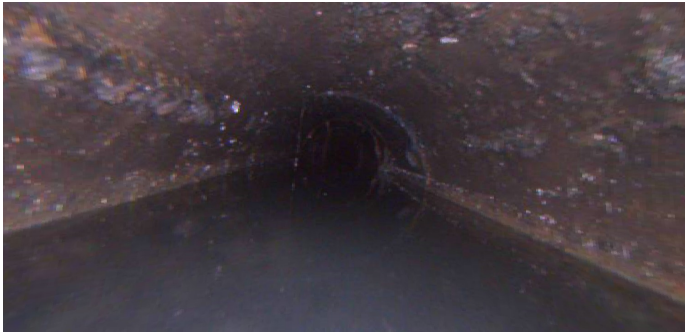
Code:	MWL
Description:	Water Level

Distance (ft):	.0
Structural Grade:	0
O&M Grade:	0
Clock Start/From:	
Clock To:	
1st Value:	
2nd Value:	
Value Percent:	25.000
Continuous Index:	
Within 8" of Joint:	NO
Remarks:

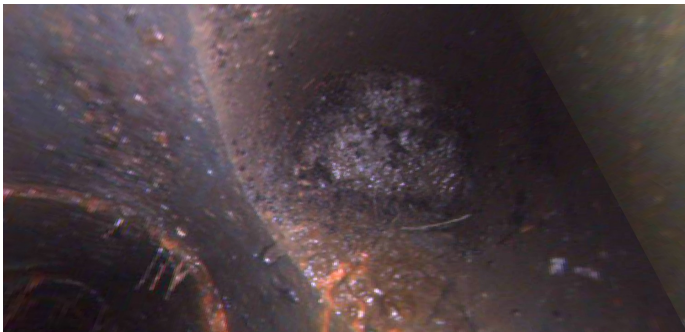
Code:	TFD
Description:	Tap Factory Defective

Distance (ft):	3.8
Structural Grade:	0
O&M Grade:	2
Clock Start/From:	2
Clock To:	
1st Value:	4.000
2nd Value:	
Value Percent:	
Continuous Index:	
Within 8" of Joint:	YES
Remarks:	blocked by roots/capped?

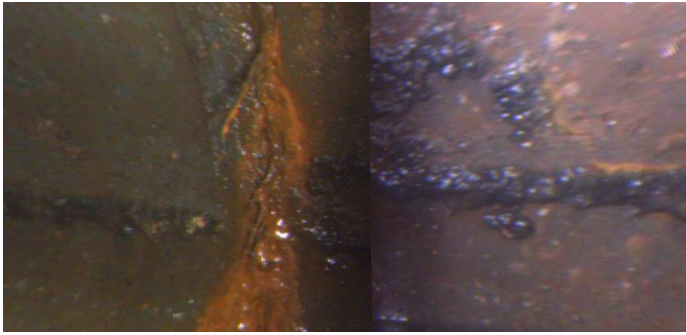
Code: **RFJ**
Description: **Roots Fine Joint**

Distance (ft): **5.0**
Structural Grade: **0**
O&M Grade: **1**
Clock Start/From: **8**
Clock To: **4**
1st Value:
2nd Value:
Value Percent:
Continuous Index: **S01**
Within 8" of Joint: **YES**
Remarks: **wandering**

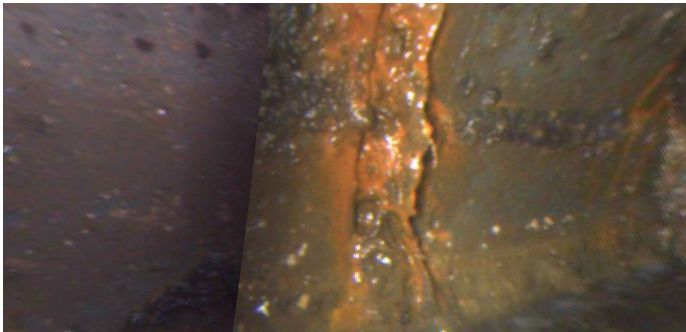
Code: **IS**
Description: **Infil Stain**

Distance (ft): **5.0**
Structural Grade: **0**
O&M Grade: **0**
Clock Start/From: **8**
Clock To: **4**
1st Value:
2nd Value:
Value Percent:
Continuous Index: **S02**
Within 8" of Joint: **YES**
Remarks:

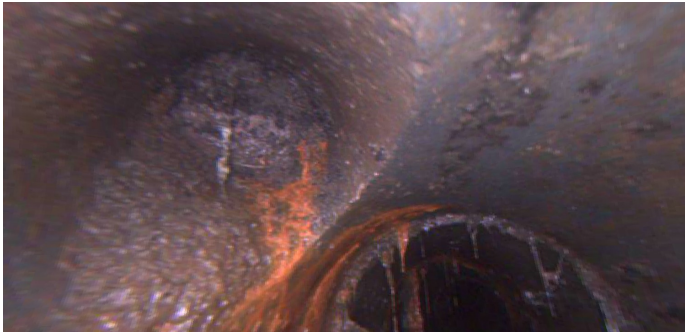
Code: **TFD**
Description: **Tap Factory Defective**

Distance (ft): **5.6**
Structural Grade: **0**
O&M Grade: **2**
Clock Start/From: **10**
Clock To:
1st Value: **4.000**
2nd Value:
Value Percent:
Continuous Index:
Within 8" of Joint: **YES**
Remarks: **blocked/capped?**

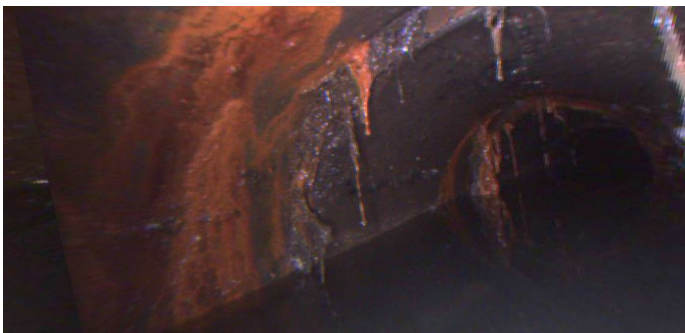
Code: **IS**
Description: **Infil Stain**

Distance (ft): **6.3**
Structural Grade: **0**
O&M Grade: **0**
Clock Start/From: **8**
Clock To: **11**
1st Value:
2nd Value:
Value Percent:
Continuous Index:
Within 8" of Joint:
Remarks:

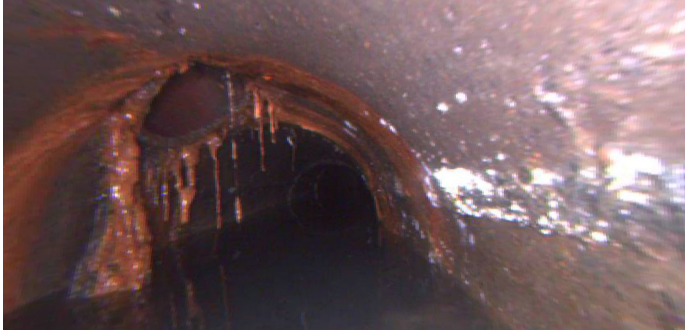
Code: **TB**
Description: **Tap Break-in**

Distance (ft): **7.5**
Structural Grade: **0**
O&M Grade: **0**
Clock Start/From: **11**
Clock To:
1st Value: **4.000**
2nd Value:
Value Percent:
Continuous Index:
Within 8" of Joint:
Remarks:

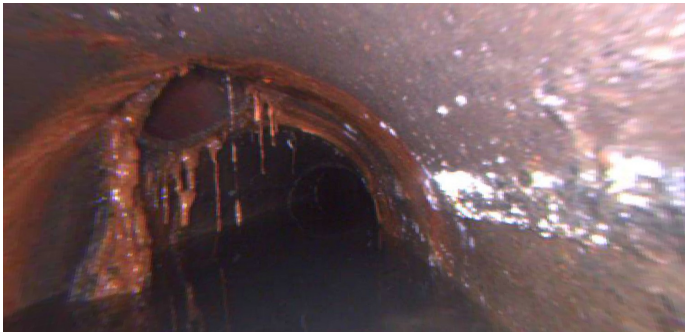
Code: **DAE**
Description: **Deposits Attached Encrustation**

Distance (ft): **7.5**
Structural Grade: **0**
O&M Grade: **2**
Clock Start/From: **8**
Clock To: **12**
1st Value:
2nd Value:
Value Percent: **5.000**
Continuous Index:
Within 8" of Joint: **NO**
Remarks:

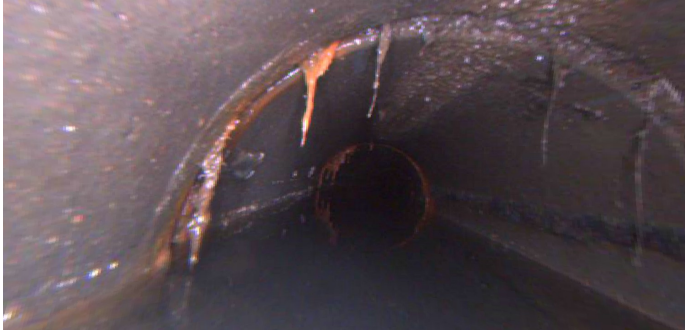
Code: **MWL**
Description: **Water Level**

Distance (ft): **14.5**
Structural Grade: **0**
O&M Grade: **0**
Clock Start/From:
Clock To:
1st Value:
2nd Value:
Value Percent: **40.000**
Continuous Index:
Within 8" of Joint: **NO**
Remarks:

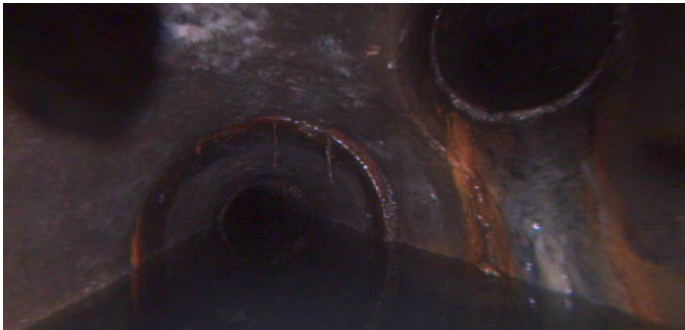
Code: **TF**
Description: **Tap Factory**

Distance (ft): **38.3**
Structural Grade: **0**
O&M Grade: **0**
Clock Start/From: **2**
Clock To:
1st Value: **4.000**
2nd Value:
Value Percent:
Continuous Index:
Within 8" of Joint: **YES**
Remarks:

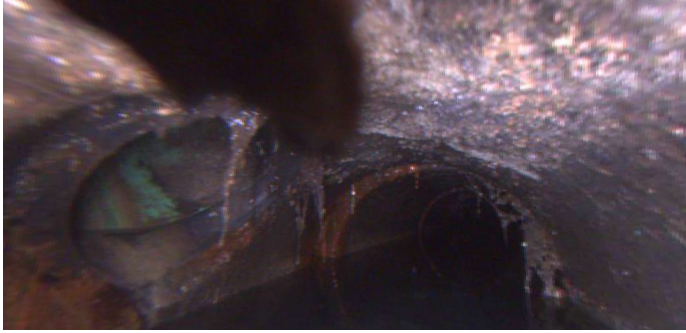
Code: **TF**
Description: **Tap Factory**

Distance (ft): **44.4**
Structural Grade: **0**
O&M Grade: **0**
Clock Start/From: **11**
Clock To:
1st Value: **4.000**
2nd Value:
Value Percent:
Continuous Index:
Within 8" of Joint: **YES**
Remarks:

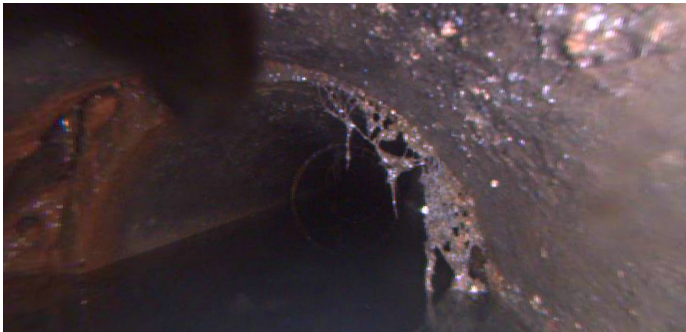
Code: **MSA**
Description: **Abandoned Survey**

Distance (ft): **45.2**
Structural Grade: **0**
O&M Grade: **0**
Clock Start/From:
Clock To:
1st Value:
2nd Value:
Value Percent:
Continuous Index:
Within 8" of Joint: **NO**
Remarks: **no blockage**

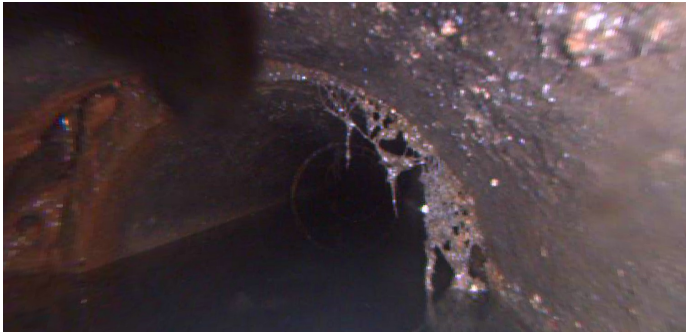
Code: **IS**
Description: **Infil Stain**

Distance (ft): **45.2**
Structural Grade: **0**
O&M Grade: **0**
Clock Start/From: **8**
Clock To: **4**
1st Value:
2nd Value:
Value Percent:
Continuous Index: **F02**
Within 8" of Joint: **YES**
Remarks:

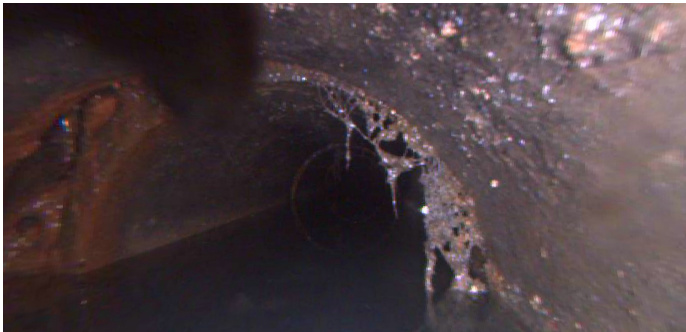
Code: **RFJ**
Description: **Roots Fine Joint**

Distance (ft): **45.2**
Structural Grade: **0**
O&M Grade: **1**
Clock Start/From: **8**
Clock To: **4**
1st Value:
2nd Value:
Value Percent:
Continuous Index: **F01**
Within 8" of Joint: **YES**
Remarks: **wandering**
