Profile/Photo Observation Report

Date:	04/20/2018	Weather:		Coding:	PACP 6.0
Pipe Length (ft):	211.4	Owner:	NA	Pre Clean:	Not Known
P.O.#:		Surveyor:	Byrd Fitzgerald	PSR:	P-805-060-059
Customer:		Clean Date:	01/01/1900	Shape:	C

Street:	DEVONSHIRE ST & S OHIO ST	Flow Control:	Not Controlled
City:	Hobart, IN	Year Renewed:	
Location:	Other	Tape/Media #:	
Purpose:	Not Known	Dia/Height:	12"
Use:	Sanitary	Material:	VCP
Drain Area:	NA	Lining:	
Category:	NA		
Comment:			
Location Details:		Direction of Survey:	Upstream
US MH:	M-805-059	DS MH:	M-805-060
		Total Length Surveyed (ft):	48.8

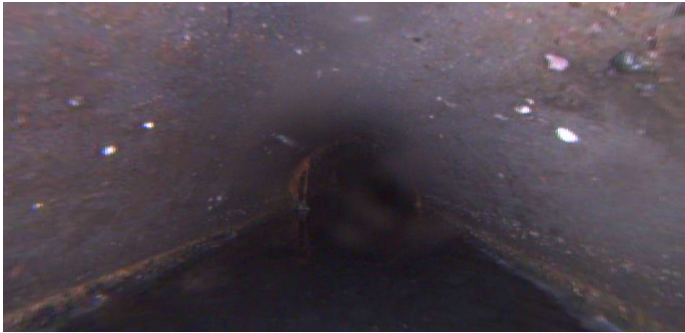
Code:	MWL
Description:	Water Level

Distance (ft):	.0
Structural Grade:	0
O&M Grade:	0
Clock Start/From:	
Clock To:	
1st Value:	
2nd Value:	
Value Percent:	15.000
Continuous Index:	
Within 8" of Joint:	NO
Remarks:

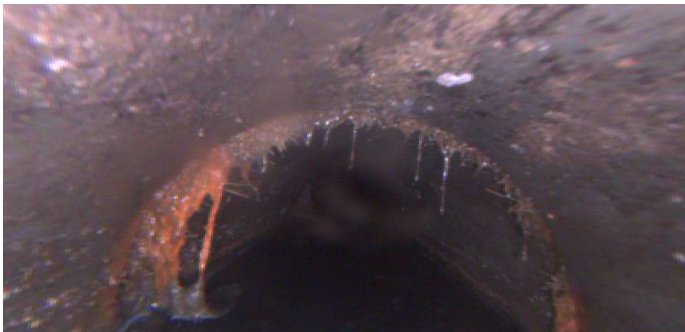
Code:	RFJ
Description:	Roots Fine Joint

Distance (ft):	3.1
Structural Grade:	0
O&M Grade:	1
Clock Start/From:	9
Clock To:	3
1st Value:	
2nd Value:	
Value Percent:	
Continuous Index:	S02
Within 8" of Joint:	YES
Remarks:	wandering

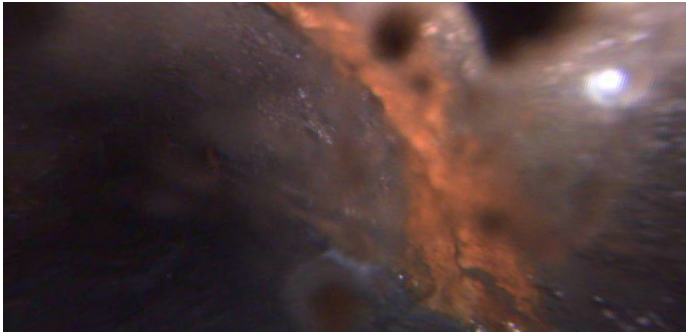
Code: **DAE**
Description: **Deposits Attached Encrustation**

Distance (ft): **5.9**
Structural Grade: **0**
O&M Grade: **2**
Clock Start/From: **8**
Clock To: **4**
1st Value:
2nd Value:
Value Percent: **5.000**
Continuous Index: **S01**
Within 8" of Joint: **YES**
Remarks: **wandering**

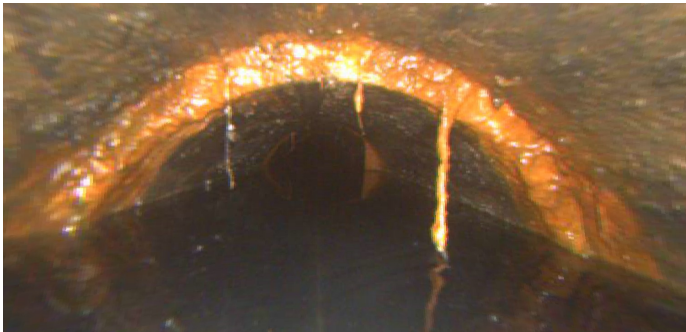
Code: **MGO**
Description: **General Observation**

Distance (ft): **17.0**
Structural Grade: **0**
O&M Grade: **0**
Clock Start/From:
Clock To:
1st Value:
2nd Value:
Value Percent:
Continuous Index:
Within 8" of Joint: **NO**
Remarks: **rear camera/lense covered**

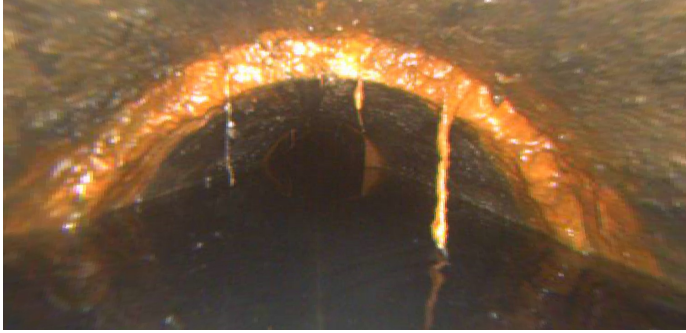
Code: **MWL**
Description: **Water Level**

Distance (ft): **17.0**
Structural Grade: **0**
O&M Grade: **0**
Clock Start/From:
Clock To:
1st Value:
2nd Value:
Value Percent: **55.000**
Continuous Index:
Within 8" of Joint: **NO**
Remarks:

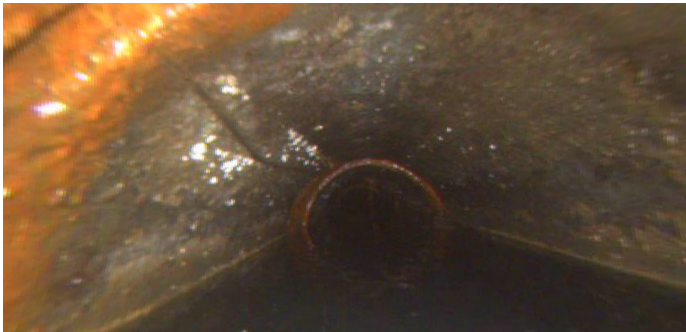
Code: **FL**
Description: **Fracture Longitudinal**

Distance (ft): **22.9**
Structural Grade: **3**
O&M Grade: **0**
Clock Start/From: **1**
Clock To:
1st Value:
2nd Value:
Value Percent:
Continuous Index:
Within 8" of Joint: **YES**
Remarks:

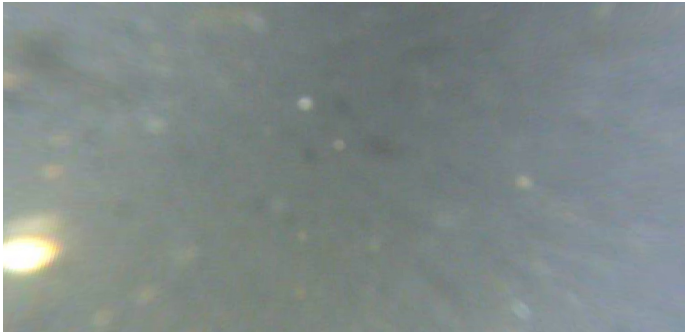
Code: **MCU**
Description: **Camera Underwater**

Distance (ft): **46.6**
Structural Grade: **0**
O&M Grade: **4**
Clock Start/From:
Clock To:
1st Value:
2nd Value:
Value Percent:
Continuous Index:
Within 8" of Joint: **NO**
Remarks:

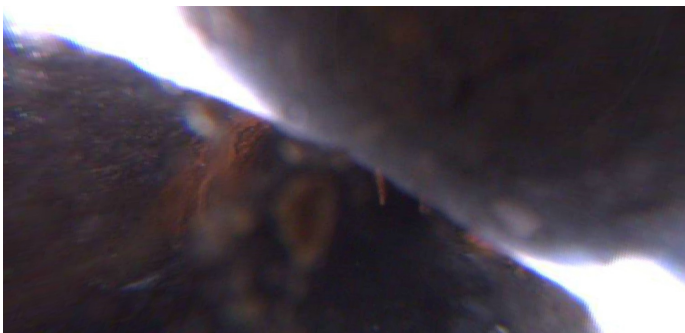
Code: **MSA**
Description: **Abandoned Survey**

Distance (ft): **48.8**
Structural Grade: **0**
O&M Grade: **0**
Clock Start/From:
Clock To:
1st Value:
2nd Value:
Value Percent:
Continuous Index:
Within 8" of Joint: **NO**
Remarks: **no blockage**

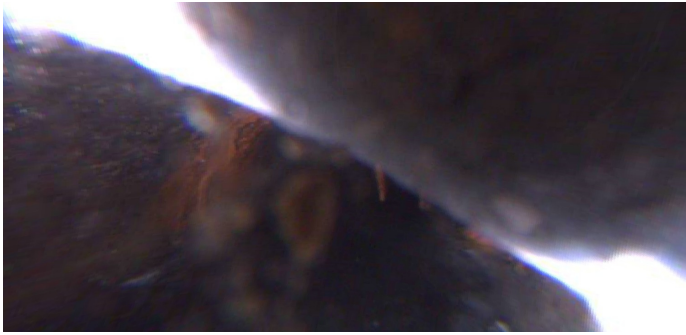
Code: **DAE**
Description: **Deposits Attached Encrustation**

Distance (ft): **48.8**
Structural Grade: **0**
O&M Grade: **2**
Clock Start/From: **8**
Clock To: **4**
1st Value:
2nd Value:
Value Percent: **5.000**
Continuous Index: **F01**
Within 8" of Joint: **YES**
Remarks: **wandering**

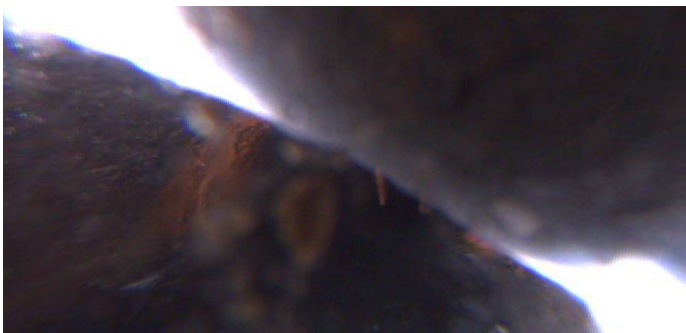
Code: **RFJ**
Description: **Roots Fine Joint**

Distance (ft): **48.8**
Structural Grade: **0**
O&M Grade: **1**
Clock Start/From: **9**
Clock To: **3**
1st Value:
2nd Value:
Value Percent:
Continuous Index: **F02**
Within 8" of Joint: **YES**
Remarks: **wandering**
