## Profile/Photo Observation Report

Street:	<b>Devonshire St.</b>	Flow Control:	<b>Not Controlled</b>
City:	<b>Hobart, IN</b>	Year Renewed:	
Location:	<b>Other</b>	Tape/Media #:	
Purpose:	<b>Not Known</b>	Dia/Height:	<b>12"</b>
Use:	<b>Sanitary</b>	Material:	<b>VCP</b>
Drain Area:	<b>NA</b>	Lining:	
Category:	<b>NA</b>		
Comment:

Location Details:		Direction of Survey:	<b>Upstream</b>
US MH:	<b>M-805-059</b>	DS MH:	<b>M-805-060</b>
		Total Length Surveyed (ft):	<b>48.8</b>

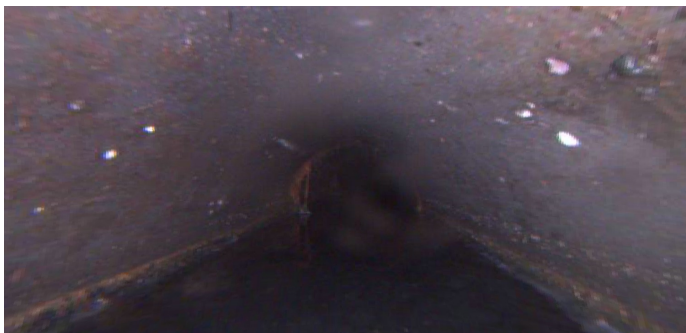
Code: **AMH**  
Description: **Manhole**

Distance (ft): **.0**  
Structural Grade: **0**  
O&M Grade: **0**  
Clock Start/From:  
Clock To:  
1st Value:  
2nd Value:  
Value Percent:  
Continuous Index:  
Within 8" of Joint: **NO**  
Remarks: **M-805-060**

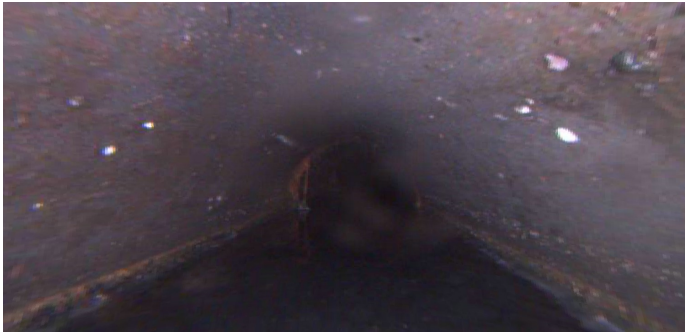
Code:	<b>MWL</b>
Description:	<b>Water Level</b>

Distance (ft):	<b>.0</b>
Structural Grade:	<b>0</b>
O&M Grade:	<b>0</b>
Clock Start/From:	
Clock To:	
1st Value:	
2nd Value:	
Value Percent:	<b>15.000</b>
Continuous Index:	
Within 8" of Joint:	<b>NO</b>
Remarks:

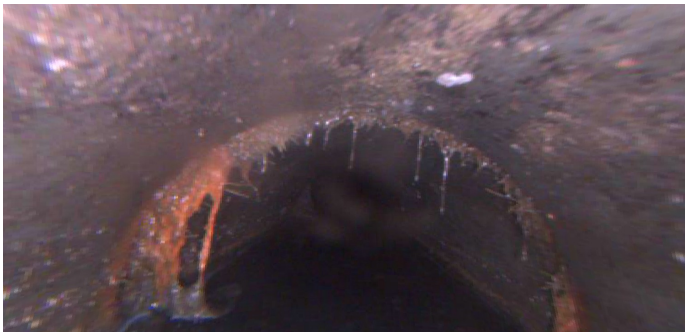
Code:	<b>RFJ</b>
Description:	<b>Roots Fine Joint</b>

Distance (ft):	<b>3.1</b>
Structural Grade:	<b>0</b>
O&M Grade:	<b>1</b>
Clock Start/From:	<b>9</b>
Clock To:	<b>3</b>
1st Value:	
2nd Value:	
Value Percent:	
Continuous Index:	<b>S02</b>
Within 8" of Joint:	<b>YES</b>
Remarks:	<b>wandering</b>

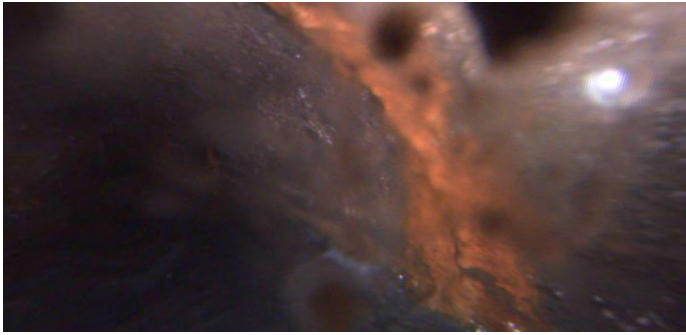
Code: **DAE**  
Description: **Deposits Attached Encrustation**

Distance (ft): **5.9**  
Structural Grade: **0**  
O&M Grade: **2**  
Clock Start/From: **8**  
Clock To: **4**  
1st Value:  
2nd Value:  
Value Percent: **5.000**  
Continuous Index: **S01**  
Within 8" of Joint: **YES**  
Remarks: **wandering**

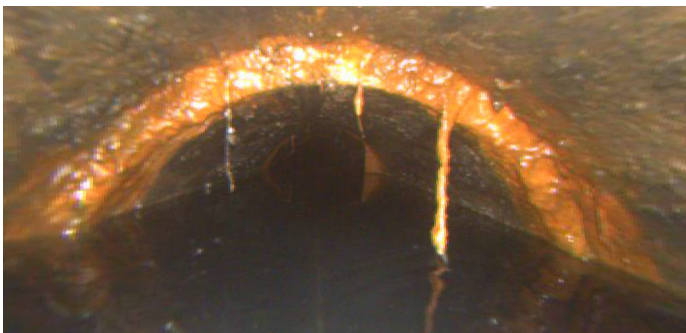
Code: **MGO**  
Description: **General Observation**

Distance (ft): **17.0**  
Structural Grade: **0**  
O&M Grade: **0**  
Clock Start/From:  
Clock To:  
1st Value:  
2nd Value:  
Value Percent:  
Continuous Index:  
Within 8" of Joint: **NO**  
Remarks: **rear camera/lense covered**

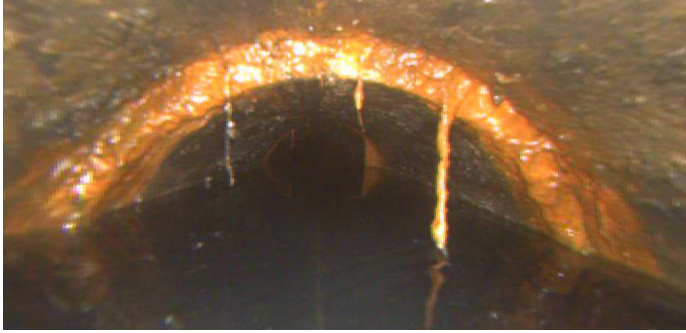
Code: **MWL**  
Description: **Water Level**

Distance (ft): **17.0**  
Structural Grade: **0**  
O&M Grade: **0**  
Clock Start/From:  
Clock To:  
1st Value:  
2nd Value:  
Value Percent: **55.000**  
Continuous Index:  
Within 8" of Joint: **NO**  
Remarks:

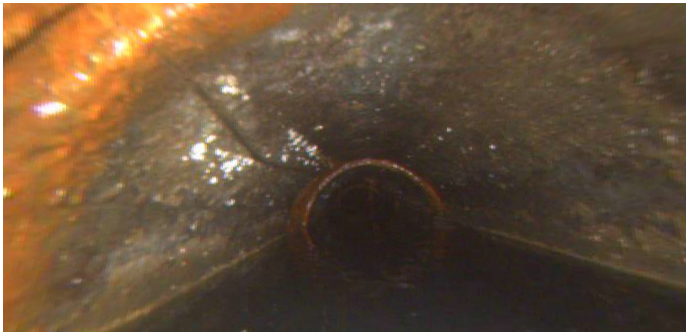
Code: **FL**  
Description: **Fracture Longitudinal**

Distance (ft): **22.9**  
Structural Grade: **3**  
O&M Grade: **0**  
Clock Start/From: **1**  
Clock To:  
1st Value:  
2nd Value:  
Value Percent:  
Continuous Index:  
Within 8" of Joint: **YES**  
Remarks:

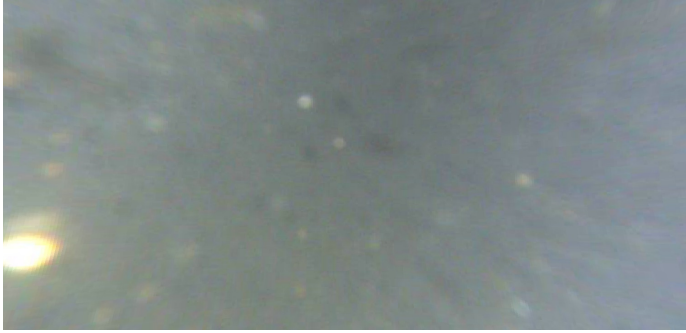
Code: **MCU**  
Description: **Camera Underwater**

Distance (ft): **46.6**  
Structural Grade: **0**  
O&M Grade: **4**  
Clock Start/From:  
Clock To:  
1st Value:  
2nd Value:  
Value Percent:  
Continuous Index:  
Within 8" of Joint: **NO**  
Remarks:

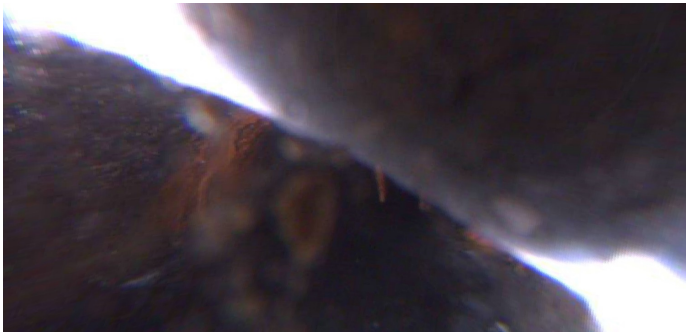
Code: **MSA**  
Description: **Abandoned Survey**

Distance (ft): **48.8**  
Structural Grade: **0**  
O&M Grade: **0**  
Clock Start/From:  
Clock To:  
1st Value:  
2nd Value:  
Value Percent:  
Continuous Index:  
Within 8" of Joint: **NO**  
Remarks: **no blockage**

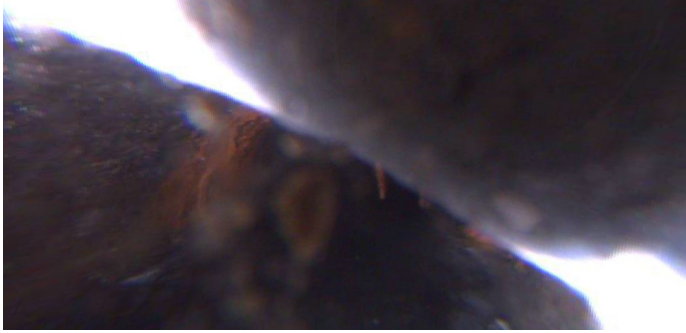
Code: **DAE**  
Description: **Deposits Attached Encrustation**

Distance (ft): **48.8**  
Structural Grade: **0**  
O&M Grade: **2**  
Clock Start/From: **8**  
Clock To: **4**  
1st Value:  
2nd Value:  
Value Percent: **5.000**  
Continuous Index: **F01**  
Within 8" of Joint: **YES**  
Remarks: **wandering**

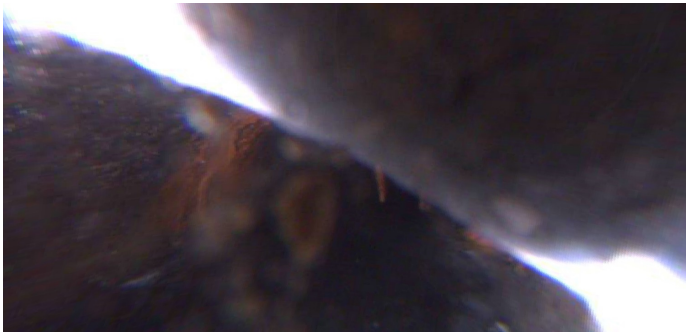
Code: **RFJ**  
Description: **Roots Fine Joint**

Distance (ft): **48.8**  
Structural Grade: **0**  
O&M Grade: **1**  
Clock Start/From: **9**  
Clock To: **3**  
1st Value:  
2nd Value:  
Value Percent:  
Continuous Index: **F02**  
Within 8" of Joint: **YES**  
Remarks: **wandering**
