Profile/Photo Observation Report

Date:	01/24/2023	Weather:		Coding:	PACP 7.0
Pipe Length (ft):	211.0	Owner:	City of Hobart	Pre Clean:	Heavy Cleaning
P.O.#:	YES502259	Surveyor:	Steven Bucklin	PSR:	P-805-060-059
Customer:	City of Hobart	Clean Date:		Shape:	C

Street:	Devanshire Street	Flow Control:	Not Controlled
City:	Hobart, IN	Year Renewed:	
Location:	Local rural streets with light traffic, t	Tape/Media #:	
Purpose:	Routine Assessment	Dia/Height:	12"
Use:	Sanitary Sewage Pipe	Material:	VCP
Drain Area:		Lining:	None
Category:	NA		
Comment:			
Location Details:		Direction of Survey:	Upstream
US MH:	M-805-059	DS MH:	M-805-060
		Total Length Surveyed (ft):	220.4

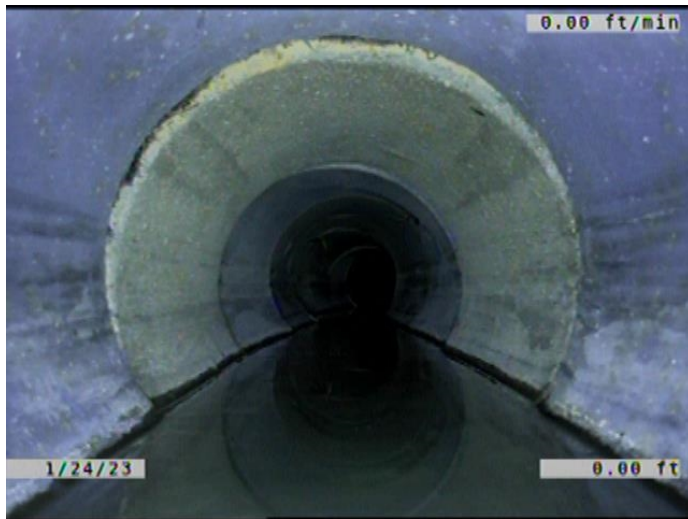
Code: **MWL**
Description: **Miscellaneous Water Level**

Distance (ft): **.0**
Structural Grade: **0**
O&M Grade: **0**
Clock Start/From:
Clock To:
1st Value:
2nd Value:
Value Percent: **10.000**
Continuous Index:
Within 8" of Joint: **NO**
Remarks:

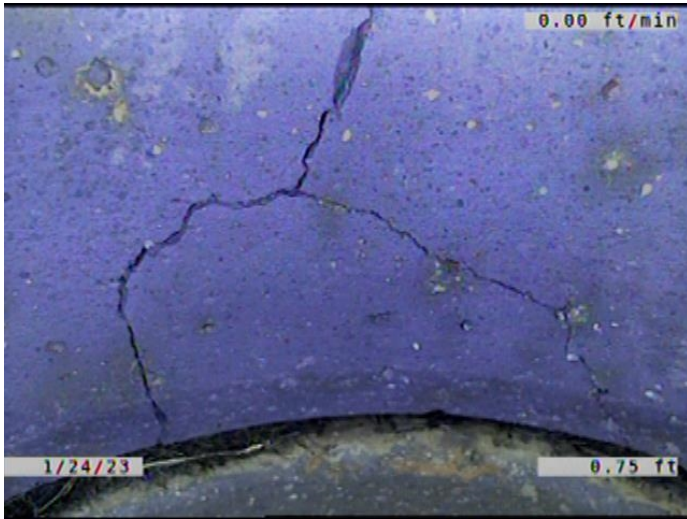
Code: **B**
 Description: **Broken**

Distance (ft): **.7**
 Structural Grade: **4**
 O&M Grade: **0**
 Clock Start/From: **11**
 Clock To: **1**
 1st Value:
 2nd Value:
 Value Percent:
 Continuous Index:
 Within 8" of Joint: **YES**
 Remarks:

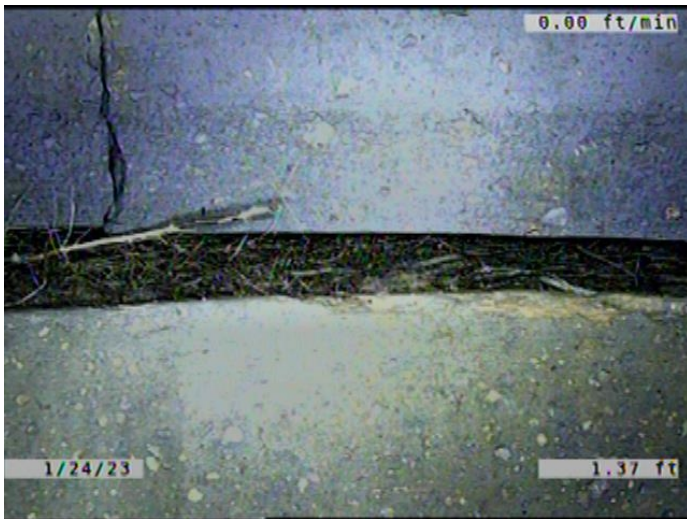
Code: **RFJ**
 Description: **Roots Fine Joint**

Distance (ft): **1.4**
 Structural Grade: **0**
 O&M Grade: **1**
 Clock Start/From: **10**
 Clock To: **2**
 1st Value:
 2nd Value:
 Value Percent:
 Continuous Index:
 Within 8" of Joint: **YES**
 Remarks:

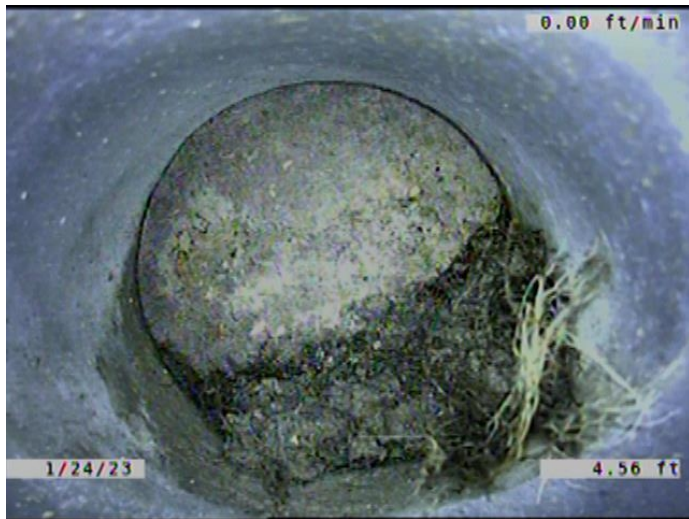
Code:	TFD
Description:	Tap Factory Defective
Distance (ft):	4.6
Structural Grade:	0
O&M Grade:	3
Clock Start/From:	1
Clock To:	
1st Value:	6.000
2nd Value:	
Value Percent:	
Continuous Index:	
Within 8" of Joint:	YES
Remarks:	CAPPED. ROOTS GROWING AROUND THE CAP IN TO THE MAIN.

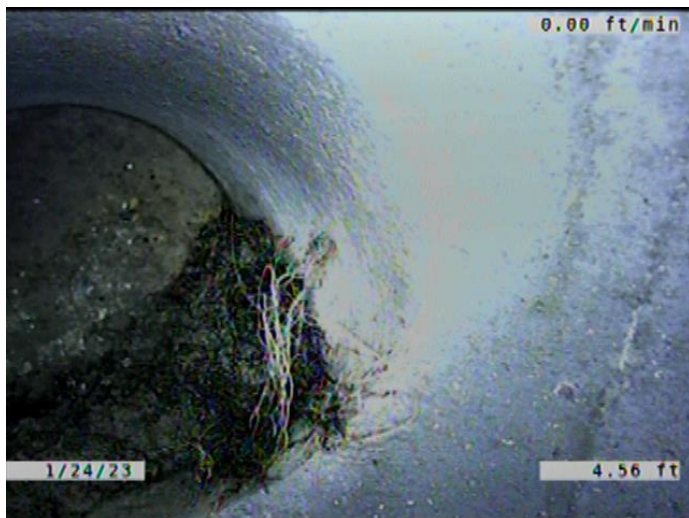
Code:	RFL
Description:	Roots Fine Lateral
Distance (ft):	4.6
Structural Grade:	0
O&M Grade:	1
Clock Start/From:	1
Clock To:	
1st Value:	
2nd Value:	
Value Percent:	
Continuous Index:	
Within 8" of Joint:	NO
Remarks:

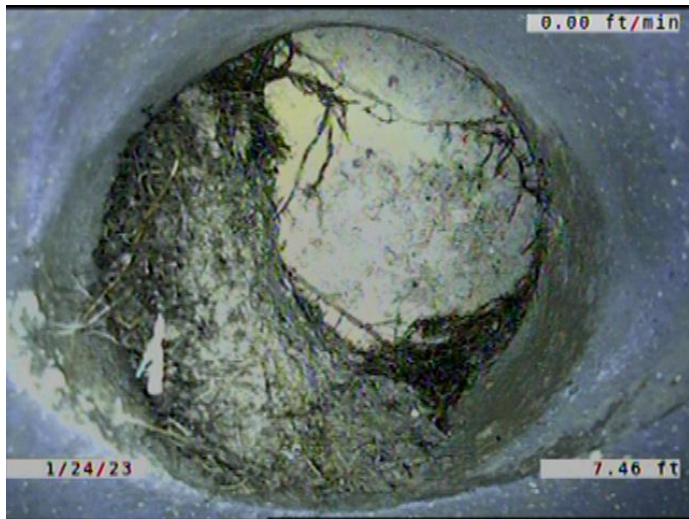
Code:	TFD
Description:	Tap Factory Defective
Distance (ft):	7.5
Structural Grade:	0
O&M Grade:	3
Clock Start/From:	11
Clock To:	
1st Value:	6.000
2nd Value:	
Value Percent:	
Continuous Index:	
Within 8" of Joint:	YES
Remarks:	CAPPED. CAP BROKEN. ROOTS GROWING AROUND THE CAP INTO T

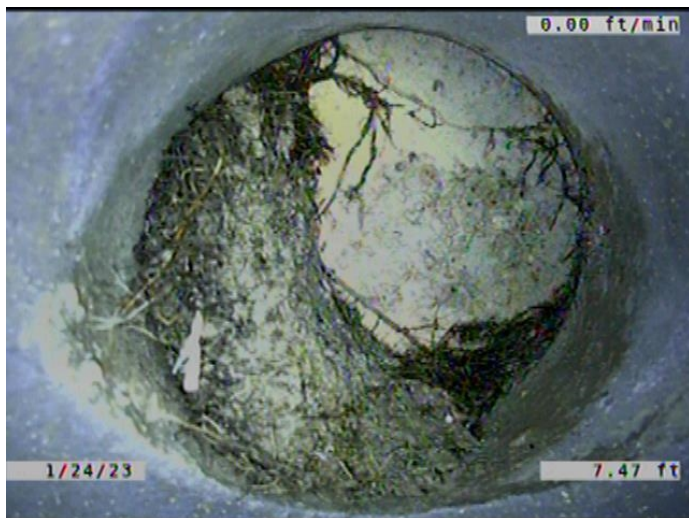
Code:	RFL
Description:	Roots Fine Lateral
Distance (ft):	7.5
Structural Grade:	0
O&M Grade:	1
Clock Start/From:	11
Clock To:	
1st Value:	
2nd Value:	
Value Percent:	
Continuous Index:	
Within 8" of Joint:	NO
Remarks:

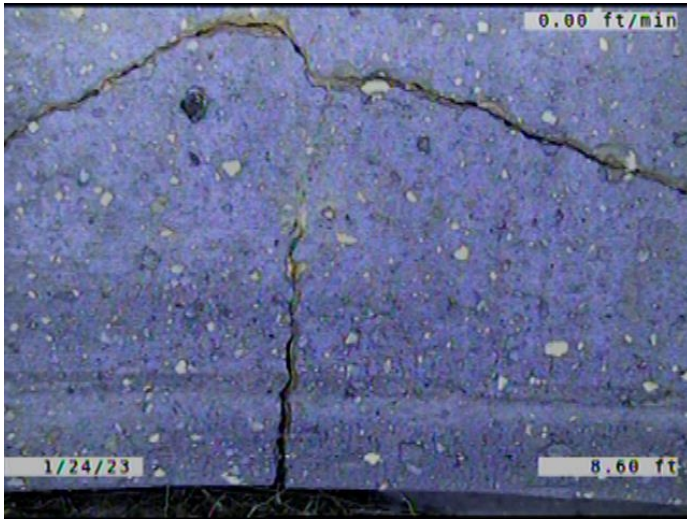
Code: **B**
Description: **Broken**

Distance (ft): **8.6**
Structural Grade: **4**
O&M Grade: **0**
Clock Start/From: **9**
Clock To: **1**
1st Value:
2nd Value:
Value Percent:
Continuous Index:
Within 8" of Joint: **YES**
Remarks:

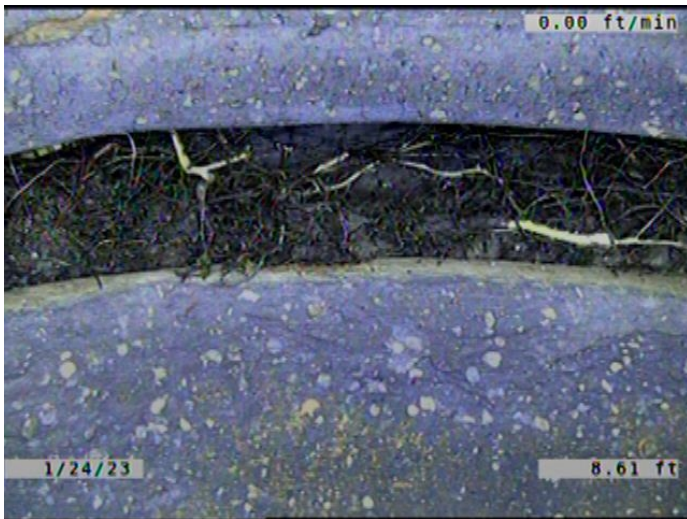
Code: **RFJ**
Description: **Roots Fine Joint**

Distance (ft): **8.6**
Structural Grade: **0**
O&M Grade: **1**
Clock Start/From: **9**
Clock To: **2**
1st Value:
2nd Value:
Value Percent:
Continuous Index:
Within 8" of Joint: **YES**
Remarks:

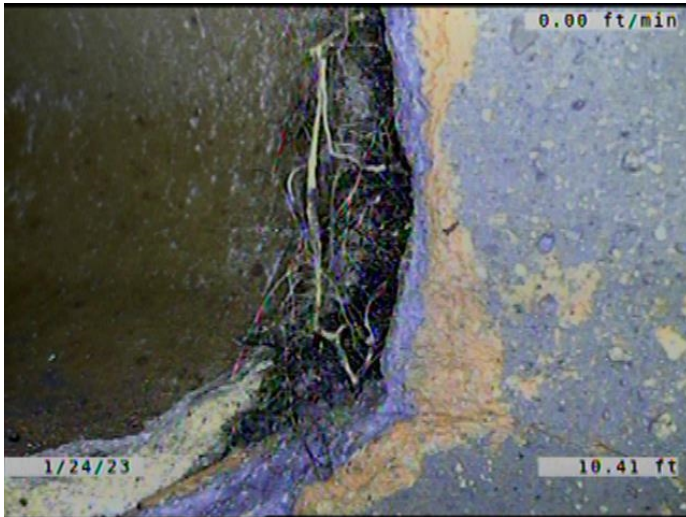
Code: **BSV**
 Description: **Broken Soil Visible**

Distance (ft): **10.4**
 Structural Grade: **5**
 O&M Grade: **0**
 Clock Start/From: **8**
 Clock To: **1**
 1st Value:
 2nd Value:
 Value Percent:
 Continuous Index:
 Within 8" of Joint: **YES**
 Remarks:

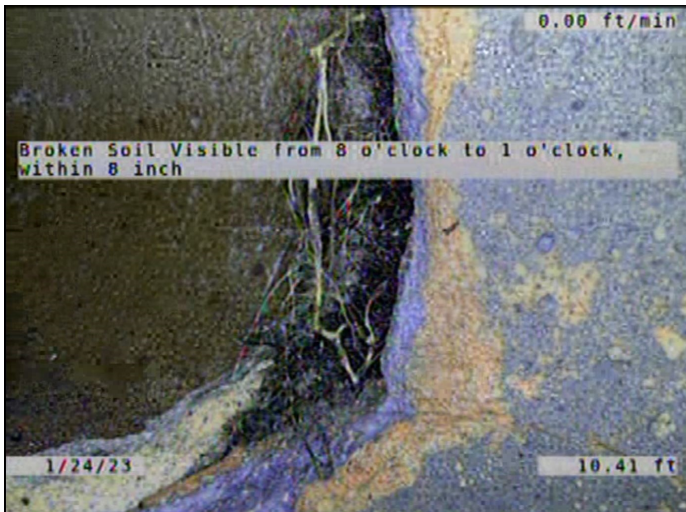
Code: **SSS**
 Description: **Surface Damage Surface Spalling**

Distance (ft): **10.4**
 Structural Grade: **2**
 O&M Grade: **0**
 Clock Start/From: **10**
 Clock To: **12**
 1st Value:
 2nd Value:
 Value Percent:
 Continuous Index:
 Within 8" of Joint: **NO**
 Remarks:

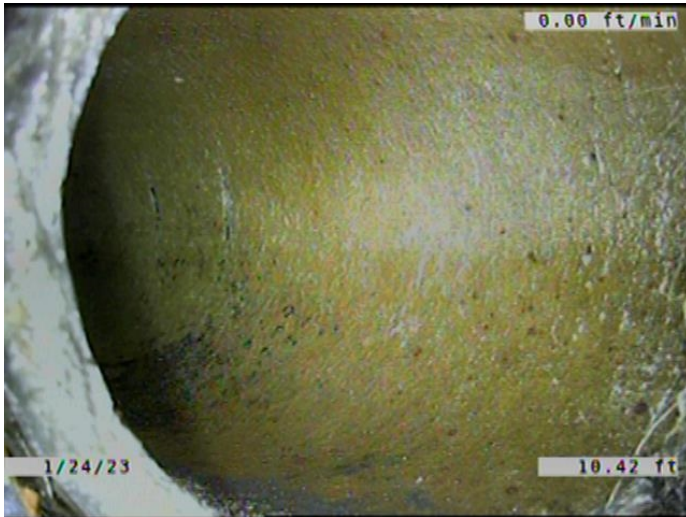
Code: **TBI**
 Description: **Tap Break-in Intruding**

Distance (ft): **10.4**
 Structural Grade: **0**
 O&M Grade: **2**
 Clock Start/From: **11**
 Clock To:
 1st Value: **6.000**
 2nd Value: **1.000**
 Value Percent:
 Continuous Index:
 Within 8" of Joint: **YES**
 Remarks:

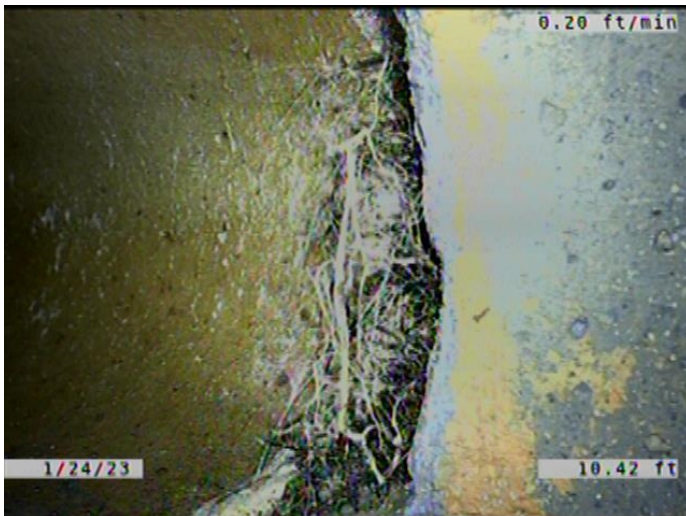
Code: **RFC**
 Description: **Roots Fine Connection**

Distance (ft): **10.4**
 Structural Grade: **0**
 O&M Grade: **1**
 Clock Start/From: **10**
 Clock To: **12**
 1st Value:
 2nd Value:
 Value Percent:
 Continuous Index:
 Within 8" of Joint: **NO**
 Remarks:

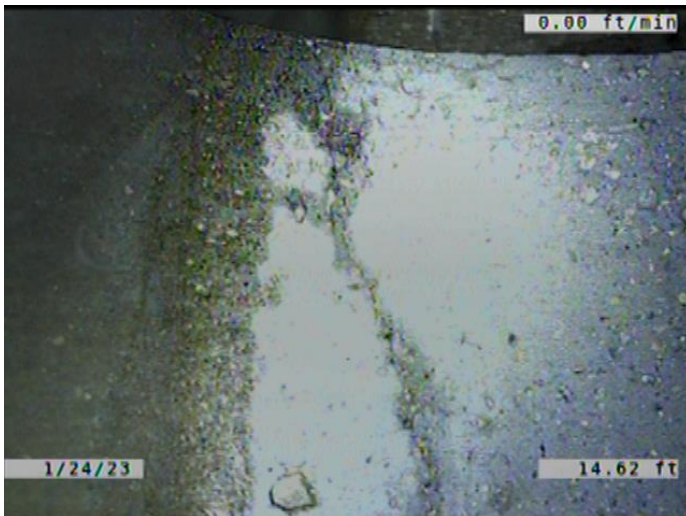
Code: **CS**
Description: **Crack Spiral**

Distance (ft): **14.6**
Structural Grade: **2**
O&M Grade: **0**
Clock Start/From: **3**
Clock To: **4**
1st Value:
2nd Value:
Value Percent:
Continuous Index:
Within 8" of Joint: **YES**
Remarks:

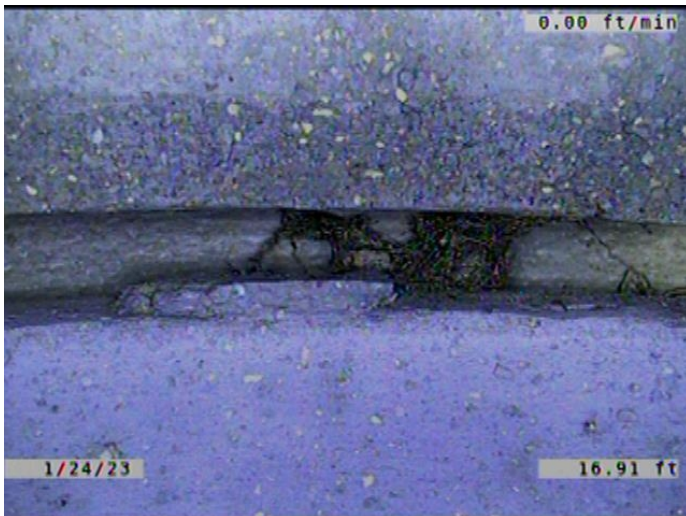
Code: **RFJ**
Description: **Roots Fine Joint**

Distance (ft): **16.9**
Structural Grade: **0**
O&M Grade: **1**
Clock Start/From: **10**
Clock To: **2**
1st Value:
2nd Value:
Value Percent:
Continuous Index: **S01**
Within 8" of Joint: **YES**
Remarks:

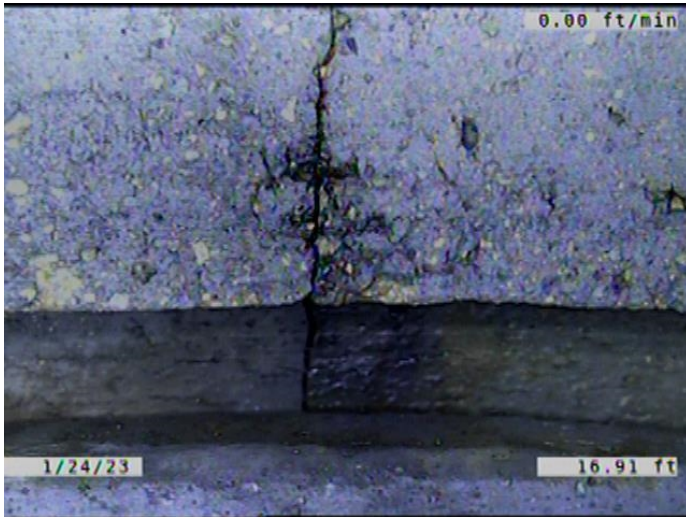
Code: **CL**
Description: **Crack Longitudinal**

Distance (ft): **16.9**
Structural Grade: **2**
O&M Grade: **0**
Clock Start/From: **8**
Clock To:
1st Value:
2nd Value:
Value Percent:
Continuous Index:
Within 8" of Joint: **YES**
Remarks:

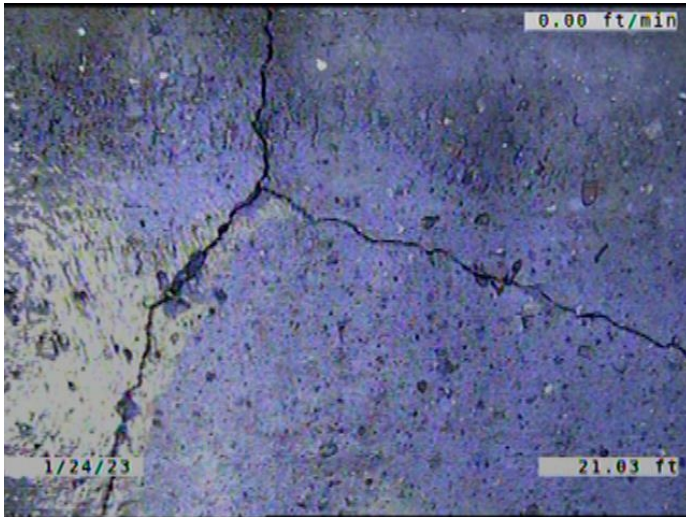
Code: **CM**
 Description: **Crack Multiple**

Distance (ft): **21.0**
 Structural Grade: **3**
 O&M Grade: **0**
 Clock Start/From: **2**
 Clock To: **5**
 1st Value:
 2nd Value:
 Value Percent:
 Continuous Index:
 Within 8" of Joint: **YES**
 Remarks:

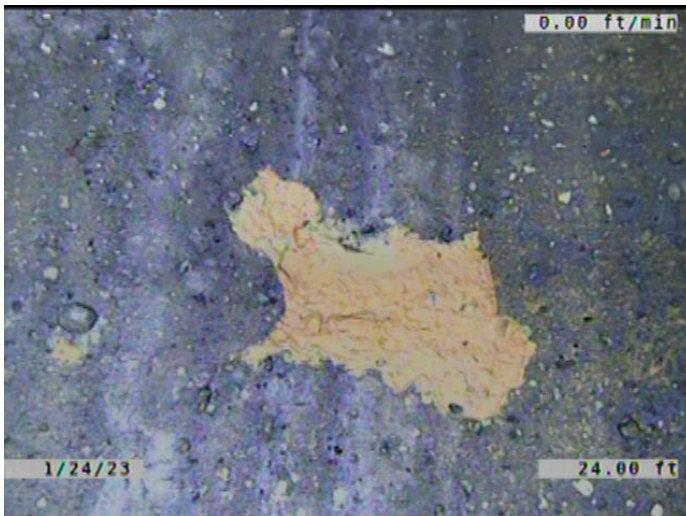
Code: **SSS**
 Description: **Surface Damage Surface Spalling**

Distance (ft): **24.0**
 Structural Grade: **2**
 O&M Grade: **0**
 Clock Start/From: **3**
 Clock To:
 1st Value:
 2nd Value:
 Value Percent:
 Continuous Index:
 Within 8" of Joint: **NO**
 Remarks:

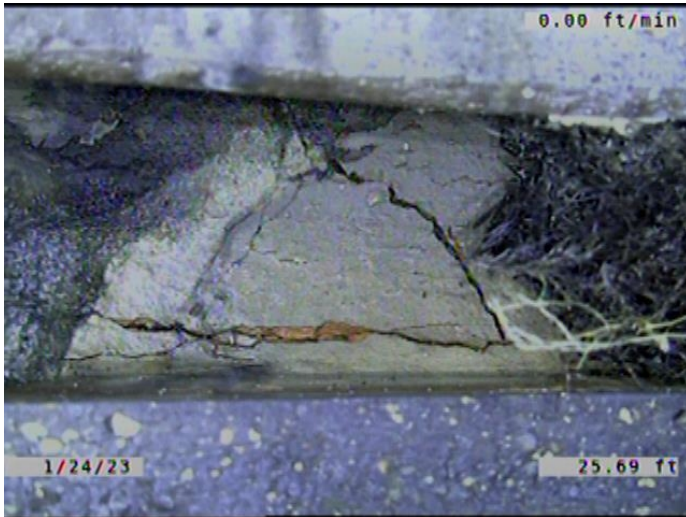
Code: **B**
Description: **Broken**

Distance (ft): **25.7**
Structural Grade: **4**
O&M Grade: **0**
Clock Start/From: **1**
Clock To: **6**
1st Value:
2nd Value:
Value Percent:
Continuous Index:
Within 8" of Joint: **YES**
Remarks:

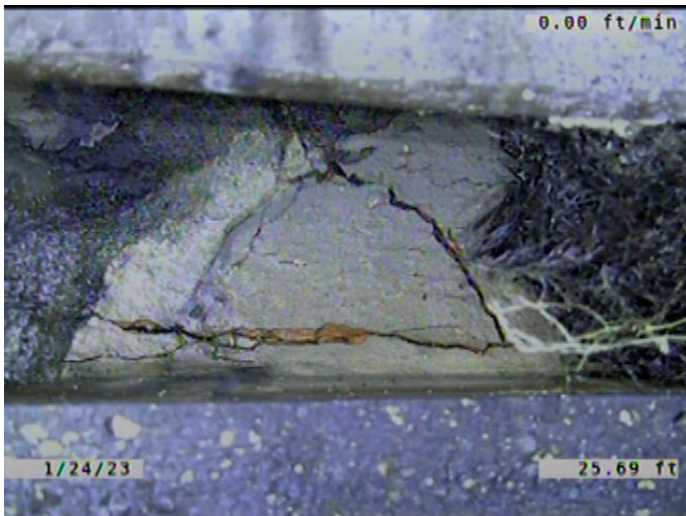
Code: **JAM**
Description: **Joint Angular Medium**

Distance (ft): **25.7**
Structural Grade: **3**
O&M Grade: **0**
Clock Start/From:
Clock To:
1st Value:
2nd Value:
Value Percent:
Continuous Index:
Within 8" of Joint: **NO**
Remarks:

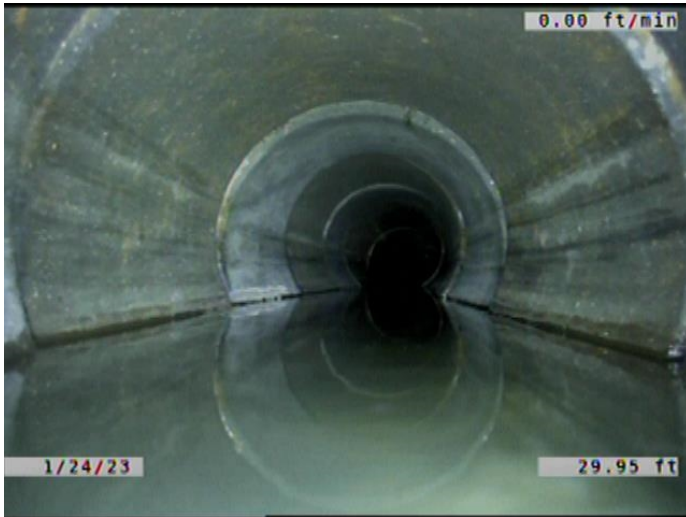
Code: **MWLS**
 Description: **Miscellaneous Water Level Sag**

Distance (ft): **30.0**
 Structural Grade: **2**
 O&M Grade: **0**
 Clock Start/From:
 Clock To:
 1st Value:
 2nd Value:
 Value Percent: **15.000**
 Continuous Index: **S02**
 Within 8" of Joint: **NO**
 Remarks:

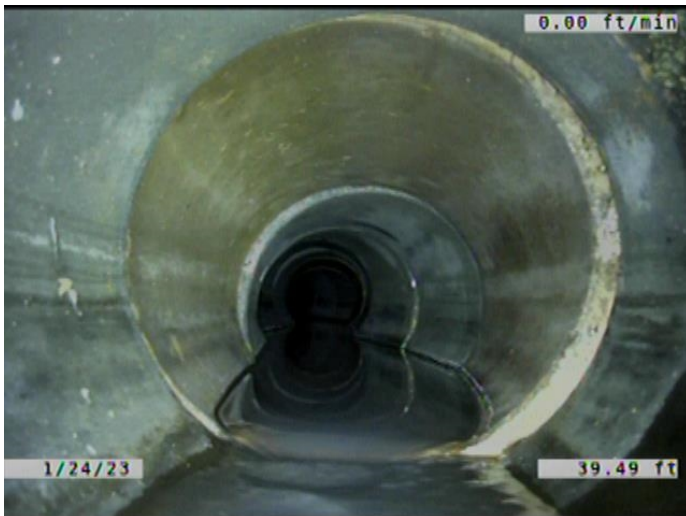
Code: **MWLS**
 Description: **Miscellaneous Water Level Sag**

Distance (ft): **39.5**
 Structural Grade: **2**
 O&M Grade: **0**
 Clock Start/From:
 Clock To:
 1st Value:
 2nd Value:
 Value Percent: **15.000**
 Continuous Index: **F02**
 Within 8" of Joint: **NO**
 Remarks:

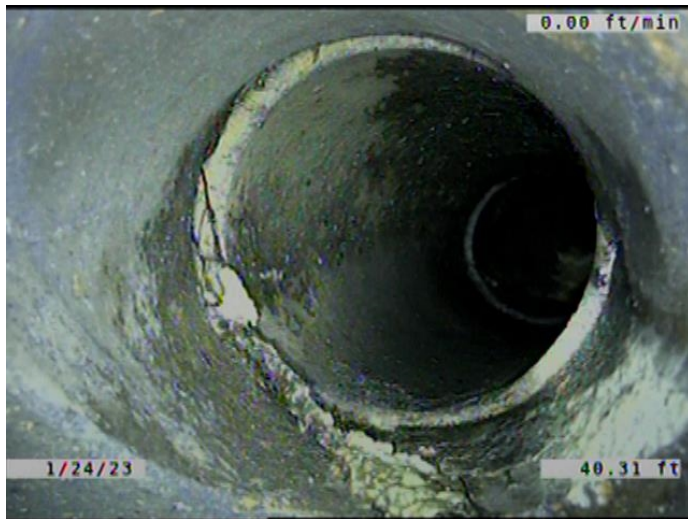
Code: **TF**
 Description: **Tap Factory**

Distance (ft): **40.3**
 Structural Grade: **0**
 O&M Grade: **0**
 Clock Start/From: **1**
 Clock To:
 1st Value: **6.000**
 2nd Value:
 Value Percent:
 Continuous Index:
 Within 8" of Joint: **YES**
 Remarks: **ROOTS GROWING FROM THE SERVICE TO MAIN CONNECTION.**

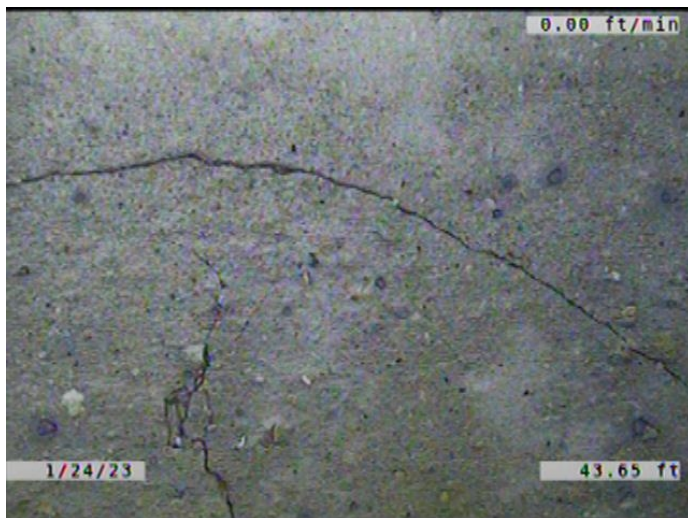
Code: **CM**
 Description: **Crack Multiple**

Distance (ft): **43.7**
 Structural Grade: **3**
 O&M Grade: **0**
 Clock Start/From: **8**
 Clock To: **1**
 1st Value:
 2nd Value:
 Value Percent:
 Continuous Index:
 Within 8" of Joint: **YES**
 Remarks:

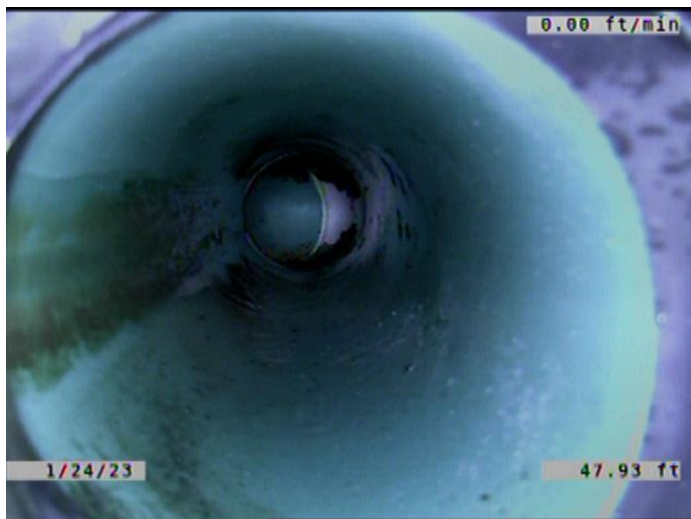
Code: **TF**
Description: **Tap Factory**

Distance (ft): **47.9**
Structural Grade: **0**
O&M Grade: **0**
Clock Start/From: **11**
Clock To:
1st Value: **6.000**
2nd Value:
Value Percent:
Continuous Index:
Within 8" of Joint: **YES**
Remarks: **CONSTANTLY RUNNING WATER.**

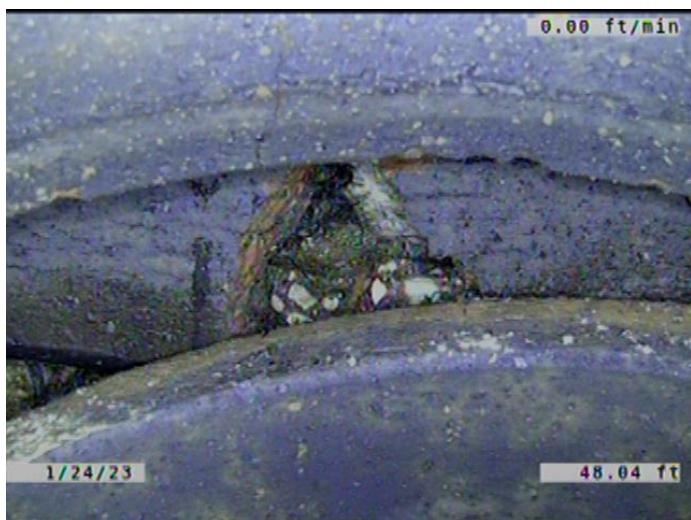
Code: **BSV**
Description: **Broken Soil Visible**

Distance (ft): **48.0**
Structural Grade: **5**
O&M Grade: **0**
Clock Start/From: **9**
Clock To: **12**
1st Value:
2nd Value:
Value Percent:
Continuous Index:
Within 8" of Joint: **YES**
Remarks: **SOIL VISIBLE.**

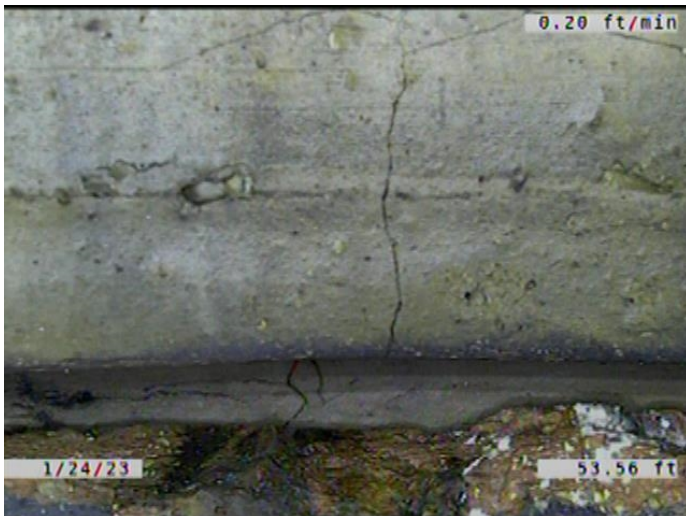
Code: **CM**
Description: **Crack Multiple**

Distance (ft): **53.5**
Structural Grade: **3**
O&M Grade: **0**
Clock Start/From: **8**
Clock To: **4**
1st Value:
2nd Value:
Value Percent:
Continuous Index:
Within 8" of Joint: **YES**
Remarks:

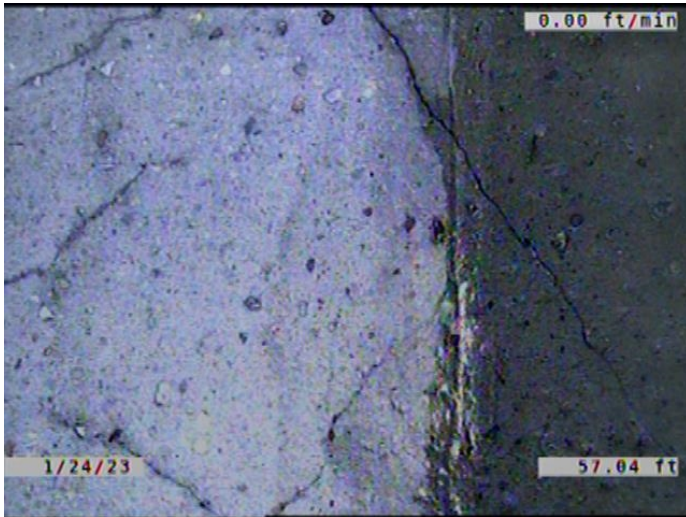
Code: **CM**
 Description: **Crack Multiple**

Distance (ft): **57.0**
 Structural Grade: **3**
 O&M Grade: **0**
 Clock Start/From: **5**
 Clock To: **9**
 1st Value:
 2nd Value:
 Value Percent:
 Continuous Index:
 Within 8" of Joint: **YES**
 Remarks:

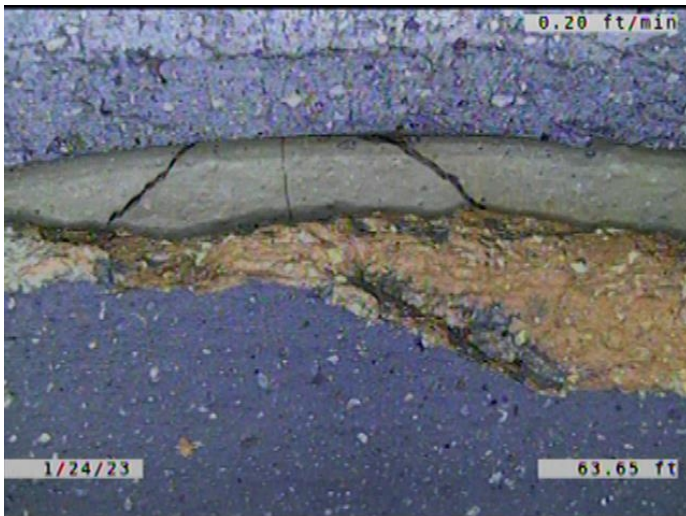
Code: **FS**
 Description: **Fracture Spiral**

Distance (ft): **63.6**
 Structural Grade: **3**
 O&M Grade: **0**
 Clock Start/From: **10**
 Clock To: **11**
 1st Value:
 2nd Value:
 Value Percent:
 Continuous Index:
 Within 8" of Joint: **YES**
 Remarks:

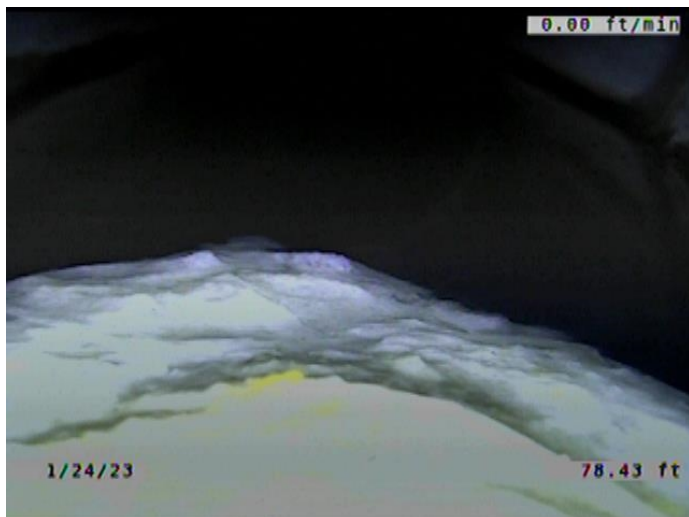
Code: **DAR**
 Description: **Deposits Attached Ragging**

Distance (ft): **78.4**
 Structural Grade: **0**
 O&M Grade: **2**
 Clock Start/From: **6**
 Clock To:
 1st Value:
 2nd Value:
 Value Percent: **5.000**
 Continuous Index:
 Within 8" of Joint: **YES**
 Remarks:

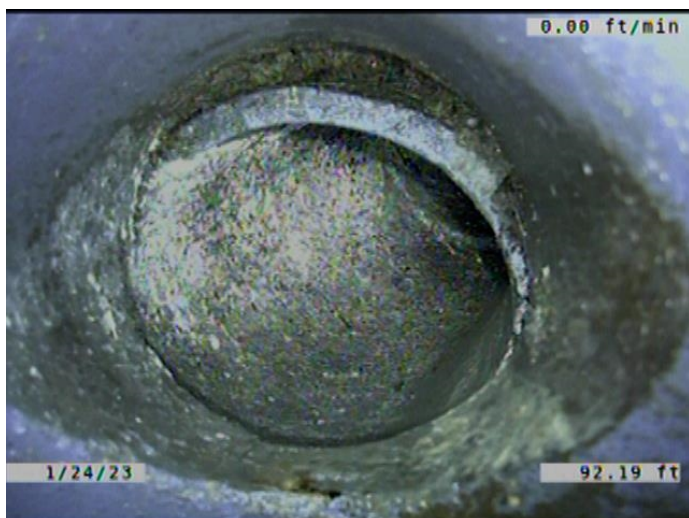
Code: **TF**
 Description: **Tap Factory**

Distance (ft): **92.2**
 Structural Grade: **0**
 O&M Grade: **0**
 Clock Start/From: **1**
 Clock To:
 1st Value: **6.000**
 2nd Value:
 Value Percent:
 Continuous Index:
 Within 8" of Joint: **YES**
 Remarks: **SERVICE OFFSET. SOIL VISIBLE.**

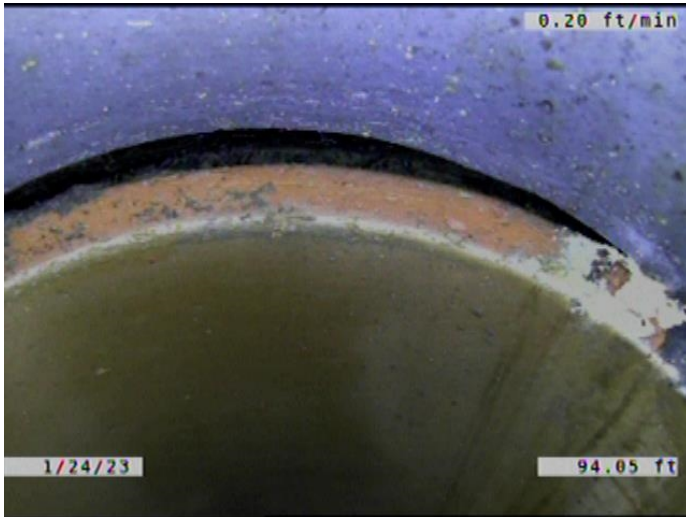
Code: **JOMD**
 Description: **Joint Offset Medium Defective**

Distance (ft): **94.0**
 Structural Grade: **3**
 O&M Grade: **0**
 Clock Start/From:
 Clock To:
 1st Value:
 2nd Value:
 Value Percent:
 Continuous Index:
 Within 8" of Joint: **NO**
 Remarks: **SOIL VISIBLE.**

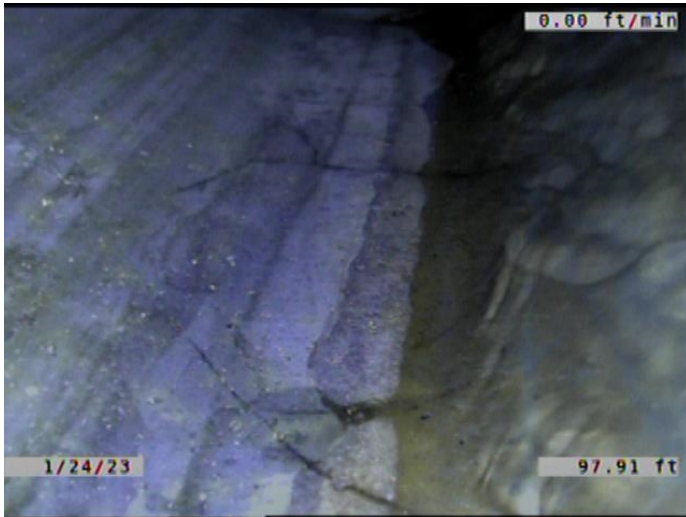
Code: **CM**
 Description: **Crack Multiple**

Distance (ft): **97.9**
 Structural Grade: **3**
 O&M Grade: **0**
 Clock Start/From: **3**
 Clock To: **9**
 1st Value:
 2nd Value:
 Value Percent:
 Continuous Index:
 Within 8" of Joint: **YES**
 Remarks:

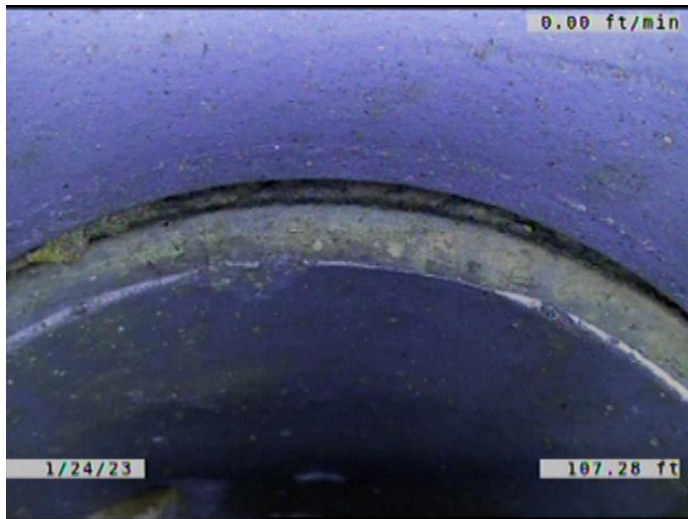
Code: **JOMD**
 Description: **Joint Offset Medium Defective**

Distance (ft): **107.3**
 Structural Grade: **3**
 O&M Grade: **0**
 Clock Start/From:
 Clock To:
 1st Value:
 2nd Value:
 Value Percent:
 Continuous Index:
 Within 8" of Joint: **NO**
 Remarks: **SOIL VISIBLE.**

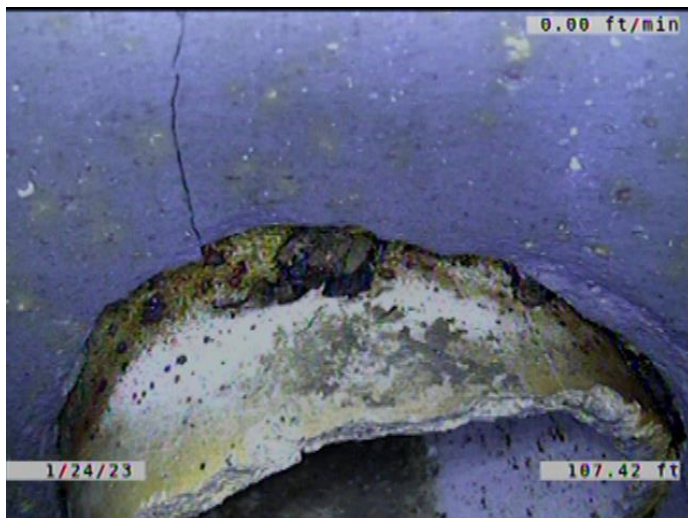
Code: **FM**
 Description: **Fracture Multiple**

Distance (ft): **107.4**
 Structural Grade: **4**
 O&M Grade: **0**
 Clock Start/From: **9**
 Clock To: **12**
 1st Value:
 2nd Value:
 Value Percent:
 Continuous Index:
 Within 8" of Joint: **YES**
 Remarks:

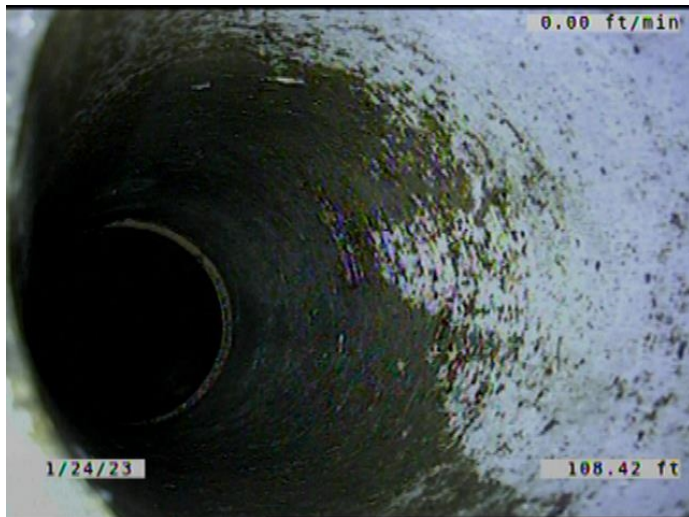
Code: **TBI**
 Description: **Tap Break-in Intruding**

Distance (ft): **108.4**
 Structural Grade: **0**
 O&M Grade: **2**
 Clock Start/From: **11**
 Clock To:
 1st Value: **6.000**
 2nd Value: **2.000**
 Value Percent:
 Continuous Index:
 Within 8" of Joint: **YES**
 Remarks: **CONSTANTLY RUNNING WATER.**

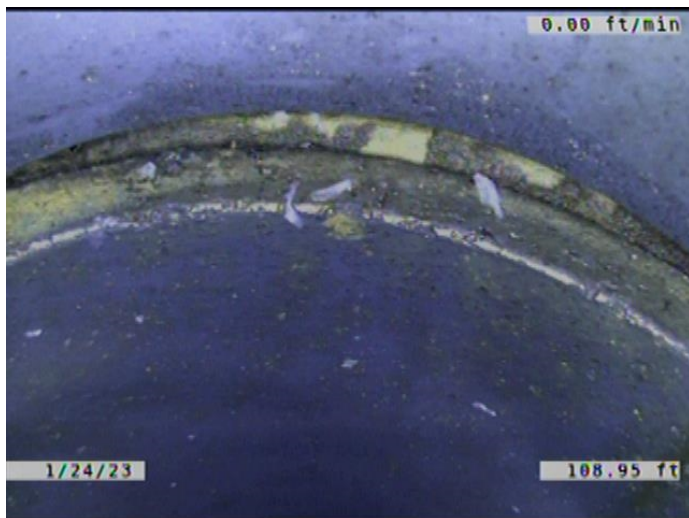
Code: **JOMD**
 Description: **Joint Offset Medium Defective**

Distance (ft): **109.0**
 Structural Grade: **3**
 O&M Grade: **0**
 Clock Start/From:
 Clock To:
 1st Value:
 2nd Value:
 Value Percent:
 Continuous Index:
 Within 8" of Joint: **NO**
 Remarks: **SOIL VISIBLE.**

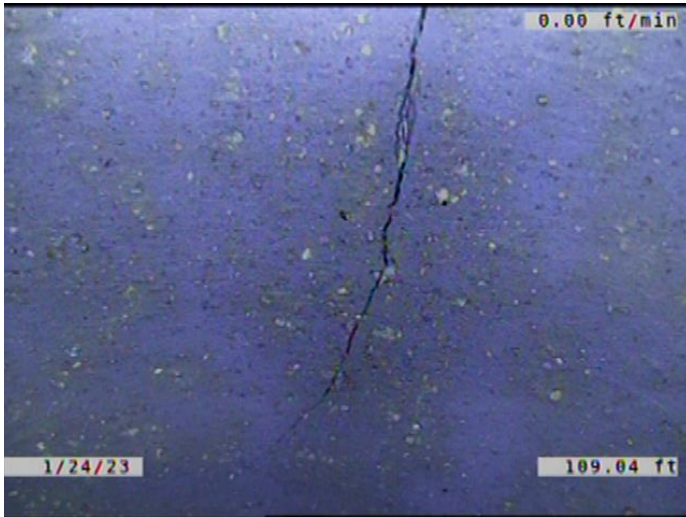
Code: **CM**
Description: **Crack Multiple**

Distance (ft): **109.0**
Structural Grade: **3**
O&M Grade: **0**
Clock Start/From: **8**
Clock To: **1**
1st Value:
2nd Value:
Value Percent:
Continuous Index:
Within 8" of Joint: **YES**
Remarks:

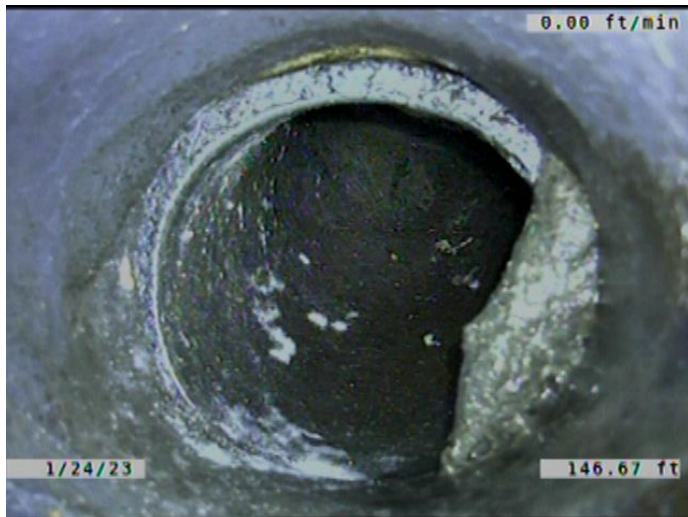
Code: **TF**
Description: **Tap Factory**

Distance (ft): **146.7**
Structural Grade: **0**
O&M Grade: **0**
Clock Start/From: **2**
Clock To:
1st Value: **6.000**
2nd Value:
Value Percent:
Continuous Index:
Within 8" of Joint: **YES**
Remarks: **SERVICE OFFSET. SOIL VISIBLE.**

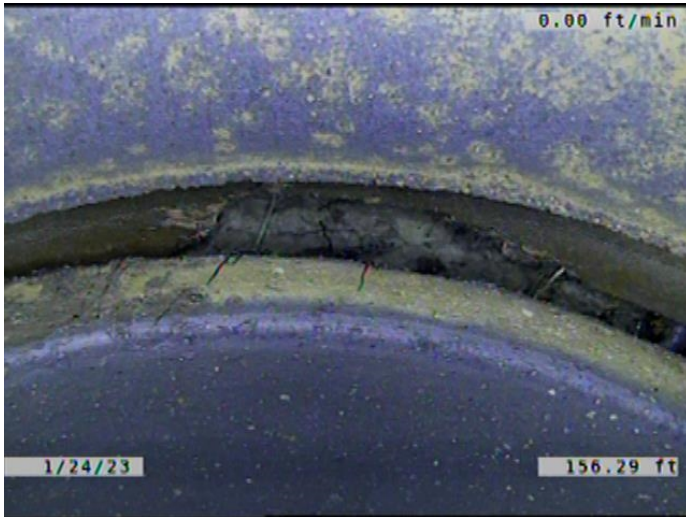
Code: **JAL**
Description: **Joint Angular Large**

Distance (ft): **156.3**
Structural Grade: **4**
O&M Grade: **0**
Clock Start/From:
Clock To:
1st Value:
2nd Value:
Value Percent:
Continuous Index:
Within 8" of Joint: **NO**
Remarks: **SOIL VISIBLE.**

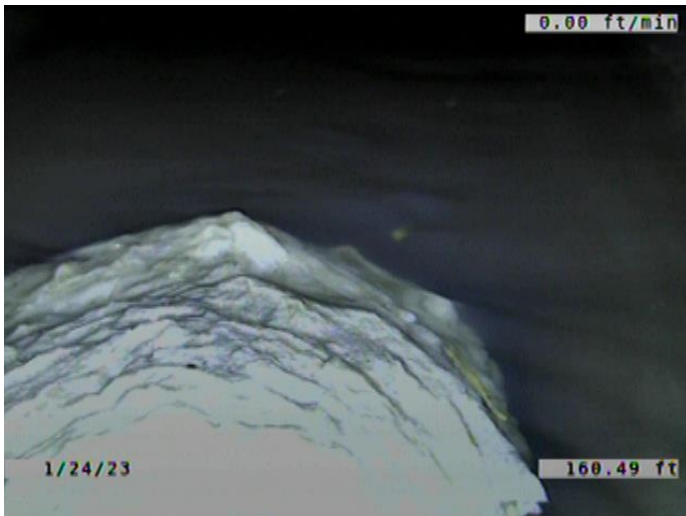
Code: **DAR**
Description: **Deposits Attached Ragging**

Distance (ft): **160.5**
Structural Grade: **0**
O&M Grade: **2**
Clock Start/From: **6**
Clock To:
1st Value:
2nd Value:
Value Percent: **5.000**
Continuous Index:
Within 8" of Joint: **YES**
Remarks:

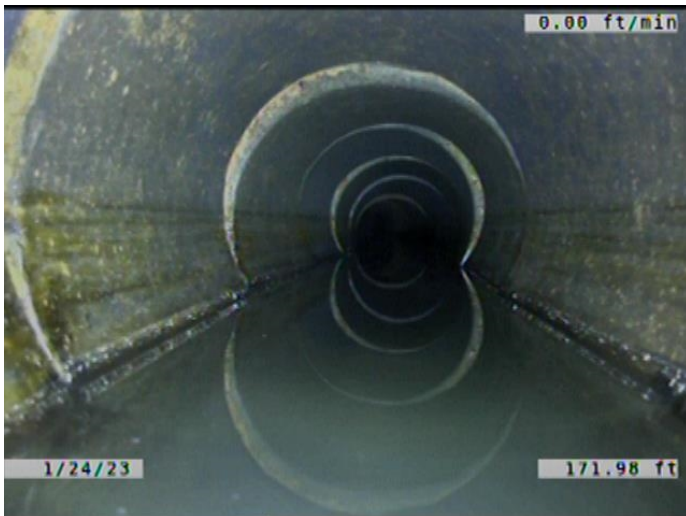
Code: **MWLS**
Description: **Miscellaneous Water Level Sag**

Distance (ft): **172.0**
Structural Grade: **2**
O&M Grade: **0**
Clock Start/From:
Clock To:
1st Value:
2nd Value:
Value Percent: **20.000**
Continuous Index: **S03**
Within 8" of Joint: **NO**
Remarks:

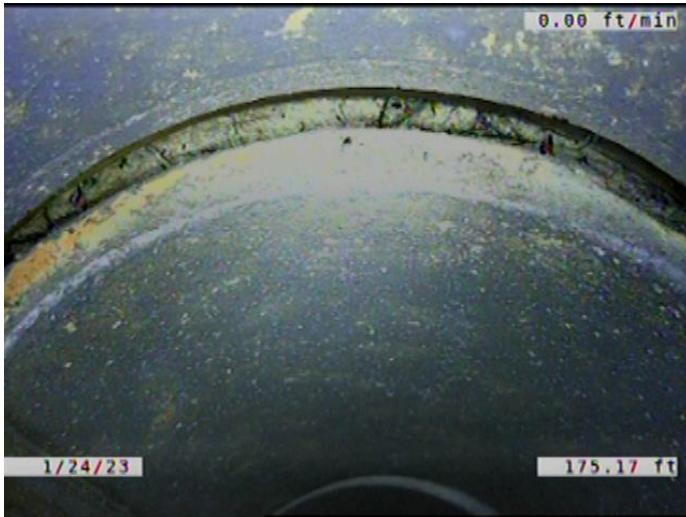
Code: **JOMD**
Description: **Joint Offset Medium Defective**

Distance (ft): **175.2**
Structural Grade: **3**
O&M Grade: **0**
Clock Start/From:
Clock To:
1st Value:
2nd Value:
Value Percent:
Continuous Index:
Within 8" of Joint: **NO**
Remarks: **SOIL VISIBLE.**

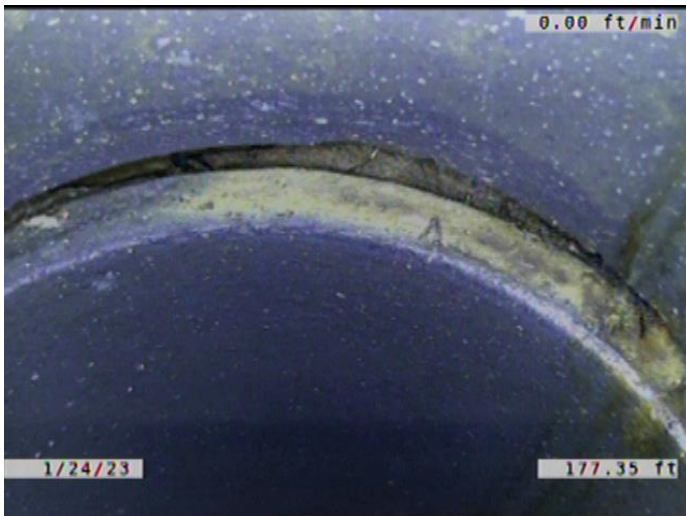
Code: **JOMD**
Description: **Joint Offset Medium Defective**

Distance (ft): **177.3**
Structural Grade: **3**
O&M Grade: **0**
Clock Start/From:
Clock To:
1st Value:
2nd Value:
Value Percent:
Continuous Index:
Within 8" of Joint: **NO**
Remarks: **SOIL VISIBLE.**

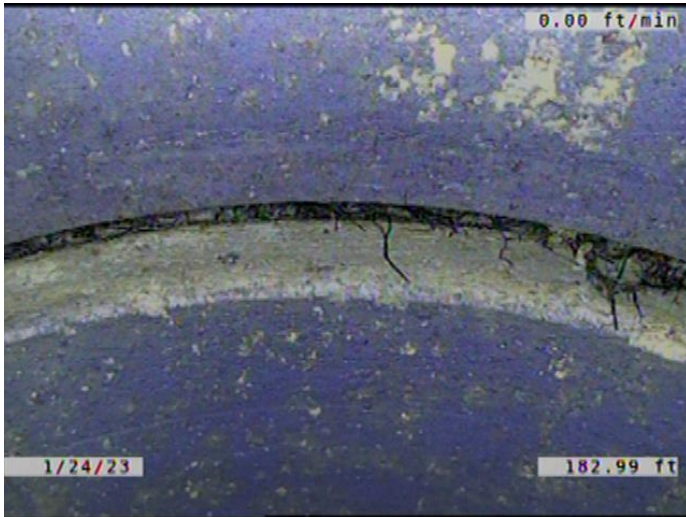
Code: **JOMD**
 Description: **Joint Offset Medium Defective**

Distance (ft): **183.0**
 Structural Grade: **3**
 O&M Grade: **0**
 Clock Start/From:
 Clock To:
 1st Value:
 2nd Value:
 Value Percent:
 Continuous Index:
 Within 8" of Joint: **NO**
 Remarks: **SOIL VISIBLE.**

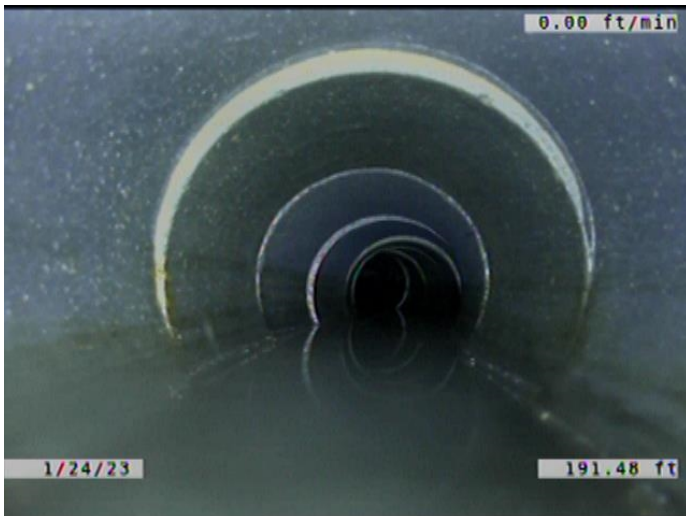
Code: **MWLS**
 Description: **Miscellaneous Water Level Sag**

Distance (ft): **191.5**
 Structural Grade: **2**
 O&M Grade: **0**
 Clock Start/From:
 Clock To:
 1st Value:
 2nd Value:
 Value Percent: **20.000**
 Continuous Index: **F03**
 Within 8" of Joint: **NO**
 Remarks:

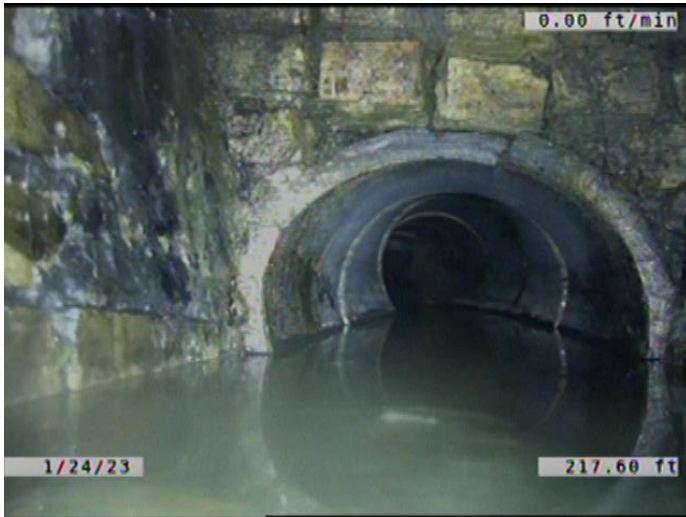
Code: **RFJ**
 Description: **Roots Fine Joint**

Distance (ft): **217.6**
 Structural Grade: **0**
 O&M Grade: **1**
 Clock Start/From: **10**
 Clock To: **2**
 1st Value:
 2nd Value:
 Value Percent:
 Continuous Index: **F01**
 Within 8" of Joint: **YES**
 Remarks:
