Profile/Photo Observation Report

Street:	DEVONSHIRE ST & S OHIO ST	Flow Control:	Not Controlled
City:	Hobart, IN	Year Renewed:	
Location:	Other	Tape/Media #:	
Purpose:	Not Known	Dia/Height:	12"
Use:	Sanitary	Material:	VCP
Drain Area:	NA	Lining:	
Category:	NA		
Comment:

Location Details:		Direction of Survey:	Upstream
US MH:	M-805-060	DS MH:	M-805-040
		Total Length Surveyed (ft):	81.0

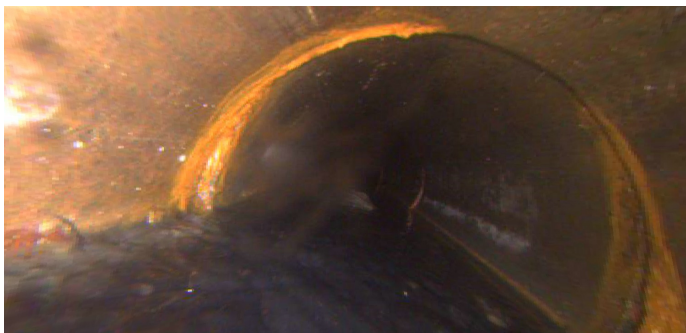
Code: **AMH**
Description: **Manhole**

Distance (ft): **.0**
Structural Grade: **0**
O&M Grade: **0**
Clock Start/From:
Clock To:
1st Value:
2nd Value:
Value Percent:
Continuous Index:
Within 8" of Joint: **NO**
Remarks: **M-805-040**

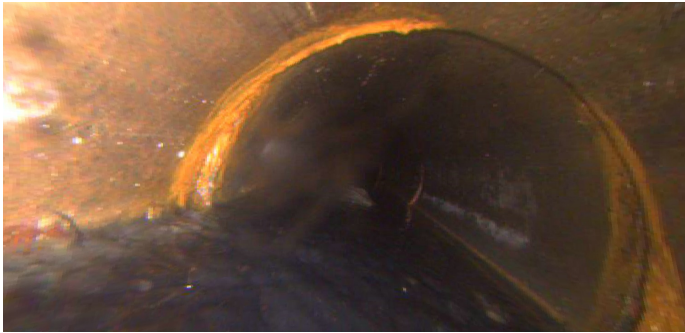
Code:	MWL
Description:	Water Level

Distance (ft):	.0
Structural Grade:	0
O&M Grade:	0
Clock Start/From:	
Clock To:	
1st Value:	
2nd Value:	
Value Percent:	5.000
Continuous Index:	
Within 8" of Joint:	NO
Remarks:

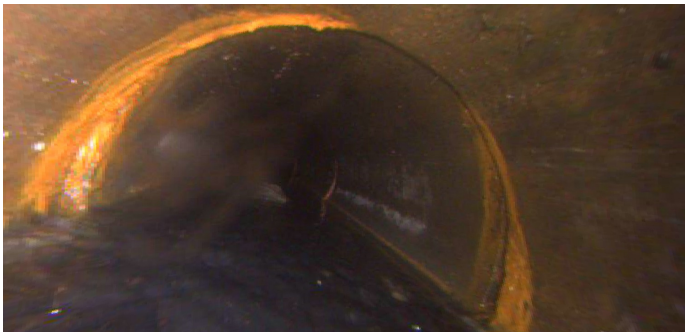
Code:	DAE
Description:	Deposits Attached Encrustation

Distance (ft):	.0
Structural Grade:	0
O&M Grade:	2
Clock Start/From:	7
Clock To:	5
1st Value:	
2nd Value:	
Value Percent:	5.000
Continuous Index:	
Within 8" of Joint:	YES
Remarks:

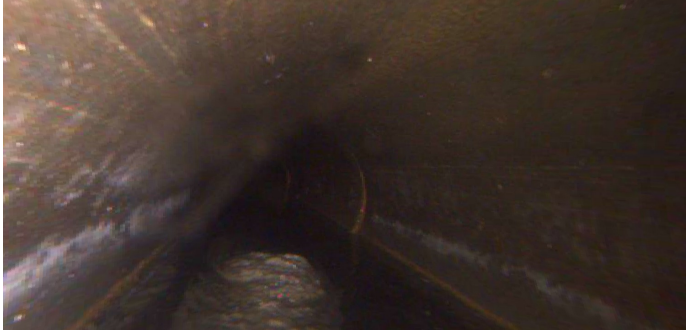
Code: **DSZ**
Description: **Deposits Settled Other**

Distance (ft): **2.5**
Structural Grade: **0**
O&M Grade: **2**
Clock Start/From: **6**
Clock To:
1st Value:
2nd Value:
Value Percent: **5.000**
Continuous Index:
Within 8" of Joint: **NO**
Remarks: **tissue**

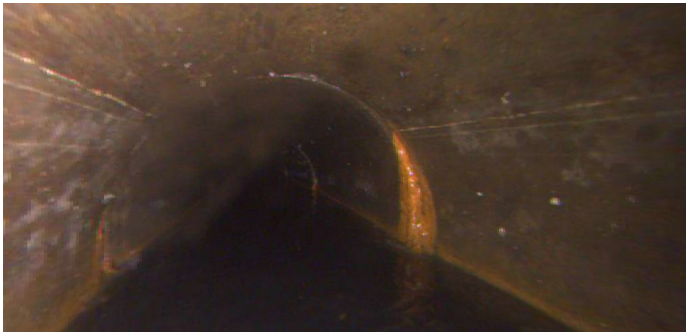
Code: **DAE**
Description: **Deposits Attached Encrustation**

Distance (ft): **7.3**
Structural Grade: **0**
O&M Grade: **2**
Clock Start/From: **7**
Clock To: **5**
1st Value:
2nd Value:
Value Percent: **5.000**
Continuous Index: **S01**
Within 8" of Joint: **YES**
Remarks: **wandering**

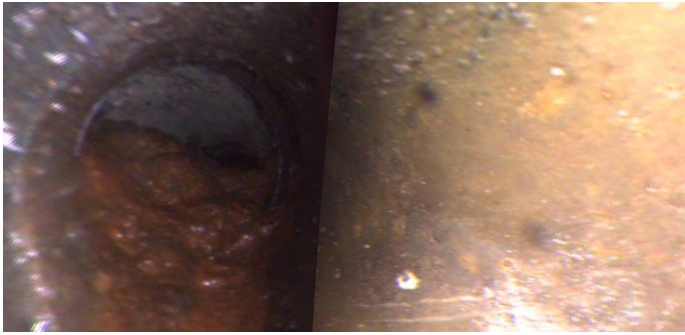
Code: **TFD**
Description: **Tap Factory Defective**

Distance (ft): **11.0**
Structural Grade: **0**
O&M Grade: **2**
Clock Start/From: **10**
Clock To:
1st Value: **4.000**
2nd Value:
Value Percent:
Continuous Index:
Within 8" of Joint:
Remarks: **blocked by dae**

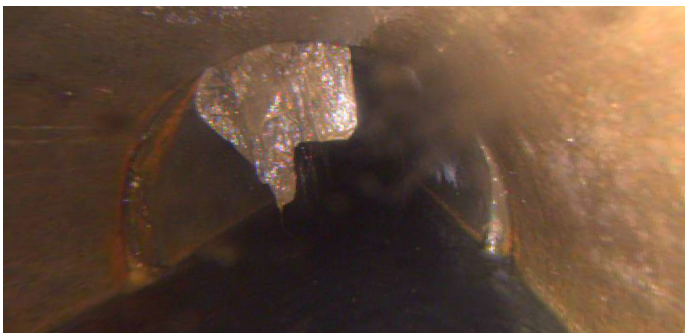
Code: **DAR**
Description: **Deposits Attached Ragging**

Distance (ft): **15.7**
Structural Grade: **0**
O&M Grade: **2**
Clock Start/From: **11**
Clock To: **12**
1st Value:
2nd Value:
Value Percent: **5.000**
Continuous Index:
Within 8" of Joint: **YES**
Remarks:

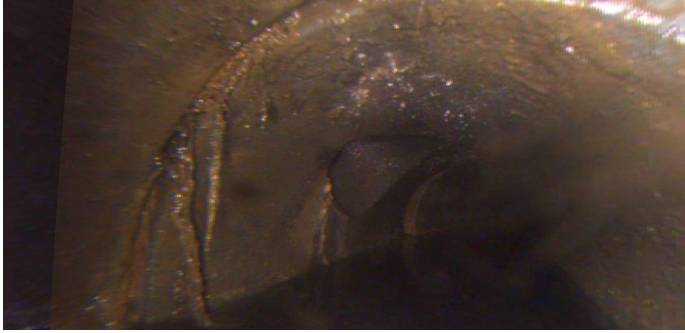
Code: **RFJ**
Description: **Roots Fine Joint**

Distance (ft): **18.1**
Structural Grade: **0**
O&M Grade: **1**
Clock Start/From: **7**
Clock To: **10**
1st Value:
2nd Value:
Value Percent:
Continuous Index:
Within 8" of Joint: **YES**
Remarks:

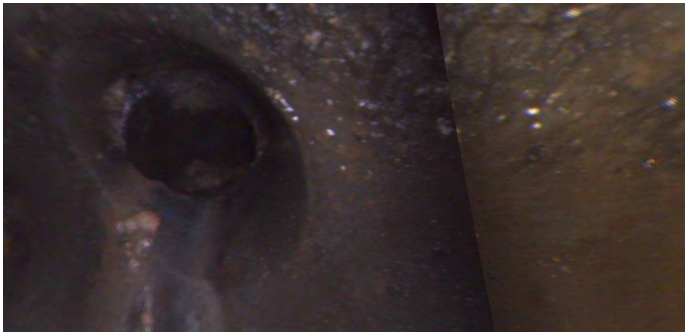
Code: **TF**
Description: **Tap Factory**

Distance (ft): **19.9**
Structural Grade: **0**
O&M Grade: **0**
Clock Start/From: **10**
Clock To:
1st Value: **4.000**
2nd Value:
Value Percent:
Continuous Index:
Within 8" of Joint: **YES**
Remarks:

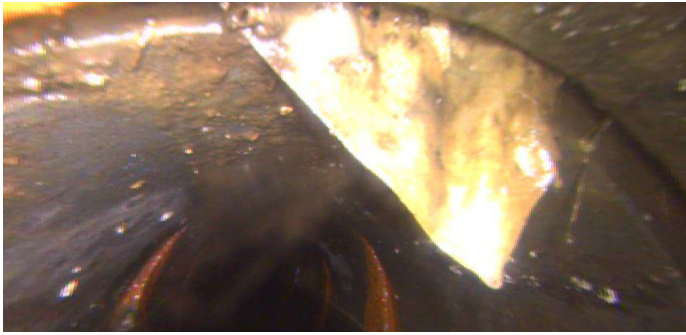
Code: **DAR**
Description: **Deposits Attached Ragging**

Distance (ft): **28.5**
Structural Grade: **0**
O&M Grade: **2**
Clock Start/From: **12**
Clock To: **1**
1st Value:
2nd Value:
Value Percent: **5.000**
Continuous Index:
Within 8" of Joint: **YES**
Remarks:

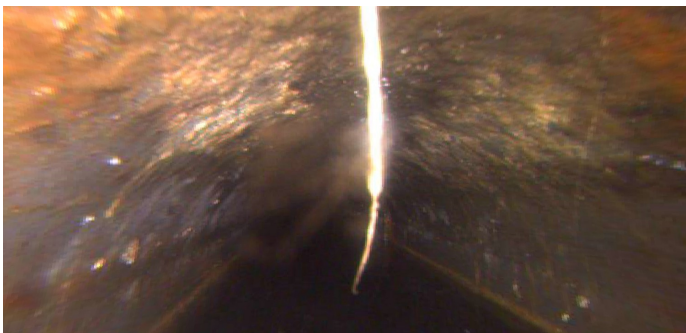
Code: **RFJ**
Description: **Roots Fine Joint**

Distance (ft): **32.8**
Structural Grade: **0**
O&M Grade: **1**
Clock Start/From: **12**
Clock To:
1st Value:
2nd Value:
Value Percent:
Continuous Index: **S02**
Within 8" of Joint: **YES**
Remarks: **wandering**

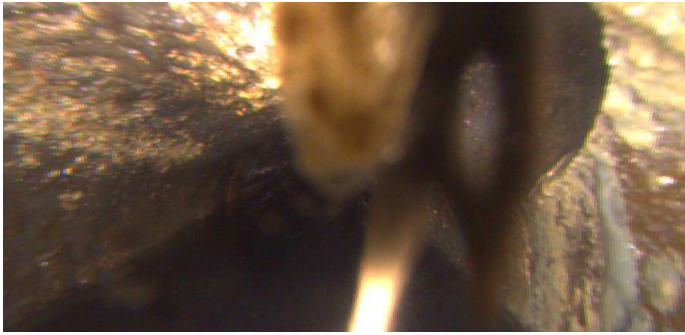
Code: **DAGS**
Description: **Deposits Attached Grease**

Distance (ft): **37.1**
Structural Grade: **0**
O&M Grade: **2**
Clock Start/From: **7**
Clock To: **5**
1st Value:
2nd Value:
Value Percent: **5.000**
Continuous Index: **S03**
Within 8" of Joint: **NO**
Remarks:

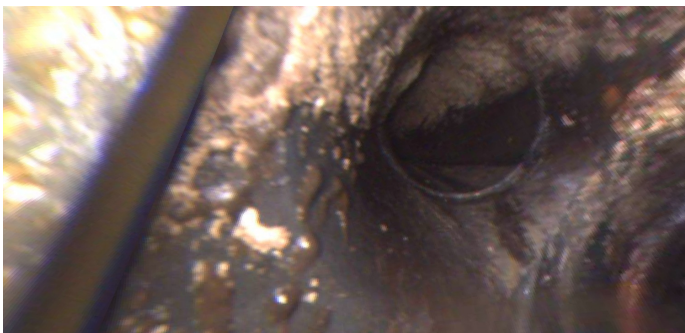
Code: **TF**
Description: **Tap Factory**

Distance (ft): **38.1**
Structural Grade: **0**
O&M Grade: **0**
Clock Start/From: **2**
Clock To:
1st Value: **4.000**
2nd Value:
Value Percent:
Continuous Index:
Within 8" of Joint: **YES**
Remarks:

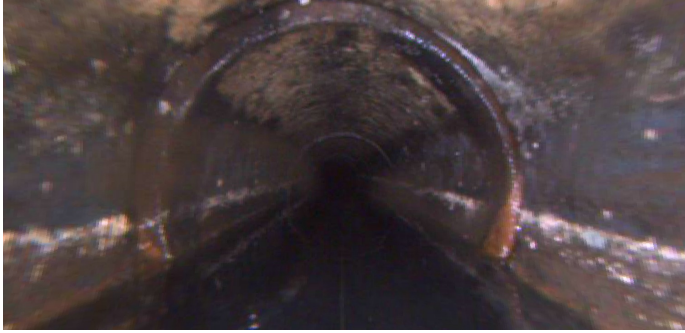
Code: **MGO**
Description: **General Observation**

Distance (ft): **45.9**
Structural Grade: **0**
O&M Grade: **0**
Clock Start/From:
Clock To:
1st Value:
2nd Value:
Value Percent:
Continuous Index:
Within 8" of Joint: **NO**
Remarks: **rear camera/lense dirty**

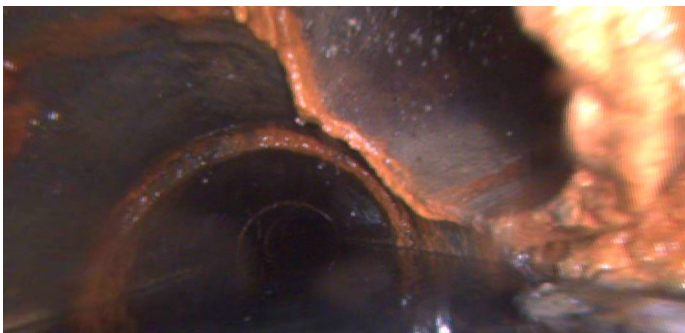
Code: **TBI**
Description: **Tap Break-in Intruding**

Distance (ft): **64.9**
Structural Grade: **0**
O&M Grade: **2**
Clock Start/From: **10**
Clock To:
1st Value: **6.000**
2nd Value: **1.000**
Value Percent:
Continuous Index:
Within 8" of Joint: **YES**
Remarks:

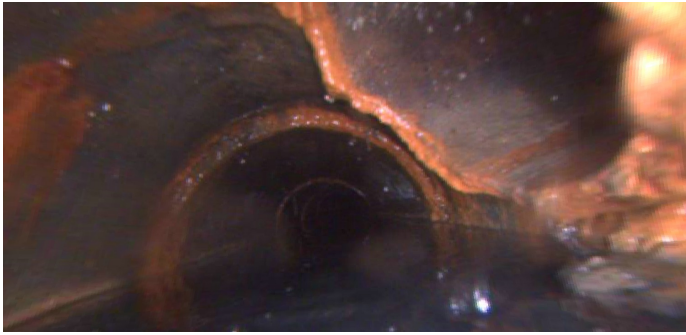
Code: **MWL**
Description: **Water Level**

Distance (ft): **64.9**
Structural Grade: **0**
O&M Grade: **0**
Clock Start/From:
Clock To:
1st Value:
2nd Value:
Value Percent: **50.000**
Continuous Index:
Within 8" of Joint: **NO**
Remarks:

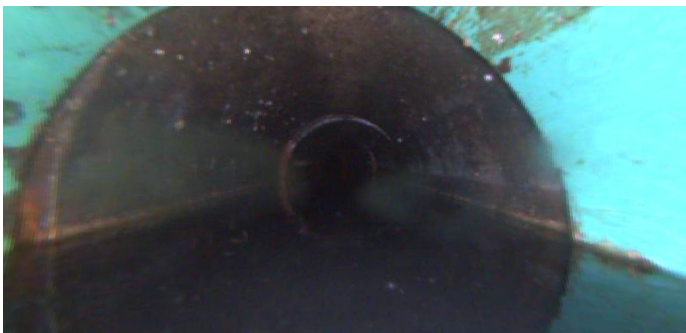
Code: **MMC**
Description: **Material Change**

Distance (ft): **76.1**
Structural Grade: **0**
O&M Grade: **0**
Clock Start/From:
Clock To:
1st Value:
2nd Value:
Value Percent:
Continuous Index:
Within 8" of Joint: **NO**
Remarks: **pvc**

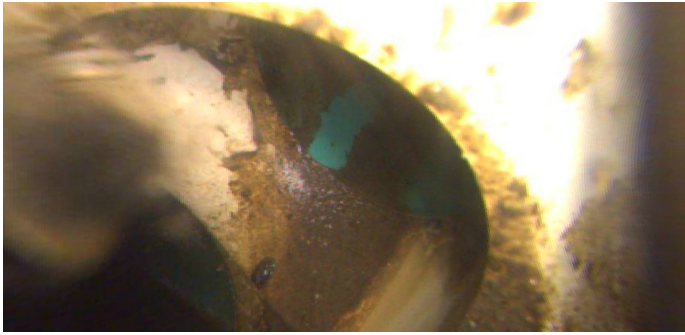
Code: **TF**
Description: **Tap Factory**

Distance (ft): **79.2**
Structural Grade: **0**
O&M Grade: **0**
Clock Start/From: **2**
Clock To:
1st Value: **4.000**
2nd Value:
Value Percent:
Continuous Index:
Within 8" of Joint: **YES**
Remarks:

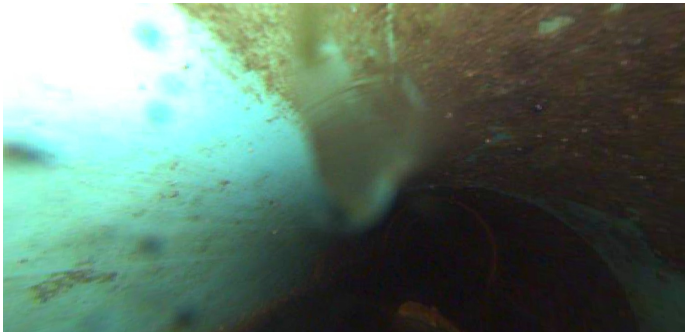
Code: **DAE**
Description: **Deposits Attached Encrustation**

Distance (ft): **81.0**
Structural Grade: **0**
O&M Grade: **2**
Clock Start/From: **7**
Clock To: **5**
1st Value:
2nd Value:
Value Percent: **5.000**
Continuous Index: **F01**
Within 8" of Joint: **YES**
Remarks: **wandering**

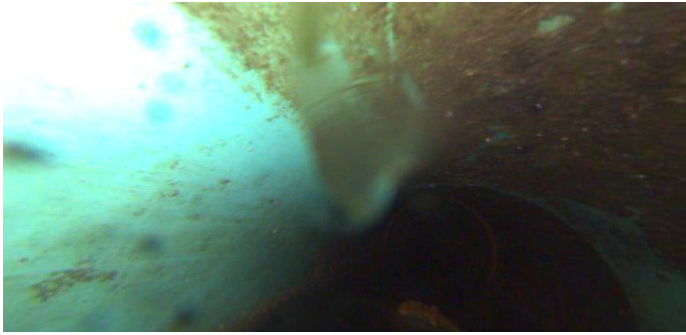
Code: **RFJ**
Description: **Roots Fine Joint**

Distance (ft): **81.0**
Structural Grade: **0**
O&M Grade: **1**
Clock Start/From: **12**
Clock To:
1st Value:
2nd Value:
Value Percent:
Continuous Index: **F02**
Within 8" of Joint: **YES**
Remarks: **wandering**

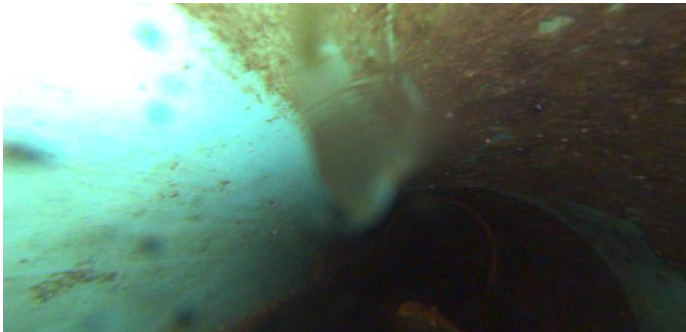
Code: **DAGS**
Description: **Deposits Attached Grease**

Distance (ft): **81.0**
Structural Grade: **0**
O&M Grade: **2**
Clock Start/From: **7**
Clock To: **5**
1st Value:
2nd Value:
Value Percent: **5.000**
Continuous Index: **F03**
Within 8" of Joint: **NO**
Remarks:

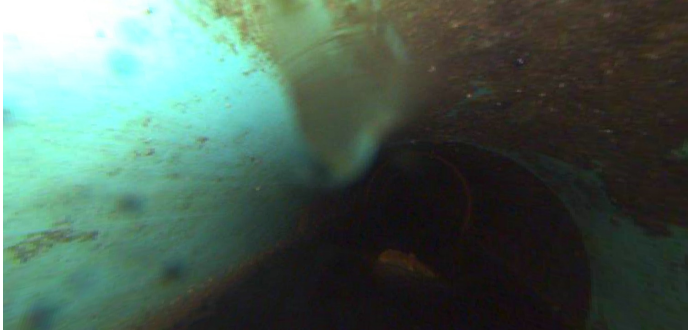
Code:	MSA
Description:	Abandoned Survey
Distance (ft):	81.0
Structural Grade:	0
O&M Grade:	0
Clock Start/From:	
Clock To:	
1st Value:	
2nd Value:	
Value Percent:	
Continuous Index:	
Within 8" of Joint:	NO
Remarks:	stuck on wall?/no blockage
