Profile/Photo Observation Report

Date:	04/20/2018	Weather:		Coding:	PACP 6.0
Pipe Length (ft):	197.3	Owner:	NA	Pre Clean:	Not Known
P.O.#:		Surveyor:	Byrd Fitzgerald	PSR:	P-805-040-060
Customer:		Clean Date:	01/01/1900	Shape:	C

Street:	Devonshire St.	Flow Control:	Not Controlled
City:	Hobart, IN	Year Renewed:	
Location:	Other	Tape/Media #:	
Purpose:	Not Known	Dia/Height:	12"
Use:	Sanitary	Material:	VCP
Drain Area:	NA	Lining:	
Category:	NA		
Comment:

Location Details:		Direction of Survey:	Upstream
US MH:	M-805-060	DS MH:	M-805-040
		Total Length Surveyed (ft):	81.0

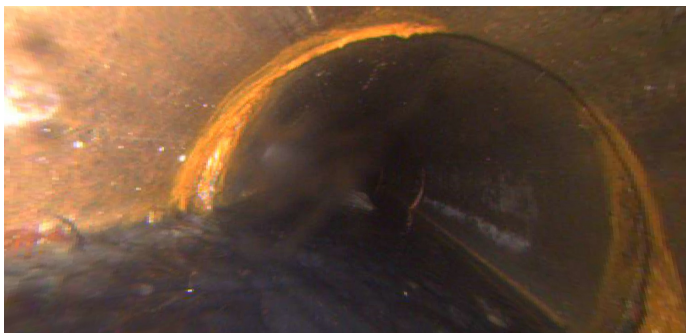
Code: **AMH**
Description: **Manhole**

Distance (ft): **.0**
Structural Grade: **0**
O&M Grade: **0**
Clock Start/From:
Clock To:
1st Value:
2nd Value:
Value Percent:
Continuous Index:
Within 8" of Joint: **NO**
Remarks: **M-805-040**

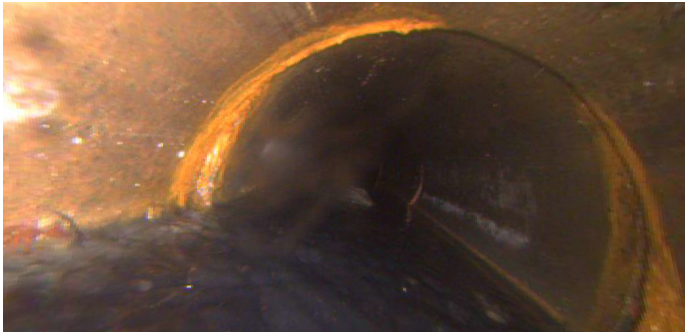
Code:	MWL
Description:	Water Level

Distance (ft):	.0
Structural Grade:	0
O&M Grade:	0
Clock Start/From:	
Clock To:	
1st Value:	
2nd Value:	
Value Percent:	5.000
Continuous Index:	
Within 8" of Joint:	NO
Remarks:

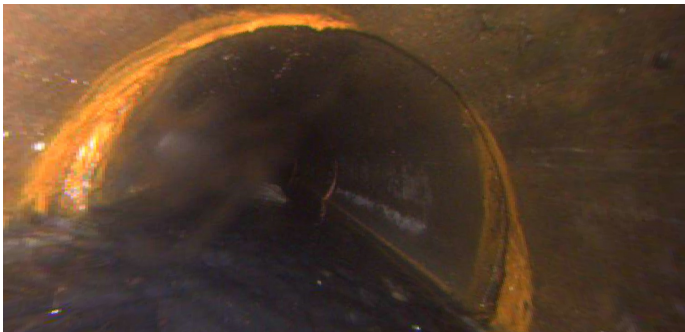
Code:	DAE
Description:	Deposits Attached Encrustation

Distance (ft):	.0
Structural Grade:	0
O&M Grade:	2
Clock Start/From:	7
Clock To:	5
1st Value:	
2nd Value:	
Value Percent:	5.000
Continuous Index:	
Within 8" of Joint:	YES
Remarks:

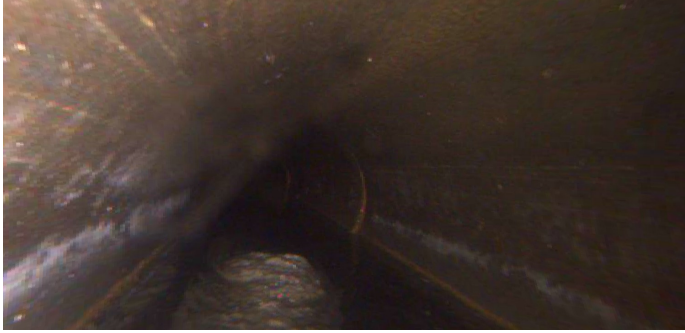
Code: **DSZ**
Description: **Deposits Settled Other**

Distance (ft): **2.5**
Structural Grade: **0**
O&M Grade: **2**
Clock Start/From: **6**
Clock To:
1st Value:
2nd Value:
Value Percent: **5.000**
Continuous Index:
Within 8" of Joint: **NO**
Remarks: **tissue**

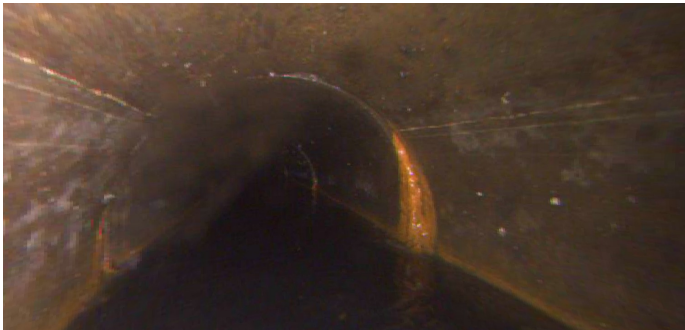
Code: **DAE**
Description: **Deposits Attached Encrustation**

Distance (ft): **7.3**
Structural Grade: **0**
O&M Grade: **2**
Clock Start/From: **7**
Clock To: **5**
1st Value:
2nd Value:
Value Percent: **5.000**
Continuous Index: **S01**
Within 8" of Joint: **YES**
Remarks: **wandering**

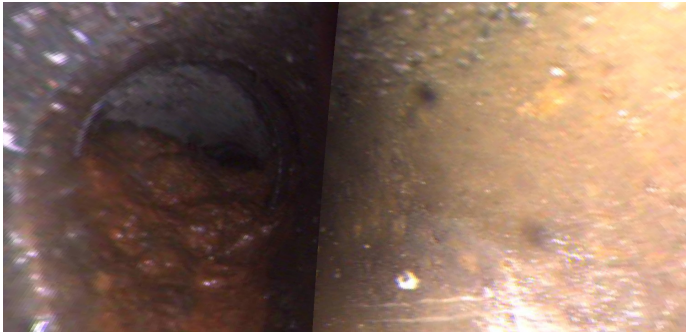
Code: **TFD**
Description: **Tap Factory Defective**

Distance (ft): **11.0**
Structural Grade: **0**
O&M Grade: **2**
Clock Start/From: **10**
Clock To:
1st Value: **4.000**
2nd Value:
Value Percent:
Continuous Index:
Within 8" of Joint:
Remarks: **blocked by dae**

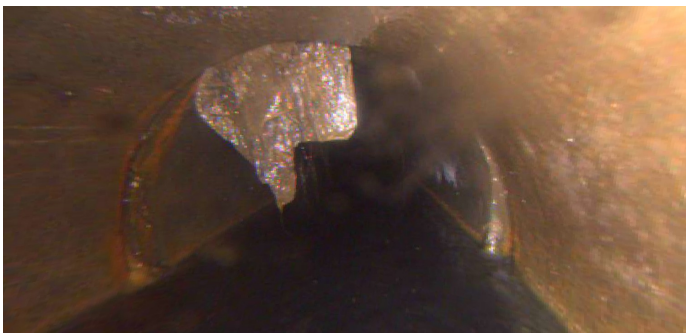
Code: **DAR**
Description: **Deposits Attached Ragging**

Distance (ft): **15.7**
Structural Grade: **0**
O&M Grade: **2**
Clock Start/From: **11**
Clock To: **12**
1st Value:
2nd Value:
Value Percent: **5.000**
Continuous Index:
Within 8" of Joint: **YES**
Remarks:

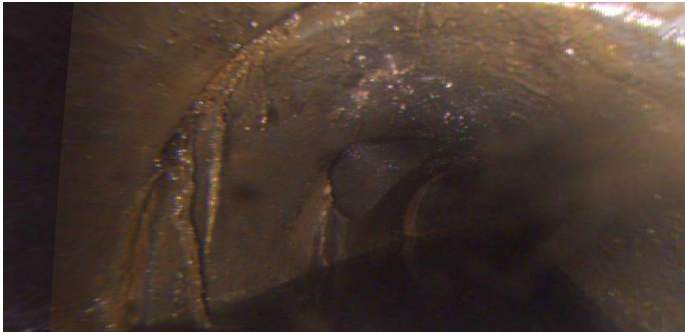
Code: **RFJ**
Description: **Roots Fine Joint**

Distance (ft): **18.1**
Structural Grade: **0**
O&M Grade: **1**
Clock Start/From: **7**
Clock To: **10**
1st Value:
2nd Value:
Value Percent:
Continuous Index:
Within 8" of Joint: **YES**
Remarks:

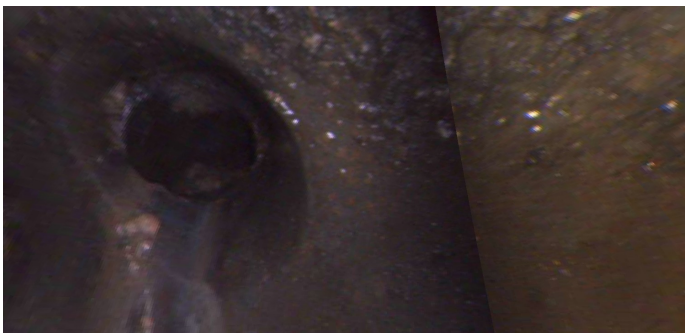
Code: **TF**
Description: **Tap Factory**

Distance (ft): **19.9**
Structural Grade: **0**
O&M Grade: **0**
Clock Start/From: **10**
Clock To:
1st Value: **4.000**
2nd Value:
Value Percent:
Continuous Index:
Within 8" of Joint: **YES**
Remarks:

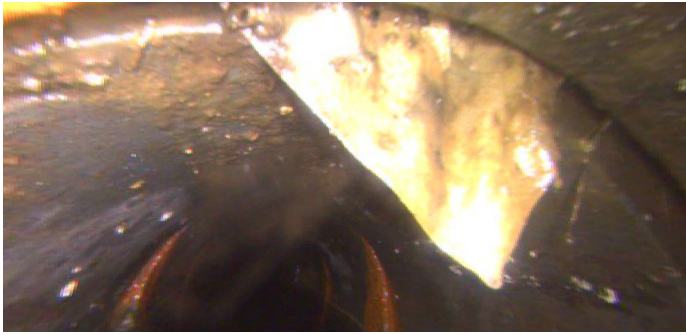
Code: **DAR**
Description: **Deposits Attached Ragging**

Distance (ft): **28.5**
Structural Grade: **0**
O&M Grade: **2**
Clock Start/From: **12**
Clock To: **1**
1st Value:
2nd Value:
Value Percent: **5.000**
Continuous Index:
Within 8" of Joint: **YES**
Remarks:

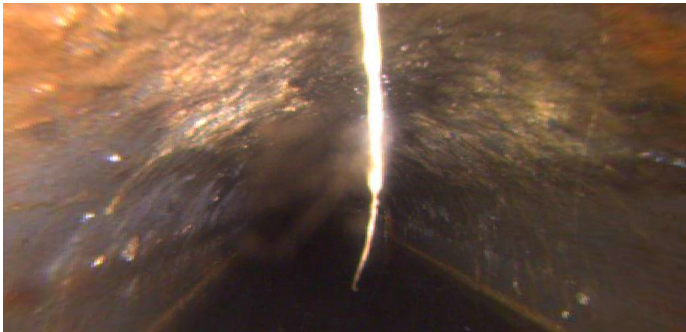
Code: **RFJ**
Description: **Roots Fine Joint**

Distance (ft): **32.8**
Structural Grade: **0**
O&M Grade: **1**
Clock Start/From: **12**
Clock To:
1st Value:
2nd Value:
Value Percent:
Continuous Index: **S02**
Within 8" of Joint: **YES**
Remarks: **wandering**

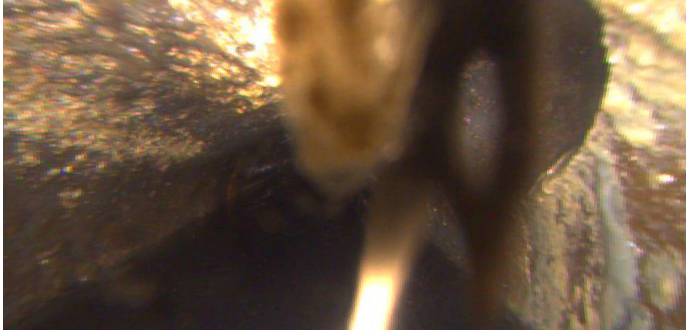
Code: **DAGS**
Description: **Deposits Attached Grease**

Distance (ft): **37.1**
Structural Grade: **0**
O&M Grade: **2**
Clock Start/From: **7**
Clock To: **5**
1st Value:
2nd Value:
Value Percent: **5.000**
Continuous Index: **S03**
Within 8" of Joint: **NO**
Remarks:

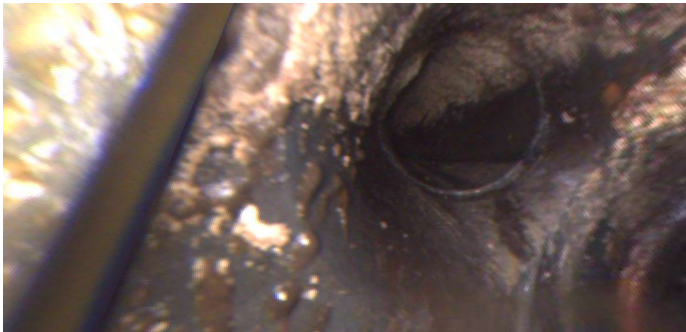
Code: **TF**
Description: **Tap Factory**

Distance (ft): **38.1**
Structural Grade: **0**
O&M Grade: **0**
Clock Start/From: **2**
Clock To:
1st Value: **4.000**
2nd Value:
Value Percent:
Continuous Index:
Within 8" of Joint: **YES**
Remarks:

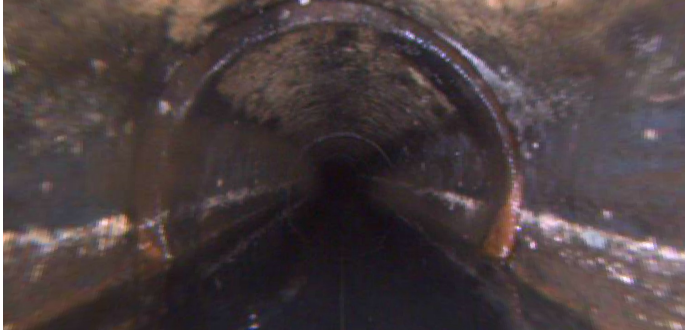
Code: **MGO**
Description: **General Observation**

Distance (ft): **45.9**
Structural Grade: **0**
O&M Grade: **0**
Clock Start/From:
Clock To:
1st Value:
2nd Value:
Value Percent:
Continuous Index:
Within 8" of Joint: **NO**
Remarks: **rear camera/lense dirty**

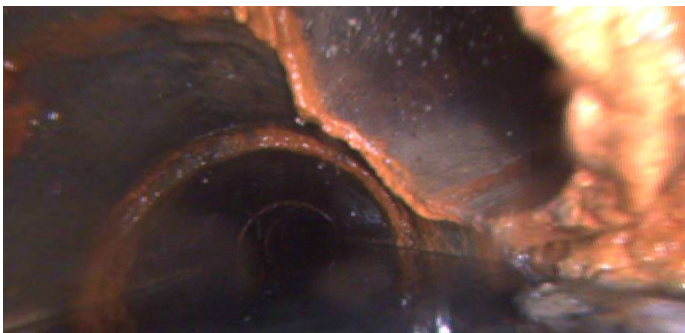
Code: **TBI**
Description: **Tap Break-in Intruding**

Distance (ft): **64.9**
Structural Grade: **0**
O&M Grade: **2**
Clock Start/From: **10**
Clock To:
1st Value: **6.000**
2nd Value: **1.000**
Value Percent:
Continuous Index:
Within 8" of Joint: **YES**
Remarks:

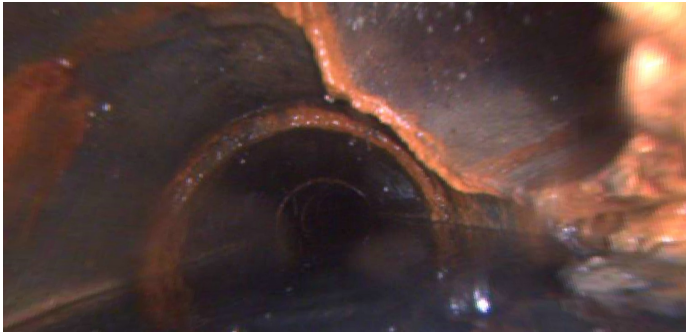
Code: **MWL**
Description: **Water Level**

Distance (ft): **64.9**
Structural Grade: **0**
O&M Grade: **0**
Clock Start/From:
Clock To:
1st Value:
2nd Value:
Value Percent: **50.000**
Continuous Index:
Within 8" of Joint: **NO**
Remarks:

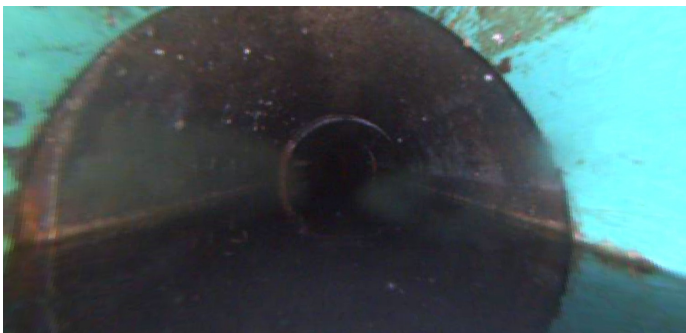
Code: **MMC**
Description: **Material Change**

Distance (ft): **76.1**
Structural Grade: **0**
O&M Grade: **0**
Clock Start/From:
Clock To:
1st Value:
2nd Value:
Value Percent:
Continuous Index:
Within 8" of Joint: **NO**
Remarks: **pvc**

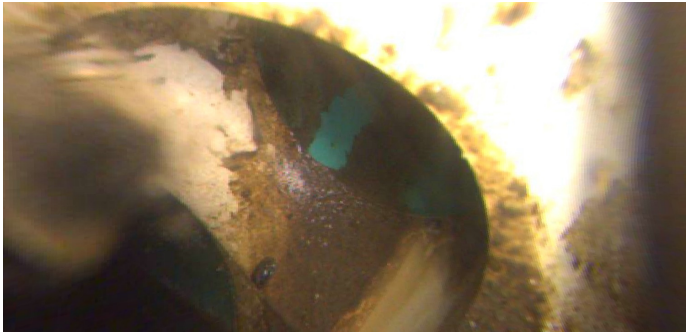
Code: **TF**
Description: **Tap Factory**

Distance (ft): **79.2**
Structural Grade: **0**
O&M Grade: **0**
Clock Start/From: **2**
Clock To:
1st Value: **4.000**
2nd Value:
Value Percent:
Continuous Index:
Within 8" of Joint: **YES**
Remarks:

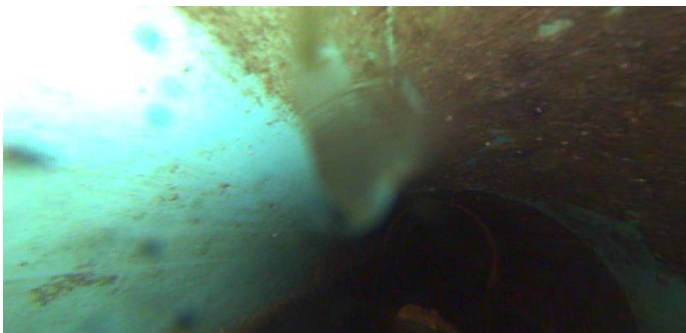
Code: **DAE**
Description: **Deposits Attached Encrustation**

Distance (ft): **81.0**
Structural Grade: **0**
O&M Grade: **2**
Clock Start/From: **7**
Clock To: **5**
1st Value:
2nd Value:
Value Percent: **5.000**
Continuous Index: **F01**
Within 8" of Joint: **YES**
Remarks: **wandering**

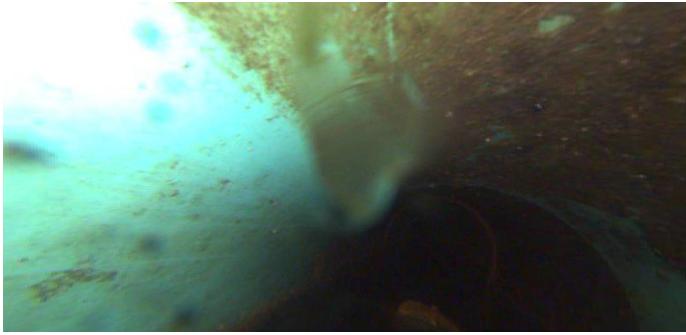
Code: **RFJ**
Description: **Roots Fine Joint**

Distance (ft): **81.0**
Structural Grade: **0**
O&M Grade: **1**
Clock Start/From: **12**
Clock To:
1st Value:
2nd Value:
Value Percent:
Continuous Index: **F02**
Within 8" of Joint: **YES**
Remarks: **wandering**

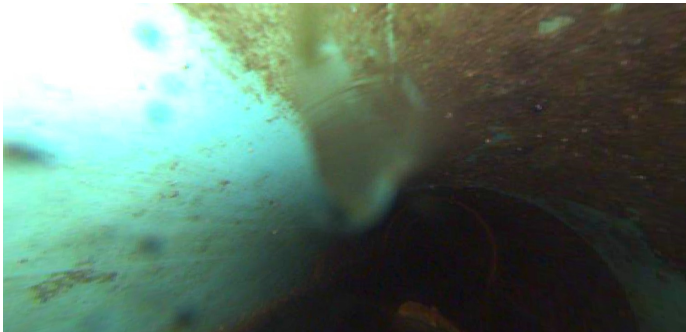
Code: **DAGS**
Description: **Deposits Attached Grease**

Distance (ft): **81.0**
Structural Grade: **0**
O&M Grade: **2**
Clock Start/From: **7**
Clock To: **5**
1st Value:
2nd Value:
Value Percent: **5.000**
Continuous Index: **F03**
Within 8" of Joint: **NO**
Remarks:

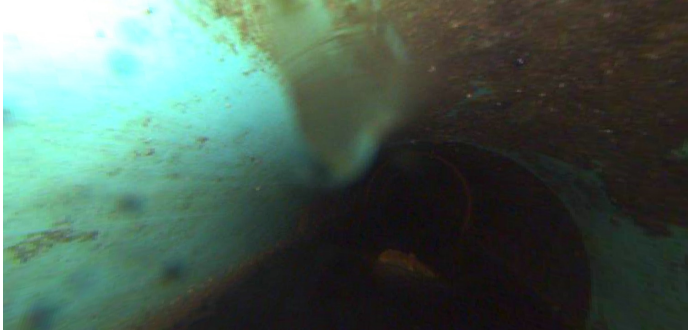
Code:	MSA
Description:	Abandoned Survey
Distance (ft):	81.0
Structural Grade:	0
O&M Grade:	0
Clock Start/From:	
Clock To:	
1st Value:	
2nd Value:	
Value Percent:	
Continuous Index:	
Within 8" of Joint:	NO
Remarks:	stuck on wall?/no blockage
