Profile/Photo Observation Report

Street:	DEVONSHIRE ST & S OHIO ST	Flow Control:	Not Controlled
City:	Hobart, IN	Year Renewed:	
Location:	Other	Tape/Media #:	
Purpose:	Not Known	Dia/Height:	8"
Use:	Sanitary	Material:	VCP
Drain Area:	NA	Lining:	
Category:	NA		
Comment:

Location Details:		Direction of Survey:	Downstream
US MH:	M-805-061	DS MH:	M-805-060
		Total Length Surveyed (ft):	7.0

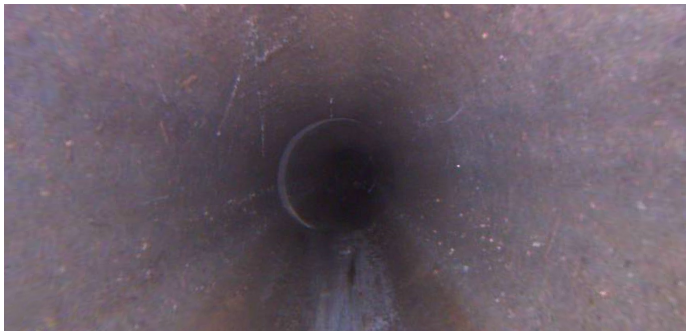
Code: **AMH**
Description: **Manhole**

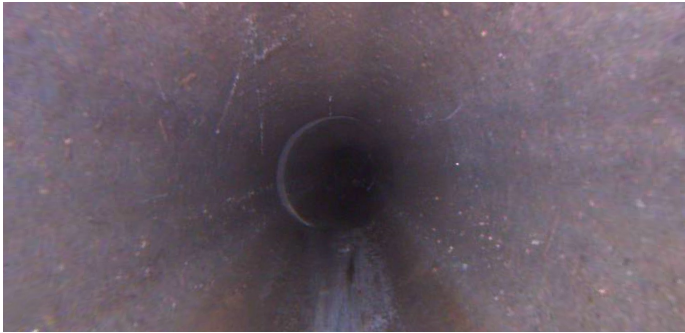
Code:	MWL
Description:	Water Level

Distance (ft):	.0
Structural Grade:	0
O&M Grade:	0
Clock Start/From:	
Clock To:	
1st Value:	
2nd Value:	
Value Percent:	5.000
Continuous Index:	
Within 8" of Joint:	NO
Remarks:

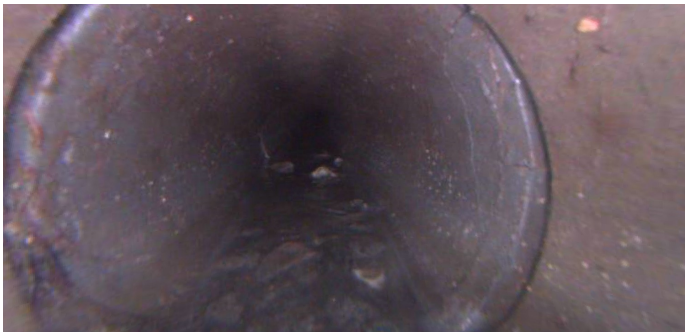
Code:	FM
Description:	Fracture Multiple

Distance (ft):	4.6
Structural Grade:	4
O&M Grade:	0
Clock Start/From:	1
Clock To:	4
1st Value:	
2nd Value:	
Value Percent:	
Continuous Index:	
Within 8" of Joint:	YES
Remarks:

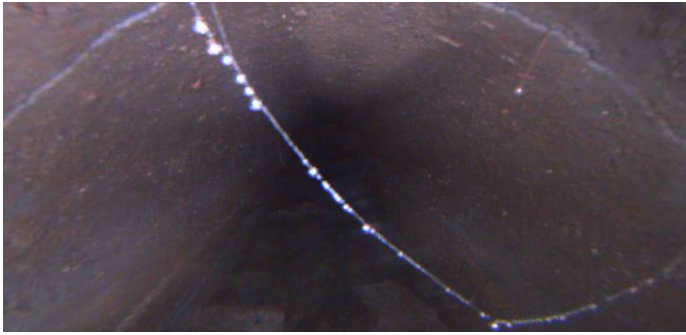
Code: **RFJ**
Description: **Roots Fine Joint**

Distance (ft): **7.0**
Structural Grade: **0**
O&M Grade: **1**
Clock Start/From: **1**
Clock To:
1st Value:
2nd Value:
Value Percent:
Continuous Index:
Within 8" of Joint: **YES**
Remarks:

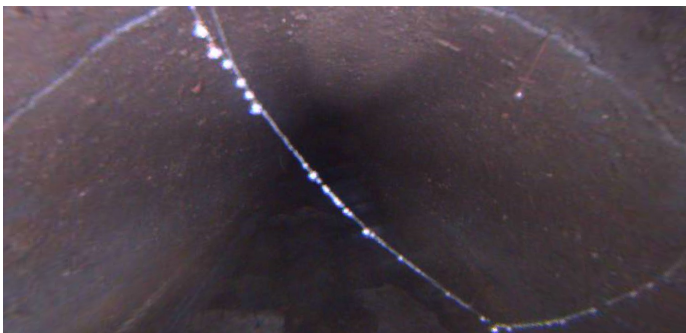
Code: **MSA**
Description: **Abandoned Survey**

Distance (ft): **7.0**
Structural Grade: **0**
O&M Grade: **0**
Clock Start/From:
Clock To:
1st Value:
2nd Value:
Value Percent:
Continuous Index:
Within 8" of Joint: **NO**
Remarks: **UNKNOWN**
