## Profile/Photo Observation Report

Street:	<b>S Ohio St.</b>	Flow Control:	<b>Not Controlled</b>
City:	<b>Hobart, IN</b>	Year Renewed:	
Location:	<b>Other</b>	Tape/Media #:	
Purpose:	<b>Not Known</b>	Dia/Height:	<b>8"</b>
Use:	<b>Sanitary</b>	Material:	<b>VCP</b>
Drain Area:	<b>NA</b>	Lining:	
Category:	<b>NA</b>		
Comment:

Location Details:		Direction of Survey:	<b>Downstream</b>
US MH:	<b>M-805-061</b>	DS MH:	<b>M-805-060</b>
		Total Length Surveyed (ft):	<b>7.0</b>

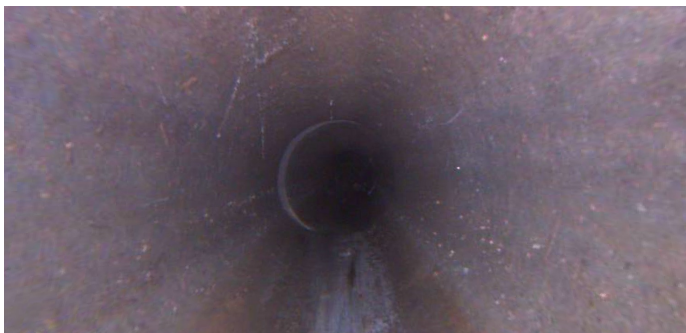
Code: **AMH**  
Description: **Manhole**

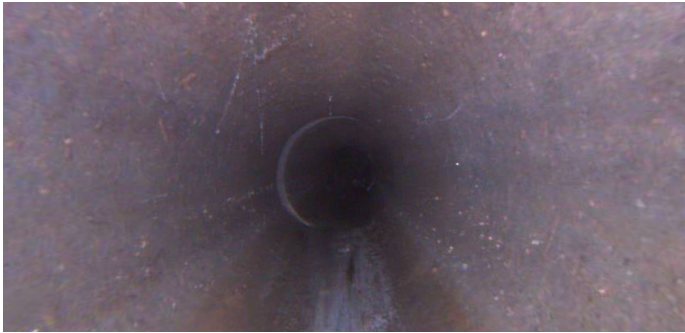
Code:	<b>MWL</b>
Description:	<b>Water Level</b>

Distance (ft):	<b>.0</b>
Structural Grade:	<b>0</b>
O&M Grade:	<b>0</b>
Clock Start/From:	
Clock To:	
1st Value:	
2nd Value:	
Value Percent:	<b>5.000</b>
Continuous Index:	
Within 8" of Joint:	<b>NO</b>
Remarks:

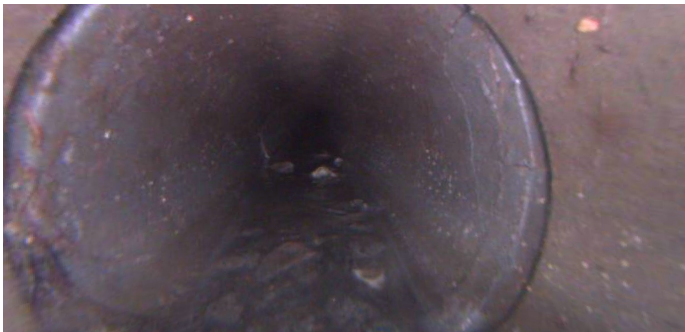
Code:	<b>FM</b>
Description:	<b>Fracture Multiple</b>

Distance (ft):	<b>4.6</b>
Structural Grade:	<b>4</b>
O&M Grade:	<b>0</b>
Clock Start/From:	<b>1</b>
Clock To:	<b>4</b>
1st Value:	
2nd Value:	
Value Percent:	
Continuous Index:	
Within 8" of Joint:	<b>YES</b>
Remarks:

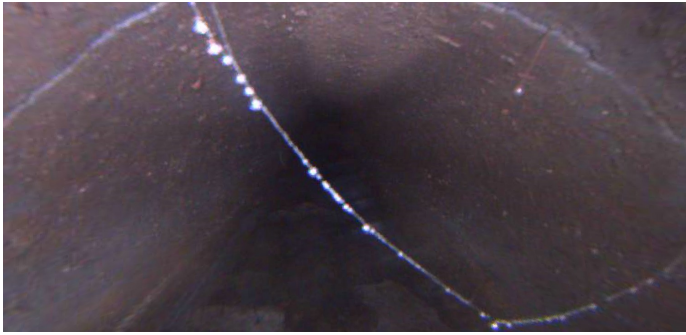
Code: **RFJ**  
Description: **Roots Fine Joint**

Distance (ft): **7.0**  
Structural Grade: **0**  
O&M Grade: **1**  
Clock Start/From: **1**  
Clock To:  
1st Value:  
2nd Value:  
Value Percent:  
Continuous Index:  
Within 8" of Joint: **YES**  
Remarks:

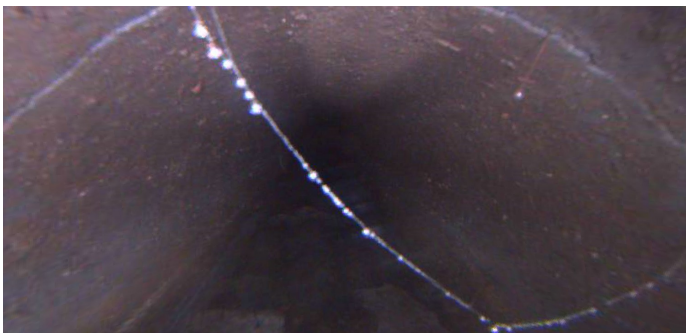
Code: **MSA**  
Description: **Abandoned Survey**

Distance (ft): **7.0**  
Structural Grade: **0**  
O&M Grade: **0**  
Clock Start/From:  
Clock To:  
1st Value:  
2nd Value:  
Value Percent:  
Continuous Index:  
Within 8" of Joint: **NO**  
Remarks: **UNKNOWN**
