Profile/Photo Observation Report

Date:	04/19/2018	Weather:		Coding:	PACP 6.0
Pipe Length (ft):	243.0	Owner:	NA	Pre Clean:	Not Known
P.O.#:		Surveyor:	Byrd Fitzgerald	PSR:	P-804-011-062
Customer:		Clean Date:	01/01/1900	Shape:	C

Street:	S INDIANA ST	Flow Control:	Not Controlled
City:	Hobart, IN	Year Renewed:	
Location:	Other	Tape/Media #:	
Purpose:	Not Known	Dia/Height:	8"
Use:	Sanitary	Material:	VCP
Drain Area:	NA	Lining:	
Category:	NA		
Comment:

Location Details:		Direction of Survey:	Downstream
US MH:	M-805-062	DS MH:	M-804-011
		Total Length Surveyed (ft):	50.9

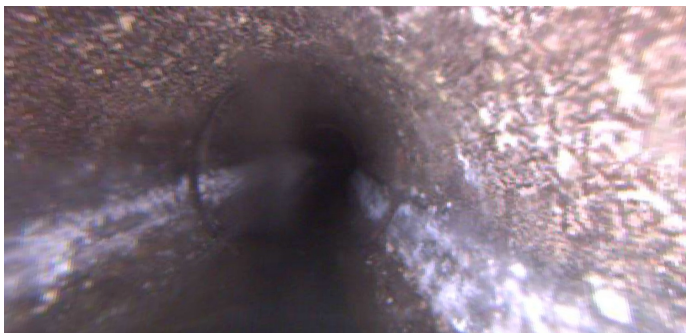
Code: **AMH**
Description: **Manhole**

Distance (ft): **.0**
Structural Grade: **0**
O&M Grade: **0**
Clock Start/From:
Clock To:
1st Value:
2nd Value:
Value Percent:
Continuous Index:
Within 8" of Joint: **NO**
Remarks: **M-805-062**

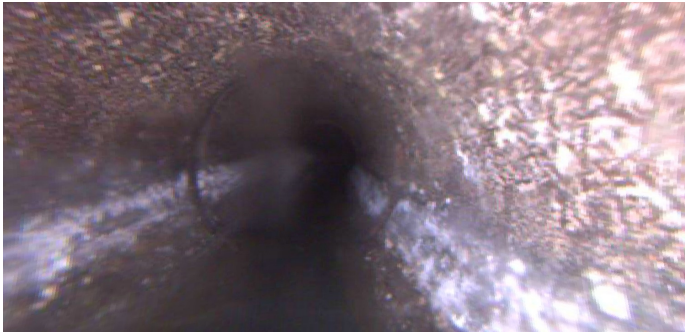
Code:	MWL
Description:	Water Level

Distance (ft):	.0
Structural Grade:	0
O&M Grade:	0
Clock Start/From:	
Clock To:	
1st Value:	
2nd Value:	
Value Percent:	5.000
Continuous Index:	
Within 8" of Joint:	NO
Remarks:

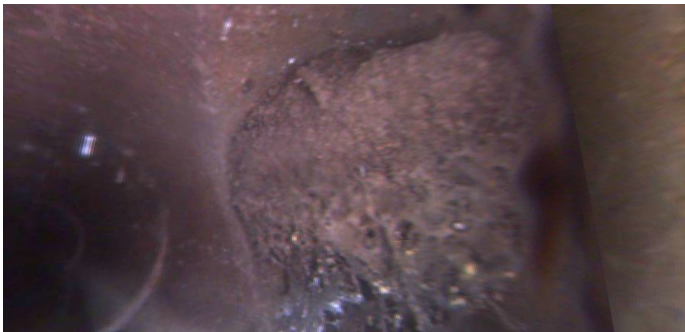
Code:	TFD
Description:	Tap Factory Defective

Distance (ft):	19.5
Structural Grade:	0
O&M Grade:	2
Clock Start/From:	3
Clock To:	
1st Value:	4.000
2nd Value:	
Value Percent:	
Continuous Index:	
Within 8" of Joint:	YES
Remarks:	blocked by roots

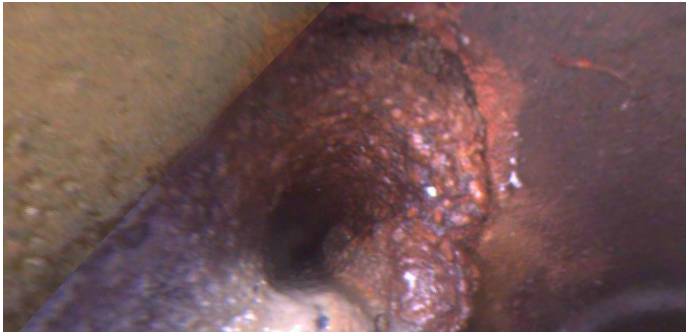
Code: **TB**
Description: **Tap Break-in**

Distance (ft): **29.8**
Structural Grade: **0**
O&M Grade: **0**
Clock Start/From: **11**
Clock To:
1st Value: **4.000**
2nd Value:
Value Percent:
Continuous Index:
Within 8" of Joint: **YES**
Remarks:

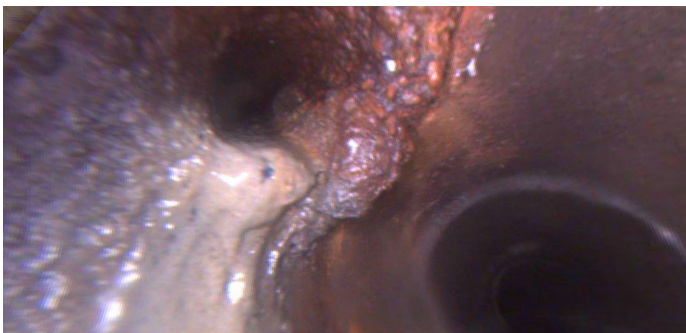
Code: **DAE**
Description: **Deposits Attached Encrustation**

Distance (ft): **29.8**
Structural Grade: **0**
O&M Grade: **2**
Clock Start/From: **11**
Clock To:
1st Value:
2nd Value:
Value Percent: **5.000**
Continuous Index:
Within 8" of Joint: **NO**
Remarks:

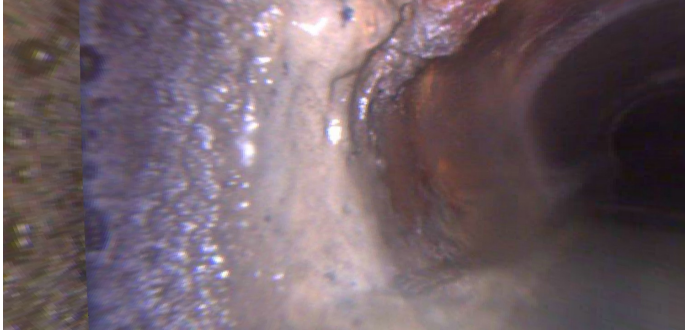
Code: **DAGS**
Description: **Deposits Attached Grease**

Distance (ft): **29.8**
Structural Grade: **0**
O&M Grade: **2**
Clock Start/From: **7**
Clock To: **10**
1st Value:
2nd Value:
Value Percent: **5.000**
Continuous Index:
Within 8" of Joint: **NO**
Remarks:

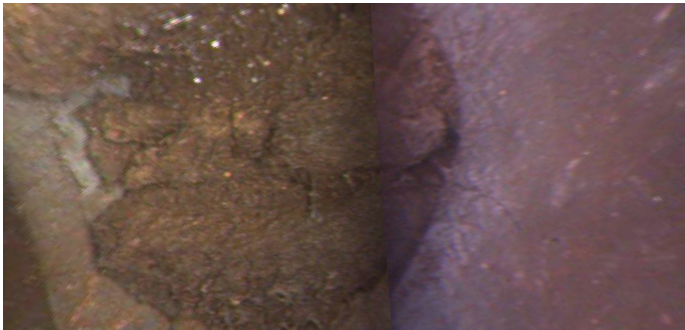
Code: **TFD**
Description: **Tap Factory Defective**

Distance (ft): **32.3**
Structural Grade: **0**
O&M Grade: **2**
Clock Start/From: **10**
Clock To:
1st Value: **4.000**
2nd Value:
Value Percent:
Continuous Index:
Within 8" of Joint: **YES**
Remarks: **blocked by roots**

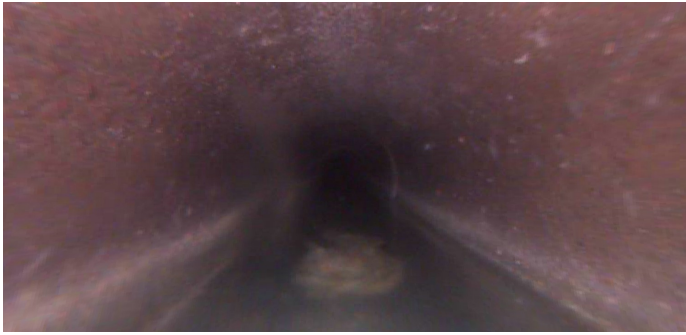
Code: **DSZ**
Description: **Deposits Settled Other**

Distance (ft): **45.6**
Structural Grade: **0**
O&M Grade: **2**
Clock Start/From: **6**
Clock To:
1st Value:
2nd Value:
Value Percent: **5.000**
Continuous Index: **S01**
Within 8" of Joint: **NO**
Remarks: **tissue**

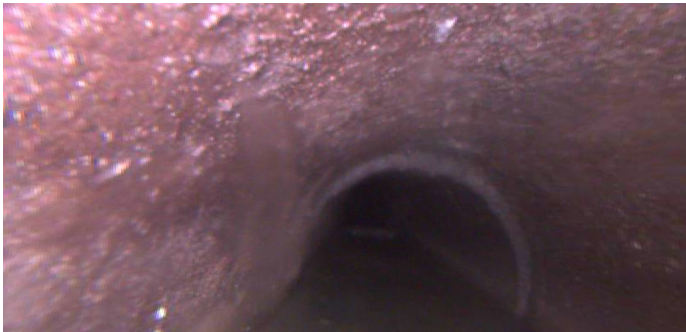
Code: **MSA**
Description: **Abandoned Survey**

Distance (ft): **50.9**
Structural Grade: **0**
O&M Grade: **0**
Clock Start/From:
Clock To:
1st Value:
2nd Value:
Value Percent:
Continuous Index:
Within 8" of Joint: **NO**
Remarks: **no blockage**

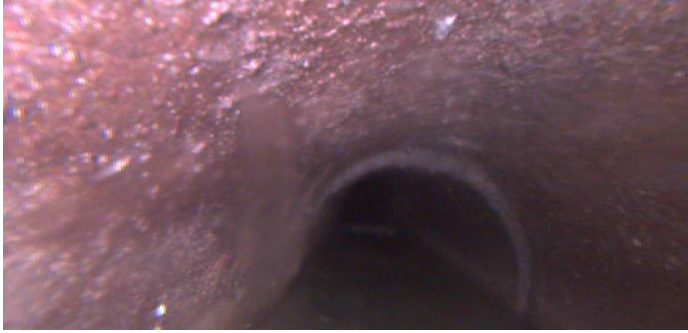
Code:	DSZ
Description:	Deposits Settled Other
Distance (ft):	50.9
Structural Grade:	0
O&M Grade:	2
Clock Start/From:	6
Clock To:	
1st Value:	
2nd Value:	
Value Percent:	5.000
Continuous Index:	F01
Within 8" of Joint:	NO
Remarks:	tissue
