Profile/Photo Observation Report

Street:	S Indiana St.	Flow Control:	Not Controlled
City:	Hobart, IN	Year Renewed:	
Location:	Other	Tape/Media #:	
Purpose:	Not Known	Dia/Height:	8"
Use:	Sanitary	Material:	VCP
Drain Area:	NA	Lining:	
Category:	NA		
Comment:

Location Details:		Direction of Survey:	Downstream
US MH:	M-805-062	DS MH:	M-804-011
		Total Length Surveyed (ft):	50.9

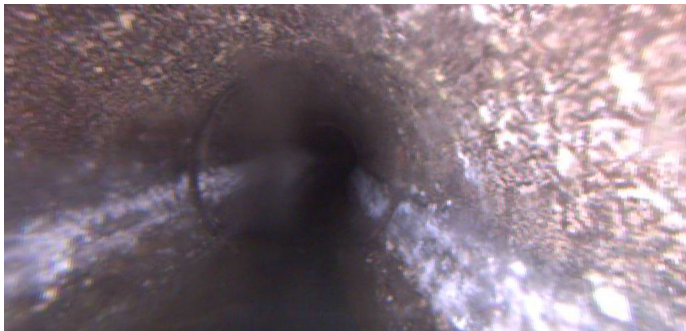
Code: **AMH**
Description: **Manhole**

Distance (ft): **.0**
Structural Grade: **0**
O&M Grade: **0**
Clock Start/From:
Clock To:
1st Value:
2nd Value:
Value Percent:
Continuous Index:
Within 8" of Joint: **NO**
Remarks: **M-805-062**

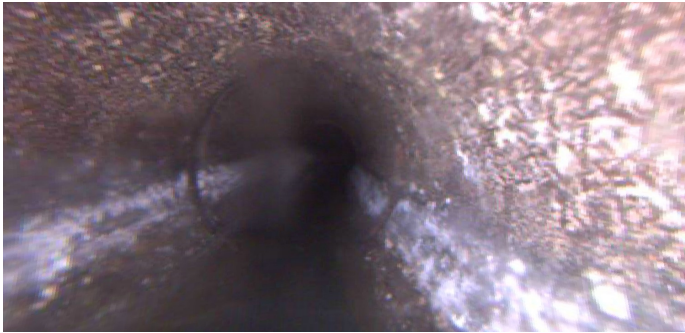
Code:	MWL
Description:	Water Level

Distance (ft):	.0
Structural Grade:	0
O&M Grade:	0
Clock Start/From:	
Clock To:	
1st Value:	
2nd Value:	
Value Percent:	5.000
Continuous Index:	
Within 8" of Joint:	NO
Remarks:

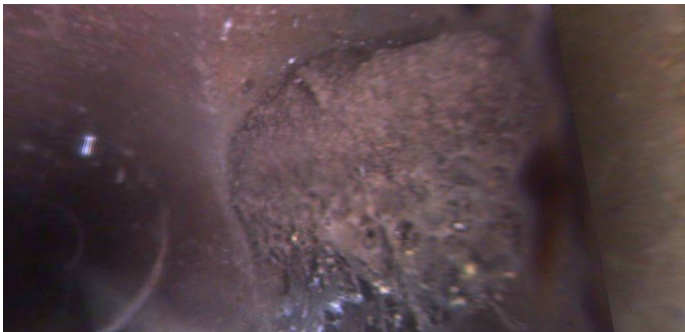
Code:	TFD
Description:	Tap Factory Defective

Distance (ft):	19.5
Structural Grade:	0
O&M Grade:	2
Clock Start/From:	3
Clock To:	
1st Value:	4.000
2nd Value:	
Value Percent:	
Continuous Index:	
Within 8" of Joint:	YES
Remarks:	blocked by roots

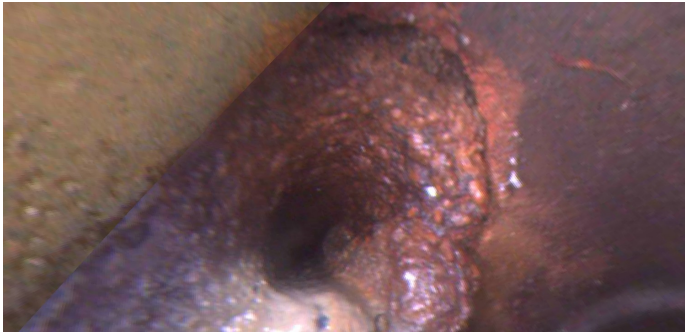
Code: **TB**
Description: **Tap Break-in**

Distance (ft): **29.8**
Structural Grade: **0**
O&M Grade: **0**
Clock Start/From: **11**
Clock To:
1st Value: **4.000**
2nd Value:
Value Percent:
Continuous Index:
Within 8" of Joint: **YES**
Remarks:

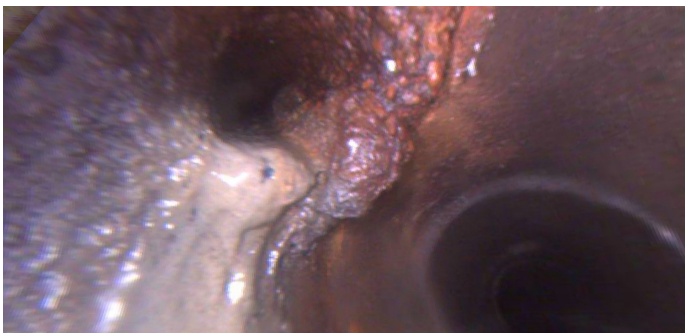
Code: **DAE**
Description: **Deposits Attached Encrustation**

Distance (ft): **29.8**
Structural Grade: **0**
O&M Grade: **2**
Clock Start/From: **11**
Clock To:
1st Value:
2nd Value:
Value Percent: **5.000**
Continuous Index:
Within 8" of Joint: **NO**
Remarks:

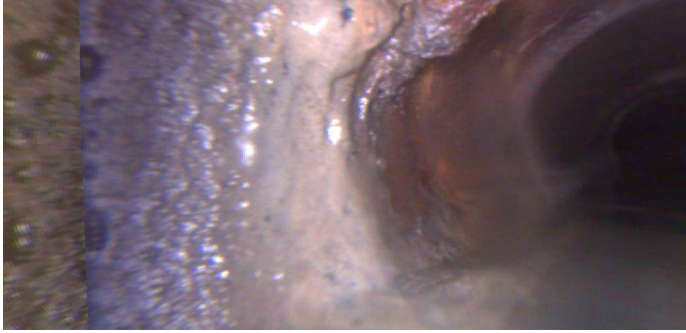
Code: **DAGS**
Description: **Deposits Attached Grease**

Distance (ft): **29.8**
Structural Grade: **0**
O&M Grade: **2**
Clock Start/From: **7**
Clock To: **10**
1st Value:
2nd Value:
Value Percent: **5.000**
Continuous Index:
Within 8" of Joint: **NO**
Remarks:

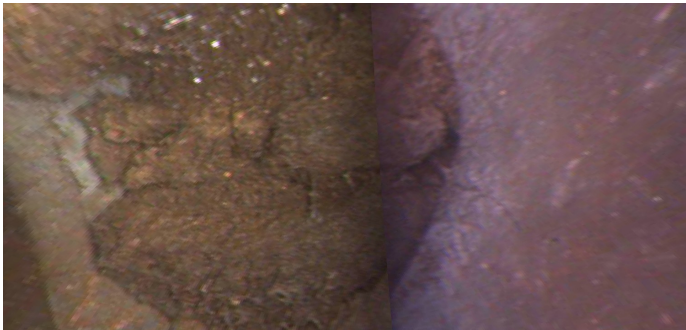
Code: **TFD**
Description: **Tap Factory Defective**

Distance (ft): **32.3**
Structural Grade: **0**
O&M Grade: **2**
Clock Start/From: **10**
Clock To:
1st Value: **4.000**
2nd Value:
Value Percent:
Continuous Index:
Within 8" of Joint: **YES**
Remarks: **blocked by roots**

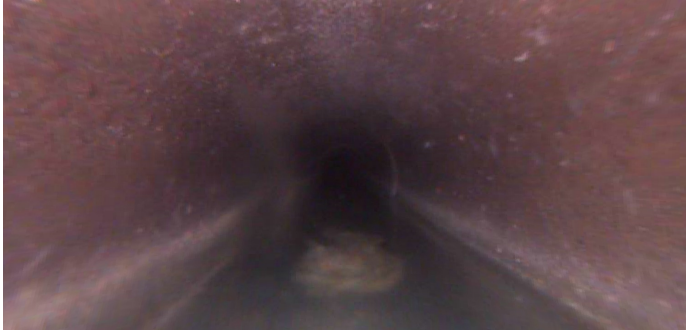
Code: **DSZ**
Description: **Deposits Settled Other**

Distance (ft): **45.6**
Structural Grade: **0**
O&M Grade: **2**
Clock Start/From: **6**
Clock To:
1st Value:
2nd Value:
Value Percent: **5.000**
Continuous Index: **S01**
Within 8" of Joint: **NO**
Remarks: **tissue**

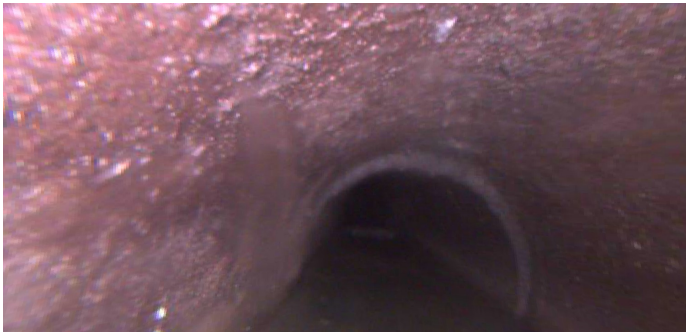
Code: **MSA**
Description: **Abandoned Survey**

Distance (ft): **50.9**
Structural Grade: **0**
O&M Grade: **0**
Clock Start/From:
Clock To:
1st Value:
2nd Value:
Value Percent:
Continuous Index:
Within 8" of Joint: **NO**
Remarks: **no blockage**

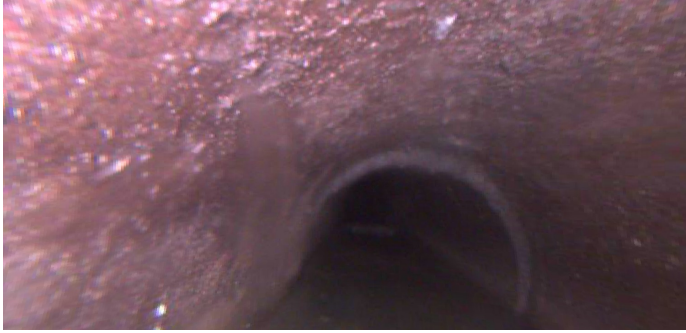
Code:	DSZ
Description:	Deposits Settled Other
Distance (ft):	50.9
Structural Grade:	0
O&M Grade:	2
Clock Start/From:	6
Clock To:	
1st Value:	
2nd Value:	
Value Percent:	5.000
Continuous Index:	F01
Within 8" of Joint:	NO
Remarks:	tissue
