Profile/Photo Observation Report

Date:	01/15/2023	Weather:		Coding:	PACP 7.0
Pipe Length (ft):	243.0	Owner:	City of Hobart	Pre Clean:	Heavy Cleaning
P.O.#:	YES502259	Surveyor:	S. Bucklin	PSR:	P-804-011-062
Customer:	City of Hobart	Clean Date:	01/12/2023	Shape:	C

Street:	South Indiana Street	Flow Control:	Not Controlled
City:	Hobart, IN	Year Renewed:	
Location:	Local rural streets with light traffic, t	Tape/Media #:	
Purpose:	Routine Assessment	Dia/Height:	8"
Use:	Sanitary Sewage Pipe	Material:	VCP
Drain Area:		Lining:	None
Category:	NA		
Comment:			
Location Details:		Direction of Survey:	Upstream
US MH:	M-805-062	DS MH:	M-804-011
		Total Length Surveyed (ft):	243.3

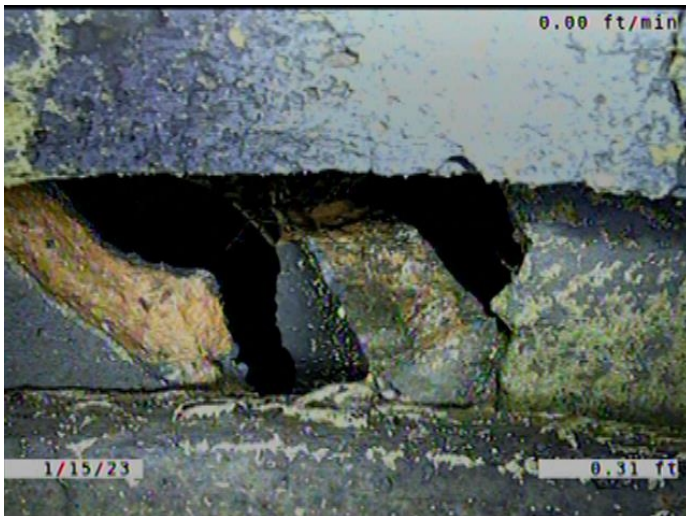
Code: **HVV**
 Description: **Hole Void Visible**

Distance (ft): **.3**
 Structural Grade: **5**
 O&M Grade: **0**
 Clock Start/From: **11**
 Clock To: **1**
 1st Value:
 2nd Value:
 Value Percent:
 Continuous Index:
 Within 8" of Joint: **YES**
 Remarks: **VOID AND SOIL VISIBLE.**

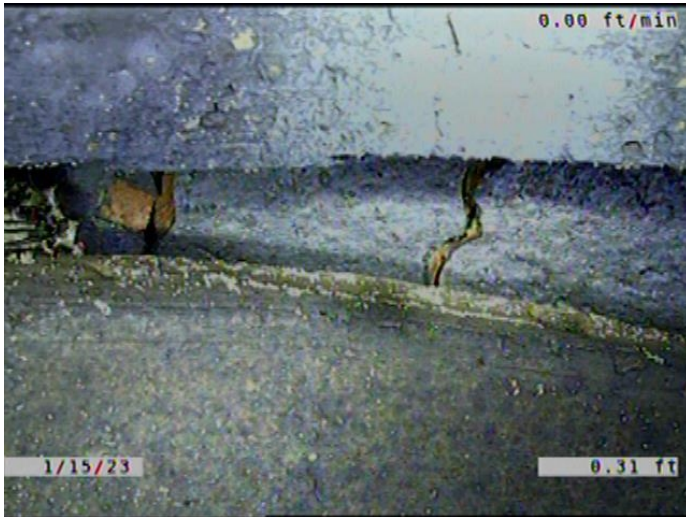
Code: **BVV**
 Description: **Broken Void Visible**

Distance (ft): **.3**
 Structural Grade: **5**
 O&M Grade: **0**
 Clock Start/From: **12**
 Clock To: **12**
 1st Value:
 2nd Value:
 Value Percent:
 Continuous Index: **S01**
 Within 8" of Joint: **YES**
 Remarks:

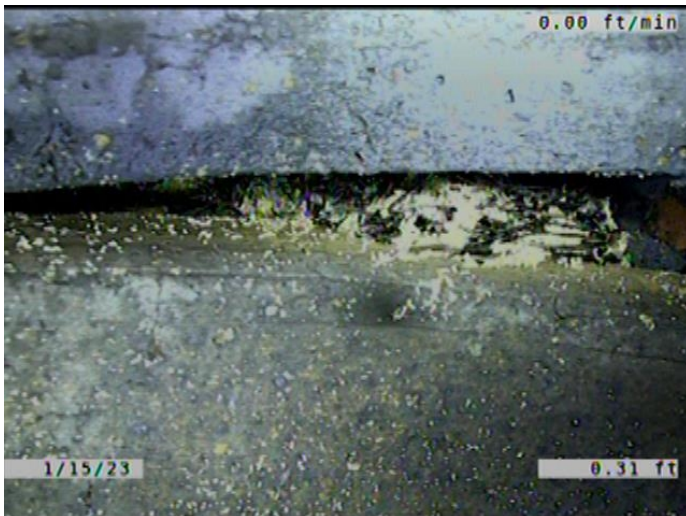
Code: **RFJ**
 Description: **Roots Fine Joint**

Distance (ft): **.3**
 Structural Grade: **0**
 O&M Grade: **1**
 Clock Start/From: **8**
 Clock To: **12**
 1st Value:
 2nd Value:
 Value Percent:
 Continuous Index:
 Within 8" of Joint: **YES**
 Remarks:

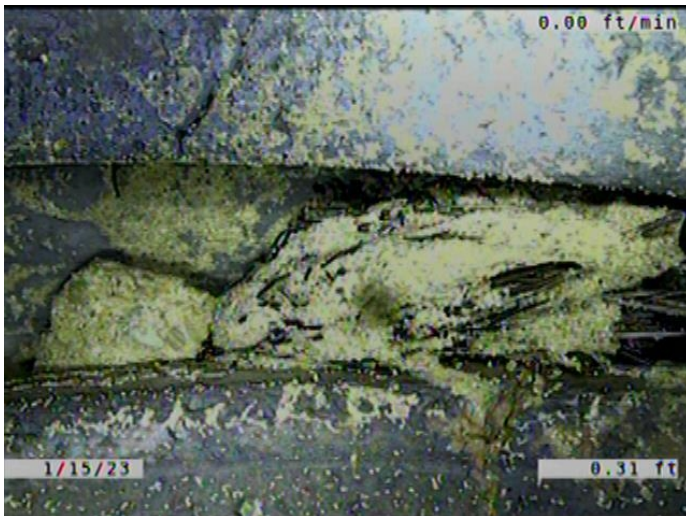
Code: **RFJ**
 Description: **Roots Fine Joint**

Distance (ft): **.3**
 Structural Grade: **0**
 O&M Grade: **1**
 Clock Start/From: **3**
 Clock To: **4**
 1st Value:
 2nd Value:
 Value Percent:
 Continuous Index:
 Within 8" of Joint: **YES**
 Remarks:

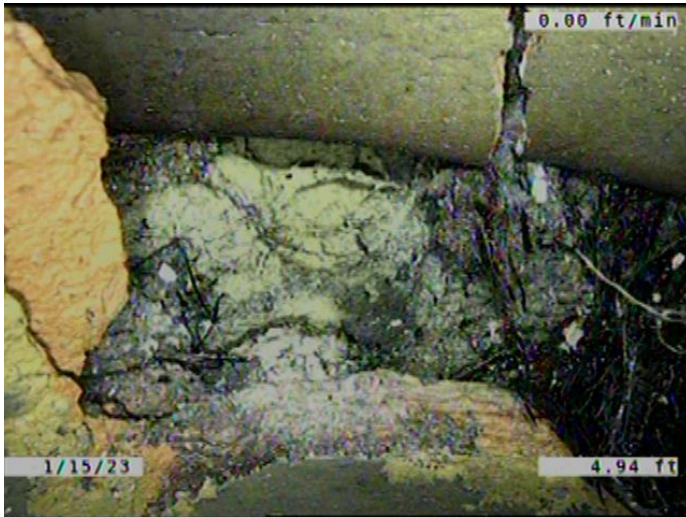
Code: **SMW**
 Description: **Surface Damage Missing Wall**

Distance (ft): **4.9**
 Structural Grade: **5**
 O&M Grade: **0**
 Clock Start/From: **1**
 Clock To: **3**
 1st Value:
 2nd Value:
 Value Percent:
 Continuous Index:
 Within 8" of Joint: **YES**
 Remarks: **SOIL VISIBLE.**

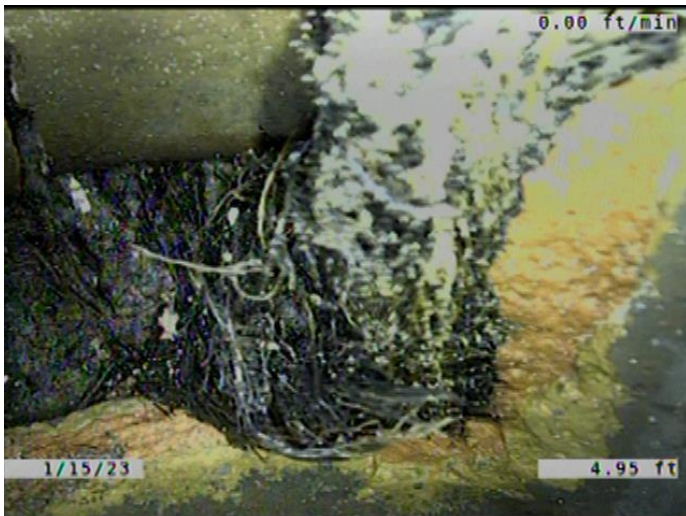
Code: **RFB**
 Description: **Roots Fine Barrel**

Distance (ft): **4.9**
 Structural Grade: **0**
 O&M Grade: **2**
 Clock Start/From: **1**
 Clock To: **3**
 1st Value:
 2nd Value:
 Value Percent:
 Continuous Index:
 Within 8" of Joint: **NO**
 Remarks:

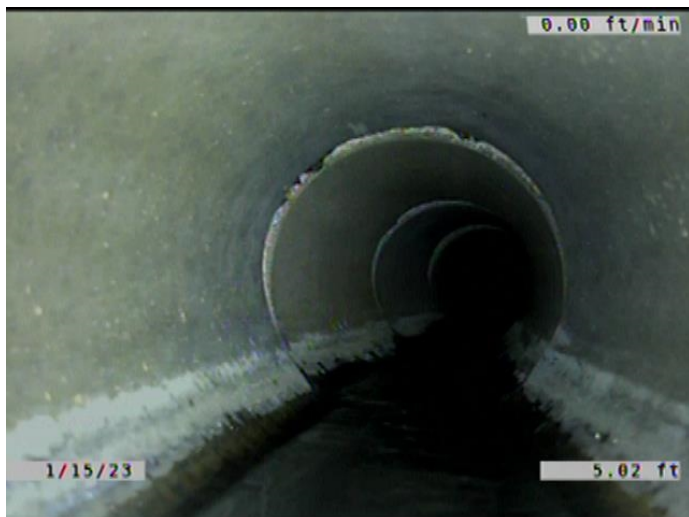
Code: **BVV**
 Description: **Broken Void Visible**

Distance (ft): **5.0**
 Structural Grade: **5**
 O&M Grade: **0**
 Clock Start/From: **12**
 Clock To: **12**
 1st Value:
 2nd Value:
 Value Percent:
 Continuous Index: **F01**
 Within 8" of Joint: **YES**
 Remarks:

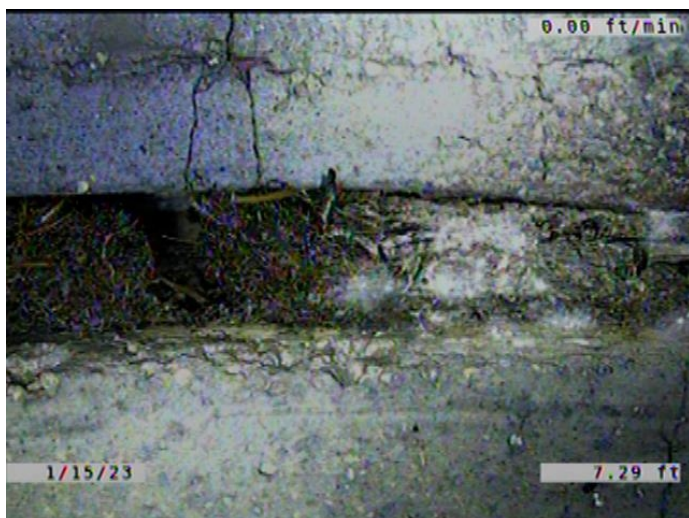
Code: **RFJ**
 Description: **Roots Fine Joint**

Distance (ft): **7.3**
 Structural Grade: **0**
 O&M Grade: **1**
 Clock Start/From: **10**
 Clock To: **2**
 1st Value:
 2nd Value:
 Value Percent:
 Continuous Index:
 Within 8" of Joint: **YES**
 Remarks:

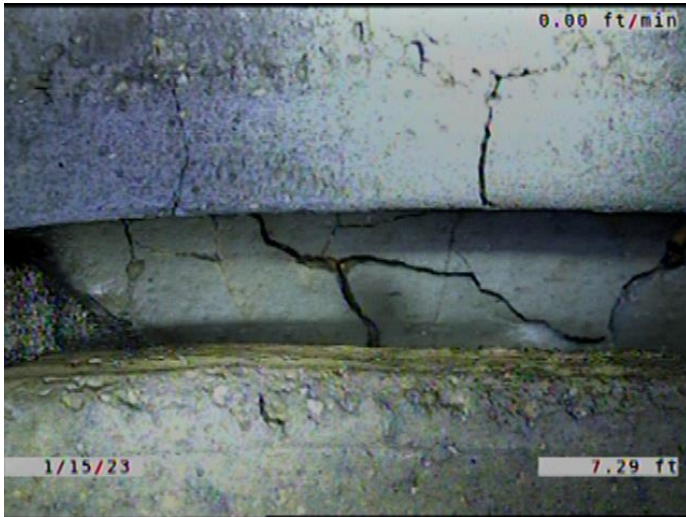
Code: **FM**
 Description: **Fracture Multiple**

Distance (ft): **7.3**
 Structural Grade: **4**
 O&M Grade: **0**
 Clock Start/From: **12**
 Clock To: **12**
 1st Value:
 2nd Value:
 Value Percent:
 Continuous Index: **S02**
 Within 8" of Joint: **YES**
 Remarks:

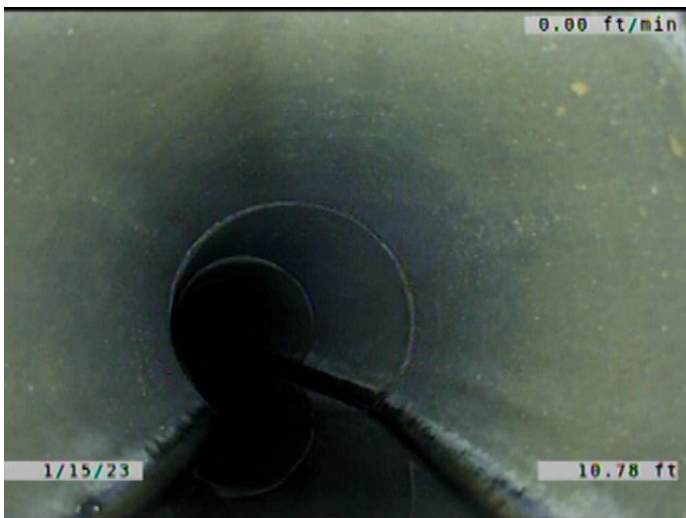
Code: **LL**
 Description: **Line Left**

Distance (ft): **10.8**
 Structural Grade: **0**
 O&M Grade: **2**
 Clock Start/From:
 Clock To:
 1st Value:
 2nd Value:
 Value Percent: **15.000**
 Continuous Index:
 Within 8" of Joint: **NO**
 Remarks:

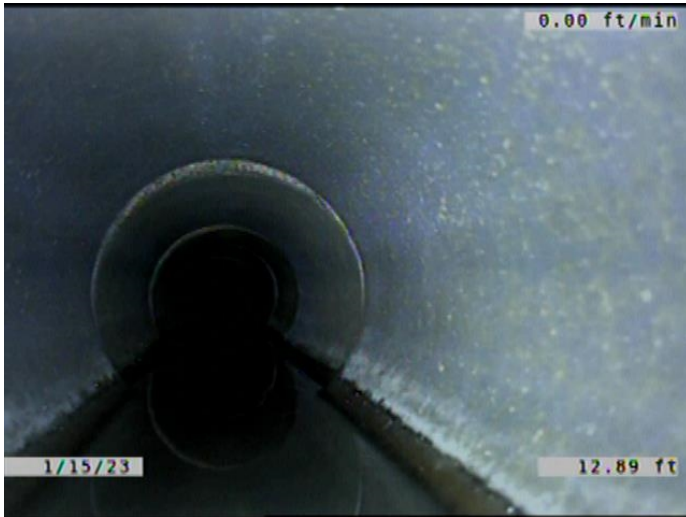
Code: **FM**
 Description: **Fracture Multiple**

Distance (ft): **12.9**
 Structural Grade: **4**
 O&M Grade: **0**
 Clock Start/From: **12**
 Clock To: **12**
 1st Value:
 2nd Value:
 Value Percent:
 Continuous Index: **F02**
 Within 8" of Joint: **YES**
 Remarks:

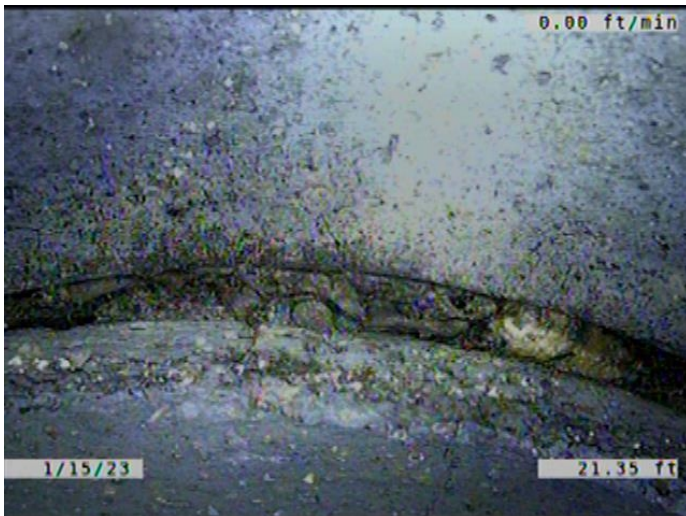
Code: **JOM**
 Description: **Joint Offset Medium**

Distance (ft): **21.3**
 Structural Grade: **3**
 O&M Grade: **0**
 Clock Start/From:
 Clock To:
 1st Value:
 2nd Value:
 Value Percent:
 Continuous Index:
 Within 8" of Joint: **NO**
 Remarks:

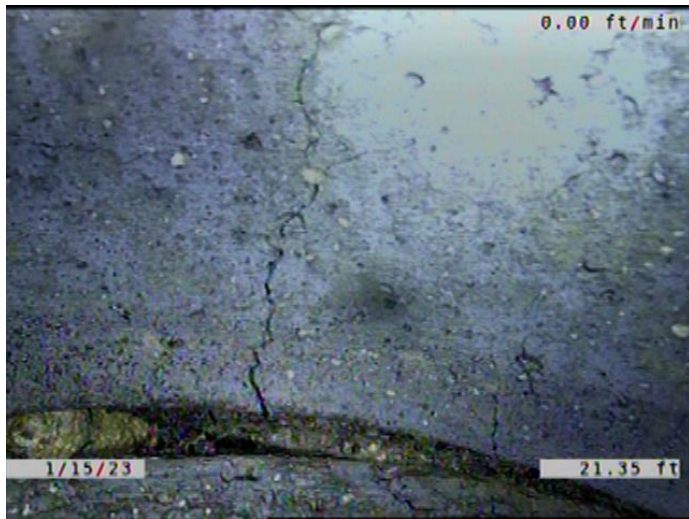
Code: **CM**
 Description: **Crack Multiple**

Distance (ft): **21.3**
 Structural Grade: **3**
 O&M Grade: **0**
 Clock Start/From: **12**
 Clock To: **12**
 1st Value:
 2nd Value:
 Value Percent:
 Continuous Index:
 Within 8" of Joint: **YES**
 Remarks:

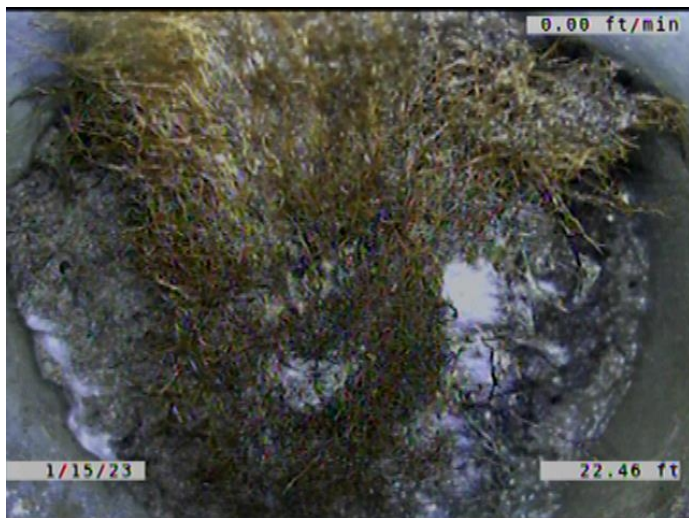
Code: **TFD**
 Description: **Tap Factory Defective**

Distance (ft): **22.5**
 Structural Grade: **0**
 O&M Grade: **3**
 Clock Start/From: **2**
 Clock To:
 1st Value: **6.000**
 2nd Value:
 Value Percent:
 Continuous Index:
 Within 8" of Joint: **YES**
 Remarks: **LOOKS TO BE 100% PLUGGED WITH DIRT AND ROOTS.**

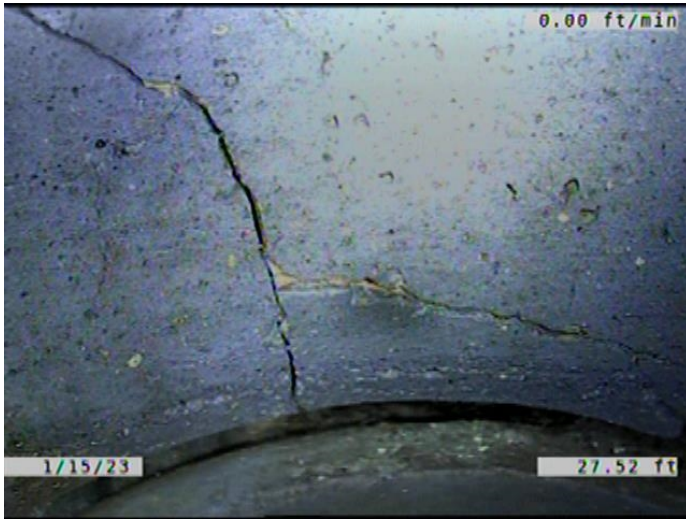
Code: **FM**
Description: **Fracture Multiple**

Distance (ft): **27.5**
Structural Grade: **4**
O&M Grade: **0**
Clock Start/From: **3**
Clock To: **12**
1st Value:
2nd Value:
Value Percent:
Continuous Index:
Within 8" of Joint: **YES**
Remarks:

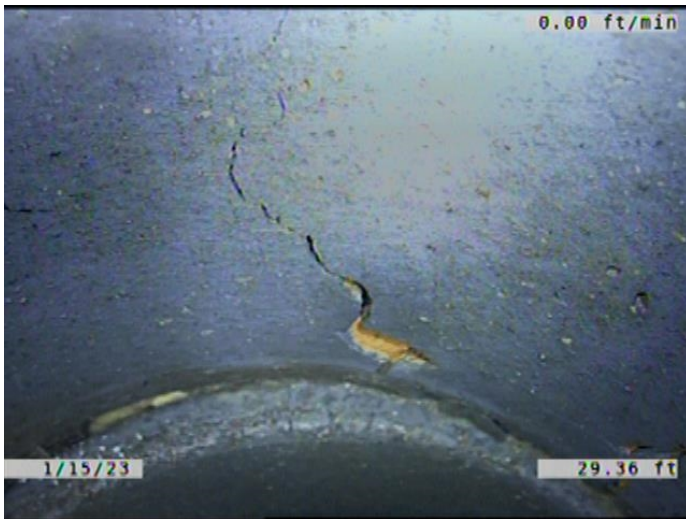
Code: **B**
Description: **Broken**

Distance (ft): **29.4**
Structural Grade: **4**
O&M Grade: **0**
Clock Start/From: **12**
Clock To: **12**
1st Value:
2nd Value:
Value Percent:
Continuous Index:
Within 8" of Joint: **YES**
Remarks:

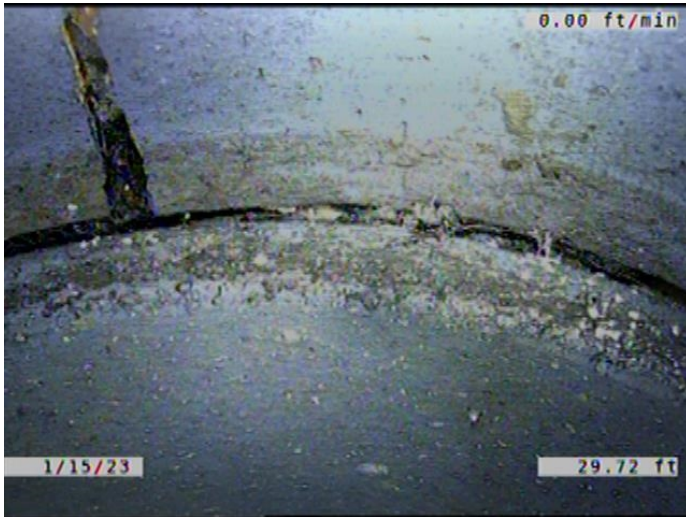
Code: **JOMD**
 Description: **Joint Offset Medium Defective**

Distance (ft): **29.7**
 Structural Grade: **3**
 O&M Grade: **0**
 Clock Start/From:
 Clock To:
 1st Value:
 2nd Value:
 Value Percent:
 Continuous Index:
 Within 8" of Joint: **NO**
 Remarks:

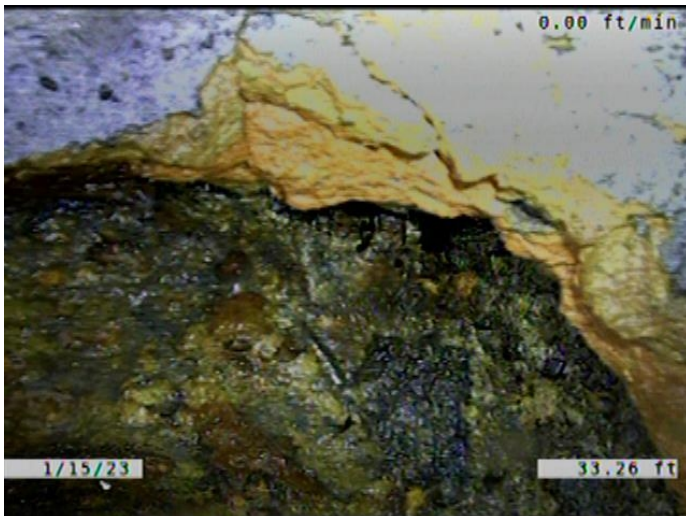
Code: **SSS**
 Description: **Surface Damage Surface Spalling**

Distance (ft): **33.3**
 Structural Grade: **2**
 O&M Grade: **0**
 Clock Start/From: **11**
 Clock To:
 1st Value:
 2nd Value:
 Value Percent:
 Continuous Index:
 Within 8" of Joint: **YES**
 Remarks:

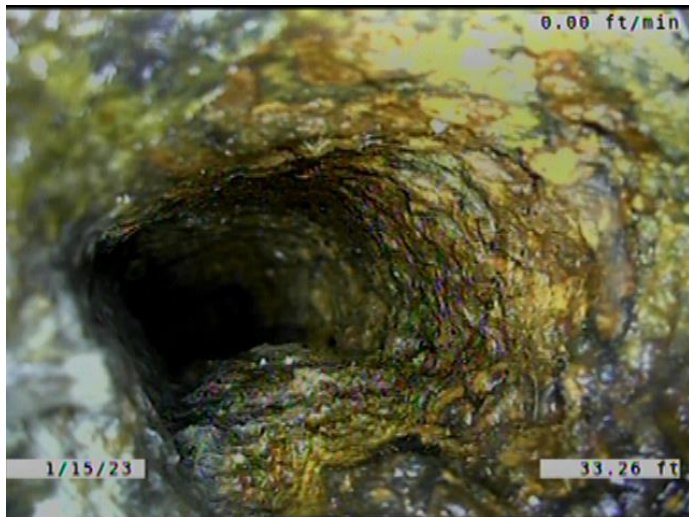
Code:	TBI
Description:	Tap Break-in Intruding
Distance (ft):	33.3
Structural Grade:	0
O&M Grade:	2
Clock Start/From:	10
Clock To:	
1st Value:	4.000
2nd Value:	1.000
Value Percent:	
Continuous Index:	
Within 8" of Joint:	YES
Remarks:	CONSTANTLY RUNNING WATER.

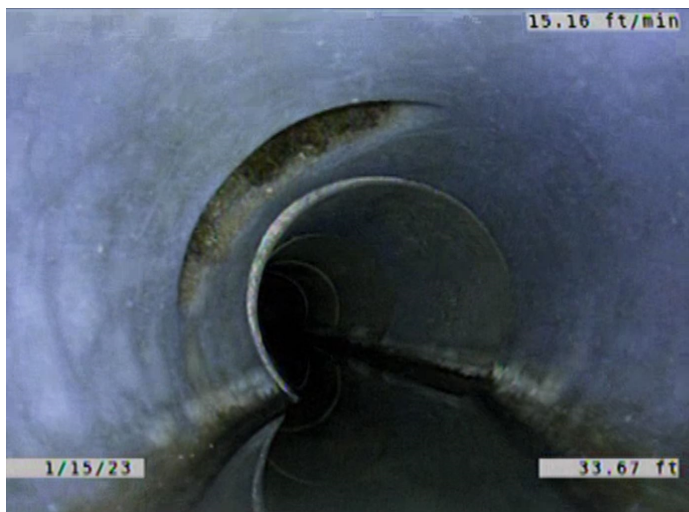
Code:	FM
Description:	Fracture Multiple
Distance (ft):	33.7
Structural Grade:	4
O&M Grade:	0
Clock Start/From:	7
Clock To:	5
1st Value:	
2nd Value:	
Value Percent:	
Continuous Index:	S03
Within 8" of Joint:	YES
Remarks:	Wandering

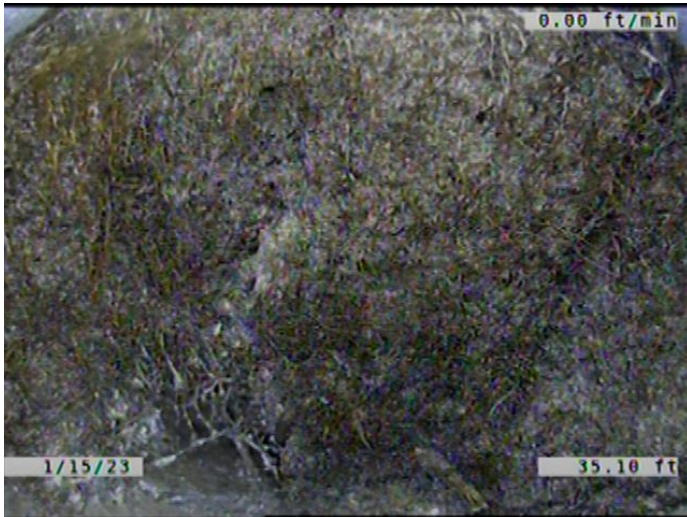
Code:	TFD
Description:	Tap Factory Defective
Distance (ft):	35.1
Structural Grade:	0
O&M Grade:	3
Clock Start/From:	11
Clock To:	
1st Value:	6.000
2nd Value:	
Value Percent:	
Continuous Index:	
Within 8" of Joint:	YES
Remarks:	95% PLUGGED WITH ROOTS.

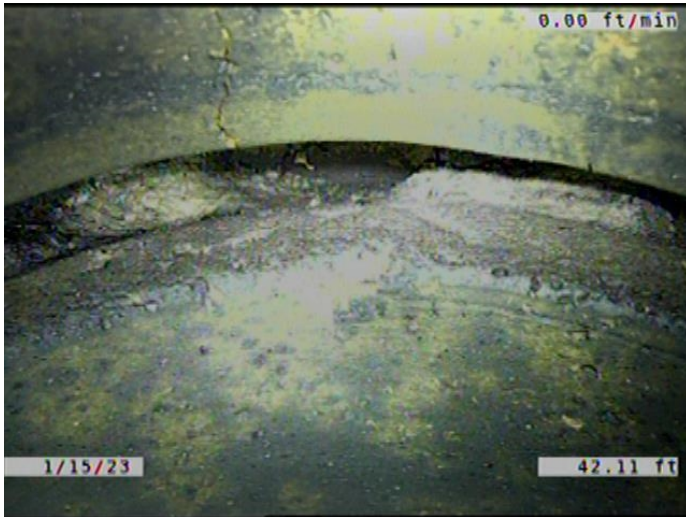
Code: **JAM**
 Description: **Joint Angular Medium**

Distance (ft): **42.1**
 Structural Grade: **3**
 O&M Grade: **0**
 Clock Start/From:
 Clock To:
 1st Value:
 2nd Value:
 Value Percent:
 Continuous Index:
 Within 8" of Joint: **NO**
 Remarks:

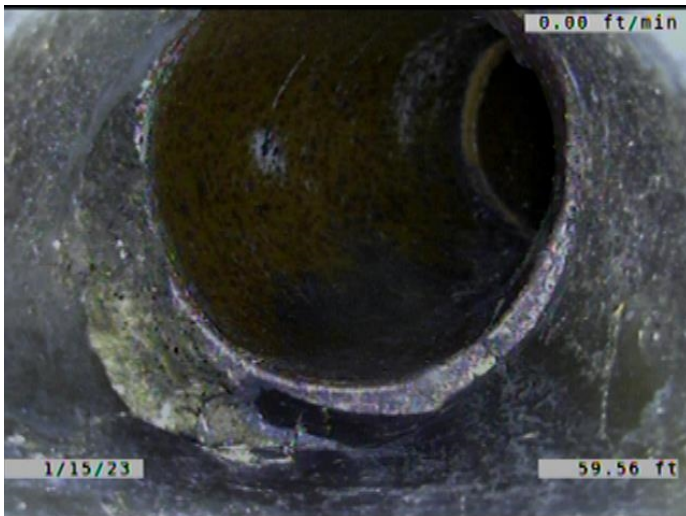
Code: **TFD**
 Description: **Tap Factory Defective**

Distance (ft): **59.6**
 Structural Grade: **0**
 O&M Grade: **3**
 Clock Start/From: **1**
 Clock To:
 1st Value: **6.000**
 2nd Value:
 Value Percent:
 Continuous Index:
 Within 8" of Joint: **YES**
 Remarks: **TAP BROKEN WITH PART MISSING.**

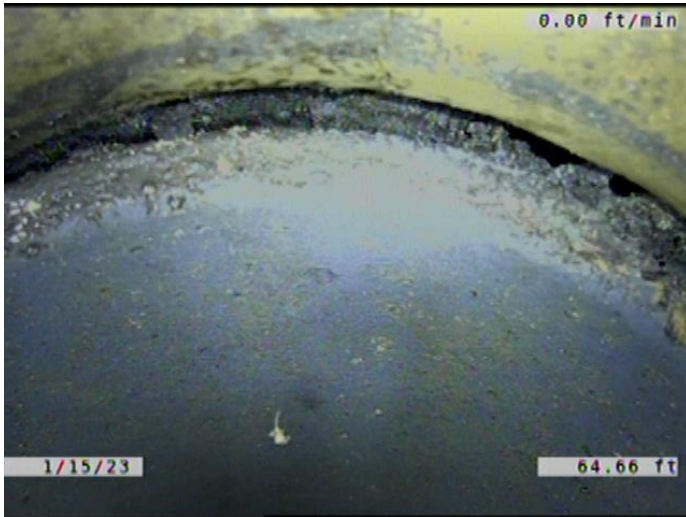
Code: **JOMD**
 Description: **Joint Offset Medium Defective**

Distance (ft): **64.7**
 Structural Grade: **3**
 O&M Grade: **0**
 Clock Start/From:
 Clock To:
 1st Value:
 2nd Value:
 Value Percent:
 Continuous Index:
 Within 8" of Joint: **NO**
 Remarks:

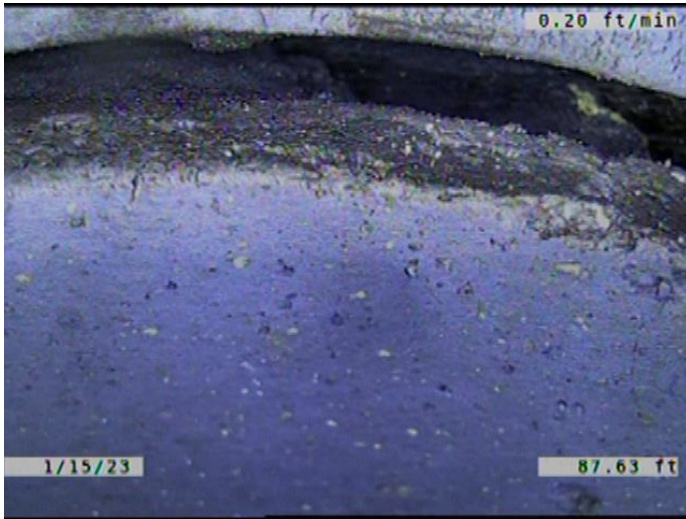
Code: **JOM**
 Description: **Joint Offset Medium**

Distance (ft): **87.6**
 Structural Grade: **3**
 O&M Grade: **0**
 Clock Start/From:
 Clock To:
 1st Value:
 2nd Value:
 Value Percent:
 Continuous Index:
 Within 8" of Joint: **NO**
 Remarks:

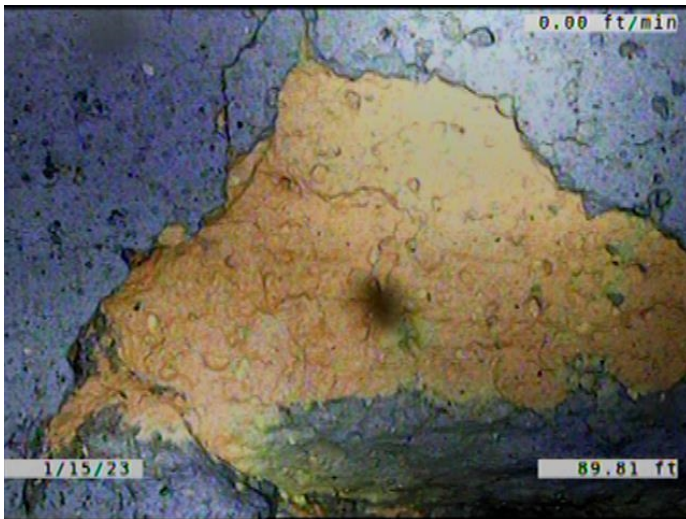
Code: **SSS**
 Description: **Surface Damage Surface Spalling**

Distance (ft): **89.8**
 Structural Grade: **2**
 O&M Grade: **0**
 Clock Start/From: **8**
 Clock To: **10**
 1st Value:
 2nd Value:
 Value Percent:
 Continuous Index:
 Within 8" of Joint: **YES**
 Remarks:

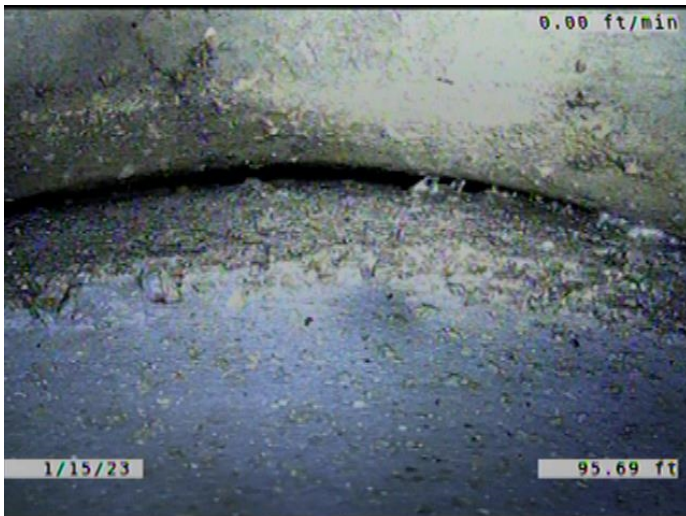
Code: **JOMD**
Description: **Joint Offset Medium Defective**

Distance (ft): **95.7**
Structural Grade: **3**
O&M Grade: **0**
Clock Start/From:
Clock To:
1st Value:
2nd Value:
Value Percent:
Continuous Index: **S07**
Within 8" of Joint: **NO**
Remarks:

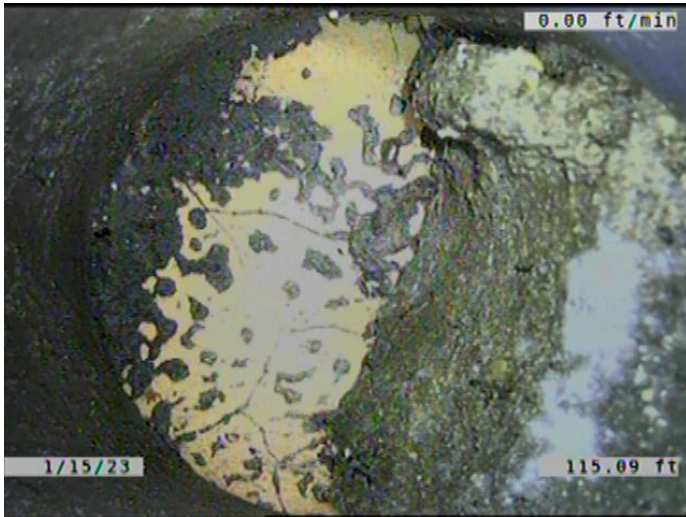
Code: **TFD**
 Description: **Tap Factory Defective**

Distance (ft): **115.1**
 Structural Grade: **0**
 O&M Grade: **3**
 Clock Start/From: **2**
 Clock To:
 1st Value: **6.000**
 2nd Value:
 Value Percent:
 Continuous Index:
 Within 8" of Joint: **YES**
 Remarks: **CAPPED. CAP CRACKED.**

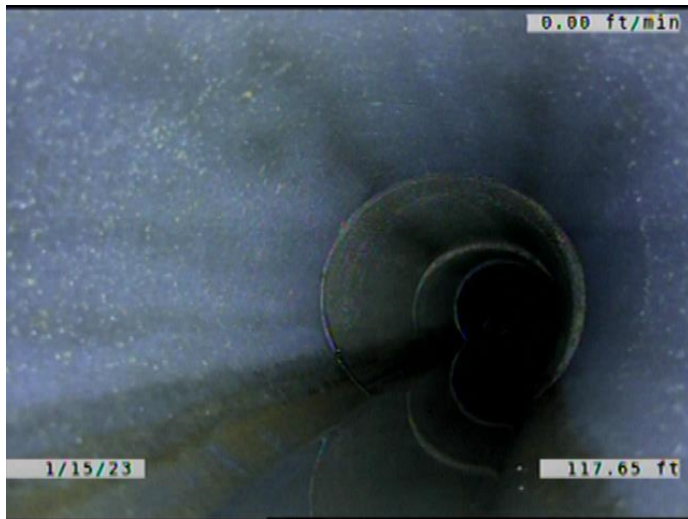
Code: **LR**
 Description: **Line Right**

Distance (ft): **117.6**
 Structural Grade: **0**
 O&M Grade: **4**
 Clock Start/From:
 Clock To:
 1st Value:
 2nd Value:
 Value Percent: **25.000**
 Continuous Index:
 Within 8" of Joint: **NO**
 Remarks:

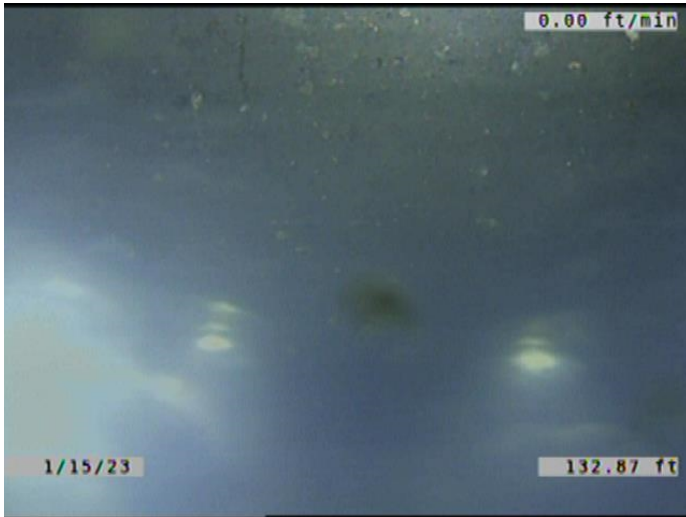
Code:	MCU
Description:	Miscellaneous Camera Underwater
Distance (ft):	132.9
Structural Grade:	0
O&M Grade:	4
Clock Start/From:	
Clock To:	
1st Value:	
2nd Value:	
Value Percent:	
Continuous Index:	
Within 8" of Joint:	NO
Remarks:	Out at 134.1

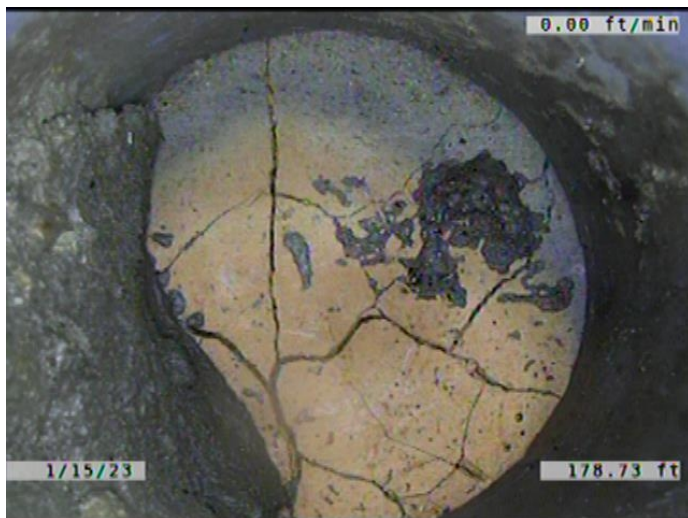
Code: **TFD**
 Description: **Tap Factory Defective**

Distance (ft): **178.7**
 Structural Grade: **0**
 O&M Grade: **3**
 Clock Start/From: **10**
 Clock To:
 1st Value: **6.000**
 2nd Value:
 Value Percent:
 Continuous Index:
 Within 8" of Joint: **YES**
 Remarks: **CAPPED. CAP BROKEN. TAP CRACKED.**

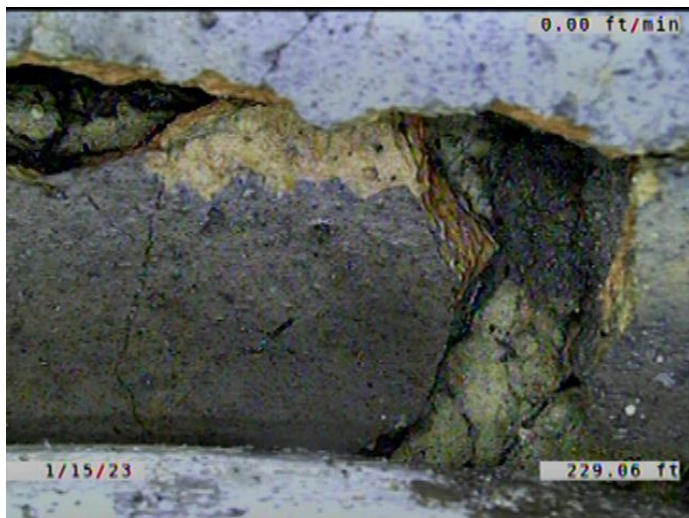
Code: **BSV**
 Description: **Broken Soil Visible**

Distance (ft): **229.1**
 Structural Grade: **5**
 O&M Grade: **0**
 Clock Start/From: **12**
 Clock To: **3**
 1st Value:
 2nd Value:
 Value Percent:
 Continuous Index:
 Within 8" of Joint: **YES**
 Remarks:

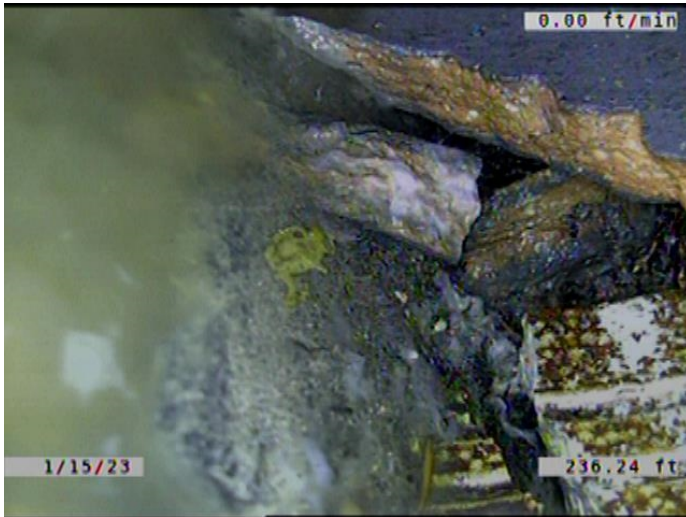
Code: **HVV**
Description: **Hole Void Visible**

Distance (ft): **236.2**
Structural Grade: **5**
O&M Grade: **0**
Clock Start/From: **3**
Clock To: **6**
1st Value:
2nd Value:
Value Percent:
Continuous Index:
Within 8" of Joint: **YES**
Remarks: **VOID AND SOIL VISIBLE.**

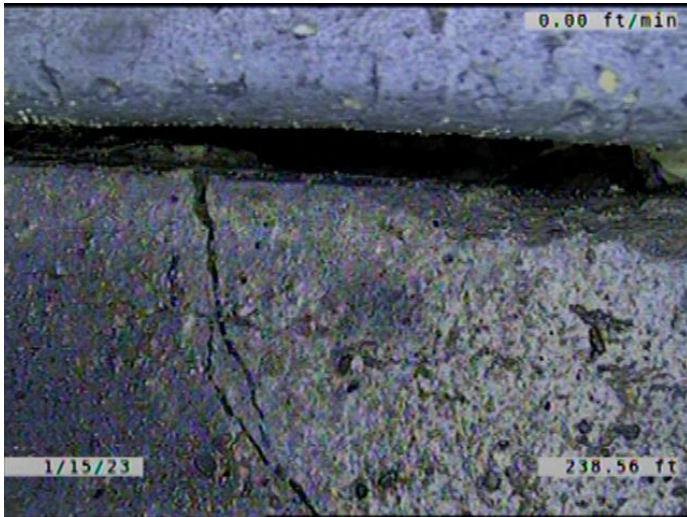
Code: **JAL**
Description: **Joint Angular Large**

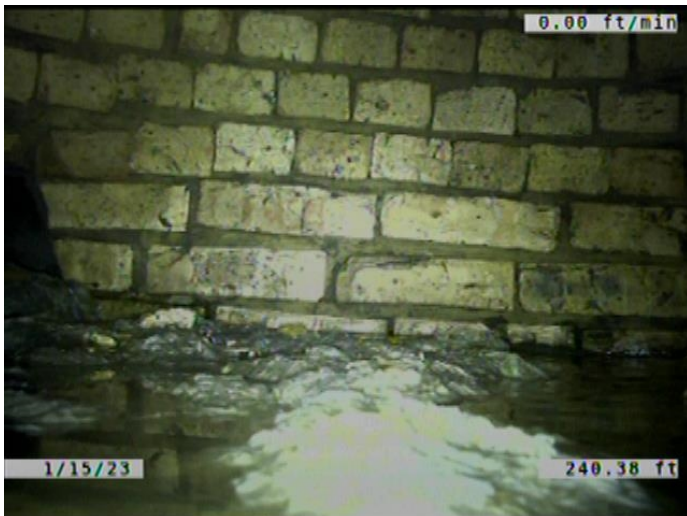
Code: **JOMD**
Description: **Joint Offset Medium Defective**

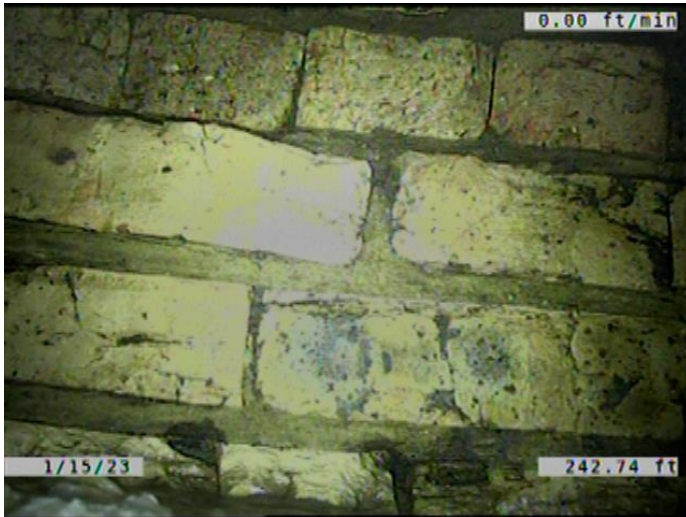
Code: **FM**
 Description: **Fracture Multiple**
