## Profile/Photo Observation Report

Street:	<b>S INDIANA ST &amp; E 1ST PL</b>	Flow Control:	<b>Not Controlled</b>
City:	<b>Hobart, IN</b>	Year Renewed:	
Location:	<b>Other</b>	Tape/Media #:	
Purpose:	<b>Not Known</b>	Dia/Height:	<b>8"</b>
Use:	<b>Sanitary</b>	Material:	<b>VCP</b>
Drain Area:	<b>NA</b>	Lining:	
Category:	<b>NA</b>		
Comment:

Location Details:		Direction of Survey:	<b>Downstream</b>
US MH:	<b>M-805-062</b>	DS MH:	<b>M-805-058</b>
		Total Length Surveyed (ft):	<b>52.3</b>

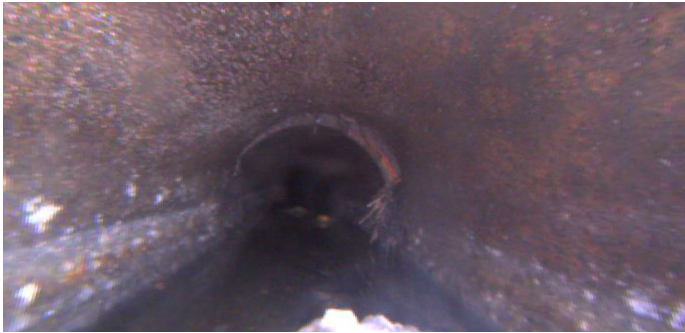
Code:	<b>MWL</b>
Description:	<b>Water Level</b>

Distance (ft):	<b>.0</b>
Structural Grade:	<b>0</b>
O&M Grade:	<b>0</b>
Clock Start/From:	
Clock To:	
1st Value:	
2nd Value:	
Value Percent:	<b>5.000</b>
Continuous Index:	
Within 8" of Joint:	<b>NO</b>
Remarks:

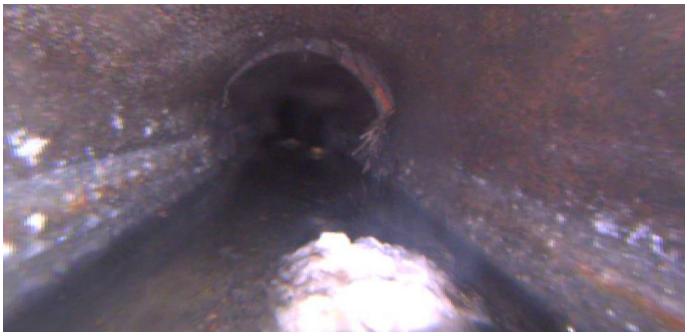
Code:	<b>DSZ</b>
Description:	<b>Deposits Settled Other</b>

Distance (ft):	<b>.0</b>
Structural Grade:	<b>0</b>
O&M Grade:	<b>2</b>
Clock Start/From:	<b>6</b>
Clock To:	
1st Value:	
2nd Value:	
Value Percent:	<b>5.000</b>
Continuous Index:	<b>S01</b>
Within 8" of Joint:	<b>NO</b>
Remarks:	<b>tissue/debris</b>

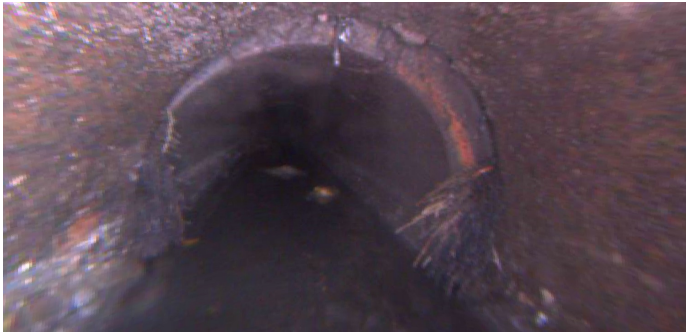
Code: **RFJ**  
Description: **Roots Fine Joint**

Distance (ft): **1.8**  
Structural Grade: **0**  
O&M Grade: **1**  
Clock Start/From: **7**  
Clock To: **5**  
1st Value:  
2nd Value:  
Value Percent:  
Continuous Index:  
Within 8" of Joint: **YES**  
Remarks:

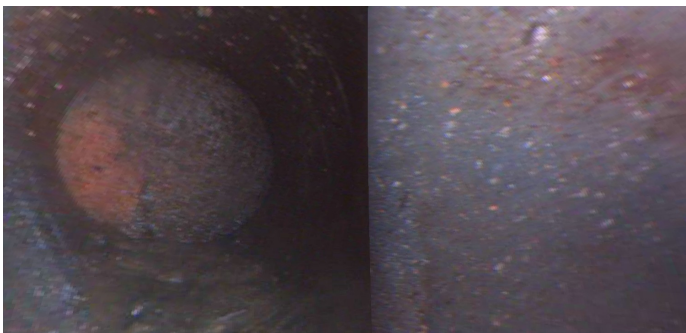
Code: **TFC**  
Description: **Tap Factory Capped**

Distance (ft): **5.4**  
Structural Grade: **0**  
O&M Grade: **0**  
Clock Start/From: **10**  
Clock To:  
1st Value: **4.000**  
2nd Value:  
Value Percent:  
Continuous Index:  
Within 8" of Joint: **YES**  
Remarks:

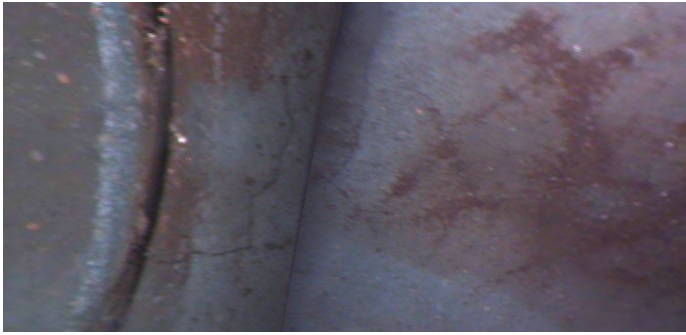
Code: **CM**  
Description: **Crack Multiple**

Distance (ft): **6.6**  
Structural Grade: **3**  
O&M Grade: **0**  
Clock Start/From: **7**  
Clock To: **5**  
1st Value:  
2nd Value:  
Value Percent:  
Continuous Index: **S02**  
Within 8" of Joint: **YES**  
Remarks: **wandering**

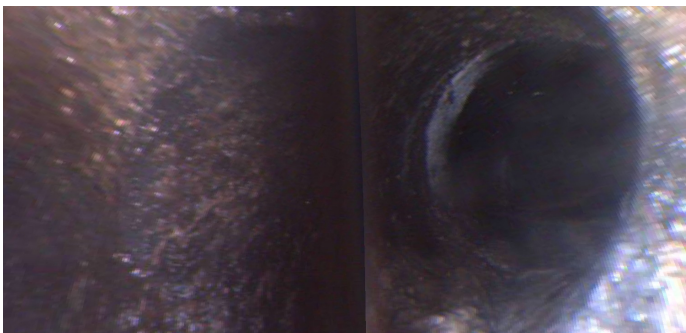
Code: **TF**  
Description: **Tap Factory**

Distance (ft): **17.4**  
Structural Grade: **0**  
O&M Grade: **0**  
Clock Start/From: **3**  
Clock To:  
1st Value: **4.000**  
2nd Value:  
Value Percent:  
Continuous Index:  
Within 8" of Joint: **YES**  
Remarks:

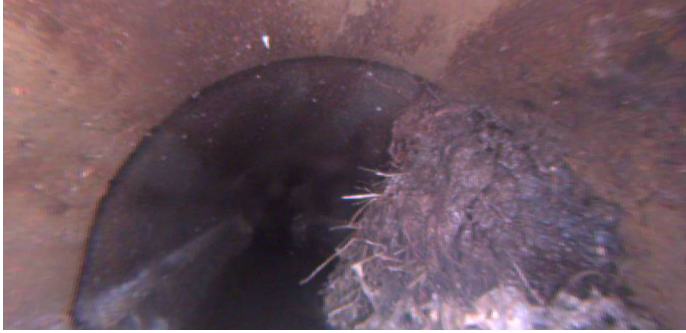
Code: **RBJ**  
Description: **Roots Ball Joint**

Distance (ft): **22.2**  
Structural Grade: **0**  
O&M Grade: **4**  
Clock Start/From: **1**  
Clock To: **5**  
1st Value:  
2nd Value:  
Value Percent: **55.000**  
Continuous Index:  
Within 8" of Joint: **YES**  
Remarks:

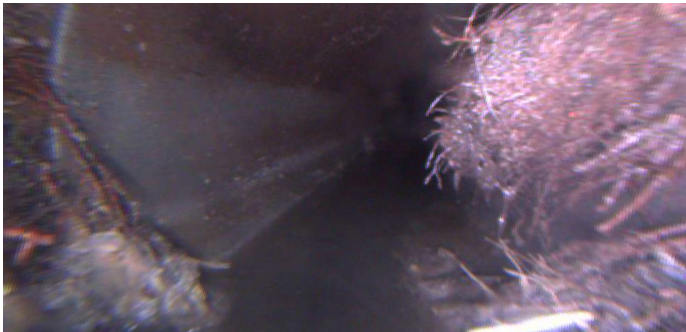
Code: **RMJ**  
Description: **Roots Medium Joint**

Distance (ft): **24.7**  
Structural Grade: **0**  
O&M Grade: **3**  
Clock Start/From: **7**  
Clock To: **5**  
1st Value:  
2nd Value:  
Value Percent: **20.000**  
Continuous Index:  
Within 8" of Joint: **YES**  
Remarks:

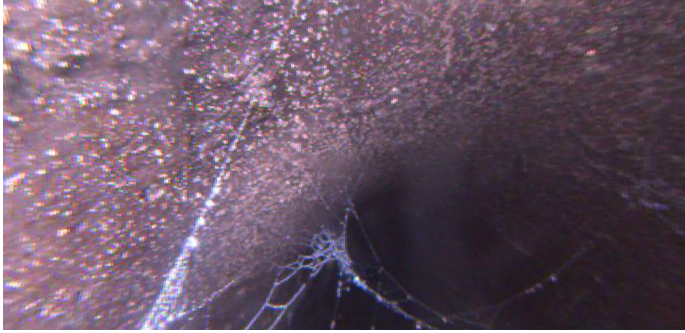
Code: **MSA**  
Description: **Abandoned Survey**

Distance (ft): **52.3**  
Structural Grade: **0**  
O&M Grade: **0**  
Clock Start/From:  
Clock To:  
1st Value:  
2nd Value:  
Value Percent:  
Continuous Index:  
Within 8" of Joint: **NO**  
Remarks: **stuck on wall/no blockage**

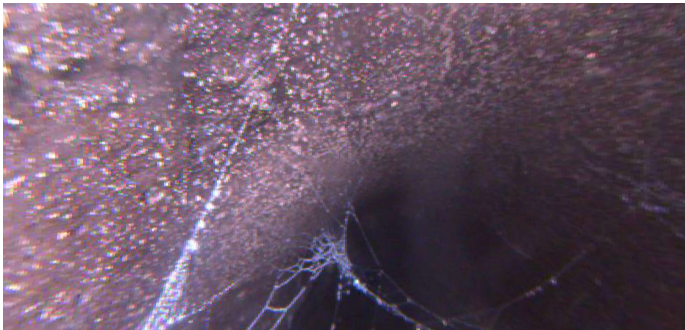
Code: **DSZ**  
Description: **Deposits Settled Other**

Distance (ft): **52.3**  
Structural Grade: **0**  
O&M Grade: **2**  
Clock Start/From: **6**  
Clock To:  
1st Value:  
2nd Value:  
Value Percent: **5.000**  
Continuous Index: **F01**  
Within 8" of Joint: **NO**  
Remarks: **tissue/debris**

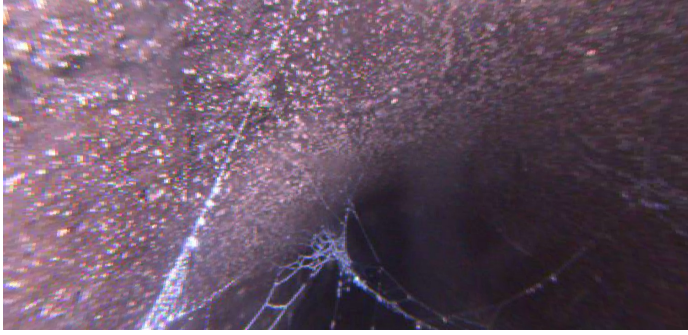
Code:	<b>CM</b>
Description:	<b>Crack Multiple</b>
Distance (ft):	<b>52.3</b>
Structural Grade:	<b>3</b>
O&M Grade:	<b>0</b>
Clock Start/From:	<b>7</b>
Clock To:	<b>5</b>
1st Value:	
2nd Value:	
Value Percent:	
Continuous Index:	<b>F02</b>
Within 8" of Joint:	<b>YES</b>
Remarks:	<b>wandering</b>
