Profile/Photo Observation Report

Street:	S Indiana St.	Flow Control:	Not Controlled
City:	Hobart, IN	Year Renewed:	
Location:	Other	Tape/Media #:	
Purpose:	Not Known	Dia/Height:	8"
Use:	Sanitary	Material:	VCP
Drain Area:	NA	Lining:	
Category:	NA		
Comment:

Location Details:		Direction of Survey:	Downstream
US MH:	M-805-062	DS MH:	M-805-058
		Total Length Surveyed (ft):	52.3

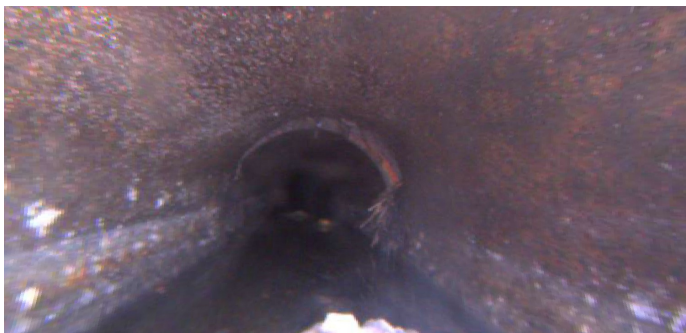
Code: **AMH**
Description: **Manhole**

Distance (ft): **.0**
Structural Grade: **0**
O&M Grade: **0**
Clock Start/From:
Clock To:
1st Value:
2nd Value:
Value Percent:
Continuous Index:
Within 8" of Joint: **NO**
Remarks: **M-805-062**

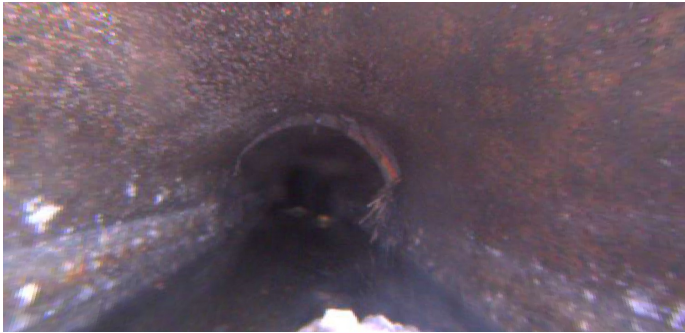
Code:	MWL
Description:	Water Level

Distance (ft):	.0
Structural Grade:	0
O&M Grade:	0
Clock Start/From:	
Clock To:	
1st Value:	
2nd Value:	
Value Percent:	5.000
Continuous Index:	
Within 8" of Joint:	NO
Remarks:

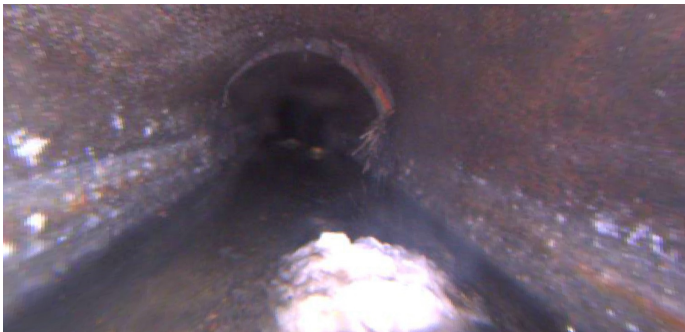
Code:	DSZ
Description:	Deposits Settled Other

Distance (ft):	.0
Structural Grade:	0
O&M Grade:	2
Clock Start/From:	6
Clock To:	
1st Value:	
2nd Value:	
Value Percent:	5.000
Continuous Index:	S01
Within 8" of Joint:	NO
Remarks:	tissue/debris

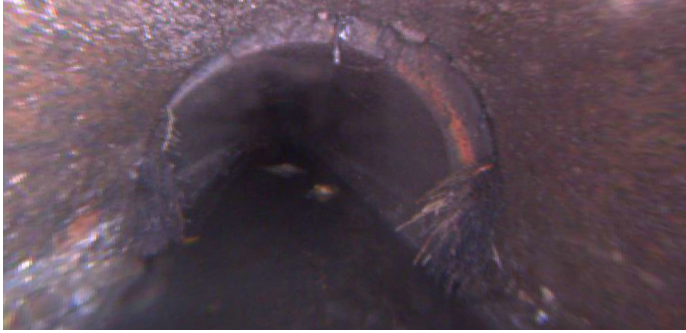
Code: **RFJ**
Description: **Roots Fine Joint**

Distance (ft): **1.8**
Structural Grade: **0**
O&M Grade: **1**
Clock Start/From: **7**
Clock To: **5**
1st Value:
2nd Value:
Value Percent:
Continuous Index:
Within 8" of Joint: **YES**
Remarks:

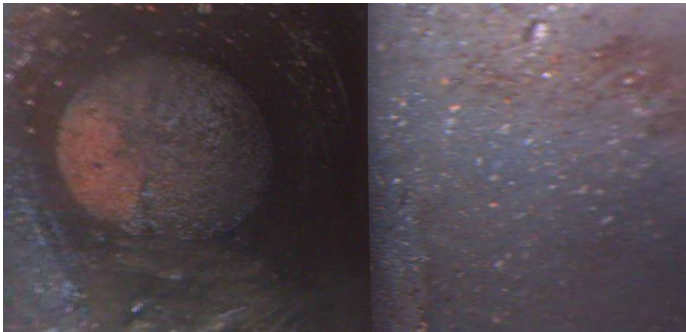
Code: **TFC**
Description: **Tap Factory Capped**

Distance (ft): **5.4**
Structural Grade: **0**
O&M Grade: **0**
Clock Start/From: **10**
Clock To:
1st Value: **4.000**
2nd Value:
Value Percent:
Continuous Index:
Within 8" of Joint: **YES**
Remarks:

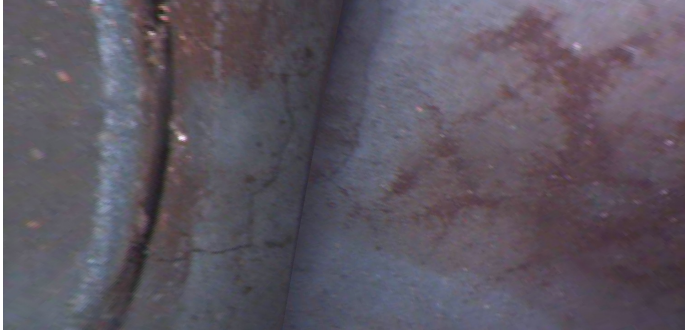
Code: **CM**
Description: **Crack Multiple**

Distance (ft): **6.6**
Structural Grade: **3**
O&M Grade: **0**
Clock Start/From: **7**
Clock To: **5**
1st Value:
2nd Value:
Value Percent:
Continuous Index: **S02**
Within 8" of Joint: **YES**
Remarks: **wandering**

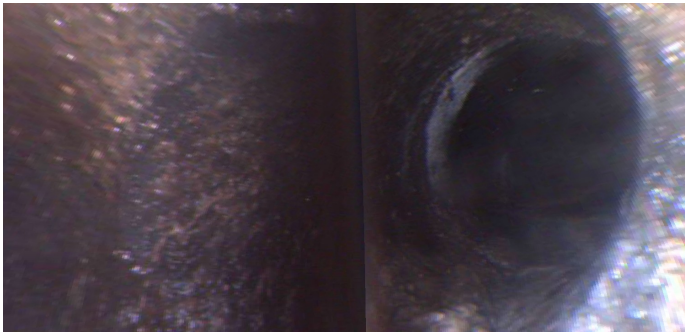
Code: **TF**
Description: **Tap Factory**

Distance (ft): **17.4**
Structural Grade: **0**
O&M Grade: **0**
Clock Start/From: **3**
Clock To:
1st Value: **4.000**
2nd Value:
Value Percent:
Continuous Index:
Within 8" of Joint: **YES**
Remarks:

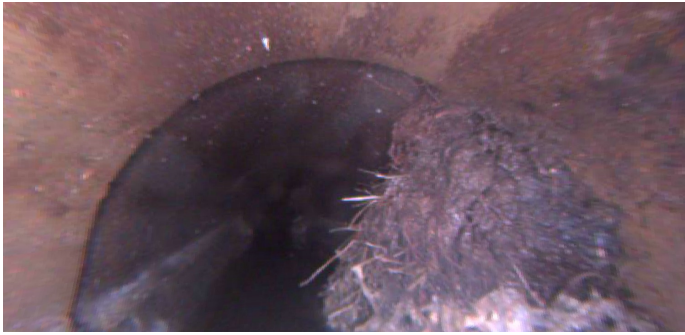
Code: **RBJ**
Description: **Roots Ball Joint**

Distance (ft): **22.2**
Structural Grade: **0**
O&M Grade: **4**
Clock Start/From: **1**
Clock To: **5**
1st Value:
2nd Value:
Value Percent: **55.000**
Continuous Index:
Within 8" of Joint: **YES**
Remarks:

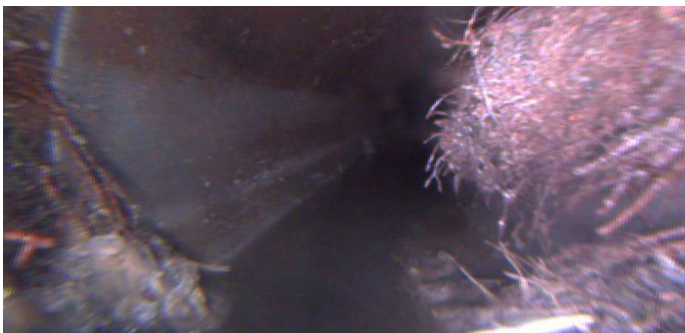
Code: **RMJ**
Description: **Roots Medium Joint**

Distance (ft): **24.7**
Structural Grade: **0**
O&M Grade: **3**
Clock Start/From: **7**
Clock To: **5**
1st Value:
2nd Value:
Value Percent: **20.000**
Continuous Index:
Within 8" of Joint: **YES**
Remarks:

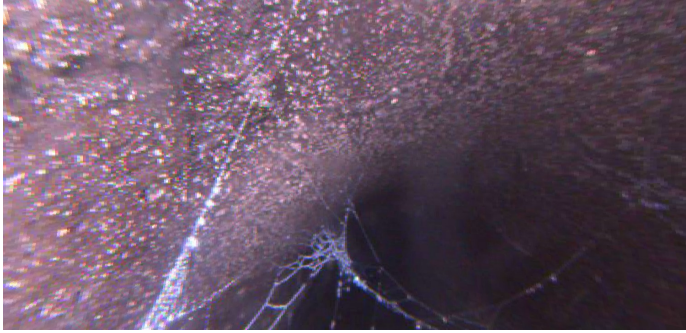
Code: **MSA**
Description: **Abandoned Survey**

Distance (ft): **52.3**
Structural Grade: **0**
O&M Grade: **0**
Clock Start/From:
Clock To:
1st Value:
2nd Value:
Value Percent:
Continuous Index:
Within 8" of Joint: **NO**
Remarks: **stuck on wall/no blockage**

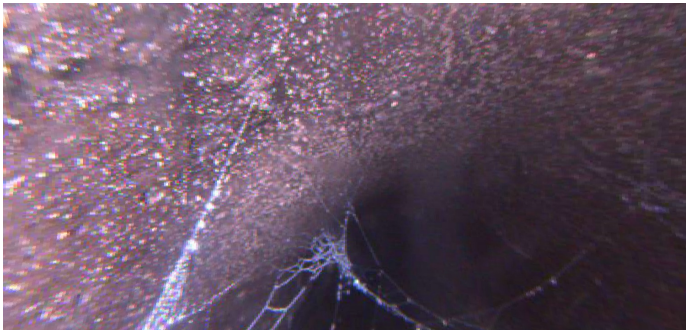
Code: **DSZ**
Description: **Deposits Settled Other**

Distance (ft): **52.3**
Structural Grade: **0**
O&M Grade: **2**
Clock Start/From: **6**
Clock To:
1st Value:
2nd Value:
Value Percent: **5.000**
Continuous Index: **F01**
Within 8" of Joint: **NO**
Remarks: **tissue/debris**

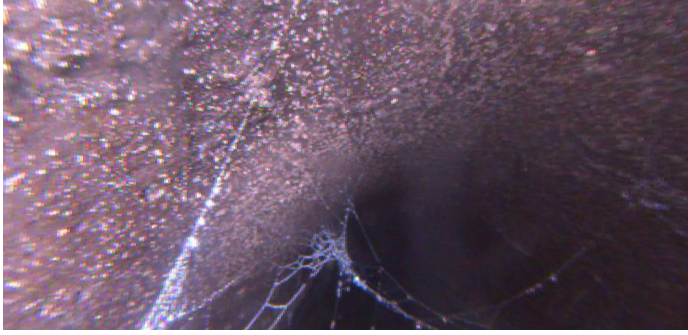
Code:	CM
Description:	Crack Multiple
Distance (ft):	52.3
Structural Grade:	3
O&M Grade:	0
Clock Start/From:	7
Clock To:	5
1st Value:	
2nd Value:	
Value Percent:	
Continuous Index:	F02
Within 8" of Joint:	YES
Remarks:	wandering
