Profile/Photo Observation Report

Date:	01/15/2023	Weather:		Coding:	PACP 7.0
Pipe Length (ft):	181.0	Owner:	City of Hobart	Pre Clean:	Heavy Cleaning
P.O.#:	YES502259	Surveyor:	S. Bucklin	PSR:	P-805-062-058
Customer:	City of Hobart	Clean Date:	01/12/2023	Shape:	C

Street:	South Indiana Street	Flow Control:	Not Controlled
City:	Hobart, IN	Year Renewed:	
Location:	Local rural streets with light traffic, t	Tape/Media #:	
Purpose:	Routine Assessment	Dia/Height:	8"
Use:	Sanitary Sewage Pipe	Material:	VCP
Drain Area:		Lining:	None
Category:	NA		
Comment:			
Location Details:		Direction of Survey:	Downstream
US MH:	M-805-062	DS MH:	M-805-058
		Total Length Surveyed (ft):	177.6

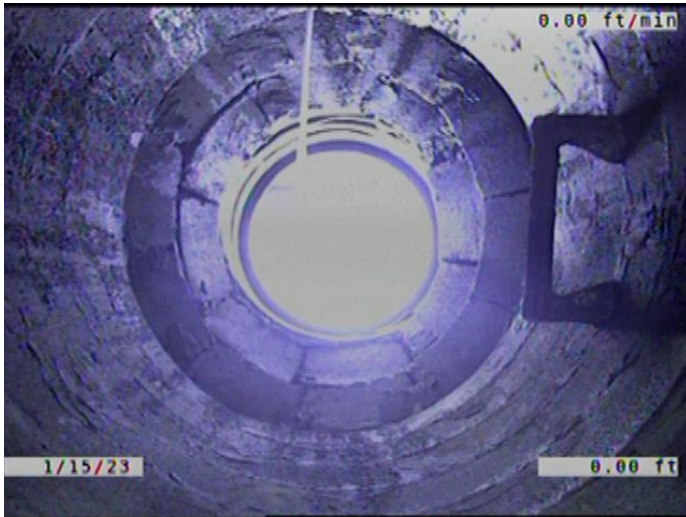
Code: **AMH**
 Description: **Manhole**

Distance (ft): **.0**
 Structural Grade: **0**
 O&M Grade: **0**
 Clock Start/From:
 Clock To:
 1st Value:
 2nd Value:
 Value Percent:
 Continuous Index:
 Within 8" of Joint: **NO**
 Remarks: **M-805-062**

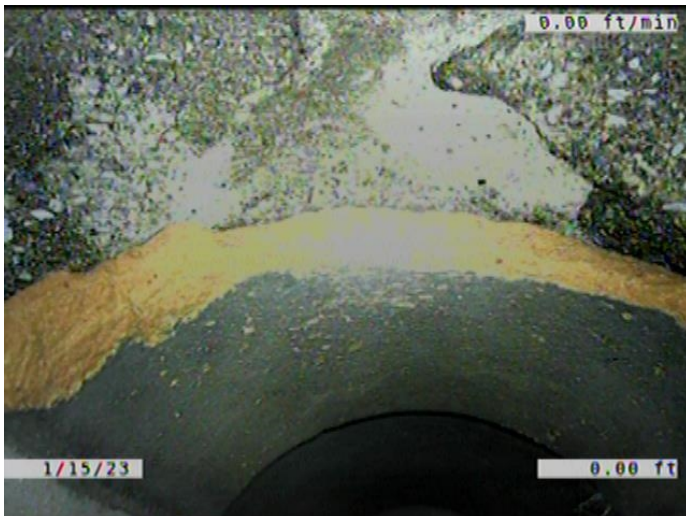
Code: **MWL**
 Description: **Miscellaneous Water Level**

Distance (ft): **.0**
 Structural Grade: **0**
 O&M Grade: **0**
 Clock Start/From:
 Clock To:
 1st Value:
 2nd Value:
 Value Percent: **35.000**
 Continuous Index:
 Within 8" of Joint: **NO**
 Remarks:

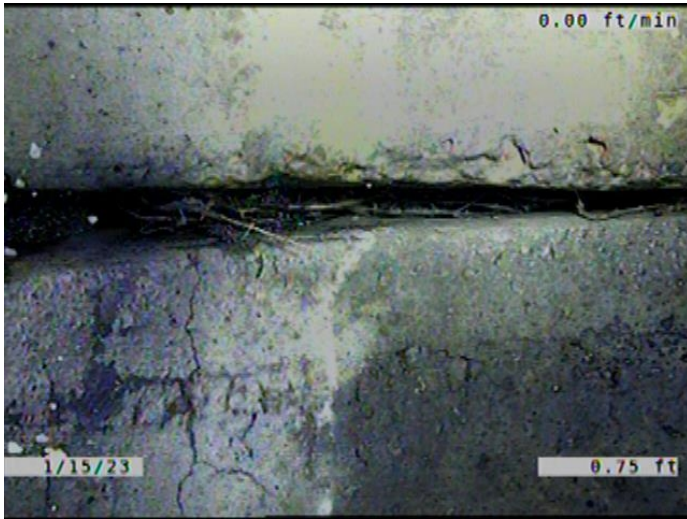
Code: **RFJ**
Description: **Roots Fine Joint**

Distance (ft): **.8**
Structural Grade: **0**
O&M Grade: **1**
Clock Start/From: **10**
Clock To: **2**
1st Value:
2nd Value:
Value Percent:
Continuous Index:
Within 8" of Joint: **YES**
Remarks:

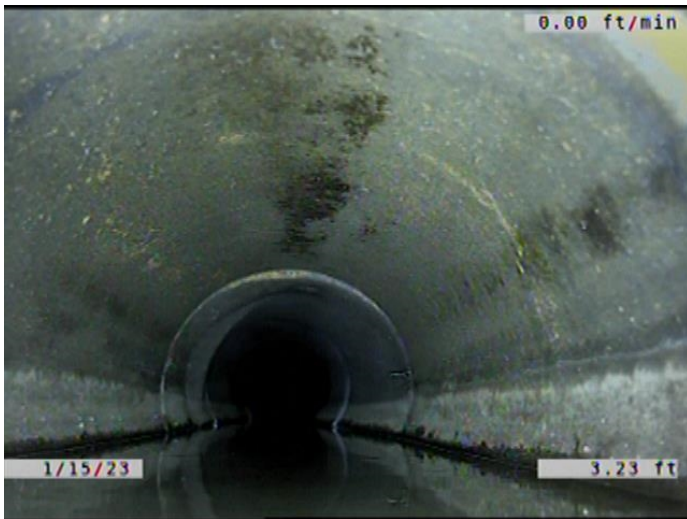
Code: **MWL**
Description: **Miscellaneous Water Level**

Distance (ft): **3.2**
Structural Grade: **0**
O&M Grade: **0**
Clock Start/From:
Clock To:
1st Value:
2nd Value:
Value Percent: **20.000**
Continuous Index:
Within 8" of Joint: **NO**
Remarks:

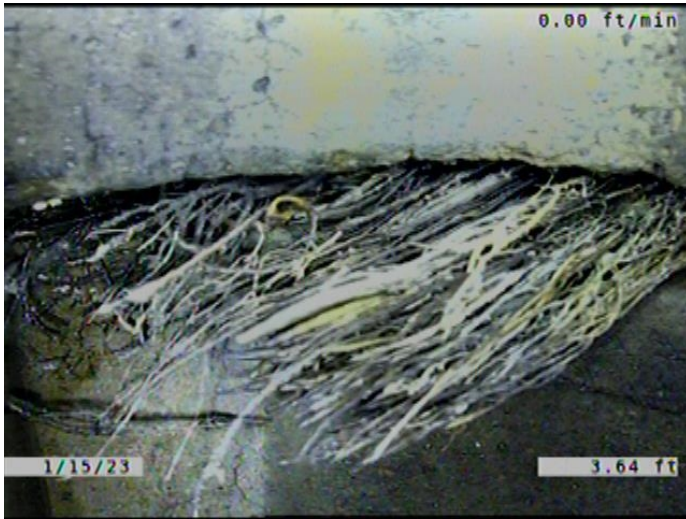
Code: **RFJ**
Description: **Roots Fine Joint**

Distance (ft): **3.6**
Structural Grade: **0**
O&M Grade: **1**
Clock Start/From: **9**
Clock To: **3**
1st Value:
2nd Value:
Value Percent:
Continuous Index: **S01**
Within 8" of Joint: **YES**
Remarks:

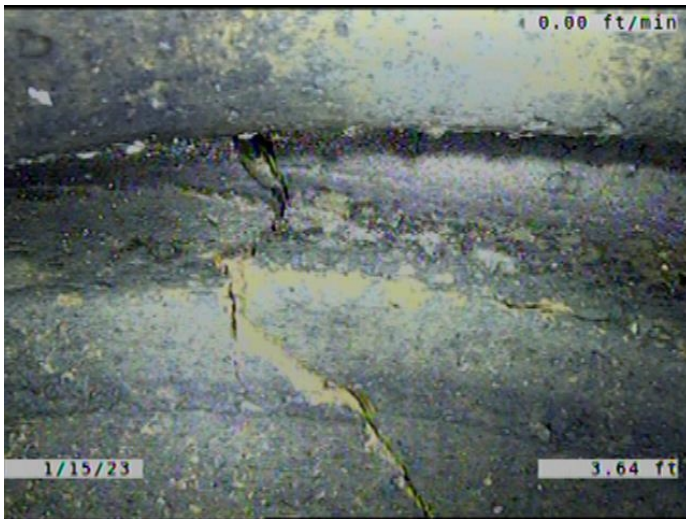
Code: **B**
Description: **Broken**

Distance (ft): **3.6**
Structural Grade: **4**
O&M Grade: **0**
Clock Start/From: **11**
Clock To: **3**
1st Value:
2nd Value:
Value Percent:
Continuous Index:
Within 8" of Joint: **YES**
Remarks:

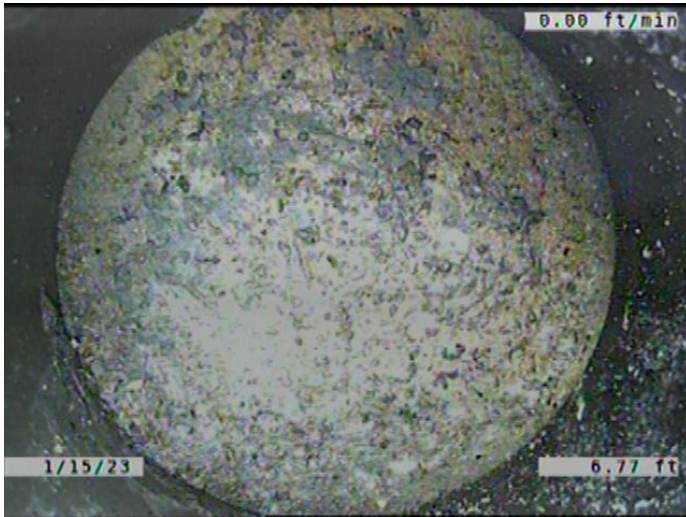
Code: **TFC**
Description: **Tap Factory Capped**

Distance (ft): **6.8**
Structural Grade: **0**
O&M Grade: **0**
Clock Start/From: **10**
Clock To:
1st Value: **6.000**
2nd Value:
Value Percent:
Continuous Index:
Within 8" of Joint: **YES**
Remarks:

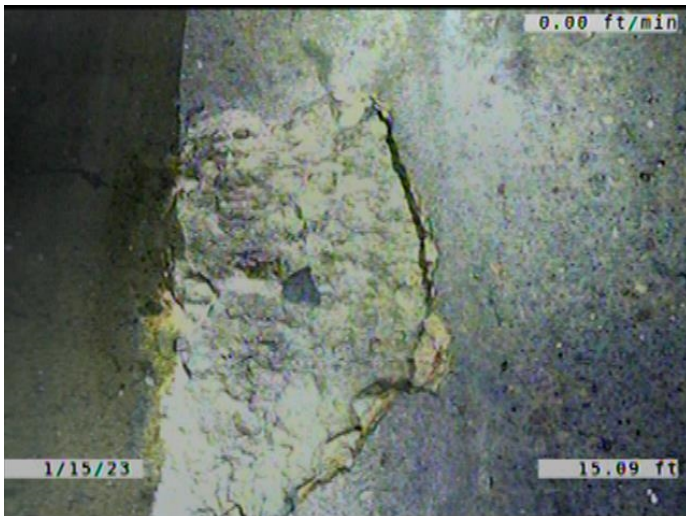
Code: **SSS**
Description: **Surface Damage Surface Spalling**

Distance (ft): **15.1**
Structural Grade: **2**
O&M Grade: **0**
Clock Start/From: **4**
Clock To:
1st Value:
2nd Value:
Value Percent:
Continuous Index:
Within 8" of Joint: **NO**
Remarks:

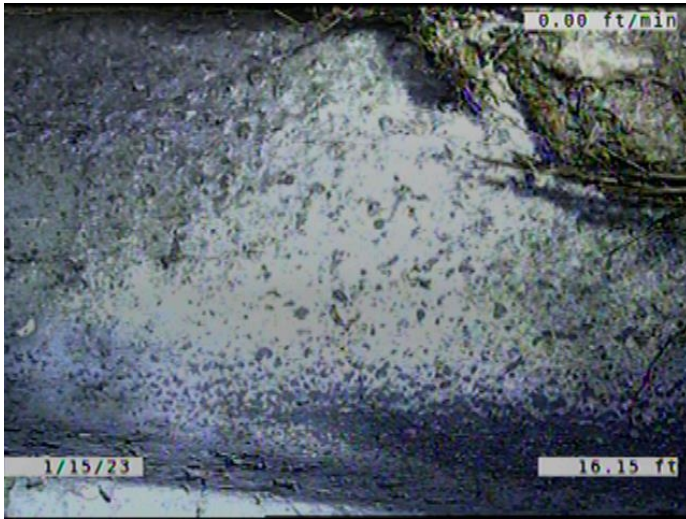
Code: **JAL**
Description: **Joint Angular Large**

Distance (ft): **16.1**
Structural Grade: **4**
O&M Grade: **0**
Clock Start/From:
Clock To:
1st Value:
2nd Value:
Value Percent:
Continuous Index:
Within 8" of Joint: **NO**
Remarks:

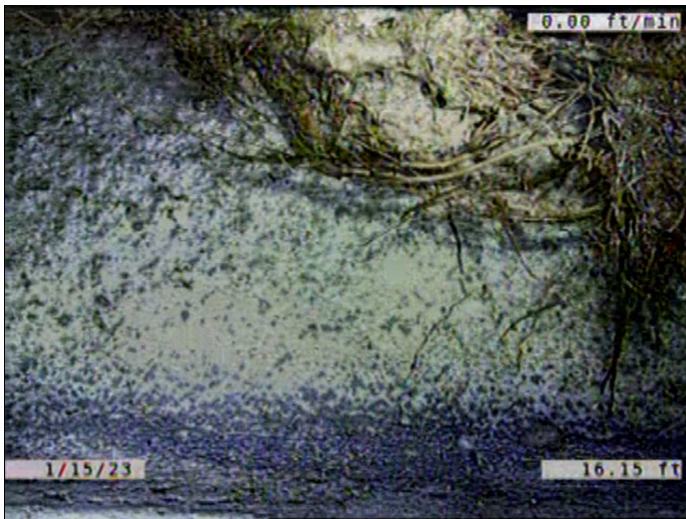
Code: **FM**
Description: **Fracture Multiple**

Distance (ft): **16.2**
Structural Grade: **4**
O&M Grade: **0**
Clock Start/From: **8**
Clock To: **4**
1st Value:
2nd Value:
Value Percent:
Continuous Index: **S02**
Within 8" of Joint: **YES**
Remarks:

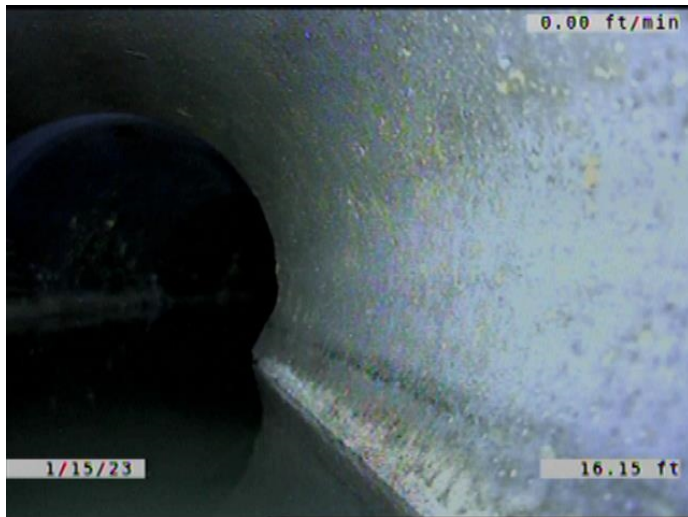
Code: **LL**
 Description: **Line Left**

Distance (ft): **16.2**
 Structural Grade: **0**
 O&M Grade: **2**
 Clock Start/From:
 Clock To:
 1st Value:
 2nd Value:
 Value Percent: **20.000**
 Continuous Index:
 Within 8" of Joint: **NO**
 Remarks:

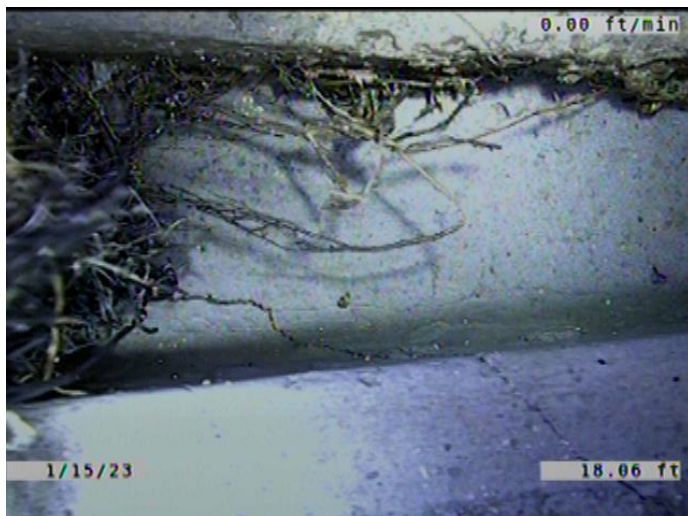
Code: **JAL**
 Description: **Joint Angular Large**

Distance (ft): **18.1**
 Structural Grade: **4**
 O&M Grade: **0**
 Clock Start/From:
 Clock To:
 1st Value:
 2nd Value:
 Value Percent:
 Continuous Index:
 Within 8" of Joint: **NO**
 Remarks:

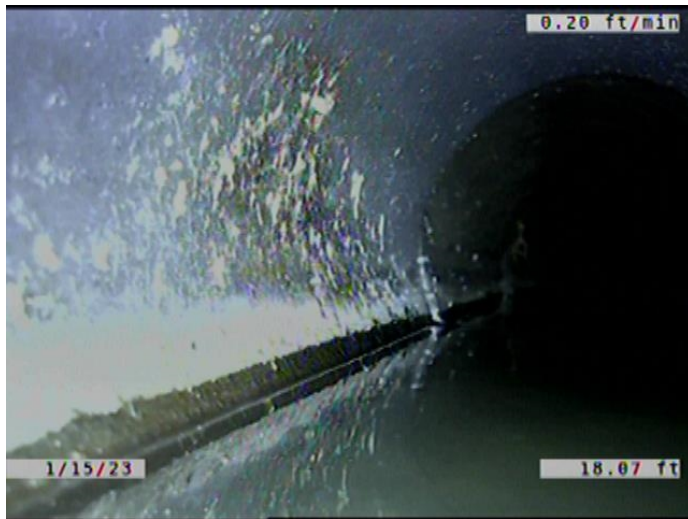
Code: **LR**
 Description: **Line Right**

Distance (ft): **18.1**
 Structural Grade: **0**
 O&M Grade: **2**
 Clock Start/From:
 Clock To:
 1st Value:
 2nd Value:
 Value Percent: **15.000**
 Continuous Index:
 Within 8" of Joint: **NO**
 Remarks:

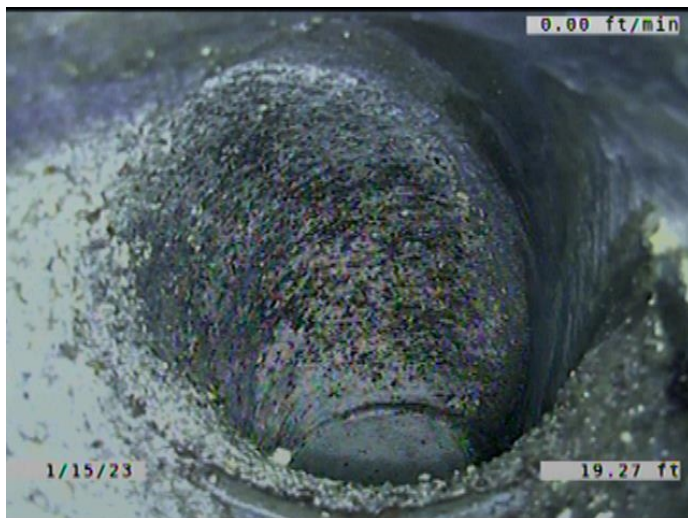
Code: **TF**
 Description: **Tap Factory**

Distance (ft): **19.3**
 Structural Grade: **0**
 O&M Grade: **0**
 Clock Start/From: **2**
 Clock To:
 1st Value: **6.000**
 2nd Value:
 Value Percent:
 Continuous Index:
 Within 8" of Joint: **YES**
 Remarks: **CCONSTANTLY RUNNING WATER.**

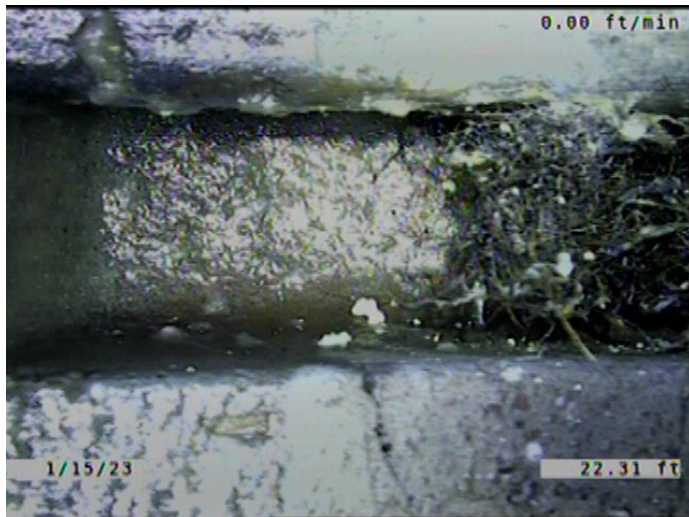
Code: **JAM**
 Description: **Joint Angular Medium**

Distance (ft): **22.3**
 Structural Grade: **3**
 O&M Grade: **0**
 Clock Start/From:
 Clock To:
 1st Value:
 2nd Value:
 Value Percent:
 Continuous Index:
 Within 8" of Joint: **NO**
 Remarks:

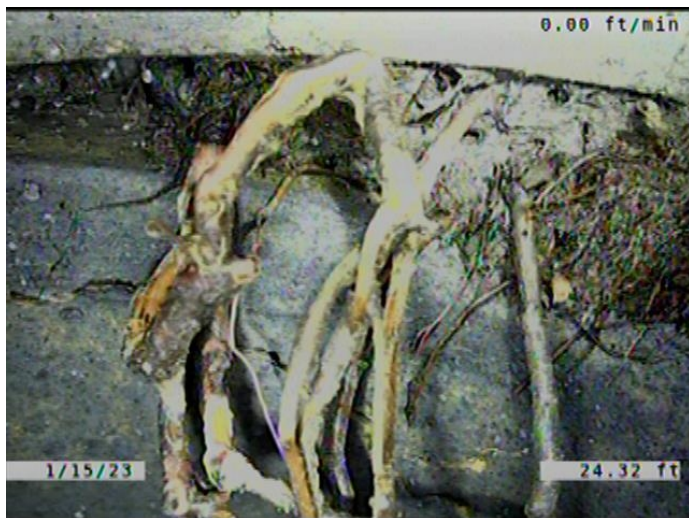
Code: **RMJ**
 Description: **Roots Medium Joint**

Distance (ft): **24.3**
 Structural Grade: **0**
 O&M Grade: **3**
 Clock Start/From: **9**
 Clock To: **3**
 1st Value:
 2nd Value:
 Value Percent: **5.000**
 Continuous Index:
 Within 8" of Joint: **YES**
 Remarks:

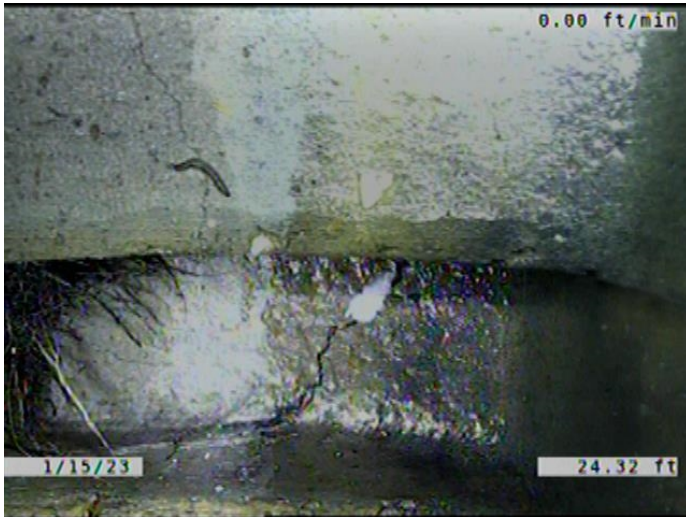
Code: **JAM**
 Description: **Joint Angular Medium**

Distance (ft): **24.3**
 Structural Grade: **3**
 O&M Grade: **0**
 Clock Start/From:
 Clock To:
 1st Value:
 2nd Value:
 Value Percent:
 Continuous Index:
 Within 8" of Joint: **NO**
 Remarks:

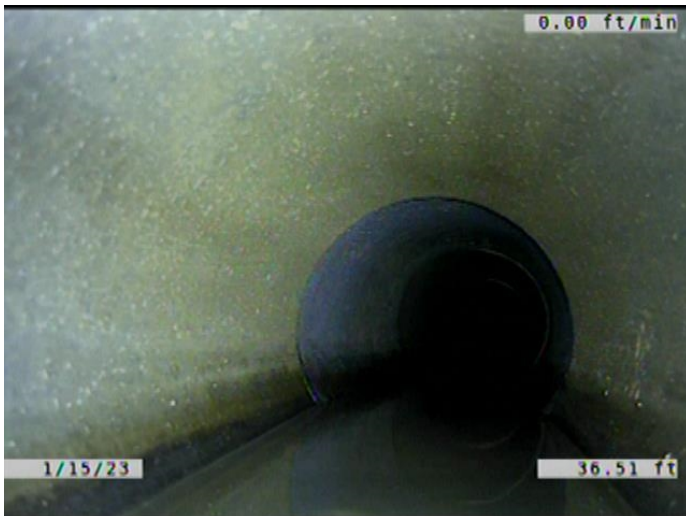
Code: **LR**
 Description: **Line Right**

Distance (ft): **36.5**
 Structural Grade: **0**
 O&M Grade: **1**
 Clock Start/From:
 Clock To:
 1st Value:
 2nd Value:
 Value Percent: **10.000**
 Continuous Index:
 Within 8" of Joint: **NO**
 Remarks:

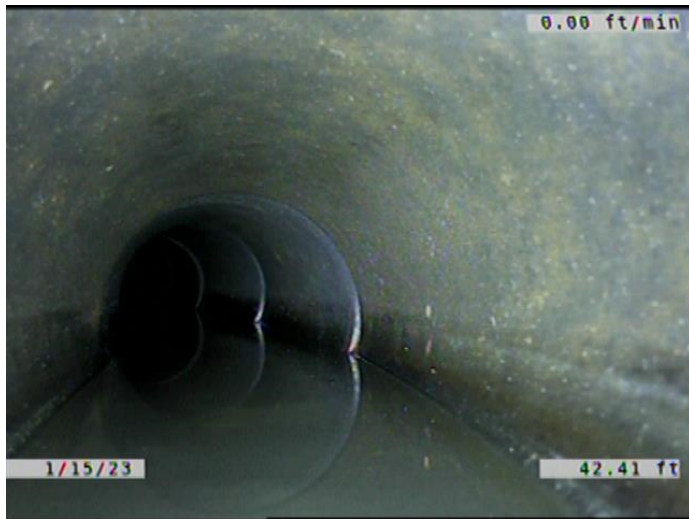
Code: **LL**
 Description: **Line Left**

Distance (ft): **42.4**
 Structural Grade: **0**
 O&M Grade: **4**
 Clock Start/From:
 Clock To:
 1st Value:
 2nd Value:
 Value Percent: **25.000**
 Continuous Index:
 Within 8" of Joint: **NO**
 Remarks:

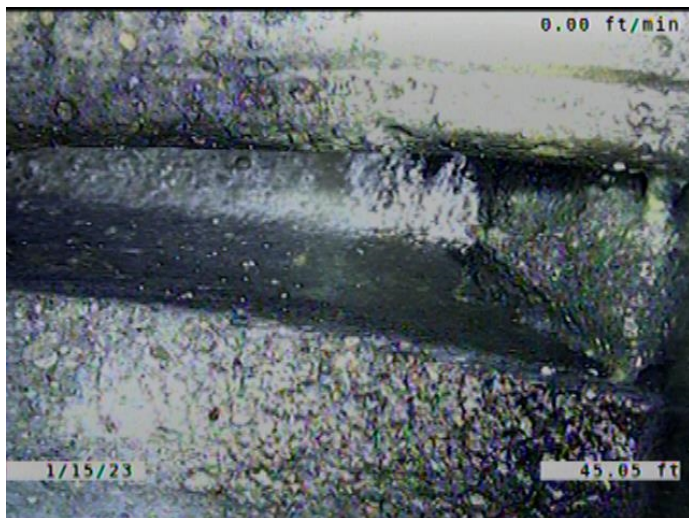
Code: **JAM**
 Description: **Joint Angular Medium**

Distance (ft): **45.0**
 Structural Grade: **3**
 O&M Grade: **0**
 Clock Start/From:
 Clock To:
 1st Value:
 2nd Value:
 Value Percent:
 Continuous Index:
 Within 8" of Joint: **NO**
 Remarks:

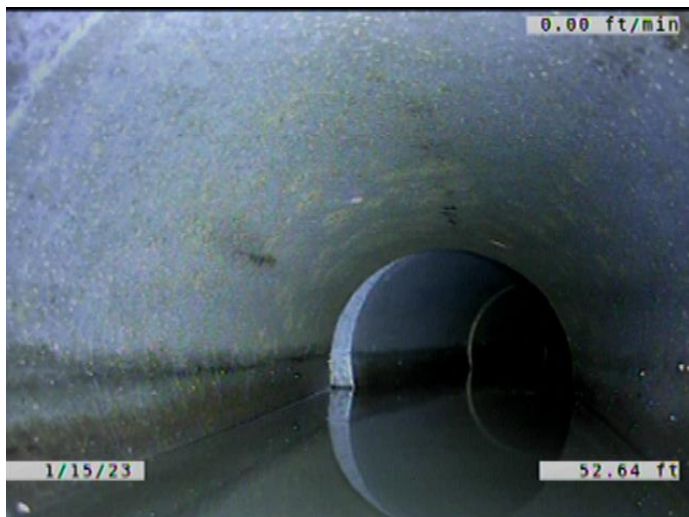
Code: **LR**
 Description: **Line Right**

Distance (ft): **52.6**
 Structural Grade: **0**
 O&M Grade: **4**
 Clock Start/From:
 Clock To:
 1st Value:
 2nd Value:
 Value Percent: **35.000**
 Continuous Index:
 Within 8" of Joint: **NO**
 Remarks:

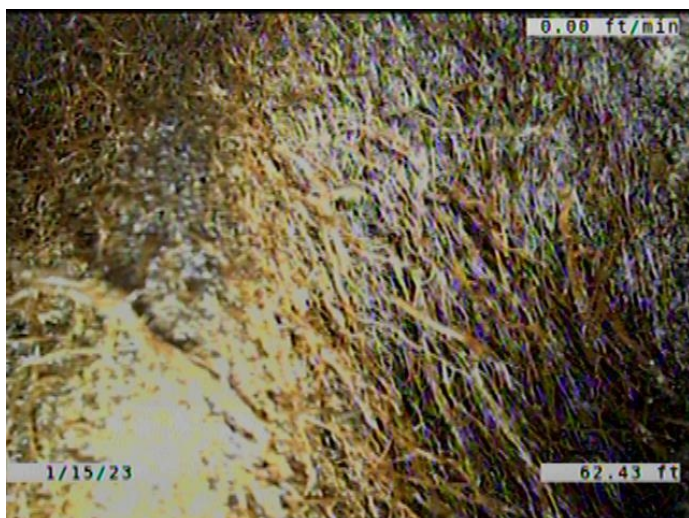
Code: **TFD**
 Description: **Tap Factory Defective**

Distance (ft): **62.4**
 Structural Grade: **0**
 O&M Grade: **3**
 Clock Start/From: **10**
 Clock To:
 1st Value: **6.000**
 2nd Value:
 Value Percent:
 Continuous Index:
 Within 8" of Joint: **YES**
 Remarks: **100% PLUGGED WITH ROOTS.**

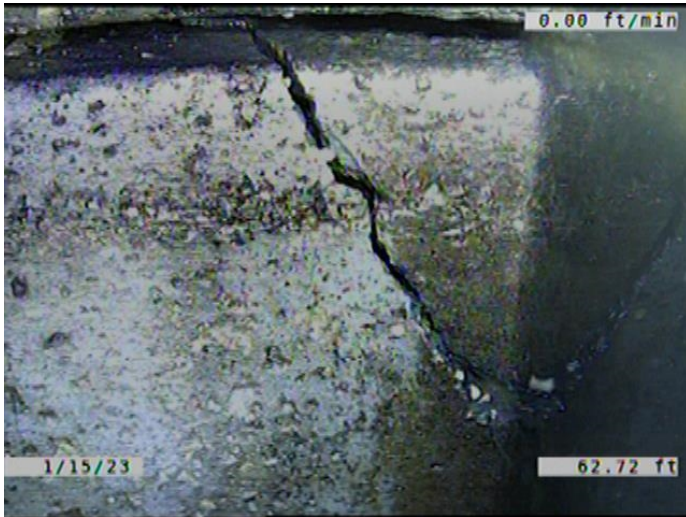
Code: **B**
Description: **Broken**

Distance (ft): **62.7**
Structural Grade: **4**
O&M Grade: **0**
Clock Start/From: **3**
Clock To: **4**
1st Value:
2nd Value:
Value Percent:
Continuous Index:
Within 8" of Joint: **YES**
Remarks:

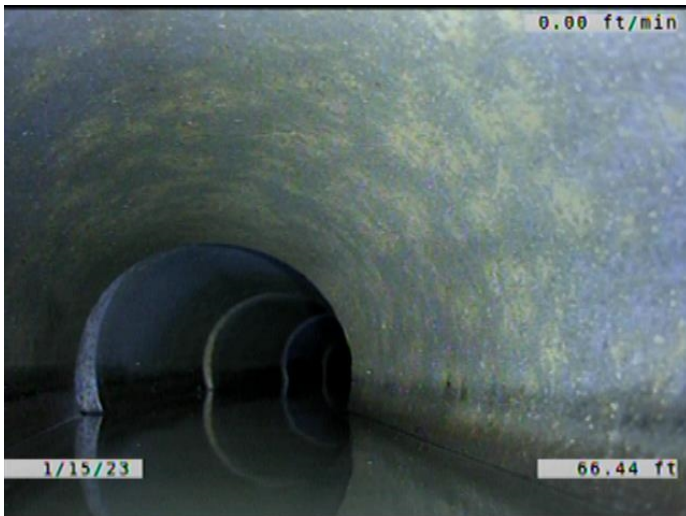
Code: **LL**
Description: **Line Left**

Distance (ft): **66.4**
Structural Grade: **0**
O&M Grade: **1**
Clock Start/From:
Clock To:
1st Value:
2nd Value:
Value Percent: **10.000**
Continuous Index:
Within 8" of Joint: **NO**
Remarks:

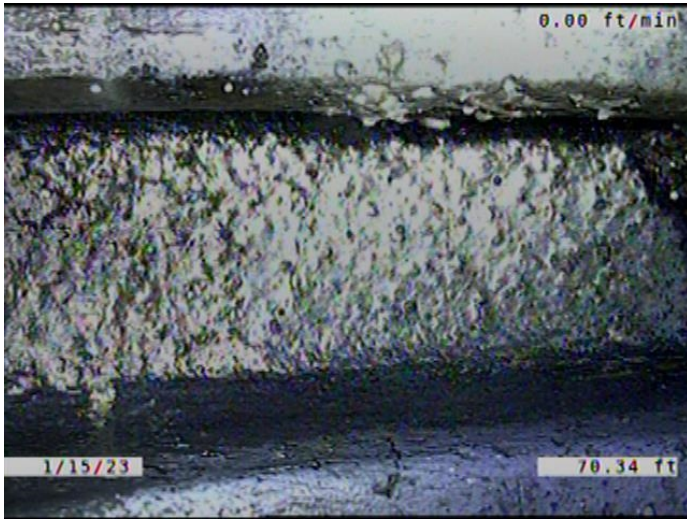
Code: **JAL**
 Description: **Joint Angular Large**

Distance (ft): **70.3**
 Structural Grade: **4**
 O&M Grade: **0**
 Clock Start/From:
 Clock To:
 1st Value:
 2nd Value:
 Value Percent:
 Continuous Index:
 Within 8" of Joint: **NO**
 Remarks:

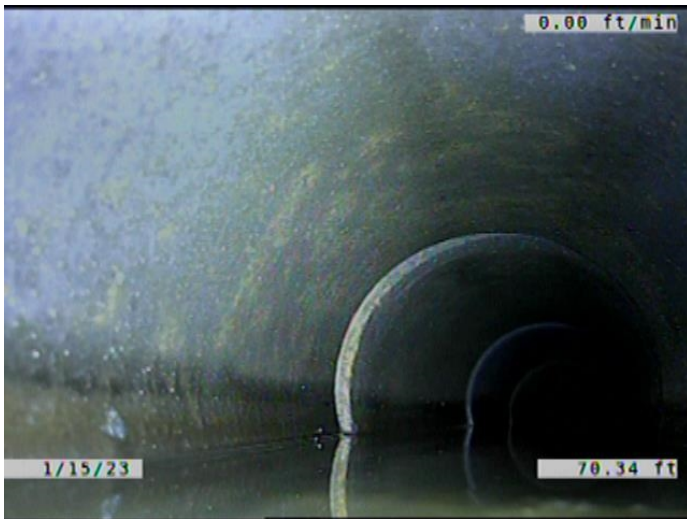
Code: **LR**
 Description: **Line Right**

Distance (ft): **70.3**
 Structural Grade: **0**
 O&M Grade: **2**
 Clock Start/From:
 Clock To:
 1st Value:
 2nd Value:
 Value Percent: **15.000**
 Continuous Index:
 Within 8" of Joint: **NO**
 Remarks:

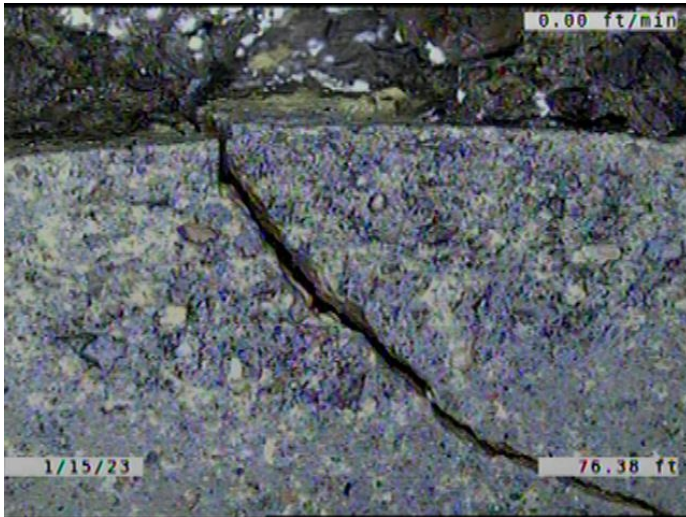
Code: **B**
 Description: **Broken**

Distance (ft): **76.4**
 Structural Grade: **4**
 O&M Grade: **0**
 Clock Start/From: **12**
 Clock To: **2**
 1st Value:
 2nd Value:
 Value Percent:
 Continuous Index:
 Within 8" of Joint: **YES**
 Remarks:

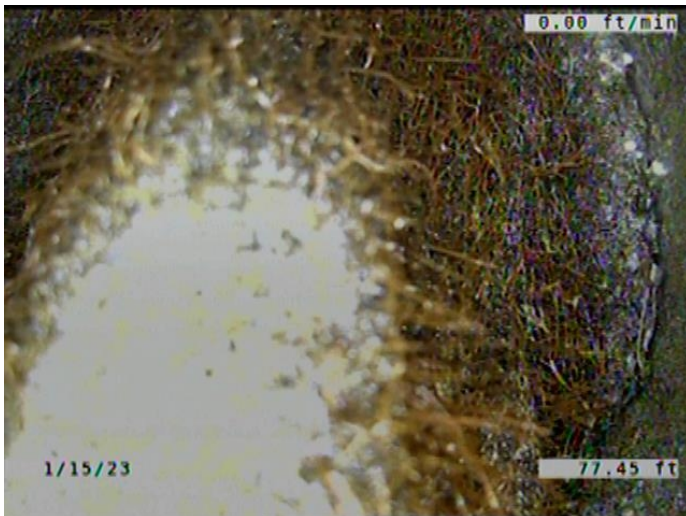
Code: **TFD**
 Description: **Tap Factory Defective**

Distance (ft): **77.5**
 Structural Grade: **0**
 O&M Grade: **3**
 Clock Start/From: **2**
 Clock To:
 1st Value: **6.000**
 2nd Value:
 Value Percent:
 Continuous Index:
 Within 8" of Joint: **YES**
 Remarks: **100% PLUGGED WITH ROOTS. ROOTS GROWING INTO THE MAIN.**

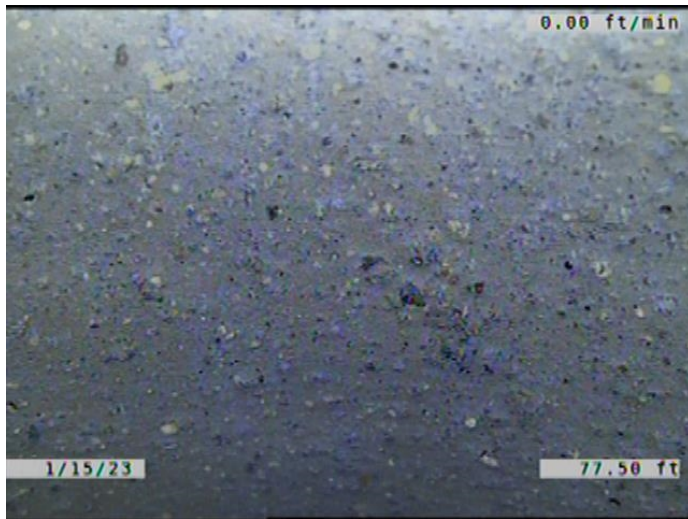
Code: **MWL**
Description: **Miscellaneous Water Level**

Distance (ft): **77.5**
Structural Grade: **0**
O&M Grade: **0**
Clock Start/From:
Clock To:
1st Value:
2nd Value:
Value Percent: **35.000**
Continuous Index:
Within 8" of Joint: **NO**
Remarks:

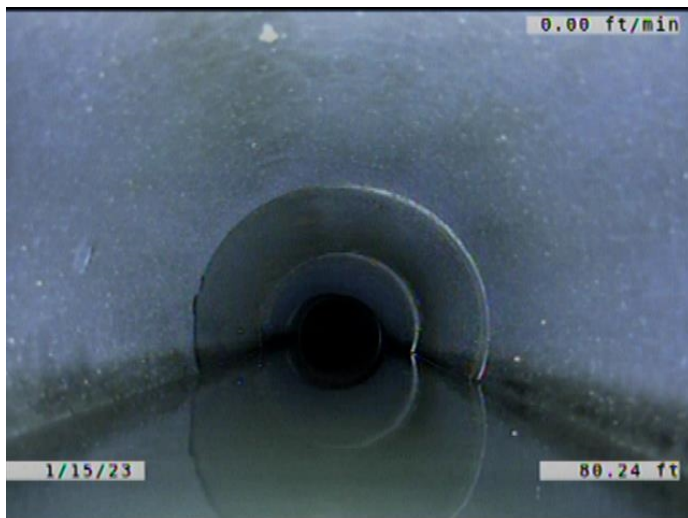
Code: **MWL**
Description: **Miscellaneous Water Level**

Distance (ft): **80.2**
Structural Grade: **0**
O&M Grade: **0**
Clock Start/From:
Clock To:
1st Value:
2nd Value:
Value Percent: **25.000**
Continuous Index:
Within 8" of Joint: **NO**
Remarks:

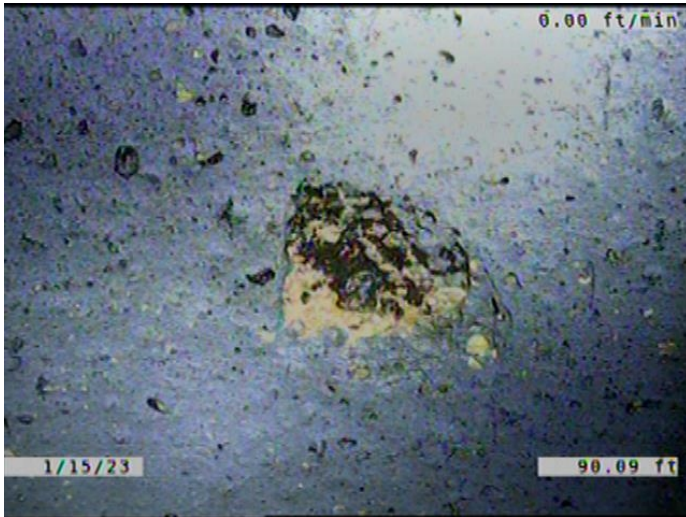
Code: **SSS**
 Description: **Surface Damage Surface Spalling**

Distance (ft): **90.1**
 Structural Grade: **2**
 O&M Grade: **0**
 Clock Start/From: **2**
 Clock To:
 1st Value:
 2nd Value:
 Value Percent:
 Continuous Index:
 Within 8" of Joint: **NO**
 Remarks:

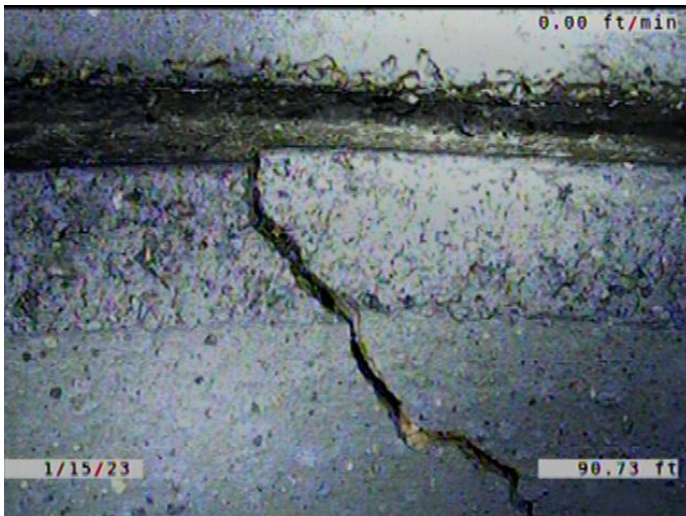
Code: **B**
 Description: **Broken**

Distance (ft): **90.7**
 Structural Grade: **4**
 O&M Grade: **0**
 Clock Start/From: **11**
 Clock To: **3**
 1st Value:
 2nd Value:
 Value Percent:
 Continuous Index:
 Within 8" of Joint: **YES**
 Remarks:

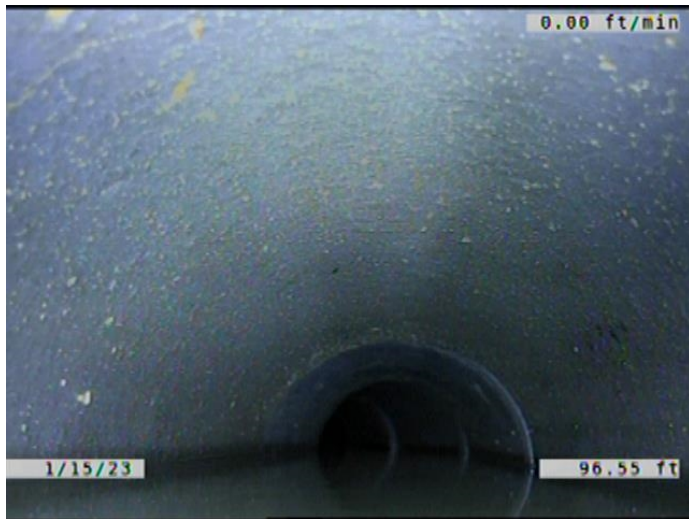
Code: **MWL**
Description: **Miscellaneous Water Level**

Distance (ft): **96.5**
Structural Grade: **0**
O&M Grade: **0**
Clock Start/From:
Clock To:
1st Value:
2nd Value:
Value Percent: **45.000**
Continuous Index:
Within 8" of Joint: **NO**
Remarks:

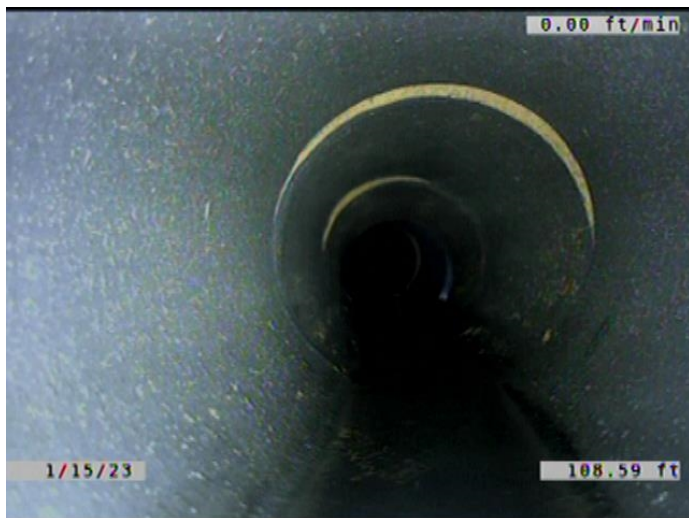
Code: **MWL**
Description: **Miscellaneous Water Level**

Distance (ft): **108.6**
Structural Grade: **0**
O&M Grade: **0**
Clock Start/From:
Clock To:
1st Value:
2nd Value:
Value Percent: **10.000**
Continuous Index:
Within 8" of Joint: **NO**
Remarks:

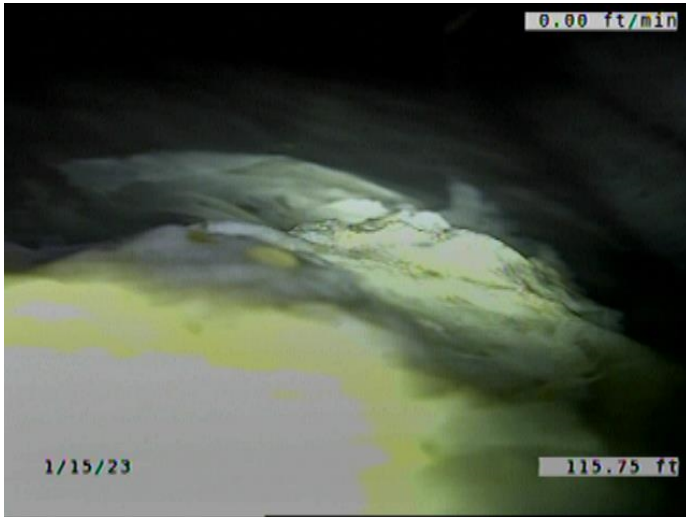
Code: **DAR**
Description: **Deposits Attached Ragging**

Distance (ft): **115.7**
Structural Grade: **0**
O&M Grade: **2**
Clock Start/From: **6**
Clock To:
1st Value:
2nd Value:
Value Percent: **5.000**
Continuous Index:
Within 8" of Joint: **YES**
Remarks:

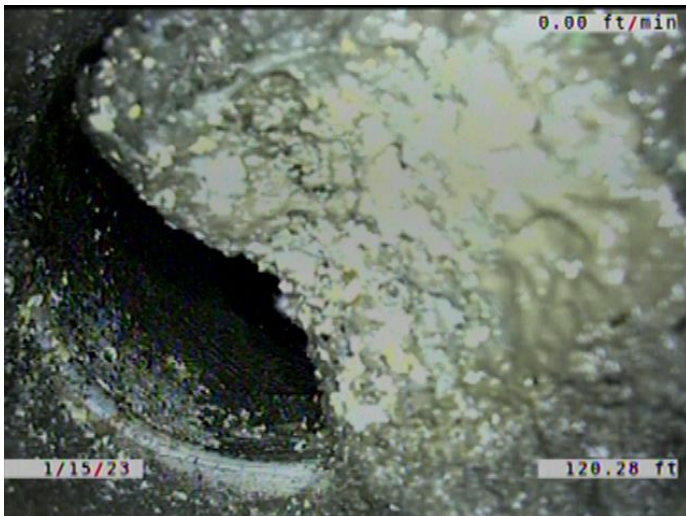
Code: **TF**
Description: **Tap Factory**

Distance (ft): **120.3**
Structural Grade: **0**
O&M Grade: **0**
Clock Start/From: **2**
Clock To:
1st Value: **6.000**
2nd Value:
Value Percent:
Continuous Index:
Within 8" of Joint: **YES**
Remarks: **85% PLUGGED WITH DIRT.**

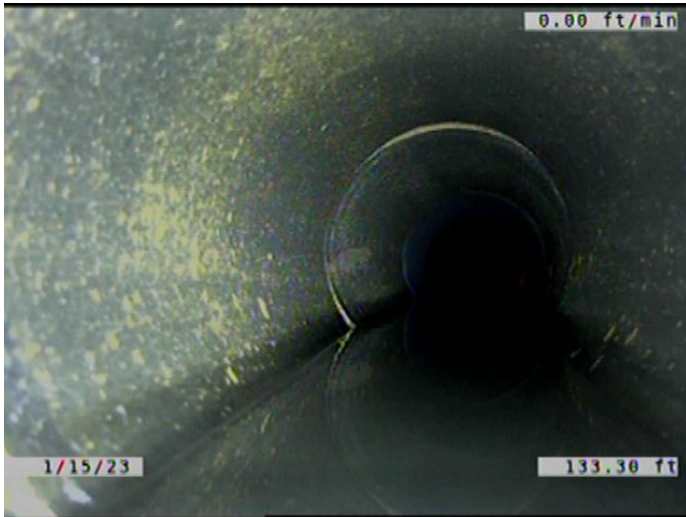
Code: **LR**
 Description: **Line Right**

Distance (ft): **133.3**
 Structural Grade: **0**
 O&M Grade: **1**
 Clock Start/From:
 Clock To:
 1st Value:
 2nd Value:
 Value Percent: **10.000**
 Continuous Index:
 Within 8" of Joint: **NO**
 Remarks:

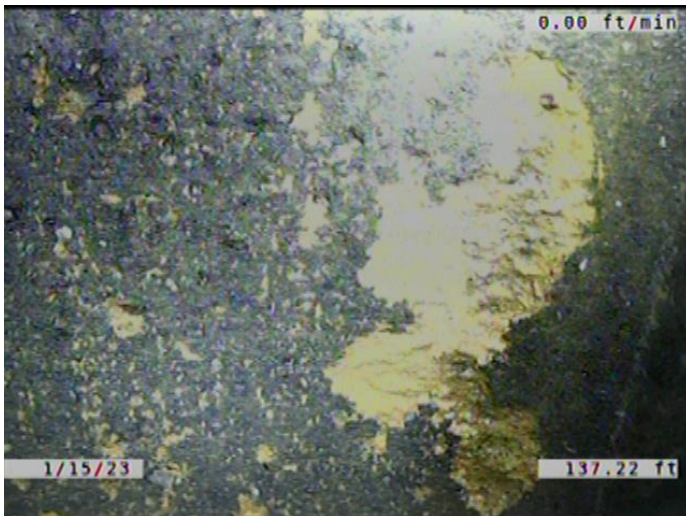
Code: **SSS**
 Description: **Surface Damage Surface Spalling**

Distance (ft): **137.2**
 Structural Grade: **2**
 O&M Grade: **0**
 Clock Start/From: **3**
 Clock To: **4**
 1st Value:
 2nd Value:
 Value Percent:
 Continuous Index:
 Within 8" of Joint: **NO**
 Remarks:

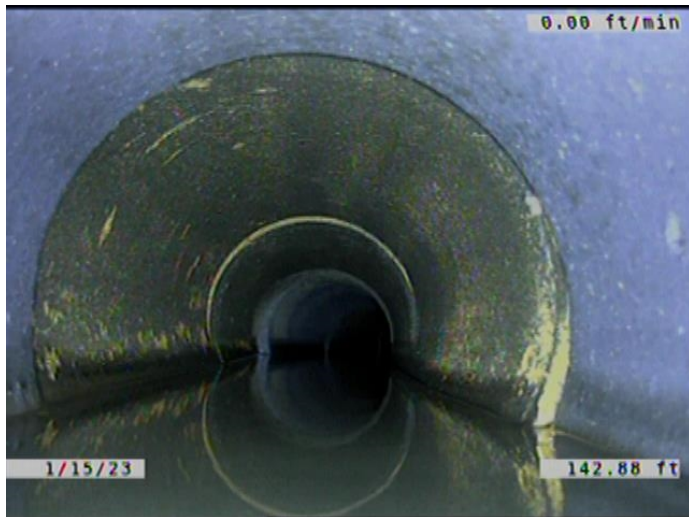
Code: **LL**
 Description: **Line Left**

Distance (ft): **142.8**
 Structural Grade: **0**
 O&M Grade: **1**
 Clock Start/From:
 Clock To:
 1st Value:
 2nd Value:
 Value Percent: **10.000**
 Continuous Index:
 Within 8" of Joint: **NO**
 Remarks:

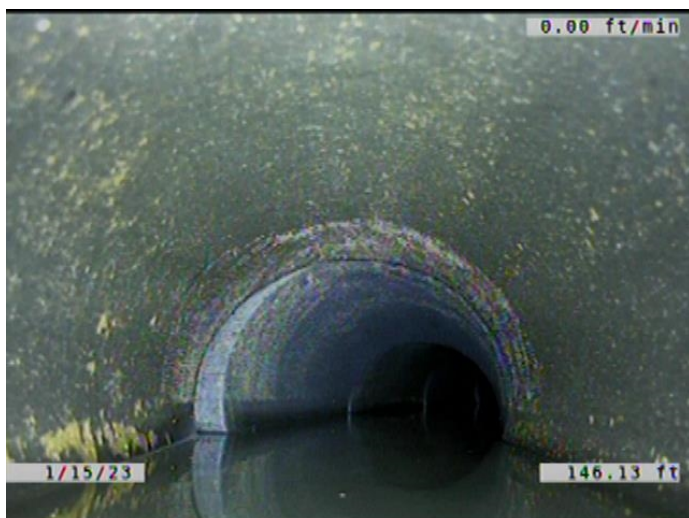
Code: **MWL**
 Description: **Miscellaneous Water Level**

Distance (ft): **146.1**
 Structural Grade: **0**
 O&M Grade: **0**
 Clock Start/From:
 Clock To:
 1st Value:
 2nd Value:
 Value Percent: **25.000**
 Continuous Index:
 Within 8" of Joint: **NO**
 Remarks:

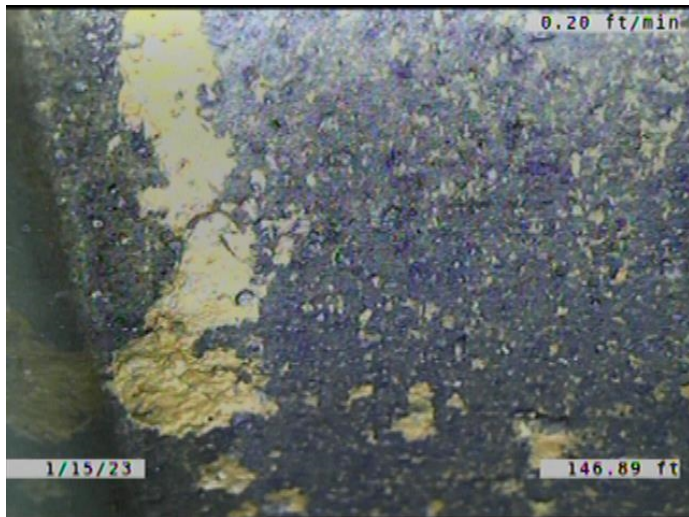
Code: **SSS**
 Description: **Surface Damage Surface Spalling**

Distance (ft): **146.8**
 Structural Grade: **2**
 O&M Grade: **0**
 Clock Start/From: **9**
 Clock To:
 1st Value:
 2nd Value:
 Value Percent:
 Continuous Index:
 Within 8" of Joint: **NO**
 Remarks:

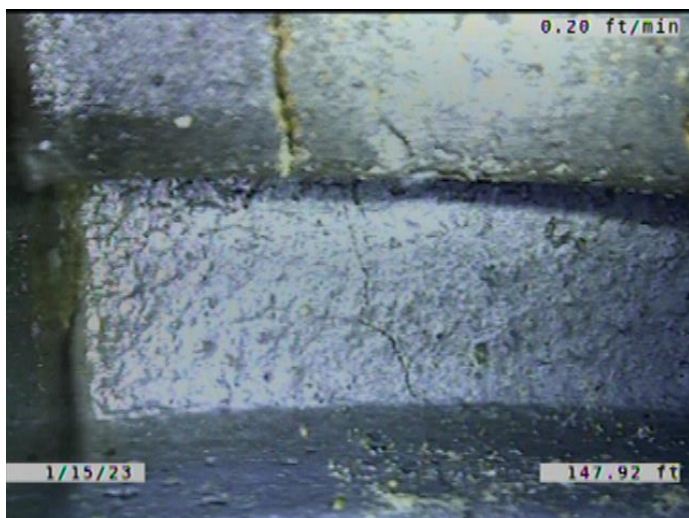
Code: **JAL**
 Description: **Joint Angular Large**

Distance (ft): **147.8**
 Structural Grade: **4**
 O&M Grade: **0**
 Clock Start/From:
 Clock To:
 1st Value:
 2nd Value:
 Value Percent:
 Continuous Index:
 Within 8" of Joint: **NO**
 Remarks:

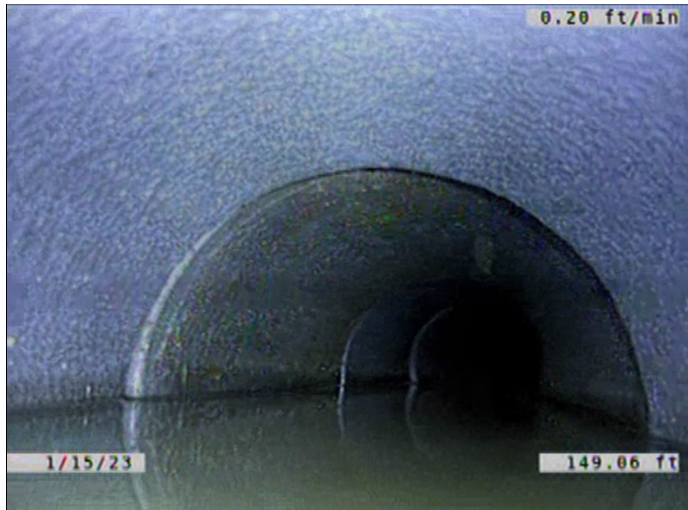
Code: **LR**
Description: **Line Right**

Distance (ft): **149.1**
Structural Grade: **0**
O&M Grade: **4**
Clock Start/From:
Clock To:
1st Value:
2nd Value:
Value Percent: **25.000**
Continuous Index:
Within 8" of Joint: **NO**
Remarks:

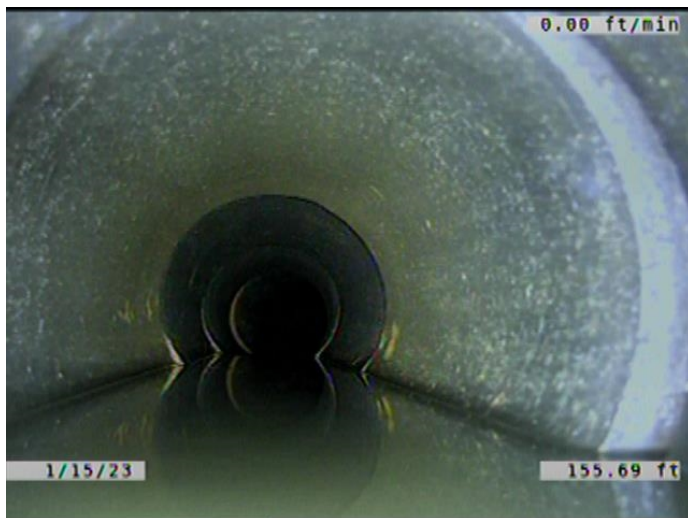
Code: **MWL**
Description: **Miscellaneous Water Level**

Distance (ft): **155.7**
Structural Grade: **0**
O&M Grade: **0**
Clock Start/From:
Clock To:
1st Value:
2nd Value:
Value Percent: **15.000**
Continuous Index:
Within 8" of Joint: **NO**
Remarks:

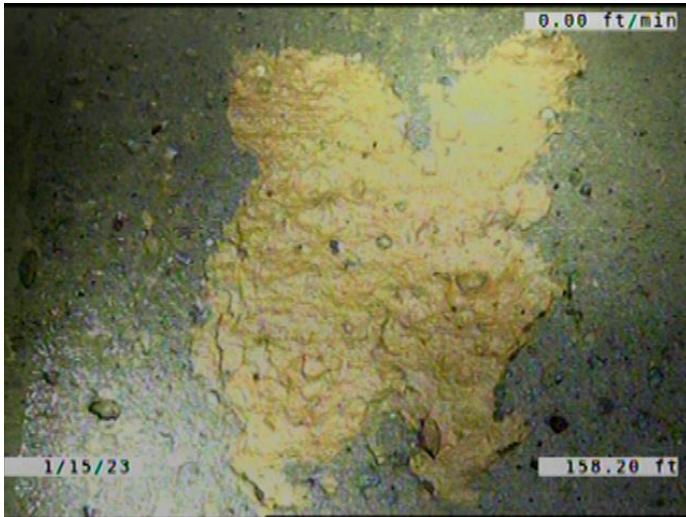
Code: **SSS**
Description: **Surface Damage Surface Spalling**

Distance (ft): **158.2**
Structural Grade: **2**
O&M Grade: **0**
Clock Start/From: **3**
Clock To:
1st Value:
2nd Value:
Value Percent:
Continuous Index:
Within 8" of Joint: **NO**
Remarks:

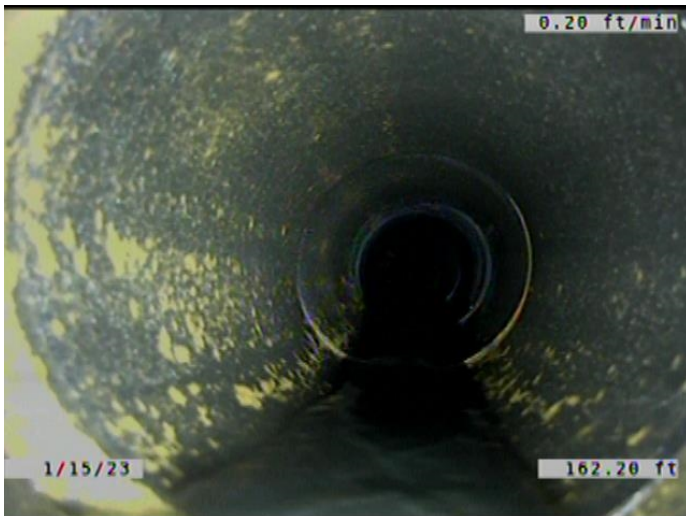
Code: **MWL**
Description: **Miscellaneous Water Level**

Distance (ft): **162.2**
Structural Grade: **0**
O&M Grade: **0**
Clock Start/From:
Clock To:
1st Value:
2nd Value:
Value Percent: **5.000**
Continuous Index:
Within 8" of Joint: **NO**
Remarks:

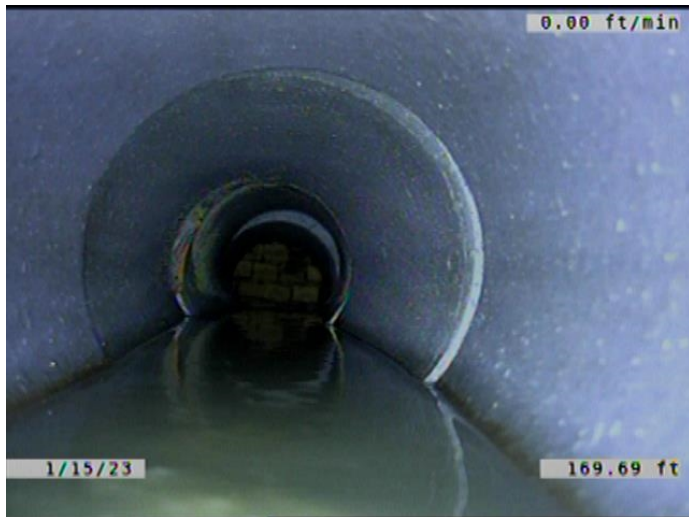
Code: **MWLS**
 Description: **Miscellaneous Water Level Sag**

Distance (ft): **169.7**
 Structural Grade: **2**
 O&M Grade: **0**
 Clock Start/From:
 Clock To:
 1st Value:
 2nd Value:
 Value Percent: **15.000**
 Continuous Index: **S05**
 Within 8" of Joint: **NO**
 Remarks:

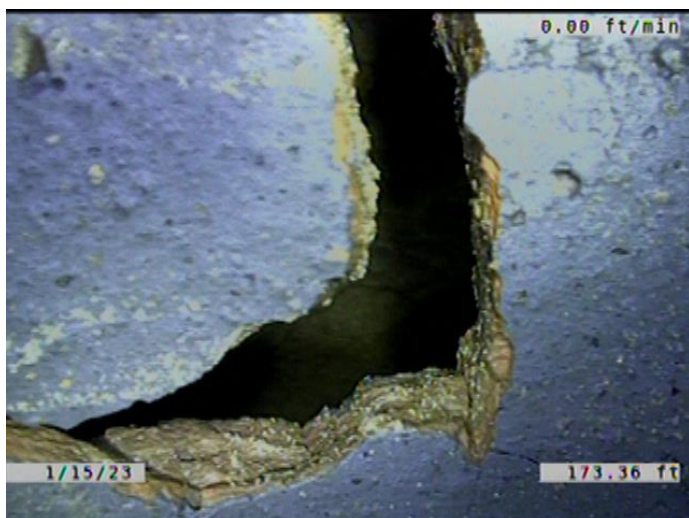
Code: **BVV**
 Description: **Broken Void Visible**

Distance (ft): **173.4**
 Structural Grade: **5**
 O&M Grade: **0**
 Clock Start/From: **8**
 Clock To: **12**
 1st Value:
 2nd Value:
 Value Percent:
 Continuous Index:
 Within 8" of Joint: **YES**
 Remarks: **SOIL AND VOID VISIBLE.**

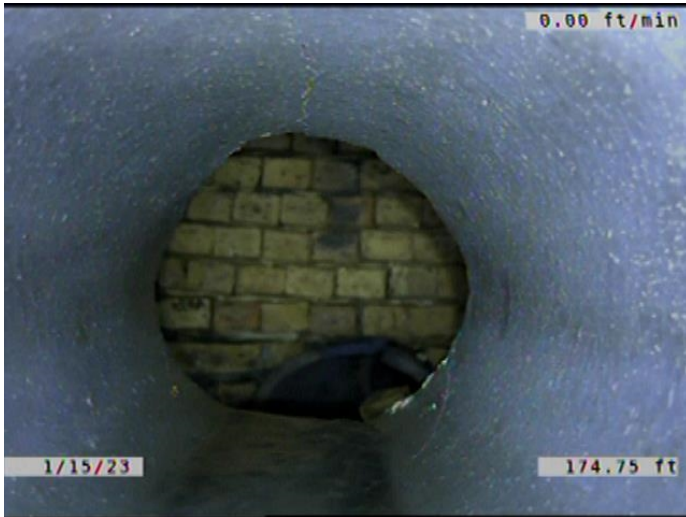
Code: **MWLS**
Description: **Miscellaneous Water Level Sag**

Distance (ft): **174.7**
Structural Grade: **2**
O&M Grade: **0**
Clock Start/From:
Clock To:
1st Value:
2nd Value:
Value Percent: **15.000**
Continuous Index: **F05**
Within 8" of Joint: **NO**
Remarks:

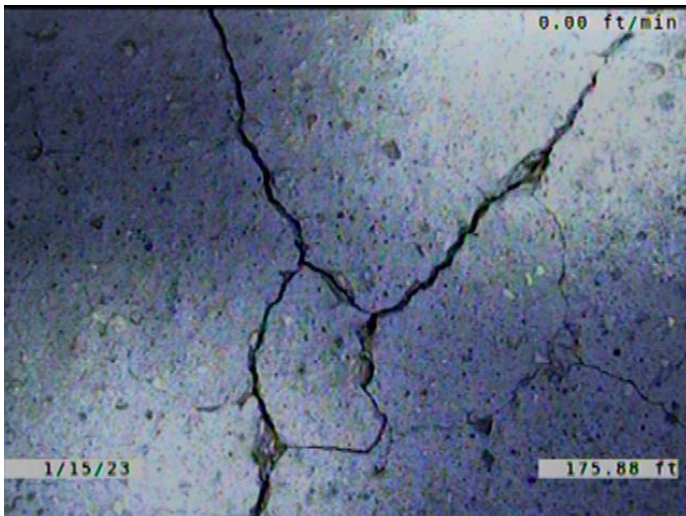
Code: **BVV**
Description: **Broken Void Visible**

Distance (ft): **175.9**
Structural Grade: **5**
O&M Grade: **0**
Clock Start/From: **12**
Clock To: **12**
1st Value:
2nd Value:
Value Percent:
Continuous Index:
Within 8" of Joint: **YES**
Remarks:

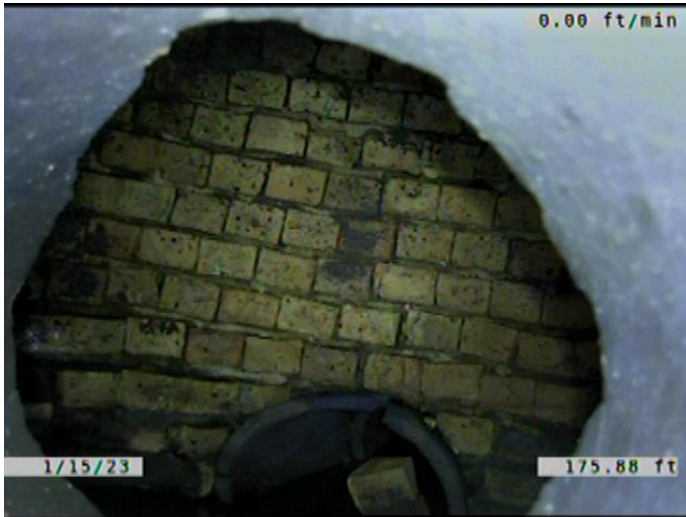
Code: **RFJ**
 Description: **Roots Fine Joint**

Distance (ft): **175.9**
 Structural Grade: **0**
 O&M Grade: **1**
 Clock Start/From: **9**
 Clock To: **3**
 1st Value:
 2nd Value:
 Value Percent:
 Continuous Index: **F01**
 Within 8" of Joint: **YES**
 Remarks:

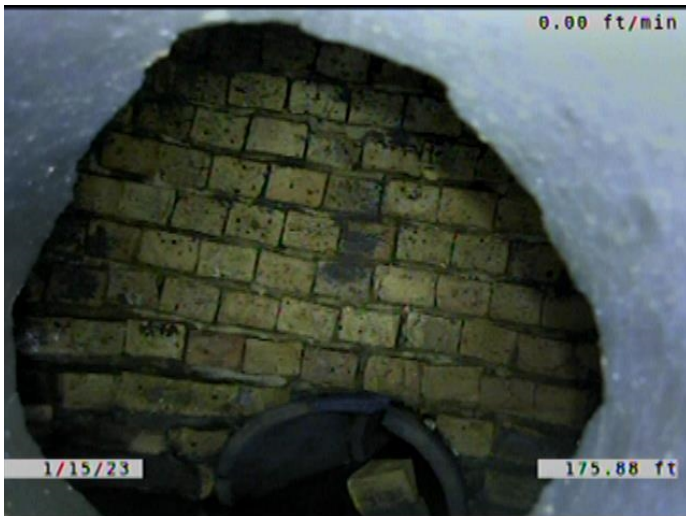
Code: **FM**
 Description: **Fracture Multiple**

Distance (ft): **175.9**
 Structural Grade: **4**
 O&M Grade: **0**
 Clock Start/From: **8**
 Clock To: **4**
 1st Value:
 2nd Value:
 Value Percent:
 Continuous Index: **F02**
 Within 8" of Joint: **YES**
 Remarks:

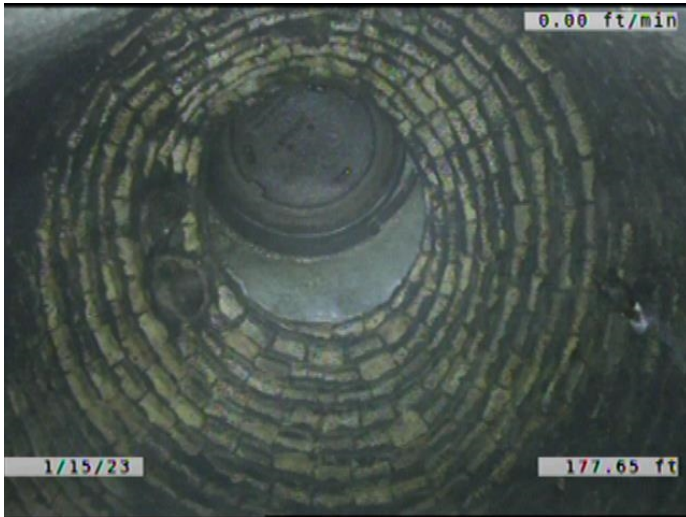
Code:	AMH
Description:	Manhole
Distance (ft):	177.6
Structural Grade:	0
O&M Grade:	0
Clock Start/From:	
Clock To:	
1st Value:	
2nd Value:	
Value Percent:	
Continuous Index:	
Within 8" of Joint:	NO
Remarks:	M-805-058
