Profile/Photo Observation Report

Date:	04/19/2018	Weather:		Coding:	PACP 6.0
Pipe Length (ft):	219.2	Owner:	NA	Pre Clean:	Not Known
P.O.#:		Surveyor:	Byrd Fitzgerald	PSR:	P-805-065-062
Customer:		Clean Date:	01/01/1900	Shape:	C

Street:	E 1st Pl.	Flow Control:	Not Controlled
City:	Hobart, IN	Year Renewed:	
Location:	Other	Tape/Media #:	
Purpose:	Not Known	Dia/Height:	8"
Use:	Sanitary	Material:	PVC
Drain Area:	NA	Lining:	
Category:	NA		
Comment:

Location Details:		Direction of Survey:	Downstream
US MH:	M-805-062	DS MH:	M-805-065
		Total Length Surveyed (ft):	216.3

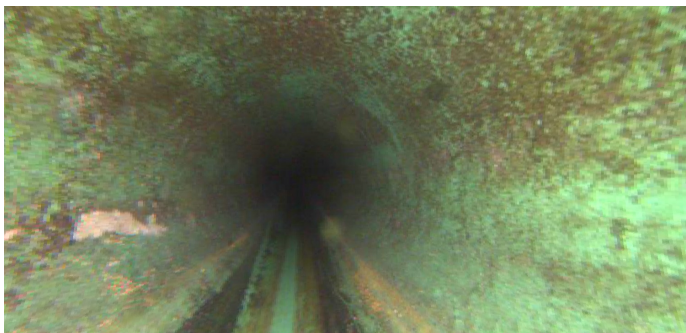
Code: **AMH**
Description: **Manhole**

Distance (ft): **.0**
Structural Grade: **0**
O&M Grade: **0**
Clock Start/From:
Clock To:
1st Value:
2nd Value:
Value Percent:
Continuous Index:
Within 8" of Joint: **NO**
Remarks: **M-805-062**

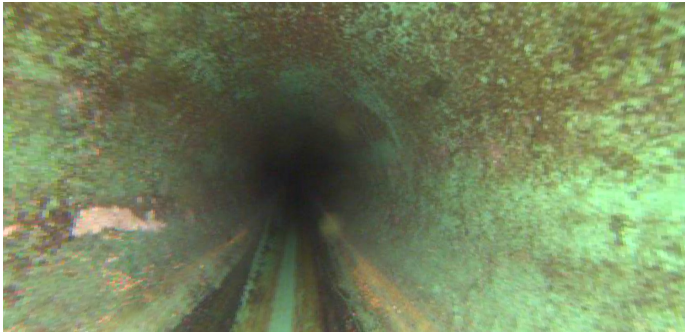
Code:	MWL
Description:	Water Level

Distance (ft):	.0
Structural Grade:	0
O&M Grade:	0
Clock Start/From:	
Clock To:	
1st Value:	
2nd Value:	
Value Percent:	5.000
Continuous Index:	
Within 8" of Joint:	NO
Remarks:

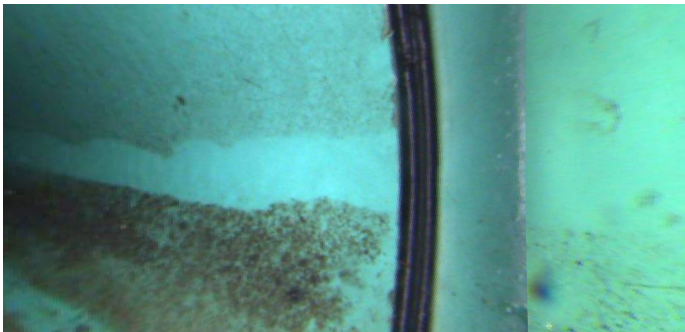
Code:	ISSR
Description:	Intruding Sealing Ring

Distance (ft):	40.5
Structural Grade:	0
O&M Grade:	2
Clock Start/From:	7
Clock To:	10
1st Value:	
2nd Value:	
Value Percent:	5.000
Continuous Index:	
Within 8" of Joint:	NO
Remarks:

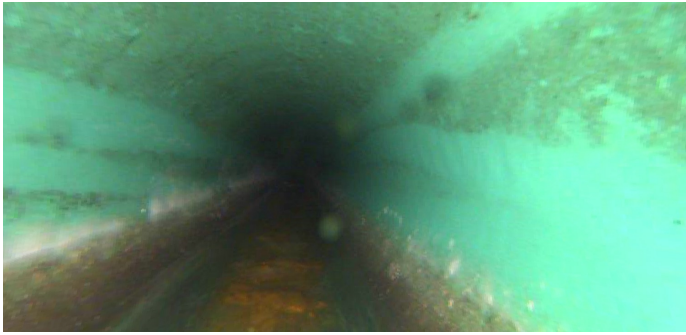
Code: **DSZ**
Description: **Deposits Settled Other**

Distance (ft): **146.2**
Structural Grade: **0**
O&M Grade: **2**
Clock Start/From: **6**
Clock To:
1st Value:
2nd Value:
Value Percent: **5.000**
Continuous Index: **S01**
Within 8" of Joint: **NO**
Remarks: **debris**

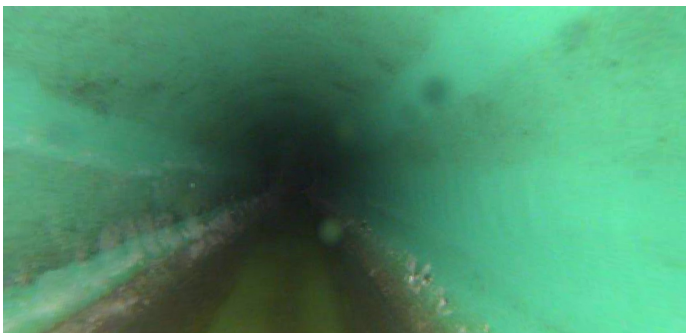
Code: **DSZ**
Description: **Deposits Settled Other**

Distance (ft): **160.9**
Structural Grade: **0**
O&M Grade: **2**
Clock Start/From: **6**
Clock To:
1st Value:
2nd Value:
Value Percent: **5.000**
Continuous Index: **F01**
Within 8" of Joint: **NO**
Remarks: **debris**

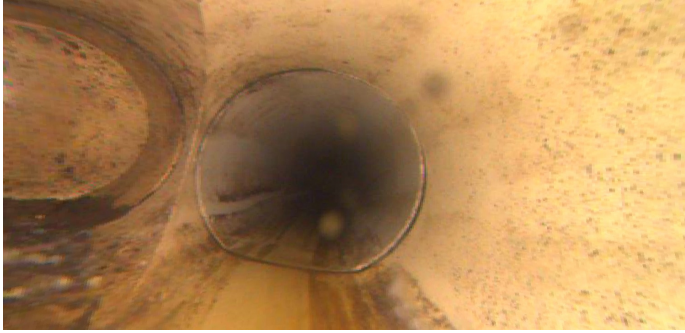
Code: **TFC**
Description: **Tap Factory Capped**

Distance (ft): **165.9**
Structural Grade: **0**
O&M Grade: **0**
Clock Start/From: **10**
Clock To:
1st Value: **4.000**
2nd Value:
Value Percent:
Continuous Index:
Within 8" of Joint: **YES**
Remarks:

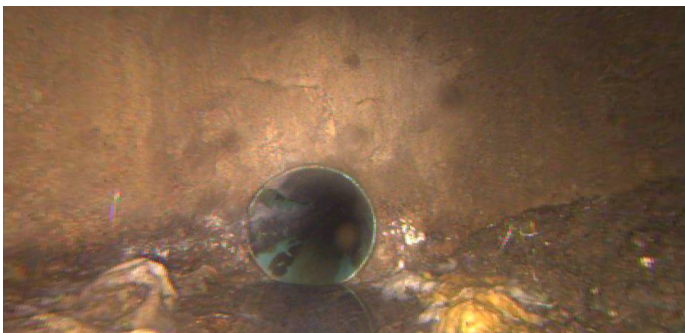
Code: **AMH**
Description: **Manhole**

Distance (ft): **216.3**
Structural Grade: **0**
O&M Grade: **0**
Clock Start/From:
Clock To:
1st Value:
2nd Value:
Value Percent:
Continuous Index:
Within 8" of Joint: **NO**
Remarks: **M-805-065**
