## Profile/Photo Observation Report

O&M Index:	2.00	O&M Quick:	2500	O&M Rating:	10.00
Structural Index:	2.64	Structural Quick:	4138	Structural Rating:	37.00
Overall Index:	2.47	Overall Quick:	4138	Overall Rating:	47.00

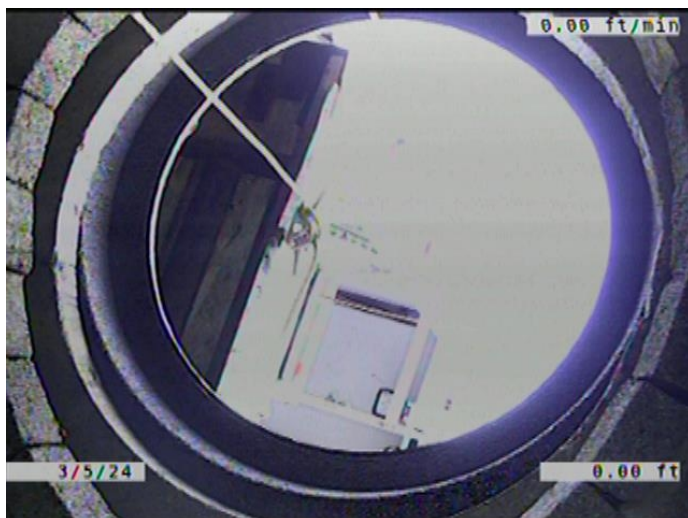
Code: **AMH**  
Description: **Manhole**

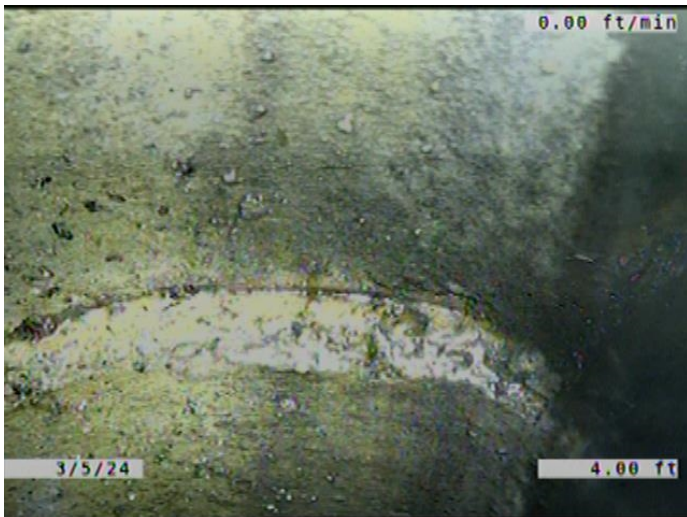
Code: **JOMD**  
Description: **Joint Offset Medium Defective**

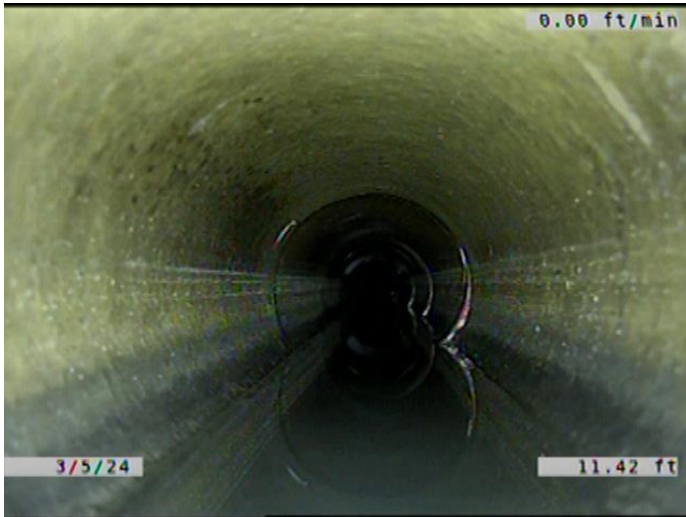
Code:	<b>MWLS</b>
Description:	<b>Miscellaneous Water Level Sag</b>
Distance (ft):	<b>11.4</b>
Structural Grade:	<b>2</b>
O&M Grade:	<b>0</b>
Clock Start/From:	
Clock To:	
1st Value:	
2nd Value:	
Value Percent:	<b>15.000</b>
Continuous Index:	<b>S02</b>
Within 8" of Joint:	<b>NO</b>
Remarks:

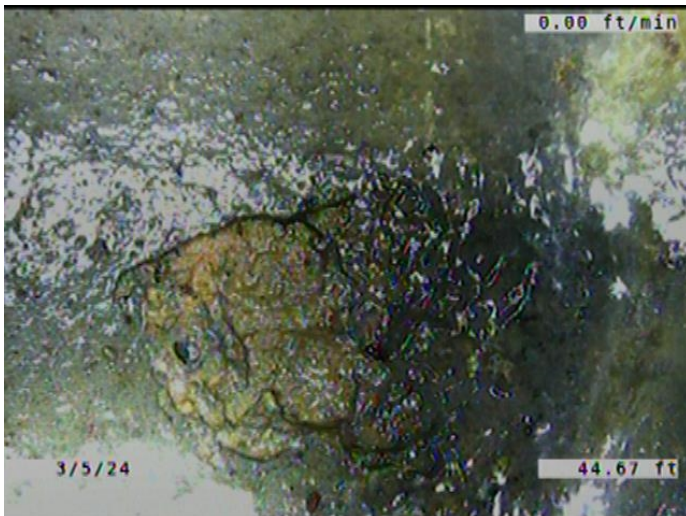
Code: **SSC**  
 Description: **Surface Spalling of Damage Coating**

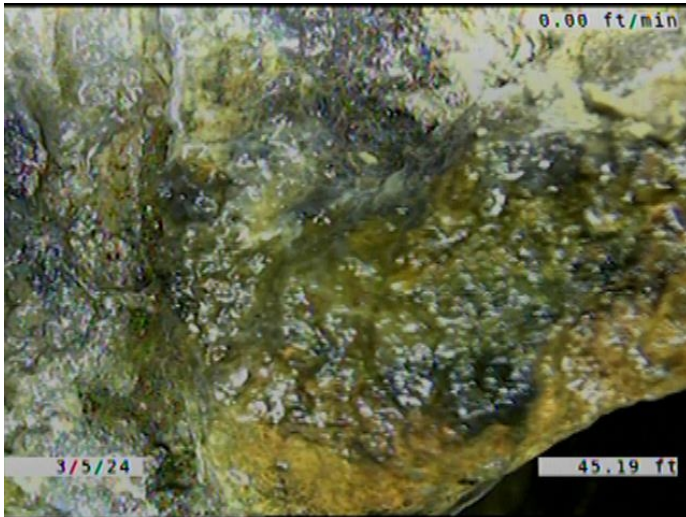
Code: **DAE**  
Description: **Deposits Attached Encrustation**

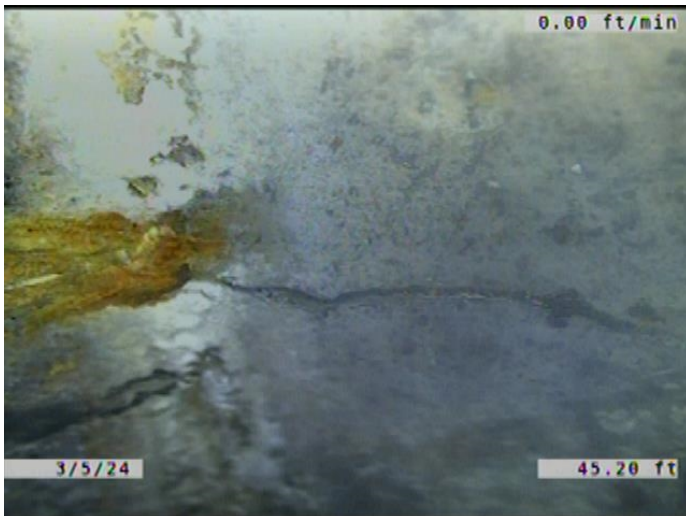
Code: **FM**  
Description: **Fracture Multiple**

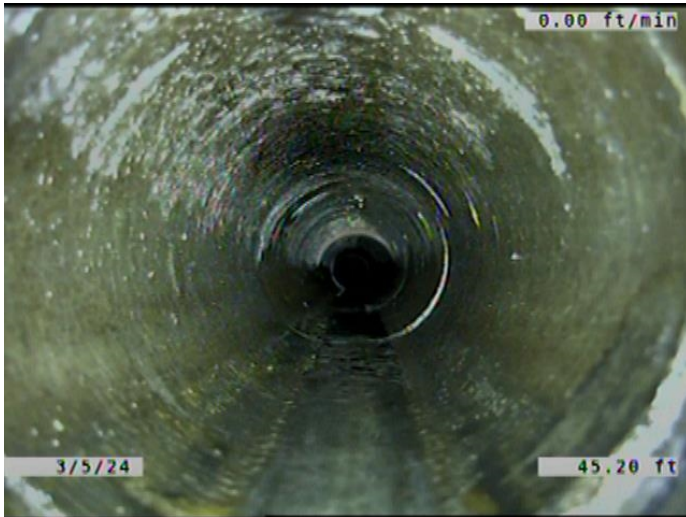
Code: **JOMD**  
Description: **Joint Offset Medium Defective**
