## Profile/Photo Observation Report

Date:	<b>04/23/2018</b>	Weather:		Coding:	<b>PACP 6.0</b>
Pipe Length (ft):	<b>456.2</b>	Owner:	<b>NA</b>	Pre Clean:	<b>Not Known</b>
P.O.#:		Surveyor:	<b>Jen Costello</b>	PSR:	<b>P-905-035-068</b>
Customer:		Clean Date:	<b>01/01/1900</b>	Shape:	<b>C</b>

Street:	<b>Hobart</b>	Flow Control:	<b>Not Controlled</b>
City:	<b>Hobart, IN</b>	Year Renewed:	
Location:	<b>Parking Lot</b>	Tape/Media #:	
Purpose:	<b>Maintenance Related</b>	Dia/Height:	<b>8"</b>
Use:	<b>Sanitary</b>	Material:	<b>PVC</b>
Drain Area:	<b>NA</b>	Lining:	<b>Cured in Place</b>
Category:	<b>NA</b>		
Comment:	<b>Robot issue.</b>

Location Details:		Direction of Survey:	<b>Upstream</b>
US MH:	<b>M-805-068</b>	DS MH:	<b>M-905-035</b>
		Total Length Surveyed (ft):	<b>9.5</b>

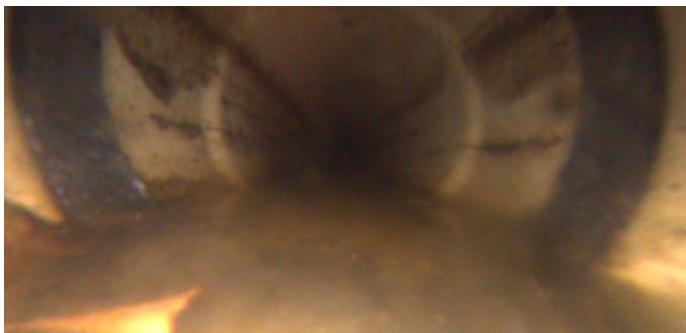
Code: **AMH**  
Description: **Manhole**

Distance (ft): **.0**  
Structural Grade: **0**  
O&M Grade: **0**  
Clock Start/From:  
Clock To:  
1st Value:  
2nd Value:  
Value Percent:  
Continuous Index:  
Within 8" of Joint: **NO**  
Remarks: **M-905-035**

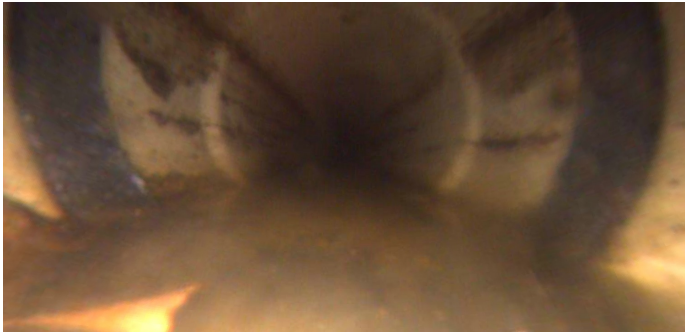
Code:	<b>MWL</b>
Description:	<b>Water Level</b>

Distance (ft):	<b>.0</b>
Structural Grade:	<b>0</b>
O&M Grade:	<b>0</b>
Clock Start/From:	
Clock To:	
1st Value:	
2nd Value:	
Value Percent:	<b>10.000</b>
Continuous Index:	
Within 8" of Joint:	<b>NO</b>
Remarks:

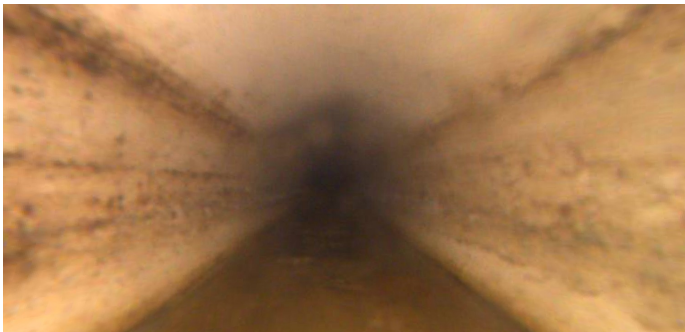
Code:	<b>MSA</b>
Description:	<b>Abandoned Survey</b>

Distance (ft):	<b>9.5</b>
Structural Grade:	<b>0</b>
O&M Grade:	<b>0</b>
Clock Start/From:	
Clock To:	
1st Value:	
2nd Value:	
Value Percent:	
Continuous Index:	
Within 8" of Joint:	<b>NO</b>
Remarks:	<b>UNKNOWN</b>
