Profile/Photo Observation Report

Street:	Hobart	Flow Control:	Not Controlled
City:	Hobart, IN	Year Renewed:	
Location:	Parking Lot	Tape/Media #:	
Purpose:	Maintenance Related	Dia/Height:	8"
Use:	Sanitary	Material:	PVC
Drain Area:	NA	Lining:	Cured in Place
Category:	NA		
Comment:	Flow direction wrong. Unknown reason for stop.		
Location Details:		Direction of Survey:	Upstream
US MH:	M-805-068	DS MH:	M-905-035
		Total Length Surveyed (ft):	26.1

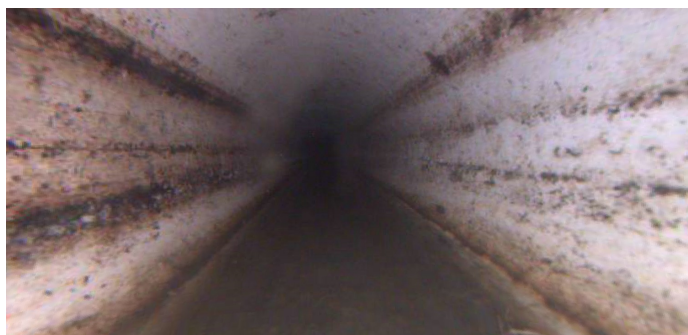
Code: **AMH**
Description: **Manhole**

Distance (ft): **.0**
Structural Grade: **0**
O&M Grade: **0**
Clock Start/From:
Clock To:
1st Value:
2nd Value:
Value Percent:
Continuous Index:
Within 8" of Joint: **NO**
Remarks: **M-905-035**

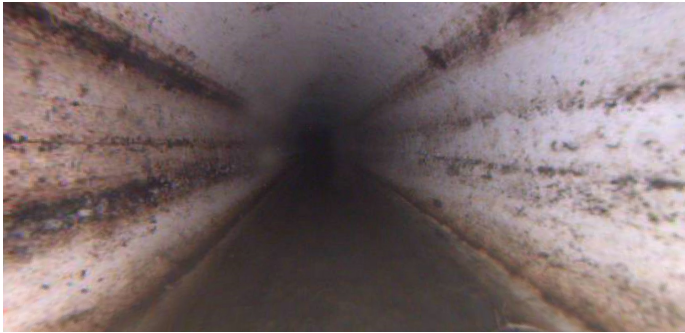
Code:	MWL
Description:	Water Level

Distance (ft):	.0
Structural Grade:	0
O&M Grade:	0
Clock Start/From:	
Clock To:	
1st Value:	
2nd Value:	
Value Percent:	10.000
Continuous Index:	
Within 8" of Joint:	NO
Remarks:

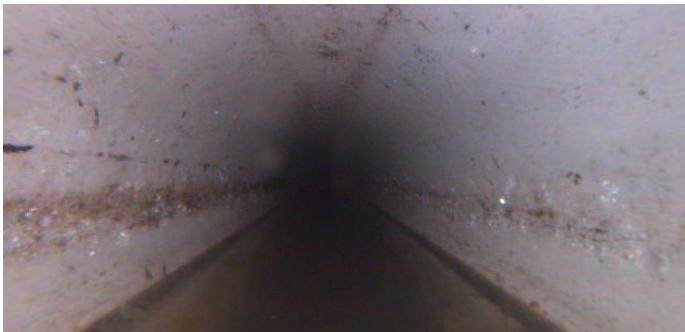
Code:	MSA
Description:	Abandoned Survey

Distance (ft):	26.1
Structural Grade:	0
O&M Grade:	0
Clock Start/From:	
Clock To:	
1st Value:	
2nd Value:	
Value Percent:	
Continuous Index:	
Within 8" of Joint:	NO
Remarks:	DEBRIS UNDER WATER
