Profile/Photo Observation Report

Date:	04/23/2018	Weather:		Coding:	PACP 6.0
Pipe Length (ft):	456.2	Owner:	NA	Pre Clean:	Not Known
P.O.#:		Surveyor:	Jen Costello	PSR:	P-905-035-068
Customer:		Clean Date:	01/01/1900	Shape:	C

Street:	S HOBART RD	Flow Control:	Not Controlled
City:	Hobart, IN	Year Renewed:	
Location:	Alley	Tape/Media #:	
Purpose:	Maintenance Related	Dia/Height:	8"
Use:	Sanitary	Material:	PVC
Drain Area:	NA	Lining:	Cured in Place
Category:	NA		
Comment:	Flow direction wrong. Reverse setup.		
Location Details:		Direction of Survey:	Downstream
US MH:	M-805-068	DS MH:	M-905-035
		Total Length Surveyed (ft):	30.3

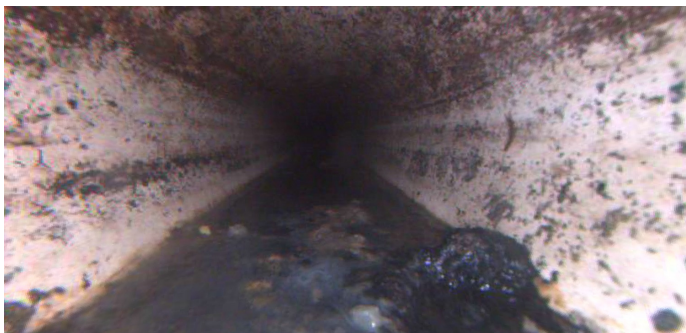
Code: **AMH**
Description: **Manhole**

Distance (ft): **.0**
Structural Grade: **0**
O&M Grade: **0**
Clock Start/From:
Clock To:
1st Value:
2nd Value:
Value Percent:
Continuous Index:
Within 8" of Joint: **NO**
Remarks: **M-805-068**

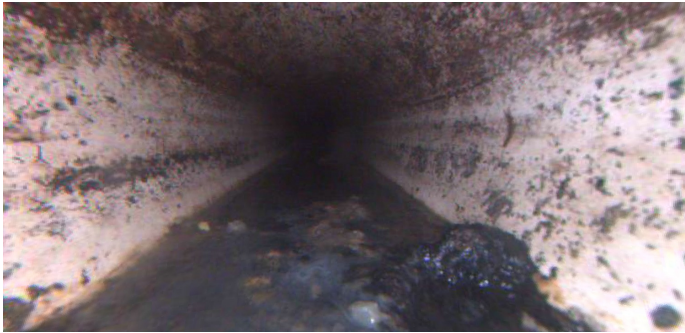
Code:	MWL
Description:	Water Level

Distance (ft):	.0
Structural Grade:	0
O&M Grade:	0
Clock Start/From:	
Clock To:	
1st Value:	
2nd Value:	
Value Percent:	10.000
Continuous Index:	
Within 8" of Joint:	NO
Remarks:

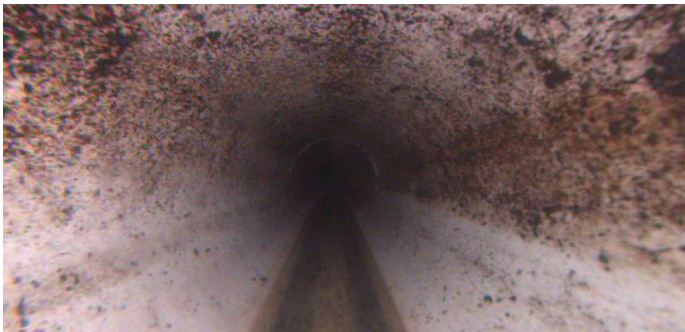
Code:	MWL
Description:	Water Level

Distance (ft):	10.4
Structural Grade:	0
O&M Grade:	0
Clock Start/From:	
Clock To:	
1st Value:	
2nd Value:	
Value Percent:	5.000
Continuous Index:	
Within 8" of Joint:	NO
Remarks:

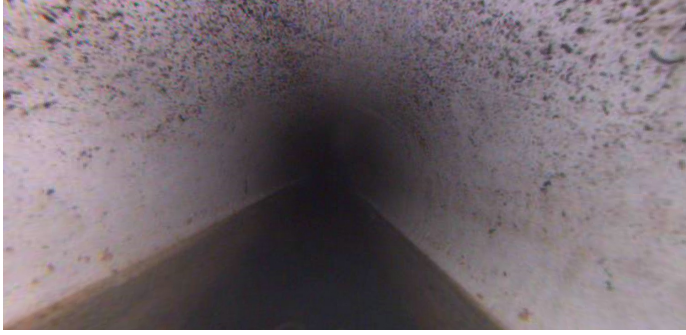
Code:	MSA
Description:	Abandoned Survey
Distance (ft):	30.3
Structural Grade:	0
O&M Grade:	0
Clock Start/From:	
Clock To:	
1st Value:	
2nd Value:	
Value Percent:	
Continuous Index:	
Within 8" of Joint:	NO
Remarks:	UNKNOWN
