Profile/Photo Observation Report

Street:	Hobart	Flow Control:	Not Controlled
City:	Hobart, IN	Year Renewed:	
Location:	Alley	Tape/Media #:	
Purpose:	Maintenance Related	Dia/Height:	8"
Use:	Sanitary	Material:	PVC
Drain Area:	NA	Lining:	Cured in Place
Category:	NA		
Comment:	Flow direction wrong. Reverse setup.		
Location Details:		Direction of Survey:	Downstream
US MH:	M-805-068	DS MH:	M-905-035
		Total Length Surveyed (ft):	30.3

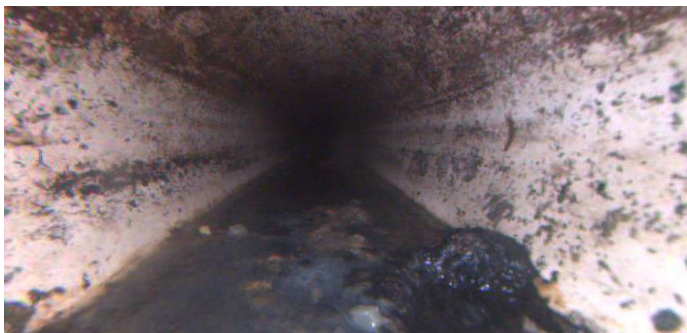
Code: **AMH**
Description: **Manhole**

Distance (ft): **.0**
Structural Grade: **0**
O&M Grade: **0**
Clock Start/From:
Clock To:
1st Value:
2nd Value:
Value Percent:
Continuous Index:
Within 8" of Joint: **NO**
Remarks: **M-805-068**

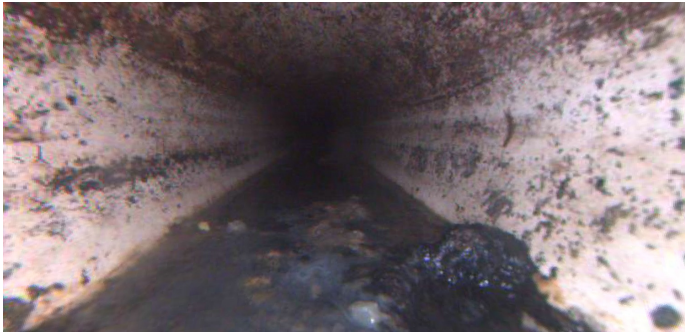
Code:	MWL
Description:	Water Level

Distance (ft):	.0
Structural Grade:	0
O&M Grade:	0
Clock Start/From:	
Clock To:	
1st Value:	
2nd Value:	
Value Percent:	10.000
Continuous Index:	
Within 8" of Joint:	NO
Remarks:

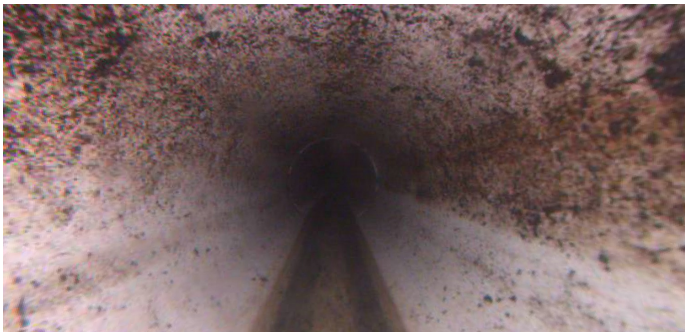
Code:	MWL
Description:	Water Level

Distance (ft):	10.4
Structural Grade:	0
O&M Grade:	0
Clock Start/From:	
Clock To:	
1st Value:	
2nd Value:	
Value Percent:	5.000
Continuous Index:	
Within 8" of Joint:	NO
Remarks:

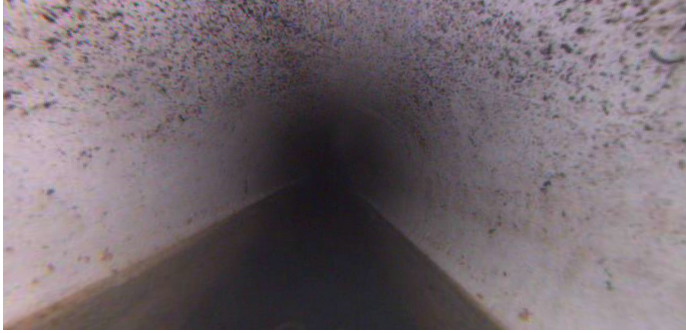
Code:	MSA
Description:	Abandoned Survey
Distance (ft):	30.3
Structural Grade:	0
O&M Grade:	0
Clock Start/From:	
Clock To:	
1st Value:	
2nd Value:	
Value Percent:	
Continuous Index:	
Within 8" of Joint:	NO
Remarks:	UNKNOWN
