## Profile/Photo Observation Report

| Street: | <b>S HOBART RD</b> | Flow Control: | <b>Not Controlled</b> |
| City: | <b>Hobart, IN</b> | Year Renewed: | |
| US MH: | <b>M-805-068</b> | DS MH: | <b>M-905-035</b> |

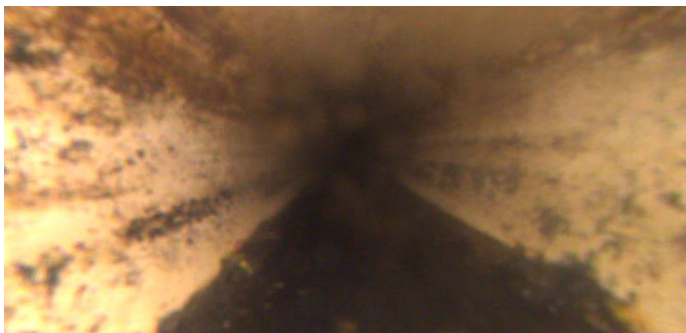
Code: **AMH**  
Description: **Manhole**

Distance (ft): **.0**  
Structural Grade: **0**  
O&M Grade: **0**  
Clock Start/From:  
Clock To:  
1st Value:  
2nd Value:  
Value Percent:  
Continuous Index:  
Within 8" of Joint: **NO**  
Remarks: **M-805-068**

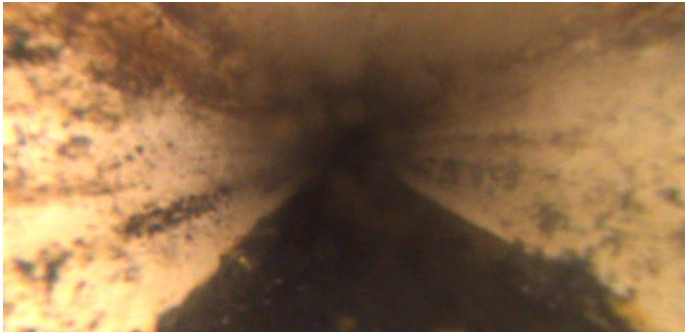
| Code: | <b>MWL</b> |
| Description: | <b>Water Level</b> |

| Distance (ft): | <b>.0</b> |
| Value Percent: | <b>10.000</b> |

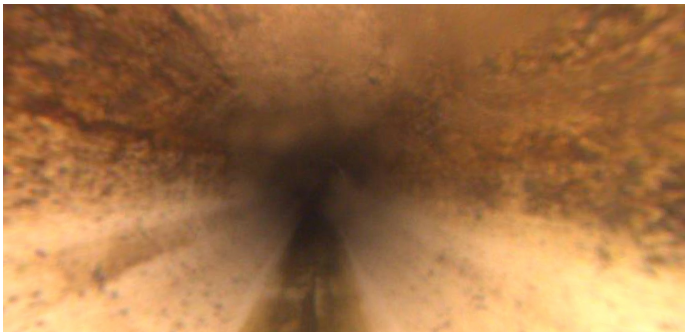
| Code: | <b>MWL</b> |
| Description: | <b>Water Level</b> |

| Distance (ft): | <b>9.2</b> |
| Value Percent: | <b>5.000</b> |

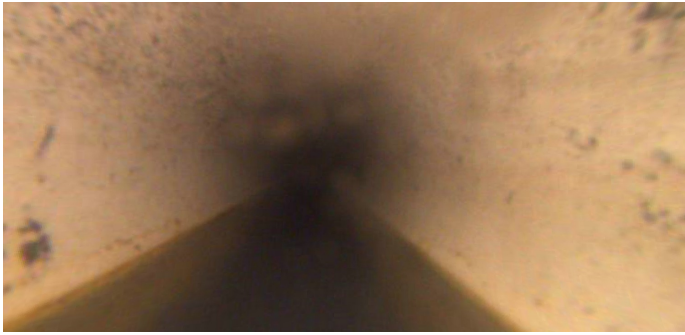
Code: **MWL**  
Description: **Water Level**

Distance (ft): **31.1**  
Structural Grade: **0**  
O&M Grade: **0**  
Clock Start/From:  
Clock To:  
1st Value:  
2nd Value:  
Value Percent: **30.000**  
Continuous Index:  
Within 8" of Joint: **NO**  
Remarks:

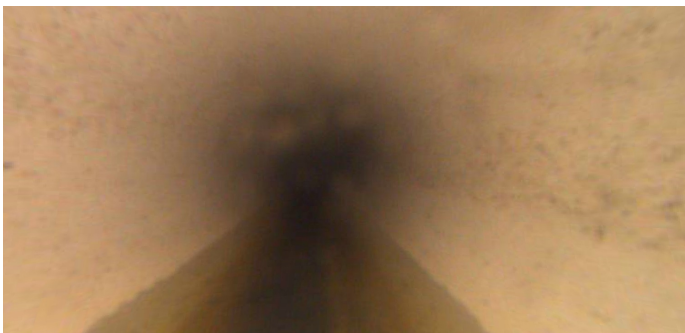
Code: **MWL**  
Description: **Water Level**

Distance (ft): **65.1**  
Structural Grade: **0**  
O&M Grade: **0**  
Clock Start/From:  
Clock To:  
1st Value:  
2nd Value:  
Value Percent: **10.000**  
Continuous Index:  
Within 8" of Joint: **NO**  
Remarks:

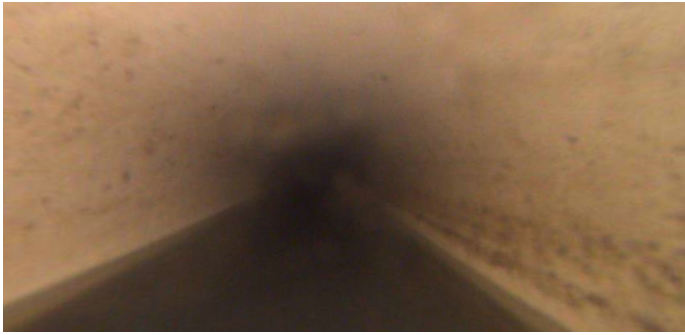
Code: **MWL**  
Description: **Water Level**

Distance (ft): **118.4**  
Structural Grade: **0**  
O&M Grade: **0**  
Clock Start/From:  
Clock To:  
1st Value:  
2nd Value:  
Value Percent: **40.000**  
Continuous Index:  
Within 8" of Joint: **NO**  
Remarks:

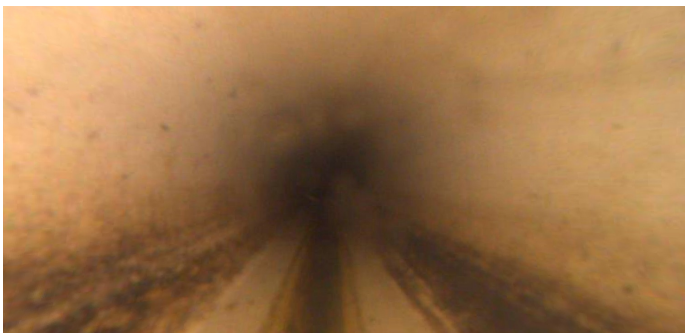
Code: **MWL**  
Description: **Water Level**

Distance (ft): **164.3**  
Structural Grade: **0**  
O&M Grade: **0**  
Clock Start/From:  
Clock To:  
1st Value:  
2nd Value:  
Value Percent: **5.000**  
Continuous Index:  
Within 8" of Joint: **NO**  
Remarks:

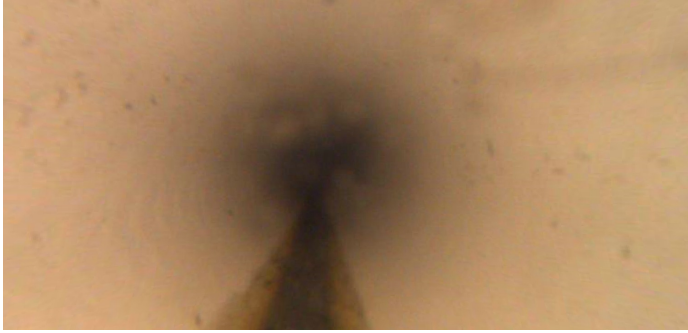
| Comment: | <b>Flow direction wrong. Redeployment.</b> | | |

| Code: | <b>MSA</b> |
| Description: | <b>Abandoned Survey</b> |
| Distance (ft): | <b>375.7</b> |
