## Profile/Photo Observation Report

Date:	<b>04/23/2018</b>	Weather:		Coding:	<b>PACP 6.0</b>
Pipe Length (ft):	<b>456.2</b>	Owner:	<b>NA</b>	Pre Clean:	<b>Not Known</b>
P.O.#:		Surveyor:	<b>Jen Costello</b>	PSR:	<b>P-905-035-068</b>
Customer:		Clean Date:	<b>01/01/1900</b>	Shape:	<b>C</b>

Street:	<b>Hobart</b>	Flow Control:	<b>Not Controlled</b>
City:	<b>Hobart, IN</b>	Year Renewed:	
Location:	<b>Alley</b>	Tape/Media #:	
Purpose:	<b>Maintenance Related</b>	Dia/Height:	<b>8"</b>
Use:	<b>Sanitary</b>	Material:	<b>PVC</b>
Drain Area:	<b>NA</b>	Lining:	<b>Cured in Place</b>
Category:	<b>NA</b>		
Comment:	<b>Flow direction wrong. Redeployment.</b>		
Location Details:		Direction of Survey:	<b>Downstream</b>
US MH:	<b>M-805-068</b>	DS MH:	<b>M-905-035</b>
		Total Length Surveyed (ft):	<b>375.7</b>

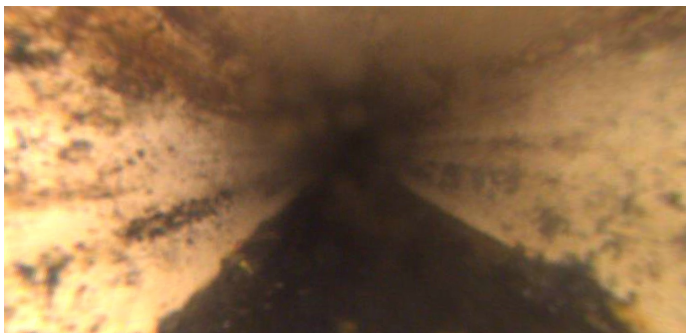
Code: **AMH**  
Description: **Manhole**

Distance (ft): **.0**  
Structural Grade: **0**  
O&M Grade: **0**  
Clock Start/From:  
Clock To:  
1st Value:  
2nd Value:  
Value Percent:  
Continuous Index:  
Within 8" of Joint: **NO**  
Remarks: **M-805-068**

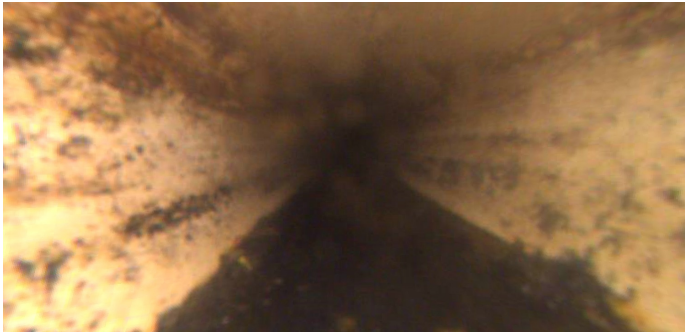
Code:	<b>MWL</b>
Description:	<b>Water Level</b>

Distance (ft):	<b>.0</b>
Structural Grade:	<b>0</b>
O&M Grade:	<b>0</b>
Clock Start/From:	
Clock To:	
1st Value:	
2nd Value:	
Value Percent:	<b>10.000</b>
Continuous Index:	
Within 8" of Joint:	<b>NO</b>
Remarks:

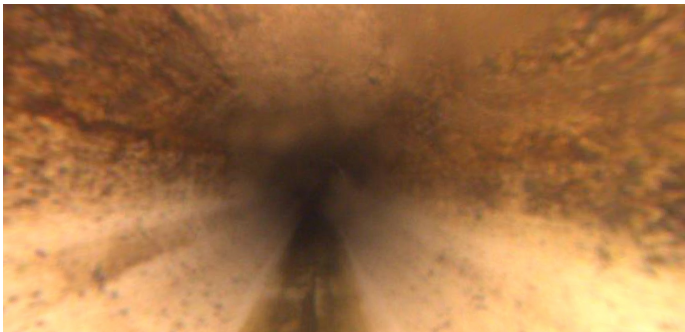
Code:	<b>MWL</b>
Description:	<b>Water Level</b>

Distance (ft):	<b>9.2</b>
Structural Grade:	<b>0</b>
O&M Grade:	<b>0</b>
Clock Start/From:	
Clock To:	
1st Value:	
2nd Value:	
Value Percent:	<b>5.000</b>
Continuous Index:	
Within 8" of Joint:	<b>NO</b>
Remarks:

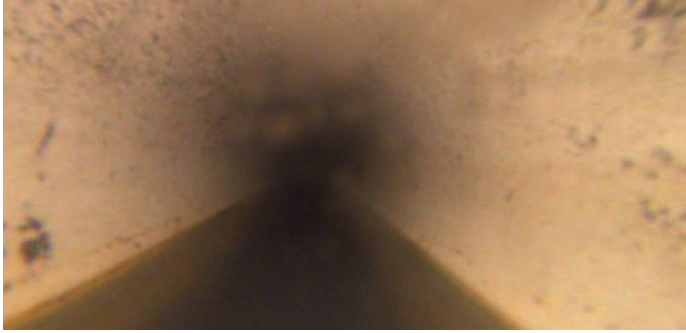
Code: **MWL**  
Description: **Water Level**

Distance (ft): **31.1**  
Structural Grade: **0**  
O&M Grade: **0**  
Clock Start/From:  
Clock To:  
1st Value:  
2nd Value:  
Value Percent: **30.000**  
Continuous Index:  
Within 8" of Joint: **NO**  
Remarks:

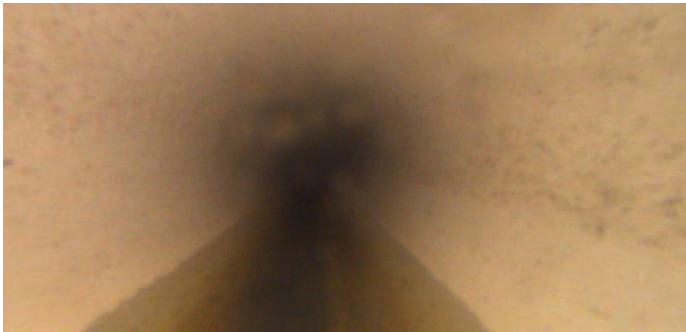
Code: **MWL**  
Description: **Water Level**

Distance (ft): **65.1**  
Structural Grade: **0**  
O&M Grade: **0**  
Clock Start/From:  
Clock To:  
1st Value:  
2nd Value:  
Value Percent: **10.000**  
Continuous Index:  
Within 8" of Joint: **NO**  
Remarks:

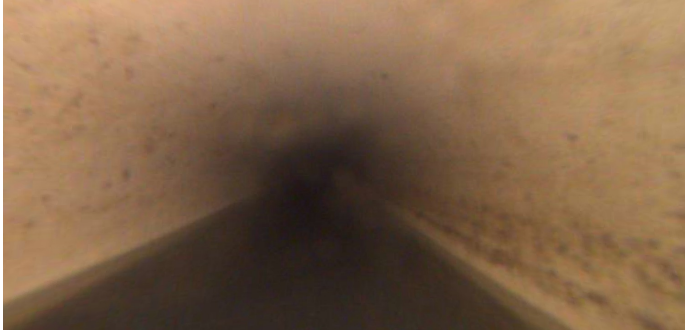
Code: **MWL**  
Description: **Water Level**

Distance (ft): **118.4**  
Structural Grade: **0**  
O&M Grade: **0**  
Clock Start/From:  
Clock To:  
1st Value:  
2nd Value:  
Value Percent: **40.000**  
Continuous Index:  
Within 8" of Joint: **NO**  
Remarks:

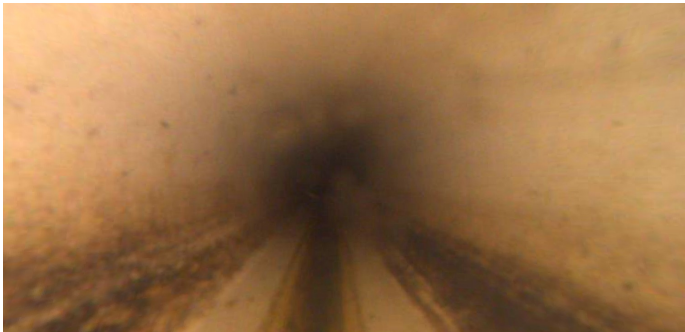
Code: **MWL**  
Description: **Water Level**

Distance (ft): **164.3**  
Structural Grade: **0**  
O&M Grade: **0**  
Clock Start/From:  
Clock To:  
1st Value:  
2nd Value:  
Value Percent: **5.000**  
Continuous Index:  
Within 8" of Joint: **NO**  
Remarks:

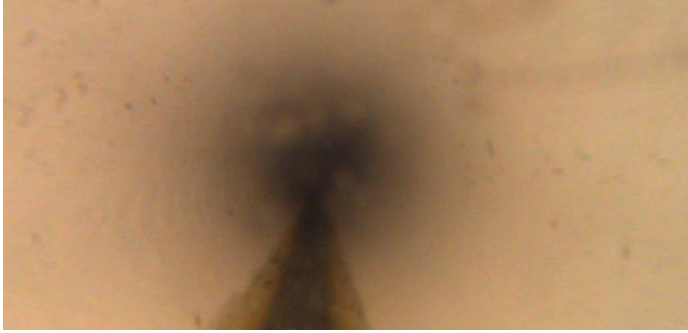
Code:	<b>MSA</b>
Description:	<b>Abandoned Survey</b>
Distance (ft):	<b>375.7</b>
Structural Grade:	<b>0</b>
O&M Grade:	<b>0</b>
Clock Start/From:	
Clock To:	
1st Value:	
2nd Value:	
Value Percent:	
Continuous Index:	
Within 8" of Joint:	<b>NO</b>
Remarks:	<b>unknown</b>
