Profile/Photo Observation Report

Street:	S HOBART RD	Flow Control:	Not Controlled
City:	Hobart, IN	Year Renewed:	
Location:	Alley	Tape/Media #:	
Purpose:	Maintenance Related	Dia/Height:	8"
Use:	Sanitary	Material:	PVC
Drain Area:	NA	Lining:	Cured in Place
Category:	NA		
Comment:	Flow direction wrong. Reverse setup.		
Location Details:		Direction of Survey:	Upstream
US MH:	M-805-068	DS MH:	M-905-035
		Total Length Surveyed (ft):	32.9

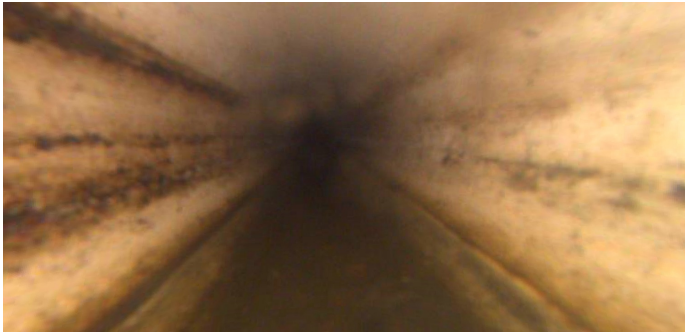
Code:	MWL
Description:	Water Level

Distance (ft):	.0
Structural Grade:	0
O&M Grade:	0
Clock Start/From:	
Clock To:	
1st Value:	
2nd Value:	
Value Percent:	10.000
Continuous Index:	
Within 8" of Joint:	NO
Remarks:

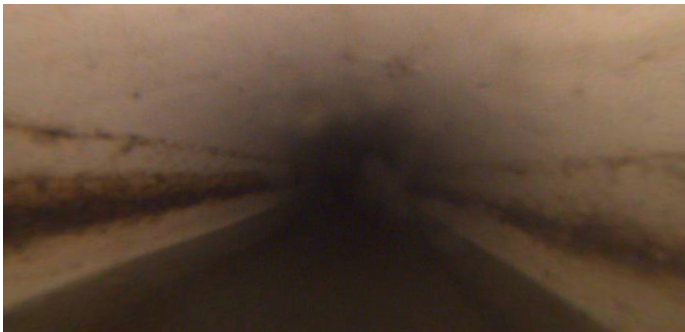
Code:	MWL
Description:	Water Level

Distance (ft):	31.1
Structural Grade:	0
O&M Grade:	0
Clock Start/From:	
Clock To:	
1st Value:	
2nd Value:	
Value Percent:	40.000
Continuous Index:	
Within 8" of Joint:	NO
Remarks:

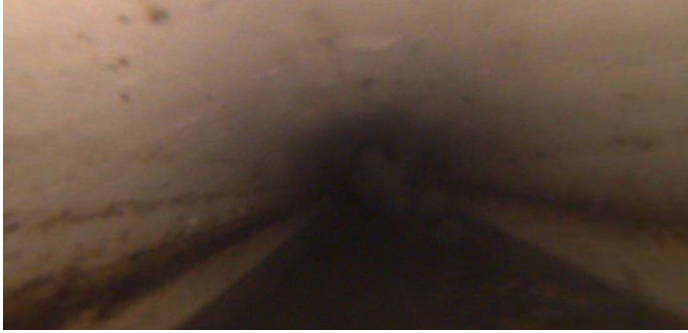
Code:	MSA
Description:	Abandoned Survey
Distance (ft):	32.9
Structural Grade:	0
O&M Grade:	0
Clock Start/From:	
Clock To:	
1st Value:	
2nd Value:	
Value Percent:	
Continuous Index:	
Within 8" of Joint:	NO
Remarks:	DEBRIS UNDER WATER
