Profile/Photo Observation Report

Date:	04/23/2018	Weather:		Coding:	PACP 6.0
Pipe Length (ft):	456.2	Owner:	NA	Pre Clean:	Not Known
P.O.#:		Surveyor:	Jen Costello	PSR:	P-905-035-068
Customer:		Clean Date:	01/01/1900	Shape:	C

Street:	Hobart	Flow Control:	Not Controlled
City:	Hobart, IN	Year Renewed:	
Location:	Alley	Tape/Media #:	
Purpose:	Maintenance Related	Dia/Height:	8"
Use:	Sanitary	Material:	PVC
Drain Area:	NA	Lining:	Cured in Place
Category:	NA		
Comment:	Flow direction wrong. Reverse setup.		
Location Details:		Direction of Survey:	Upstream
US MH:	M-805-068	DS MH:	M-905-035
		Total Length Surveyed (ft):	32.9

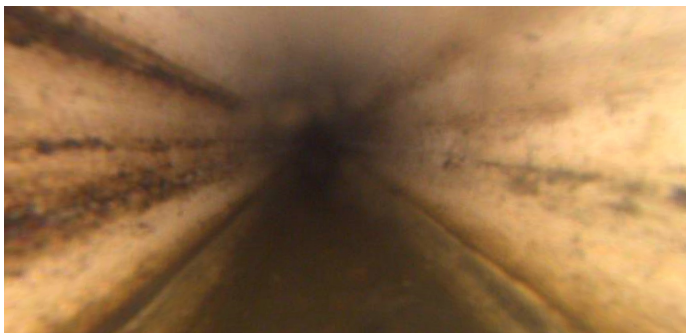
Code: **AMH**
Description: **Manhole**

Distance (ft): **.0**
Structural Grade: **0**
O&M Grade: **0**
Clock Start/From:
Clock To:
1st Value:
2nd Value:
Value Percent:
Continuous Index:
Within 8" of Joint: **NO**
Remarks: **M-905-035**

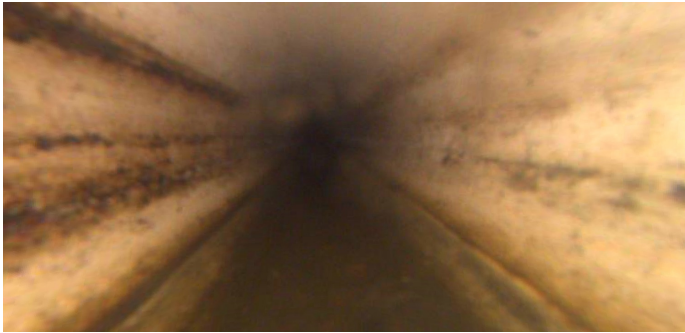
Code:	MWL
Description:	Water Level

Distance (ft):	.0
Structural Grade:	0
O&M Grade:	0
Clock Start/From:	
Clock To:	
1st Value:	
2nd Value:	
Value Percent:	10.000
Continuous Index:	
Within 8" of Joint:	NO
Remarks:

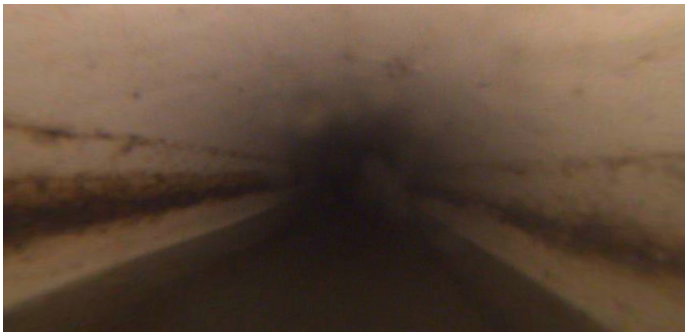
Code:	MWL
Description:	Water Level

Distance (ft):	31.1
Structural Grade:	0
O&M Grade:	0
Clock Start/From:	
Clock To:	
1st Value:	
2nd Value:	
Value Percent:	40.000
Continuous Index:	
Within 8" of Joint:	NO
Remarks:

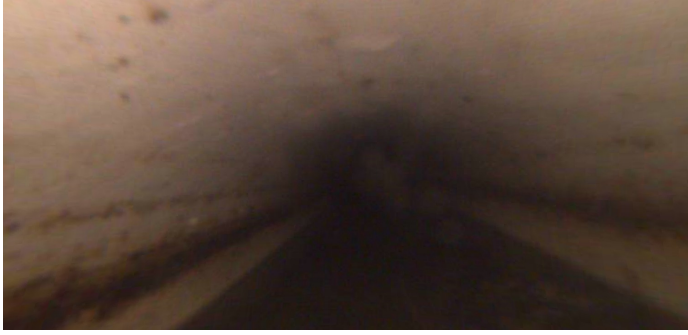
Code:	MSA
Description:	Abandoned Survey
Distance (ft):	32.9
Structural Grade:	0
O&M Grade:	0
Clock Start/From:	
Clock To:	
1st Value:	
2nd Value:	
Value Percent:	
Continuous Index:	
Within 8" of Joint:	NO
Remarks:	DEBRIS UNDER WATER
