Profile/Photo Observation Report

Date:	04/13/2018	Weather:		Coding:	PACP 6.0
Pipe Length (ft):	289.9	Owner:	NA	Pre Clean:	Not Known
P.O.#:		Surveyor:	Jen Costello	PSR:	P-806-001-002
Customer:		Clean Date:	01/01/1900	Shape:	C

Street:	LUTHER DR	Flow Control:	Not Controlled
City:	Hobart, IN	Year Renewed:	
Location:	Light Highway	Tape/Media #:	
Purpose:	Maintenance Related	Dia/Height:	8"
Use:	Sanitary	Material:	VCP
Drain Area:	NA	Lining:	Cured in Place
Category:	NA		
Comment:	debris on front cam-MH found.flow incorrect.		
Location Details:		Direction of Survey:	Downstream
US MH:	M-806-002	DS MH:	M-806-001
		Total Length Surveyed (ft):	289.5

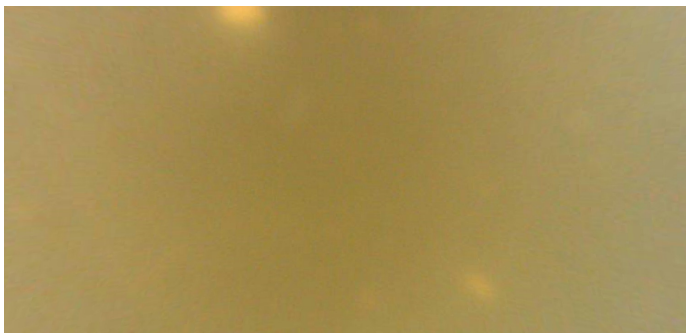
Code: **AMH**
Description: **Manhole**

Distance (ft): **.0**
Structural Grade: **0**
O&M Grade: **0**
Clock Start/From:
Clock To:
1st Value:
2nd Value:
Value Percent:
Continuous Index:
Within 8" of Joint: **NO**
Remarks: **M-806-002**

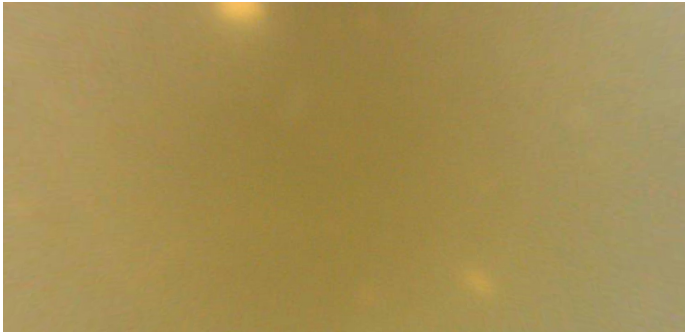
Code:	MWL
Description:	Water Level

Distance (ft):	.0
Structural Grade:	0
O&M Grade:	0
Clock Start/From:	
Clock To:	
1st Value:	
2nd Value:	
Value Percent:	100.000
Continuous Index:	
Within 8" of Joint:	NO
Remarks:

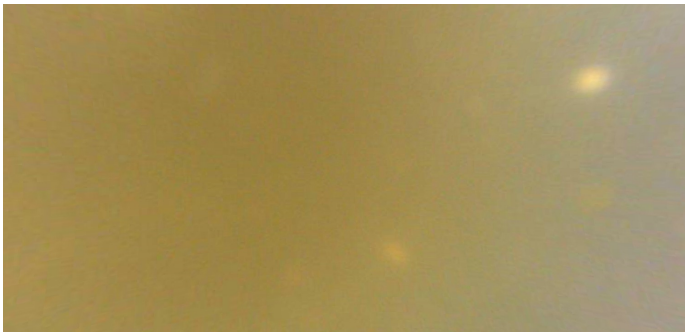
Code:	MCU
Description:	Camera Underwater

Distance (ft):	.0
Structural Grade:	0
O&M Grade:	4
Clock Start/From:	
Clock To:	
1st Value:	
2nd Value:	
Value Percent:	
Continuous Index:	S01
Within 8" of Joint:	NO
Remarks:

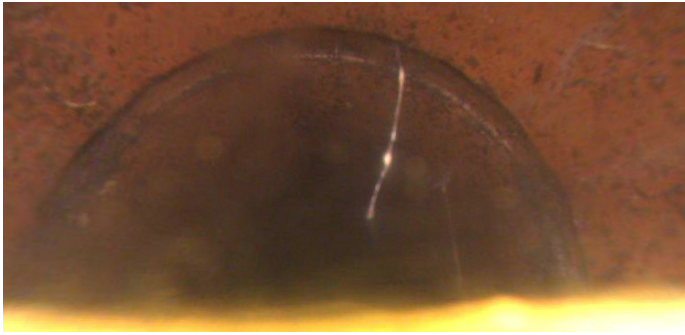
Code: **RFJ**
Description: **Roots Fine Joint**

Distance (ft): **83.1**
Structural Grade: **0**
O&M Grade: **1**
Clock Start/From: **12**
Clock To:
1st Value:
2nd Value:
Value Percent:
Continuous Index:
Within 8" of Joint: **YES**
Remarks:

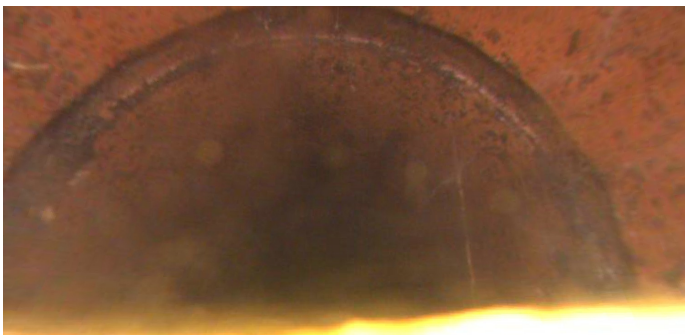
Code: **MCU**
Description: **Camera Underwater**

Distance (ft): **83.1**
Structural Grade: **0**
O&M Grade: **4**
Clock Start/From:
Clock To:
1st Value:
2nd Value:
Value Percent:
Continuous Index: **F01**
Within 8" of Joint: **NO**
Remarks:

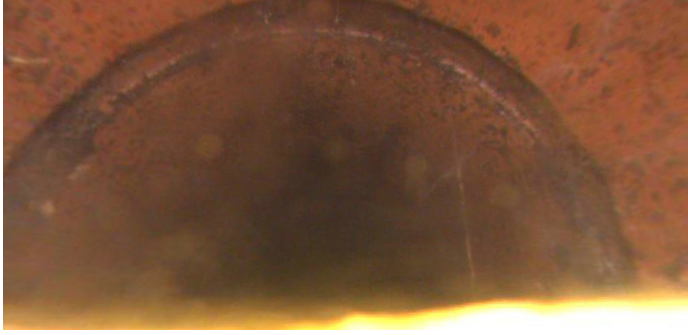
Code:	MGO
Description:	General Observation
Distance (ft):	83.1
Structural Grade:	0
O&M Grade:	0
Clock Start/From:	
Clock To:	
1st Value:	
2nd Value:	
Value Percent:	
Continuous Index:	
Within 8" of Joint:	NO
Remarks:	rear camera

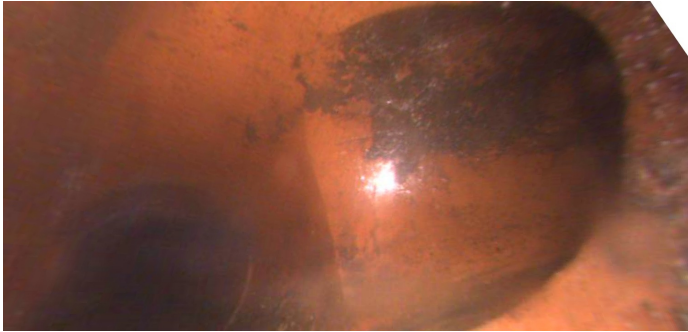
Code:	TFA
Description:	Tap Factory Active
Distance (ft):	104.8
Structural Grade:	0
O&M Grade:	0
Clock Start/From:	9
Clock To:	
1st Value:	4.000
2nd Value:	
Value Percent:	
Continuous Index:	
Within 8" of Joint:	
Remarks:

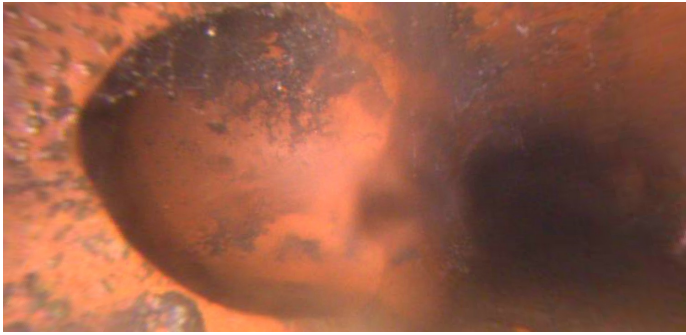
Code: **TF**
Description: **Tap Factory**

Distance (ft): **106.9**
Structural Grade: **0**
O&M Grade: **0**
Clock Start/From: **3**
Clock To:
1st Value: **4.000**
2nd Value:
Value Percent:
Continuous Index:
Within 8" of Joint:
Remarks:

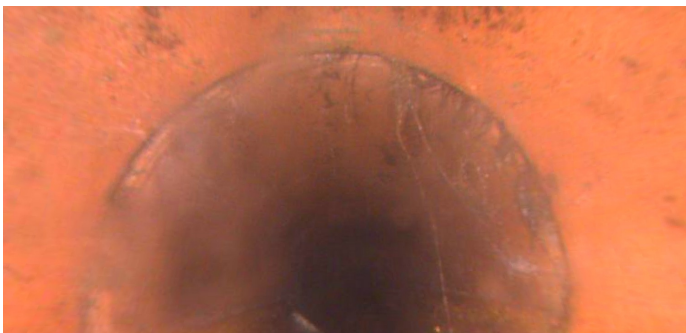
Code: **RFJ**
Description: **Roots Fine Joint**

Distance (ft): **112.9**
Structural Grade: **0**
O&M Grade: **1**
Clock Start/From: **8**
Clock To: **4**
1st Value:
2nd Value:
Value Percent:
Continuous Index:
Within 8" of Joint: **YES**
Remarks:

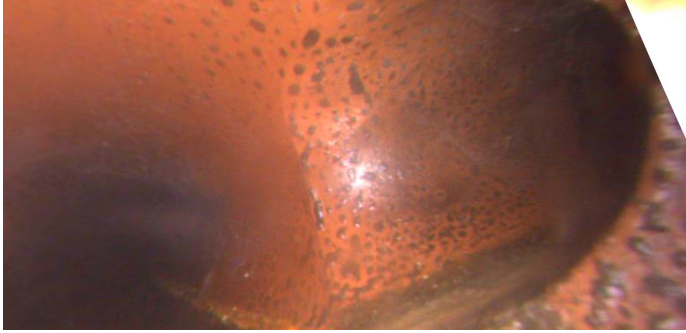
Code: **TF**
Description: **Tap Factory**

Distance (ft): **195.4**
Structural Grade: **0**
O&M Grade: **0**
Clock Start/From: **9**
Clock To:
1st Value: **4.000**
2nd Value:
Value Percent:
Continuous Index:
Within 8" of Joint:
Remarks:

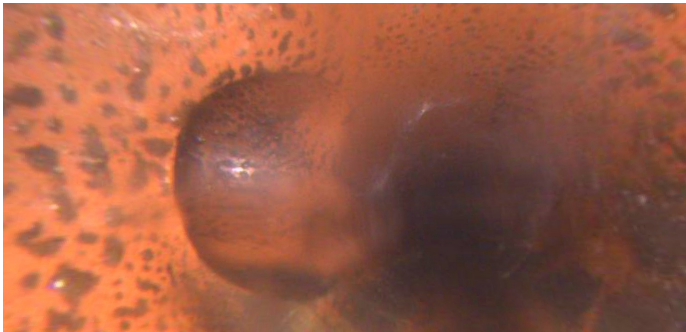
Code: **TF**
Description: **Tap Factory**

Distance (ft): **197.9**
Structural Grade: **0**
O&M Grade: **0**
Clock Start/From: **3**
Clock To:
1st Value: **4.000**
2nd Value:
Value Percent:
Continuous Index:
Within 8" of Joint:
Remarks:

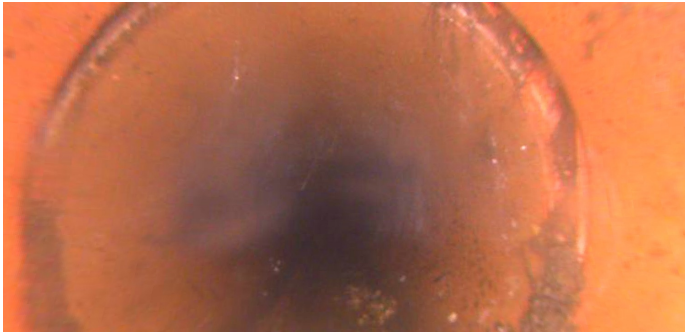
Code: **RFJ**
Description: **Roots Fine Joint**

Distance (ft): **213.7**
Structural Grade: **0**
O&M Grade: **1**
Clock Start/From: **8**
Clock To: **4**
1st Value:
2nd Value:
Value Percent:
Continuous Index: **S02**
Within 8" of Joint: **YES**
Remarks:

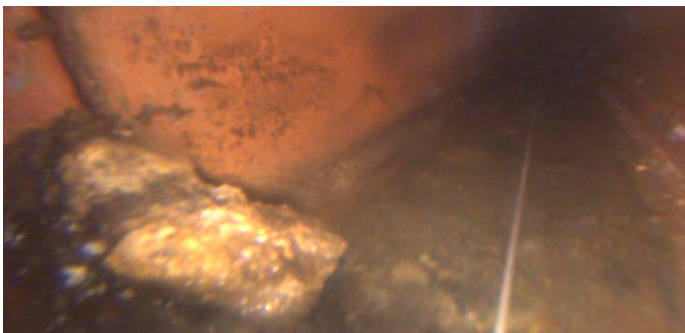
Code: **DAGS**
Description: **Deposits Attached Grease**

Distance (ft): **274.4**
Structural Grade: **0**
O&M Grade: **2**
Clock Start/From: **3**
Clock To: **4**
1st Value:
2nd Value:
Value Percent: **10.000**
Continuous Index:
Within 8" of Joint: **YES**
Remarks:

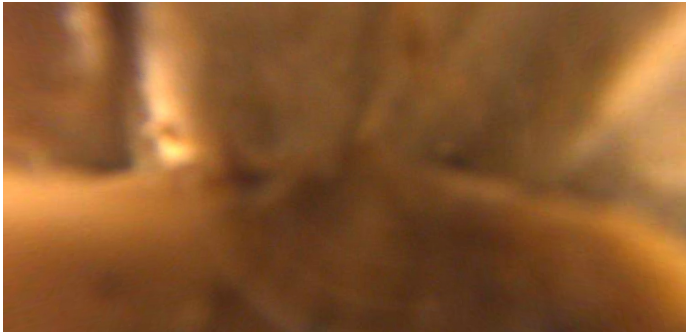
Code: **MSA**
Description: **Abandoned Survey**

Distance (ft): **289.5**
Structural Grade: **0**
O&M Grade: **0**
Clock Start/From:
Clock To:
1st Value:
2nd Value:
Value Percent:
Continuous Index:
Within 8" of Joint: **NO**
Remarks: **under water**

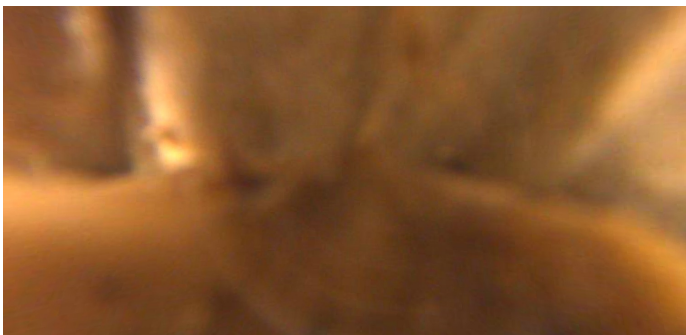
Code: **RFJ**
Description: **Roots Fine Joint**

Distance (ft): **289.5**
Structural Grade: **0**
O&M Grade: **1**
Clock Start/From: **8**
Clock To: **4**
1st Value:
2nd Value:
Value Percent:
Continuous Index: **F02**
Within 8" of Joint: **YES**
Remarks:
