Profile/Photo Observation Report

Date:	04/13/2018	Weather:		Coding:	PACP 6.0
Pipe Length (ft):	289.9	Owner:	NA	Pre Clean:	Not Known
P.O.#:		Surveyor:	Jen Costello	PSR:	P-806-001-002
Customer:		Clean Date:	01/01/1900	Shape:	C

Street:	Capitol	Flow Control:	Not Controlled
City:	Hobart, IN	Year Renewed:	
Location:	Light Highway	Tape/Media #:	
Purpose:	Maintenance Related	Dia/Height:	8"
Use:	Sanitary	Material:	VCP
Drain Area:	NA	Lining:	Cured in Place
Category:	NA		
Comment:	debris on front cam-MH found.flow incorrect.		
Location Details:		Direction of Survey:	Downstream
US MH:	M-806-002	DS MH:	M-806-001
		Total Length Surveyed (ft):	289.5

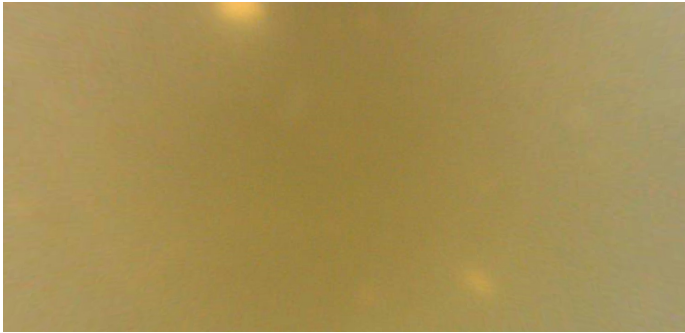
Code:	MWL
Description:	Water Level

Distance (ft):	.0
Structural Grade:	0
O&M Grade:	0
Clock Start/From:	
Clock To:	
1st Value:	
2nd Value:	
Value Percent:	100.000
Continuous Index:	
Within 8" of Joint:	NO
Remarks:

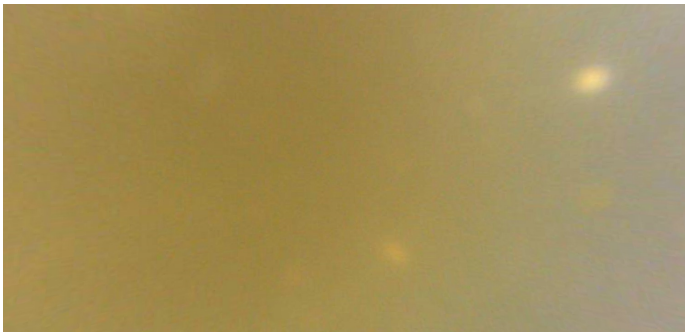
Code:	MCU
Description:	Camera Underwater

Distance (ft):	.0
Structural Grade:	0
O&M Grade:	4
Clock Start/From:	
Clock To:	
1st Value:	
2nd Value:	
Value Percent:	
Continuous Index:	S01
Within 8" of Joint:	NO
Remarks:

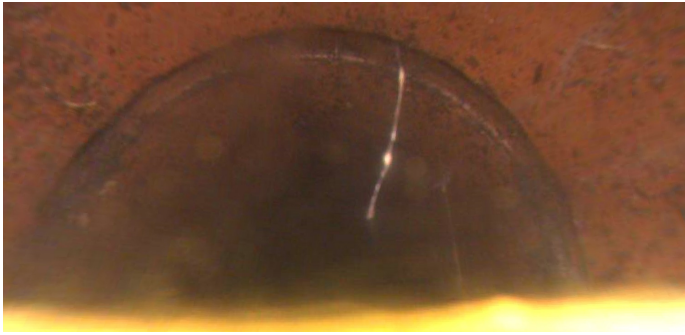
Code: **RFJ**
Description: **Roots Fine Joint**

Distance (ft): **83.1**
Structural Grade: **0**
O&M Grade: **1**
Clock Start/From: **12**
Clock To:
1st Value:
2nd Value:
Value Percent:
Continuous Index:
Within 8" of Joint: **YES**
Remarks:

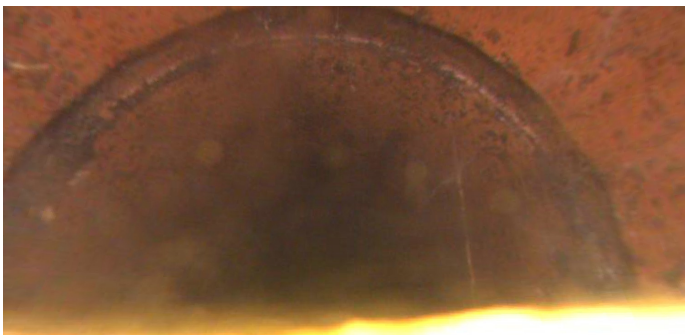
Code: **MCU**
Description: **Camera Underwater**

Distance (ft): **83.1**
Structural Grade: **0**
O&M Grade: **4**
Clock Start/From:
Clock To:
1st Value:
2nd Value:
Value Percent:
Continuous Index: **F01**
Within 8" of Joint: **NO**
Remarks:

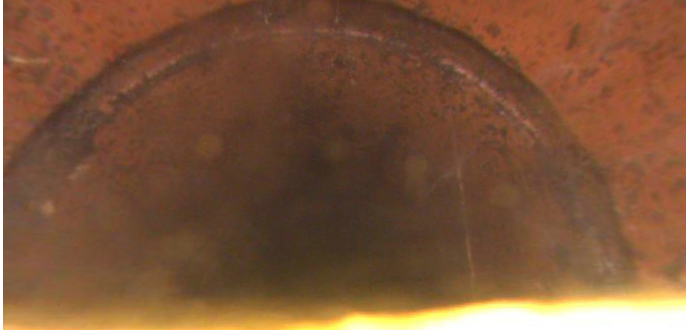
Code:	MGO
Description:	General Observation
Distance (ft):	83.1
Structural Grade:	0
O&M Grade:	0
Clock Start/From:	
Clock To:	
1st Value:	
2nd Value:	
Value Percent:	
Continuous Index:	
Within 8" of Joint:	NO
Remarks:	rear camera

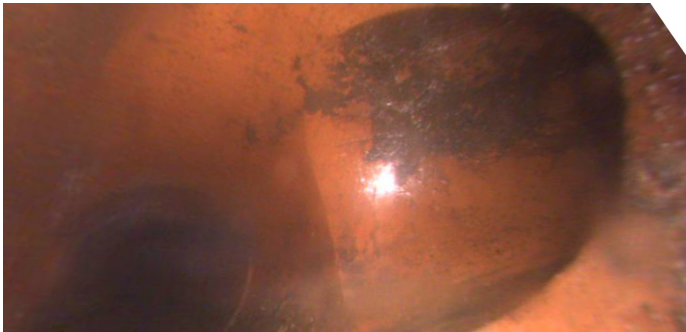
Code:	TFA
Description:	Tap Factory Active
Distance (ft):	104.8
Structural Grade:	0
O&M Grade:	0
Clock Start/From:	9
Clock To:	
1st Value:	4.000
2nd Value:	
Value Percent:	
Continuous Index:	
Within 8" of Joint:	
Remarks:

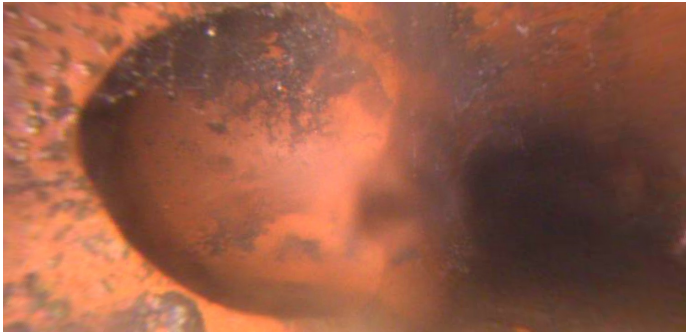
Code: **TF**
Description: **Tap Factory**

Distance (ft): **106.9**
Structural Grade: **0**
O&M Grade: **0**
Clock Start/From: **3**
Clock To:
1st Value: **4.000**
2nd Value:
Value Percent:
Continuous Index:
Within 8" of Joint:
Remarks:

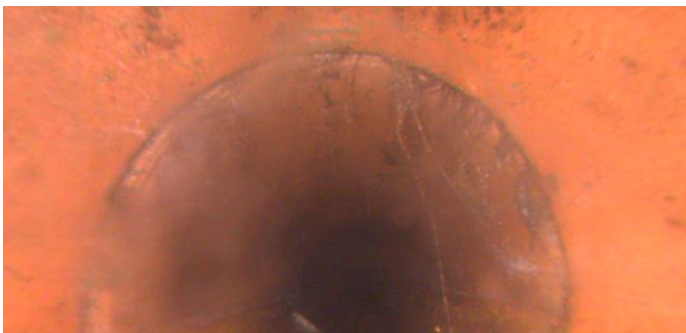
Code: **RFJ**
Description: **Roots Fine Joint**

Distance (ft): **112.9**
Structural Grade: **0**
O&M Grade: **1**
Clock Start/From: **8**
Clock To: **4**
1st Value:
2nd Value:
Value Percent:
Continuous Index:
Within 8" of Joint: **YES**
Remarks:

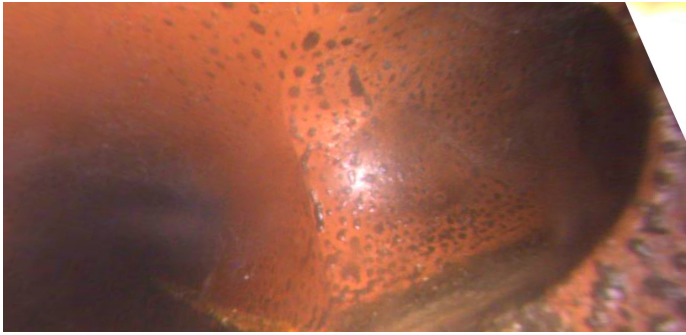
Code: **TF**
Description: **Tap Factory**

Distance (ft): **195.4**
Structural Grade: **0**
O&M Grade: **0**
Clock Start/From: **9**
Clock To:
1st Value: **4.000**
2nd Value:
Value Percent:
Continuous Index:
Within 8" of Joint:
Remarks:

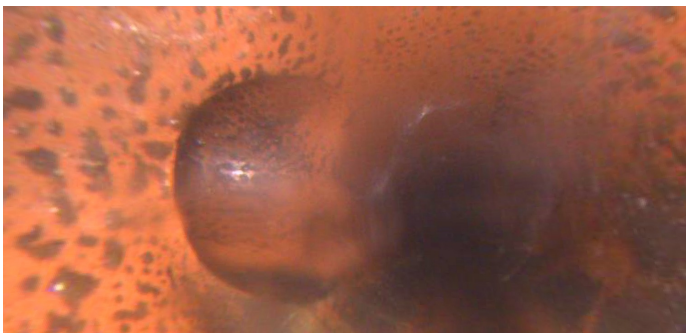
Code: **TF**
Description: **Tap Factory**

Distance (ft): **197.9**
Structural Grade: **0**
O&M Grade: **0**
Clock Start/From: **3**
Clock To:
1st Value: **4.000**
2nd Value:
Value Percent:
Continuous Index:
Within 8" of Joint:
Remarks:

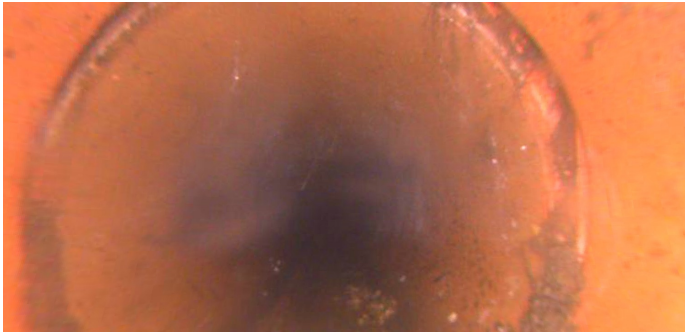
Code: **RFJ**
Description: **Roots Fine Joint**

Distance (ft): **213.7**
Structural Grade: **0**
O&M Grade: **1**
Clock Start/From: **8**
Clock To: **4**
1st Value:
2nd Value:
Value Percent:
Continuous Index: **S02**
Within 8" of Joint: **YES**
Remarks:

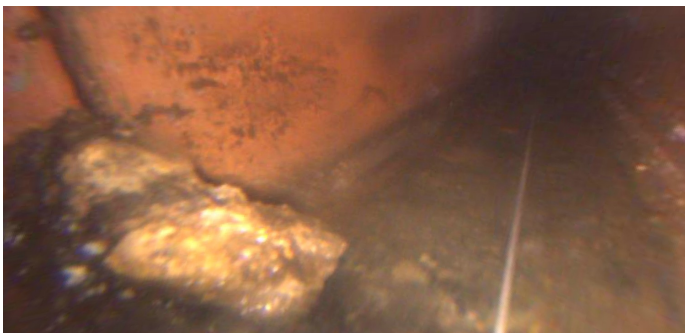
Code: **DAGS**
Description: **Deposits Attached Grease**

Distance (ft): **274.4**
Structural Grade: **0**
O&M Grade: **2**
Clock Start/From: **3**
Clock To: **4**
1st Value:
2nd Value:
Value Percent: **10.000**
Continuous Index:
Within 8" of Joint: **YES**
Remarks:

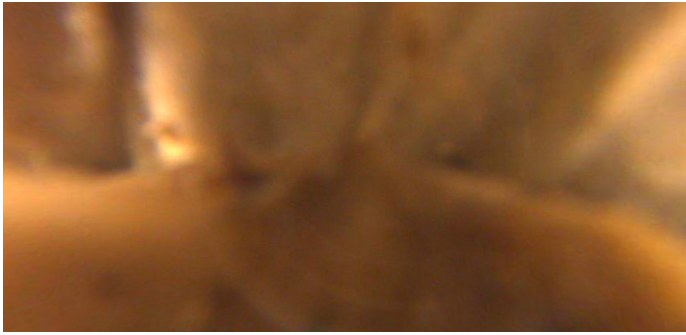
Code: **MSA**
Description: **Abandoned Survey**

Distance (ft): **289.5**
Structural Grade: **0**
O&M Grade: **0**
Clock Start/From:
Clock To:
1st Value:
2nd Value:
Value Percent:
Continuous Index:
Within 8" of Joint: **NO**
Remarks: **under water**

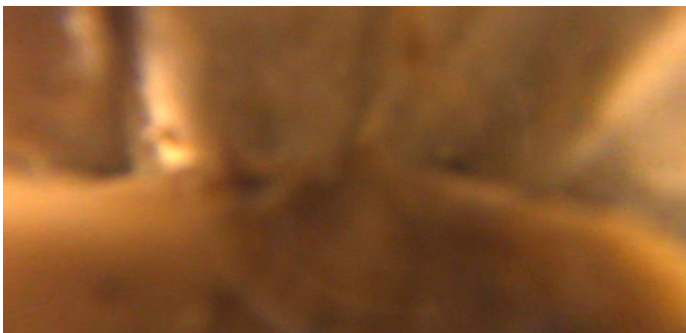
Code: **RFJ**
Description: **Roots Fine Joint**

Distance (ft): **289.5**
Structural Grade: **0**
O&M Grade: **1**
Clock Start/From: **8**
Clock To: **4**
1st Value:
2nd Value:
Value Percent:
Continuous Index: **F02**
Within 8" of Joint: **YES**
Remarks:
