Profile/Photo Observation Report

Date:	04/13/2018	Weather:		Coding:	PACP 6.0
Pipe Length (ft):	237.5	Owner:	NA	Pre Clean:	Not Known
P.O.#:		Surveyor:	Jen Costello	PSR:	P-806-002-003
Customer:		Clean Date:	01/01/1900	Shape:	C

Street:	LUTHER DR	Flow Control:	Not Controlled
City:	Hobart, IN	Year Renewed:	
Location:	Light Highway	Tape/Media #:	
Purpose:	Maintenance Related	Dia/Height:	8"
Use:	Sanitary	Material:	VCP
Drain Area:	NA	Lining:	Cured in Place
Category:	NA		
Comment:	heavy debris at 50', no flow in line, flow incorrect.		
Location Details:		Direction of Survey:	Upstream
US MH:	M-806-003	DS MH:	M-806-002
		Total Length Surveyed (ft):	51.3

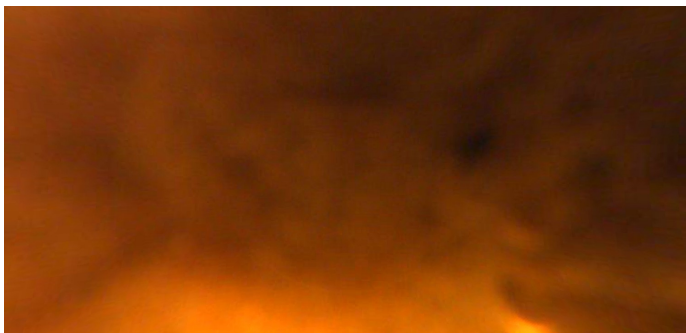
Code: **AMH**
Description: **Manhole**

Distance (ft): **.0**
Structural Grade: **0**
O&M Grade: **0**
Clock Start/From:
Clock To:
1st Value:
2nd Value:
Value Percent:
Continuous Index:
Within 8" of Joint: **NO**
Remarks: **M-806-002**

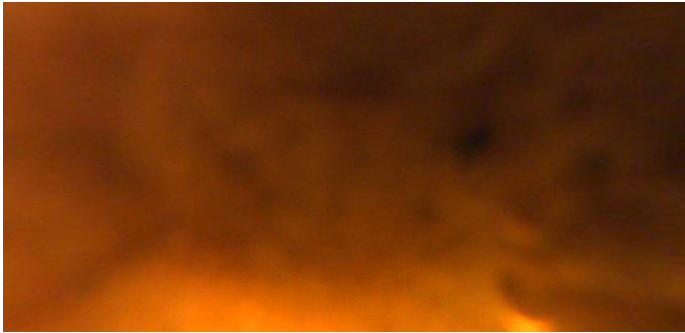
Code:	MWL
Description:	Water Level

Distance (ft):	.0
Structural Grade:	0
O&M Grade:	0
Clock Start/From:	
Clock To:	
1st Value:	
2nd Value:	
Value Percent:	100.000
Continuous Index:	
Within 8" of Joint:	NO
Remarks:

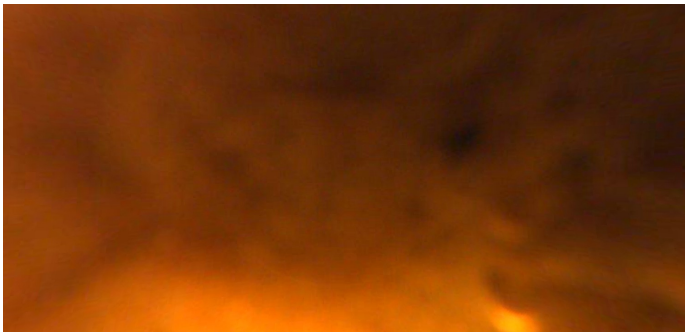
Code:	MCU
Description:	Camera Underwater

Distance (ft):	.0
Structural Grade:	0
O&M Grade:	4
Clock Start/From:	
Clock To:	
1st Value:	
2nd Value:	
Value Percent:	
Continuous Index:	S01
Within 8" of Joint:	NO
Remarks:

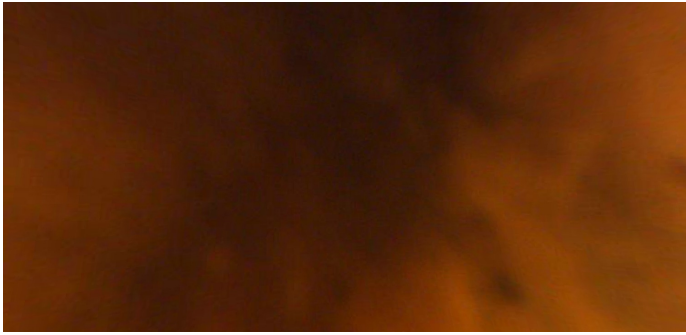
Code: **MCU**
Description: **Camera Underwater**

Distance (ft): **51.3**
Structural Grade: **0**
O&M Grade: **4**
Clock Start/From:
Clock To:
1st Value:
2nd Value:
Value Percent:
Continuous Index: **F01**
Within 8" of Joint: **NO**
Remarks:

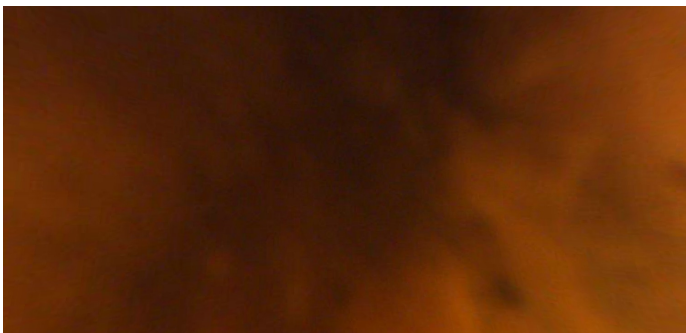
Code: **MSA**
Description: **Abandoned Survey**

Distance (ft): **51.3**
Structural Grade: **0**
O&M Grade: **0**
Clock Start/From:
Clock To:
1st Value:
2nd Value:
Value Percent:
Continuous Index:
Within 8" of Joint: **NO**
Remarks: **mcu**
