## Profile/Photo Observation Report

Date:	<b>04/13/2018</b>	Weather:		Coding:	<b>PACP 6.0</b>
Pipe Length (ft):	<b>237.5</b>	Owner:	<b>NA</b>	Pre Clean:	<b>Not Known</b>
P.O.#:		Surveyor:	<b>Jen Costello</b>	PSR:	<b>P-806-002-003</b>
Customer:		Clean Date:	<b>01/01/1900</b>	Shape:	<b>C</b>

Street:	<b>Capitol</b>	Flow Control:	<b>Not Controlled</b>
City:	<b>Hobart, IN</b>	Year Renewed:	
Location:	<b>Light Highway</b>	Tape/Media #:	
Purpose:	<b>Maintenance Related</b>	Dia/Height:	<b>8"</b>
Use:	<b>Sanitary</b>	Material:	<b>VCP</b>
Drain Area:	<b>NA</b>	Lining:	<b>Cured in Place</b>
Category:	<b>NA</b>		
Comment:	<b>heavy debris at 50', no flow in line, flow incorrect.</b>		
Location Details:		Direction of Survey:	<b>Upstream</b>
US MH:	<b>M-806-003</b>	DS MH:	<b>M-806-002</b>
		Total Length Surveyed (ft):	<b>51.3</b>

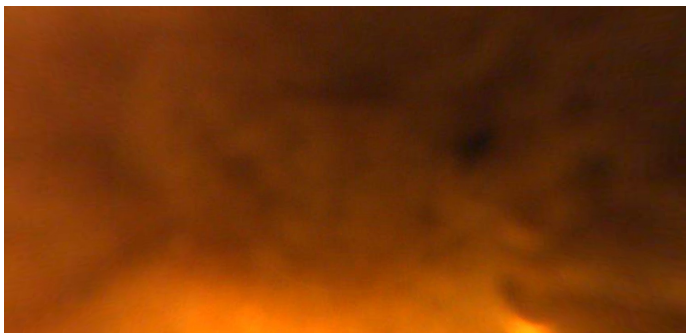
Code: **AMH**  
Description: **Manhole**

Distance (ft): **.0**  
Structural Grade: **0**  
O&M Grade: **0**  
Clock Start/From:  
Clock To:  
1st Value:  
2nd Value:  
Value Percent:  
Continuous Index:  
Within 8" of Joint: **NO**  
Remarks: **M-806-002**

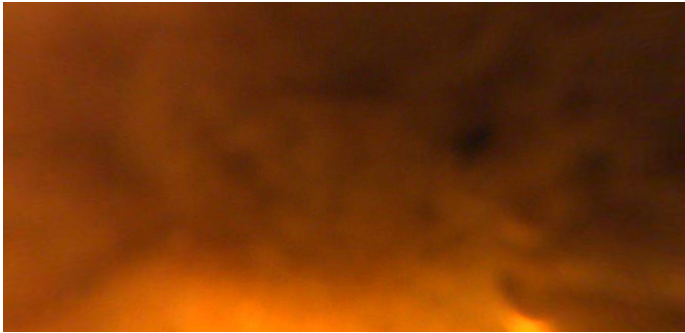
Code:	<b>MWL</b>
Description:	<b>Water Level</b>

Distance (ft):	<b>.0</b>
Structural Grade:	<b>0</b>
O&M Grade:	<b>0</b>
Clock Start/From:	
Clock To:	
1st Value:	
2nd Value:	
Value Percent:	<b>100.000</b>
Continuous Index:	
Within 8" of Joint:	<b>NO</b>
Remarks:

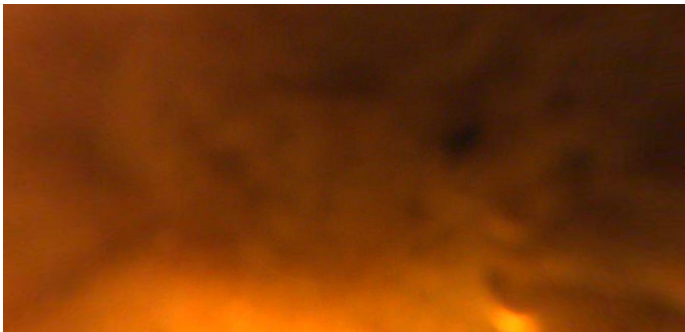
Code:	<b>MCU</b>
Description:	<b>Camera Underwater</b>

Distance (ft):	<b>.0</b>
Structural Grade:	<b>0</b>
O&M Grade:	<b>4</b>
Clock Start/From:	
Clock To:	
1st Value:	
2nd Value:	
Value Percent:	
Continuous Index:	<b>S01</b>
Within 8" of Joint:	<b>NO</b>
Remarks:

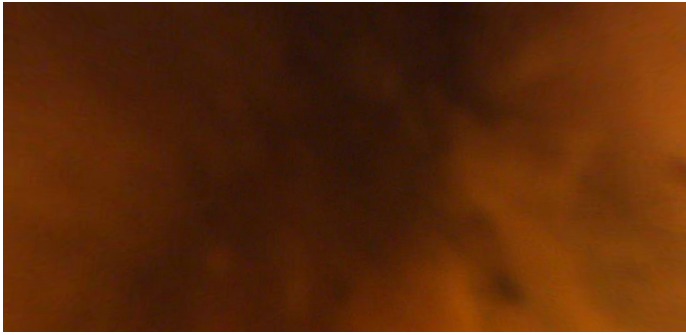
Code: **MCU**  
Description: **Camera Underwater**

Distance (ft): **51.3**  
Structural Grade: **0**  
O&M Grade: **4**  
Clock Start/From:  
Clock To:  
1st Value:  
2nd Value:  
Value Percent:  
Continuous Index: **F01**  
Within 8" of Joint: **NO**  
Remarks:

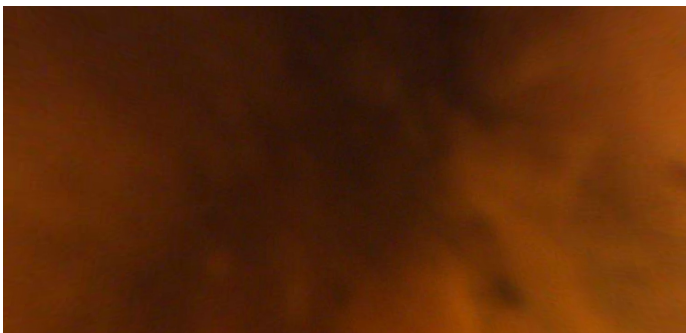
Code: **MSA**  
Description: **Abandoned Survey**

Distance (ft): **51.3**  
Structural Grade: **0**  
O&M Grade: **0**  
Clock Start/From:  
Clock To:  
1st Value:  
2nd Value:  
Value Percent:  
Continuous Index:  
Within 8" of Joint: **NO**  
Remarks: **mcu**
