Profile/Photo Observation Report

Date:	04/13/2018	Weather:		Coding:	PACP 6.0
Pipe Length (ft):	237.5	Owner:	NA	Pre Clean:	Not Known
P.O.#:		Surveyor:	Jen Costello	PSR:	P-806-002-003
Customer:		Clean Date:	01/01/1900	Shape:	C

Street:	LUTHER DR	Flow Control:	Not Controlled
City:	Hobart, IN	Year Renewed:	
Location:	Light Highway	Tape/Media #:	
Purpose:	Maintenance Related	Dia/Height:	8"
Use:	Sanitary	Material:	VCP
Drain Area:	NA	Lining:	Cured in Place
Category:	NA		
Comment:	possible root ball filling entire pipe at 55'. -flow incorrect.		
Location Details:		Direction of Survey:	Downstream
US MH:	M-806-003	DS MH:	M-806-002
		Total Length Surveyed (ft):	56.2

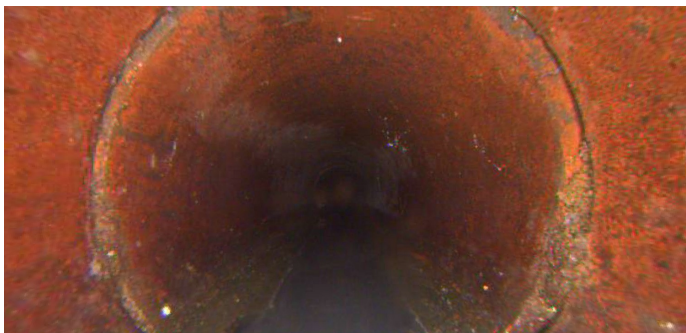
Code: **AMH**
Description: **Manhole**

Distance (ft): **.0**
Structural Grade: **0**
O&M Grade: **0**
Clock Start/From:
Clock To:
1st Value:
2nd Value:
Value Percent:
Continuous Index:
Within 8" of Joint: **NO**
Remarks: **M-806-003**

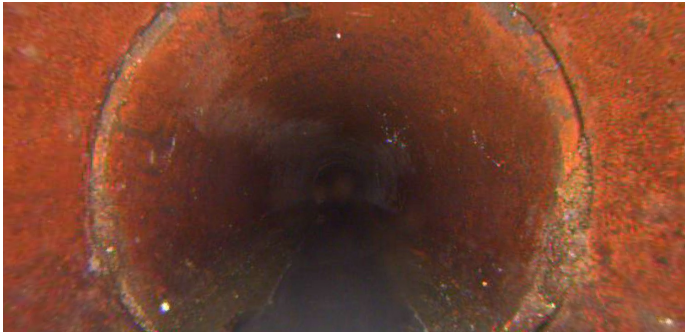
Code:	MWL
Description:	Water Level

Distance (ft):	.0
Structural Grade:	0
O&M Grade:	0
Clock Start/From:	
Clock To:	
1st Value:	
2nd Value:	
Value Percent:	5.000
Continuous Index:	
Within 8" of Joint:	NO
Remarks:

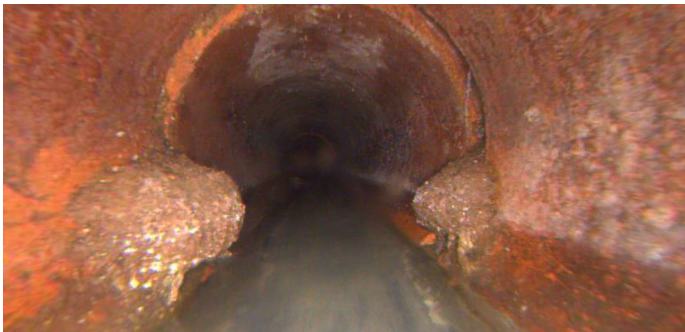
Code:	DAZ
Description:	Deposits Attached Other

Distance (ft):	4.7
Structural Grade:	0
O&M Grade:	2
Clock Start/From:	8
Clock To:	4
1st Value:	
2nd Value:	
Value Percent:	5.000
Continuous Index:	
Within 8" of Joint:	YES
Remarks:

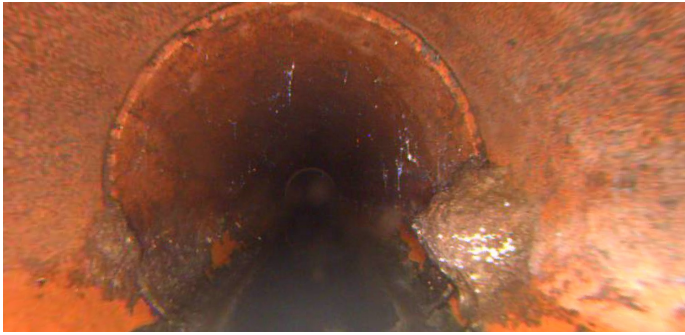
Code: **DAZ**
Description: **Deposits Attached Other**

Distance (ft): **12.8**
Structural Grade: **0**
O&M Grade: **2**
Clock Start/From: **8**
Clock To: **4**
1st Value:
2nd Value:
Value Percent: **5.000**
Continuous Index:
Within 8" of Joint: **YES**
Remarks:

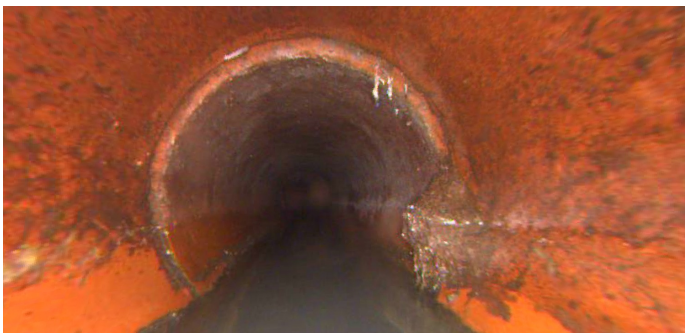
Code: **RFJ**
Description: **Roots Fine Joint**

Distance (ft): **16.7**
Structural Grade: **0**
O&M Grade: **1**
Clock Start/From: **1**
Clock To: **2**
1st Value:
2nd Value:
Value Percent:
Continuous Index:
Within 8" of Joint: **YES**
Remarks:

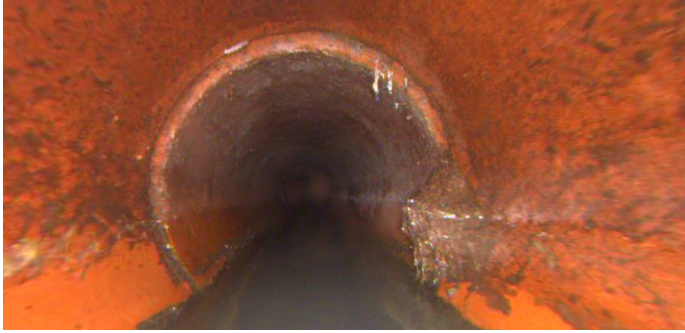
Code: **DAZ**
Description: **Deposits Attached Other**

Distance (ft): **16.7**
Structural Grade: **0**
O&M Grade: **2**
Clock Start/From: **3**
Clock To: **4**
1st Value:
2nd Value:
Value Percent: **5.000**
Continuous Index:
Within 8" of Joint: **YES**
Remarks:

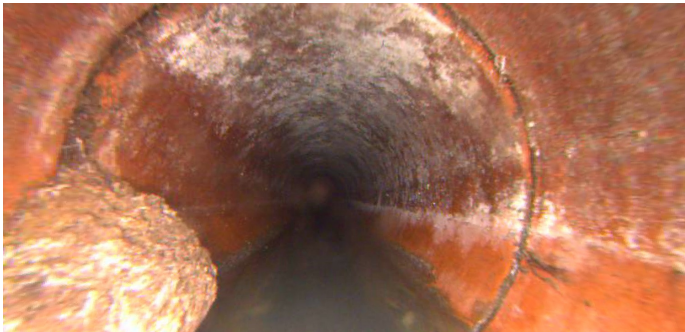
Code: **DAZ**
Description: **Deposits Attached Other**

Distance (ft): **25.0**
Structural Grade: **0**
O&M Grade: **2**
Clock Start/From: **7**
Clock To: **9**
1st Value:
2nd Value:
Value Percent: **10.000**
Continuous Index:
Within 8" of Joint: **YES**
Remarks:

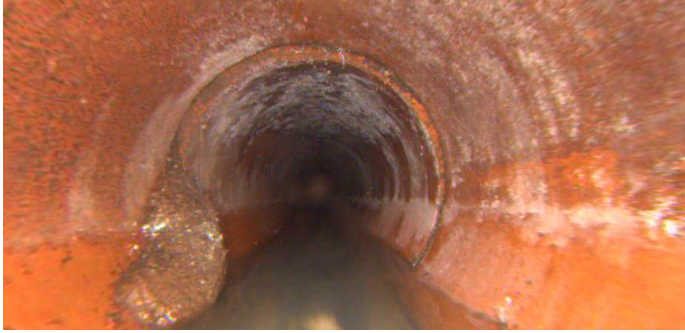
Code: **DAZ**
Description: **Deposits Attached Other**

Distance (ft): **28.8**
Structural Grade: **0**
O&M Grade: **2**
Clock Start/From: **7**
Clock To: **9**
1st Value:
2nd Value:
Value Percent: **5.000**
Continuous Index:
Within 8" of Joint: **YES**
Remarks:

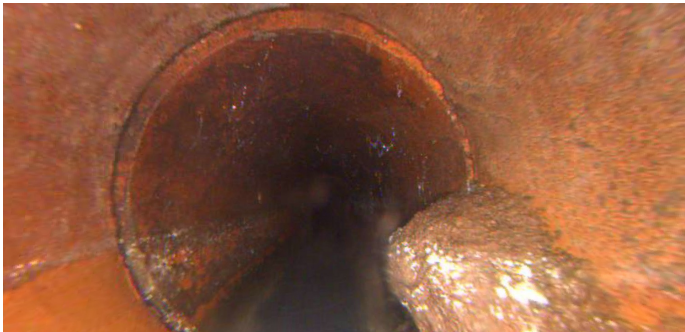
Code: **DAZ**
Description: **Deposits Attached Other**

Distance (ft): **32.9**
Structural Grade: **0**
O&M Grade: **2**
Clock Start/From: **3**
Clock To: **4**
1st Value:
2nd Value:
Value Percent: **10.000**
Continuous Index:
Within 8" of Joint: **YES**
Remarks:

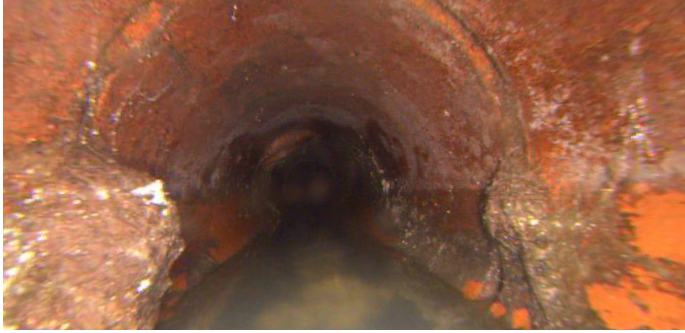
Code: **DAZ**
Description: **Deposits Attached Other**

Distance (ft): **37.2**
Structural Grade: **0**
O&M Grade: **2**
Clock Start/From: **8**
Clock To: **4**
1st Value:
2nd Value:
Value Percent: **10.000**
Continuous Index:
Within 8" of Joint: **YES**
Remarks:

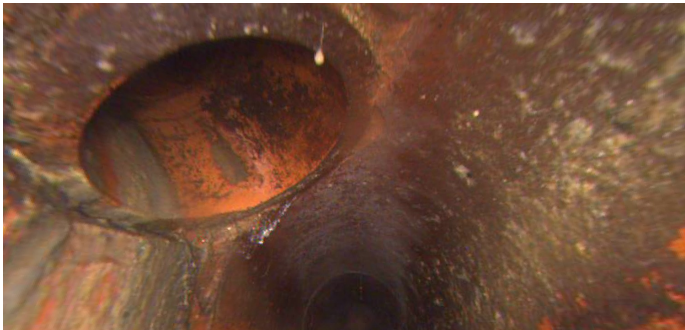
Code: **TBI**
Description: **Tap Break-in Intruding**

Distance (ft): **39.2**
Structural Grade: **0**
O&M Grade: **2**
Clock Start/From: **11**
Clock To:
1st Value: **4.000**
2nd Value: **1.000**
Value Percent:
Continuous Index:
Within 8" of Joint:
Remarks:

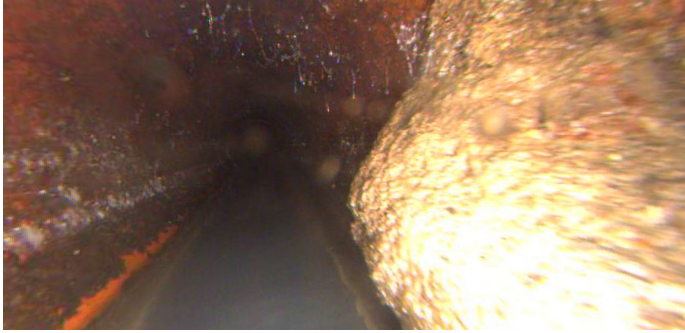
Code: **DAE**
Description: **Deposits Attached Encrustation**

Distance (ft): **45.4**
Structural Grade: **0**
O&M Grade: **3**
Clock Start/From: **1**
Clock To: **4**
1st Value:
2nd Value:
Value Percent: **15.000**
Continuous Index:
Within 8" of Joint: **YES**
Remarks:

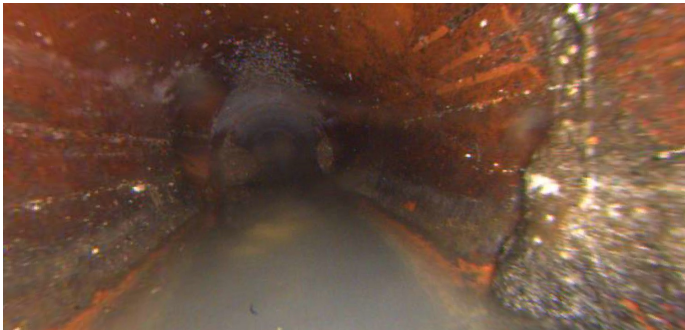
Code: **DAZ**
Description: **Deposits Attached Other**

Distance (ft): **49.5**
Structural Grade: **0**
O&M Grade: **2**
Clock Start/From: **3**
Clock To: **4**
1st Value:
2nd Value:
Value Percent: **5.000**
Continuous Index:
Within 8" of Joint: **YES**
Remarks:

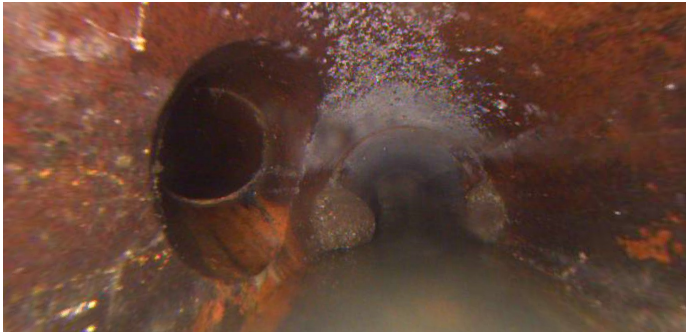
Code: **TF**
Description: **Tap Factory**

Distance (ft): **50.4**
Structural Grade: **0**
O&M Grade: **0**
Clock Start/From: **9**
Clock To:
1st Value: **4.000**
2nd Value:
Value Percent:
Continuous Index:
Within 8" of Joint:
Remarks:

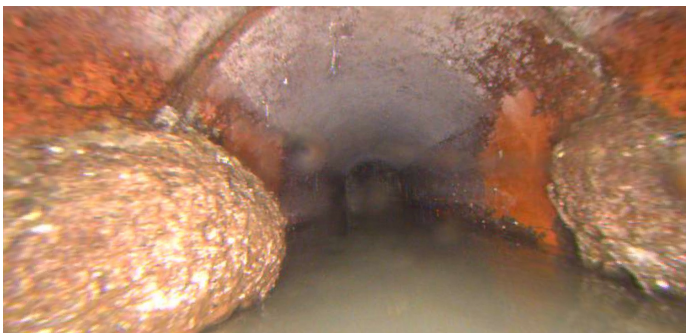
Code: **DAZ**
Description: **Deposits Attached Other**

Distance (ft): **51.3**
Structural Grade: **0**
O&M Grade: **3**
Clock Start/From: **8**
Clock To: **4**
1st Value:
2nd Value:
Value Percent: **20.000**
Continuous Index:
Within 8" of Joint: **YES**
Remarks:

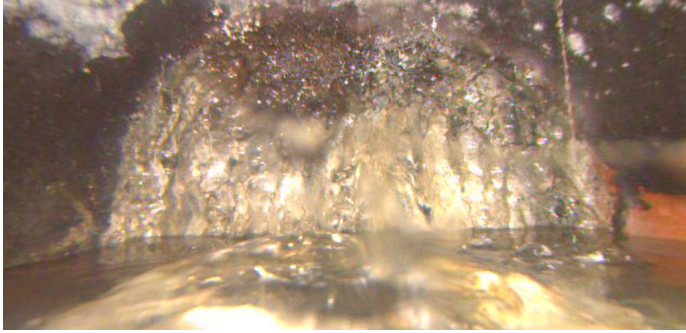
Code: **RBJ**
Description: **Roots Ball Joint**

Distance (ft): **55.0**
Structural Grade: **0**
O&M Grade: **4**
Clock Start/From: **12**
Clock To: **12**
1st Value:
2nd Value:
Value Percent: **90.000**
Continuous Index:
Within 8" of Joint: **YES**
Remarks:
