## Profile/Photo Observation Report

Date:	<b>04/13/2018</b>	Weather:		Coding:	<b>PACP 6.0</b>
Pipe Length (ft):	<b>237.5</b>	Owner:	<b>NA</b>	Pre Clean:	<b>Not Known</b>
P.O.#:		Surveyor:	<b>Jen Costello</b>	PSR:	<b>P-806-002-003</b>
Customer:		Clean Date:	<b>01/01/1900</b>	Shape:	<b>C</b>

Street:	<b>Capitol</b>	Flow Control:	<b>Not Controlled</b>
City:	<b>Hobart, IN</b>	Year Renewed:	
Location:	<b>Light Highway</b>	Tape/Media #:	
Purpose:	<b>Maintenance Related</b>	Dia/Height:	<b>8"</b>
Use:	<b>Sanitary</b>	Material:	<b>VCP</b>
Drain Area:	<b>NA</b>	Lining:	<b>Cured in Place</b>
Category:	<b>NA</b>		
Comment:	<b>possible root ball filling entire pipe at 55'.-flow incorrect.</b>		
Location Details:		Direction of Survey:	<b>Downstream</b>
US MH:	<b>M-806-003</b>	DS MH:	<b>M-806-002</b>
		Total Length Surveyed (ft):	<b>56.2</b>

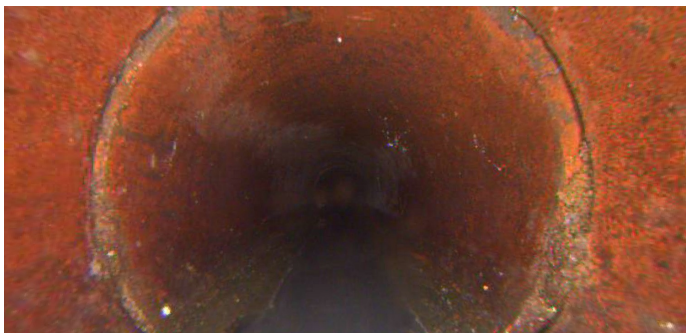
Code: **AMH**  
Description: **Manhole**

Distance (ft): **.0**  
Structural Grade: **0**  
O&M Grade: **0**  
Clock Start/From:  
Clock To:  
1st Value:  
2nd Value:  
Value Percent:  
Continuous Index:  
Within 8" of Joint: **NO**  
Remarks: **M-806-003**

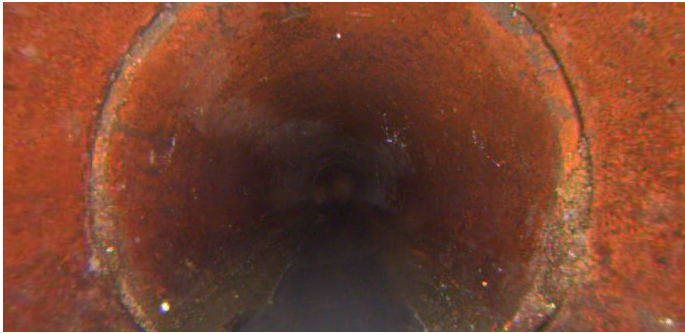
Code:	<b>MWL</b>
Description:	<b>Water Level</b>

Distance (ft):	<b>.0</b>
Structural Grade:	<b>0</b>
O&M Grade:	<b>0</b>
Clock Start/From:	
Clock To:	
1st Value:	
2nd Value:	
Value Percent:	<b>5.000</b>
Continuous Index:	
Within 8" of Joint:	<b>NO</b>
Remarks:

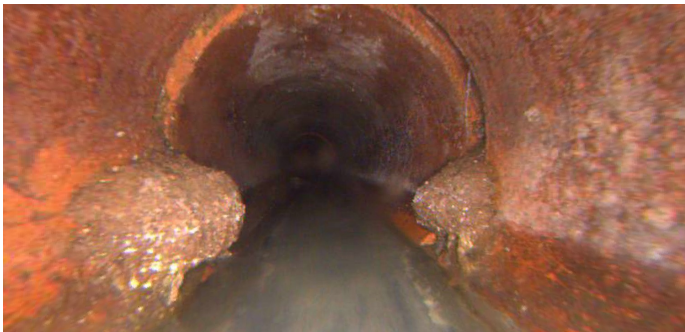
Code:	<b>DAZ</b>
Description:	<b>Deposits Attached Other</b>

Distance (ft):	<b>4.7</b>
Structural Grade:	<b>0</b>
O&M Grade:	<b>2</b>
Clock Start/From:	<b>8</b>
Clock To:	<b>4</b>
1st Value:	
2nd Value:	
Value Percent:	<b>5.000</b>
Continuous Index:	
Within 8" of Joint:	<b>YES</b>
Remarks:

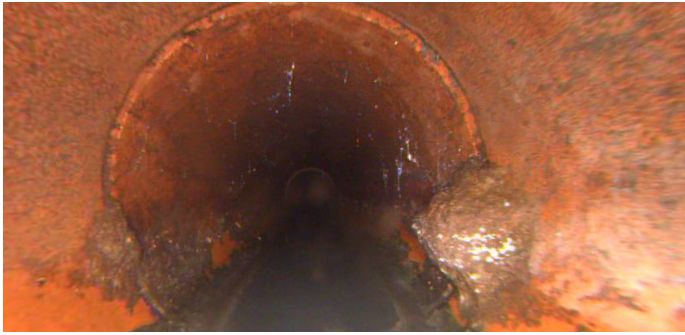
Code: **DAZ**  
Description: **Deposits Attached Other**

Distance (ft): **12.8**  
Structural Grade: **0**  
O&M Grade: **2**  
Clock Start/From: **8**  
Clock To: **4**  
1st Value:  
2nd Value:  
Value Percent: **5.000**  
Continuous Index:  
Within 8" of Joint: **YES**  
Remarks:

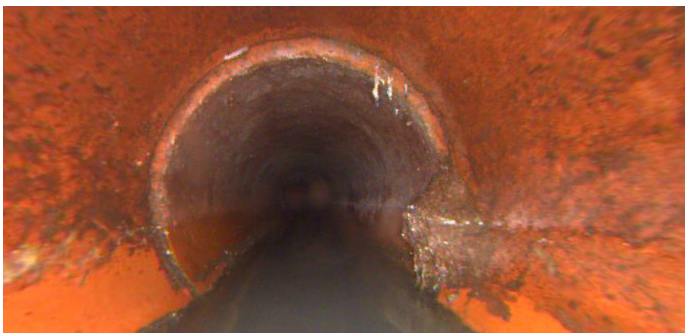
Code: **RFJ**  
Description: **Roots Fine Joint**

Distance (ft): **16.7**  
Structural Grade: **0**  
O&M Grade: **1**  
Clock Start/From: **1**  
Clock To: **2**  
1st Value:  
2nd Value:  
Value Percent:  
Continuous Index:  
Within 8" of Joint: **YES**  
Remarks:

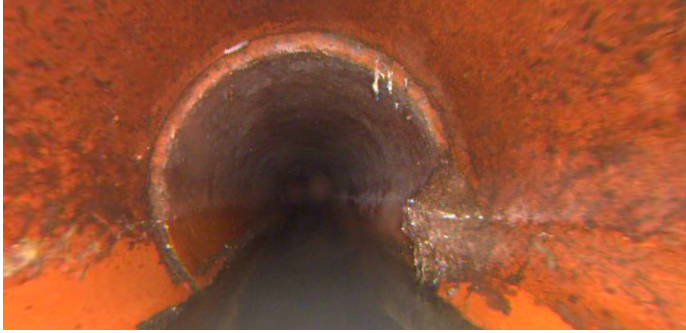
Code: **DAZ**  
Description: **Deposits Attached Other**

Distance (ft): **16.7**  
Structural Grade: **0**  
O&M Grade: **2**  
Clock Start/From: **3**  
Clock To: **4**  
1st Value:  
2nd Value:  
Value Percent: **5.000**  
Continuous Index:  
Within 8" of Joint: **YES**  
Remarks:

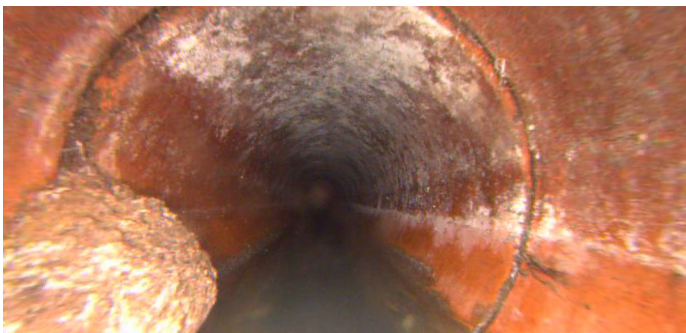
Code: **DAZ**  
Description: **Deposits Attached Other**

Distance (ft): **25.0**  
Structural Grade: **0**  
O&M Grade: **2**  
Clock Start/From: **7**  
Clock To: **9**  
1st Value:  
2nd Value:  
Value Percent: **10.000**  
Continuous Index:  
Within 8" of Joint: **YES**  
Remarks:

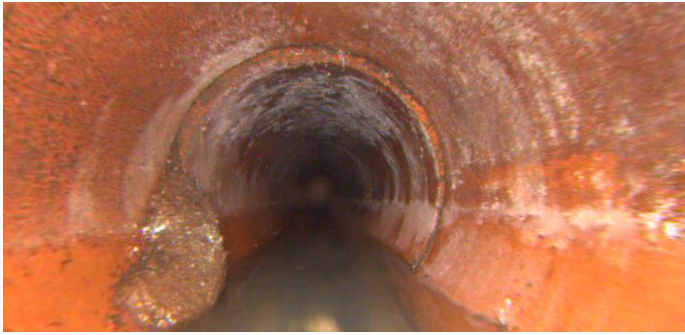
Code: **DAZ**  
Description: **Deposits Attached Other**

Distance (ft): **28.8**  
Structural Grade: **0**  
O&M Grade: **2**  
Clock Start/From: **7**  
Clock To: **9**  
1st Value:  
2nd Value:  
Value Percent: **5.000**  
Continuous Index:  
Within 8" of Joint: **YES**  
Remarks:

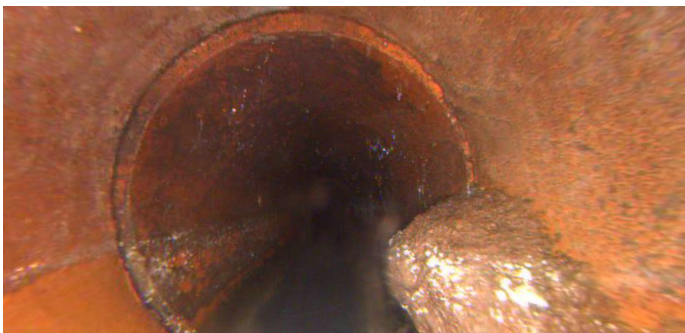
Code: **DAZ**  
Description: **Deposits Attached Other**

Distance (ft): **32.9**  
Structural Grade: **0**  
O&M Grade: **2**  
Clock Start/From: **3**  
Clock To: **4**  
1st Value:  
2nd Value:  
Value Percent: **10.000**  
Continuous Index:  
Within 8" of Joint: **YES**  
Remarks:

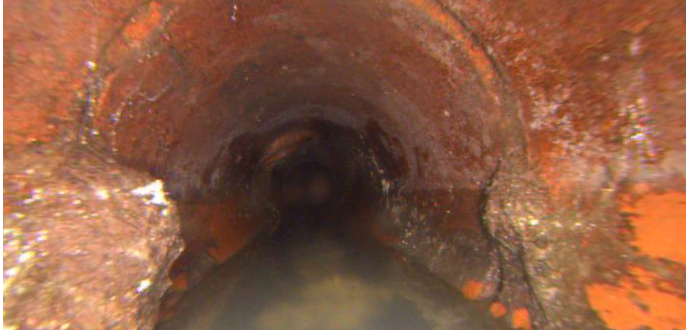
Code: **DAZ**  
Description: **Deposits Attached Other**

Distance (ft): **37.2**  
Structural Grade: **0**  
O&M Grade: **2**  
Clock Start/From: **8**  
Clock To: **4**  
1st Value:  
2nd Value:  
Value Percent: **10.000**  
Continuous Index:  
Within 8" of Joint: **YES**  
Remarks:

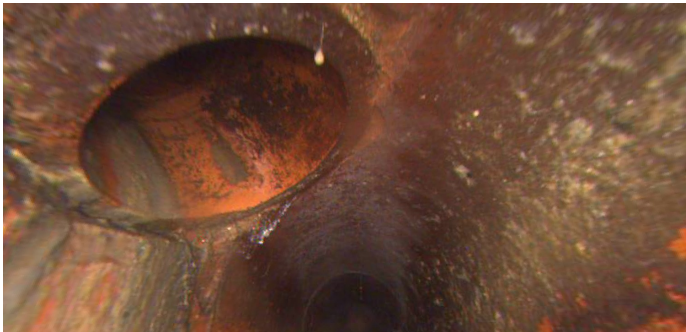
Code: **TBI**  
Description: **Tap Break-in Intruding**

Distance (ft): **39.2**  
Structural Grade: **0**  
O&M Grade: **2**  
Clock Start/From: **11**  
Clock To:  
1st Value: **4.000**  
2nd Value: **1.000**  
Value Percent:  
Continuous Index:  
Within 8" of Joint:  
Remarks:

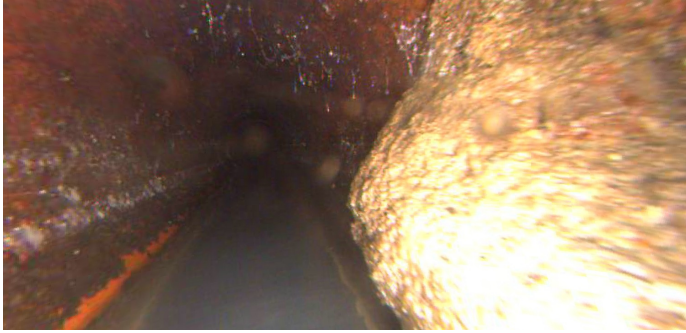
Code: **DAE**  
Description: **Deposits Attached Encrustation**

Distance (ft): **45.4**  
Structural Grade: **0**  
O&M Grade: **3**  
Clock Start/From: **1**  
Clock To: **4**  
1st Value:  
2nd Value:  
Value Percent: **15.000**  
Continuous Index:  
Within 8" of Joint: **YES**  
Remarks:

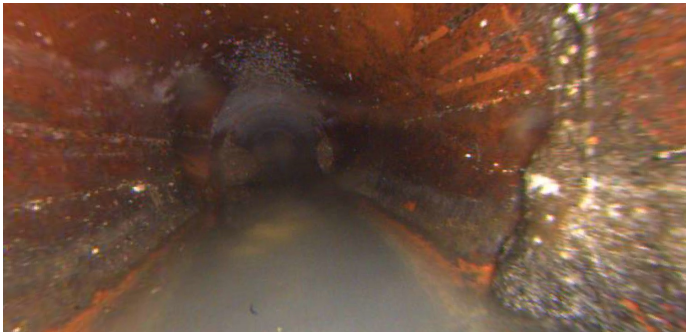
Code: **DAZ**  
Description: **Deposits Attached Other**

Distance (ft): **49.5**  
Structural Grade: **0**  
O&M Grade: **2**  
Clock Start/From: **3**  
Clock To: **4**  
1st Value:  
2nd Value:  
Value Percent: **5.000**  
Continuous Index:  
Within 8" of Joint: **YES**  
Remarks:

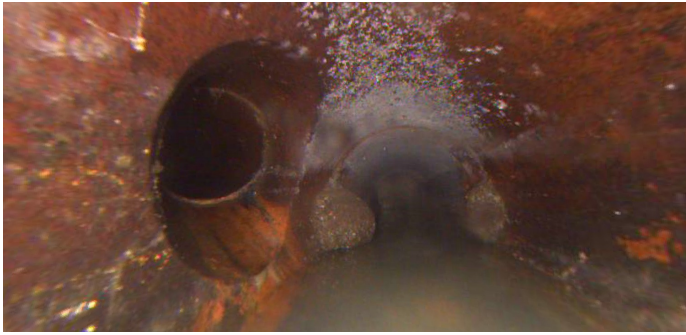
Code: **TF**  
Description: **Tap Factory**

Distance (ft): **50.4**  
Structural Grade: **0**  
O&M Grade: **0**  
Clock Start/From: **9**  
Clock To:  
1st Value: **4.000**  
2nd Value:  
Value Percent:  
Continuous Index:  
Within 8" of Joint:  
Remarks:

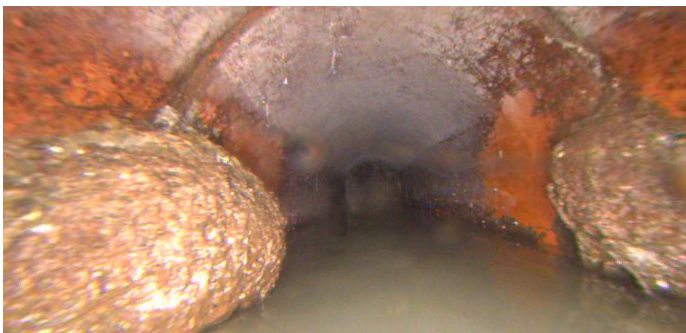
Code: **DAZ**  
Description: **Deposits Attached Other**

Distance (ft): **51.3**  
Structural Grade: **0**  
O&M Grade: **3**  
Clock Start/From: **8**  
Clock To: **4**  
1st Value:  
2nd Value:  
Value Percent: **20.000**  
Continuous Index:  
Within 8" of Joint: **YES**  
Remarks:

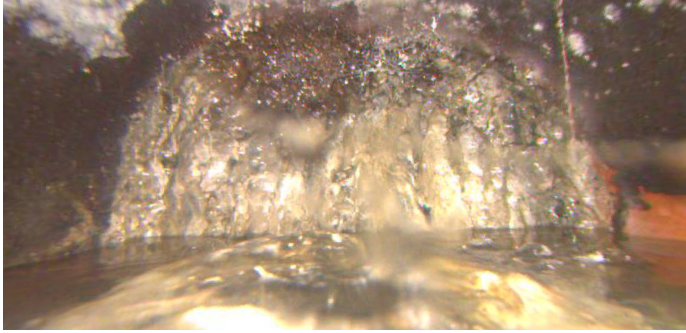
Code: **RBJ**  
Description: **Roots Ball Joint**

Distance (ft): **55.0**  
Structural Grade: **0**  
O&M Grade: **4**  
Clock Start/From: **12**  
Clock To: **12**  
1st Value:  
2nd Value:  
Value Percent: **90.000**  
Continuous Index:  
Within 8" of Joint: **YES**  
Remarks:
