Profile/Photo Observation Report

Street:	LUTHER DR	Flow Control:	Not Controlled
City:	Hobart, IN	Year Renewed:	
Location:	Light Highway	Tape/Media #:	
Purpose:	Maintenance Related	Dia/Height:	8"
Use:	Sanitary	Material:	VCP
Drain Area:	NA	Lining:	Cured in Place
Category:	NA		
Comment:	flow incorrect.

Location Details:		Direction of Survey:	Upstream
US MH:	M-806-004	DS MH:	M-806-003
		Total Length Surveyed (ft):	198.0

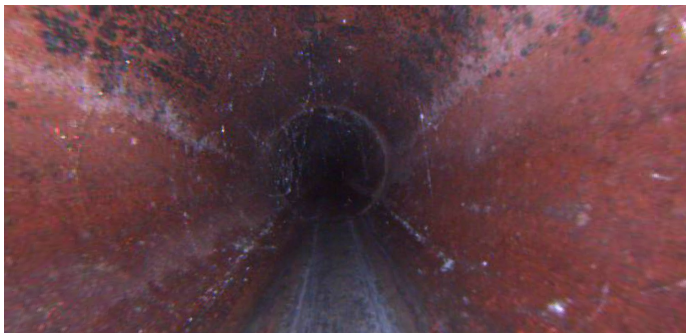
Code: **AMH**
Description: **Manhole**

Distance (ft): **.0**
Structural Grade: **0**
O&M Grade: **0**
Clock Start/From:
Clock To:
1st Value:
2nd Value:
Value Percent:
Continuous Index:
Within 8" of Joint: **NO**
Remarks: **M-806-003**

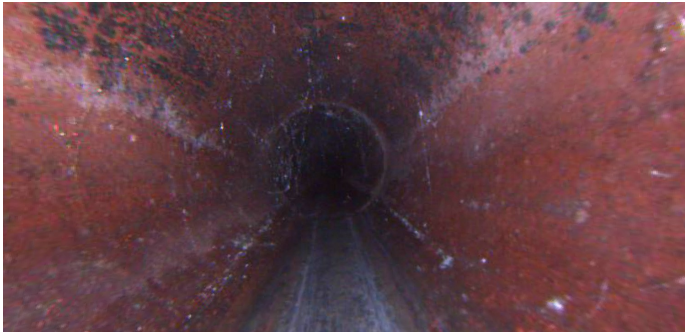
Code:	MWL
Description:	Water Level

Distance (ft):	.0
Structural Grade:	0
O&M Grade:	0
Clock Start/From:	
Clock To:	
1st Value:	
2nd Value:	
Value Percent:	5.000
Continuous Index:	
Within 8" of Joint:	NO
Remarks:

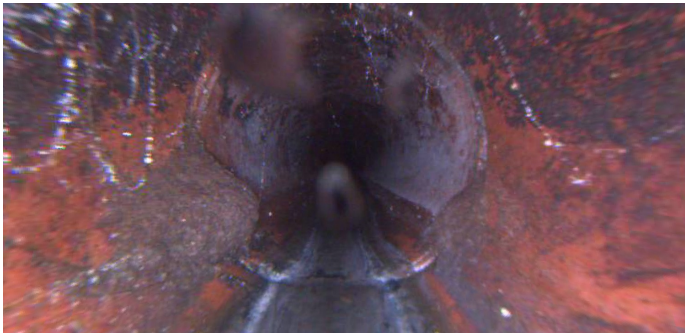
Code:	DAZ
Description:	Deposits Attached Other

Distance (ft):	5.5
Structural Grade:	0
O&M Grade:	2
Clock Start/From:	8
Clock To:	4
1st Value:	
2nd Value:	
Value Percent:	5.000
Continuous Index:	
Within 8" of Joint:	YES
Remarks:

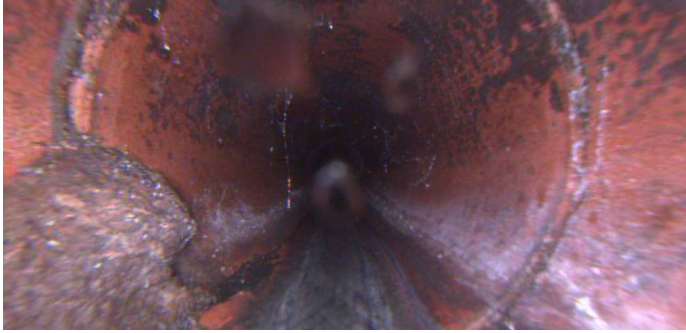
Code: **DAE**
Description: **Deposits Attached Encrustation**

Distance (ft): **9.7**
Structural Grade: **0**
O&M Grade: **2**
Clock Start/From: **8**
Clock To: **9**
1st Value:
2nd Value:
Value Percent: **10.000**
Continuous Index:
Within 8" of Joint: **YES**
Remarks:

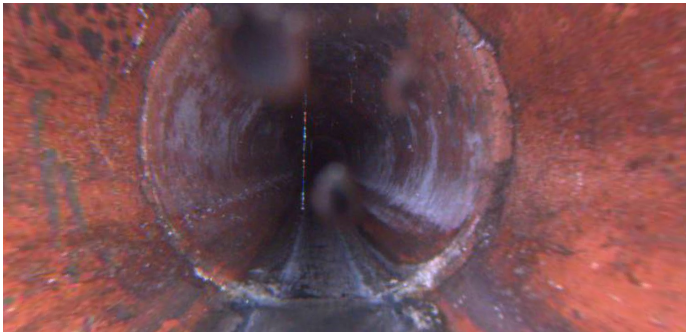
Code: **RFJ**
Description: **Roots Fine Joint**

Distance (ft): **13.5**
Structural Grade: **0**
O&M Grade: **1**
Clock Start/From: **1**
Clock To: **4**
1st Value:
2nd Value:
Value Percent:
Continuous Index:
Within 8" of Joint: **YES**
Remarks:

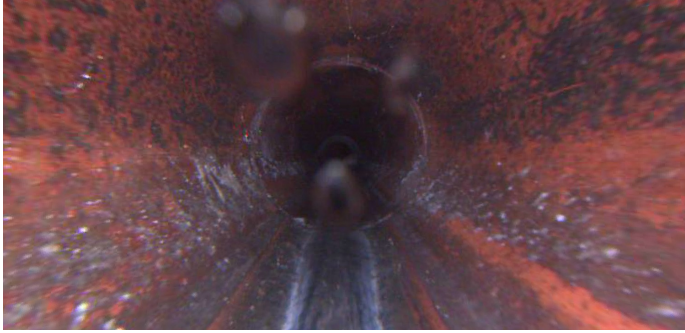
Code: **DAGS**
Description: **Deposits Attached Grease**

Distance (ft): **20.7**
Structural Grade: **0**
O&M Grade: **2**
Clock Start/From: **8**
Clock To: **4**
1st Value:
2nd Value:
Value Percent: **5.000**
Continuous Index: **S01**
Within 8" of Joint: **NO**
Remarks:

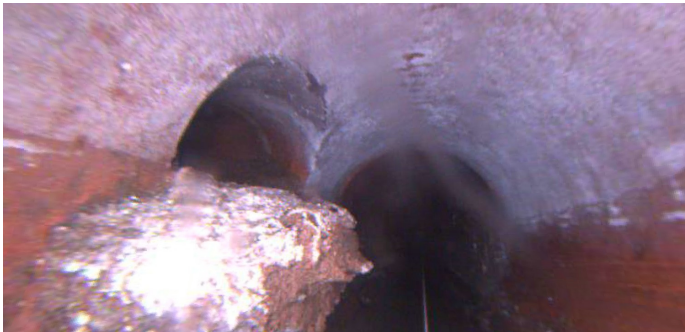
Code: **TFD**
Description: **Tap Factory Defective**

Distance (ft): **27.4**
Structural Grade: **0**
O&M Grade: **2**
Clock Start/From: **3**
Clock To:
1st Value: **4.000**
2nd Value:
Value Percent:
Continuous Index:
Within 8" of Joint:
Remarks: **rml**

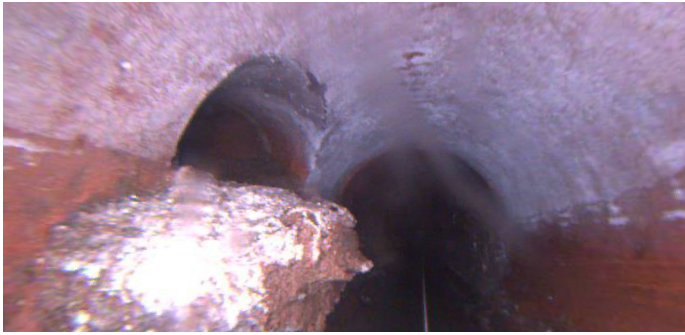
Code: **RML**
Description: **Roots Medium Lateral**

Distance (ft): **27.4**
Structural Grade: **0**
O&M Grade: **3**
Clock Start/From: **3**
Clock To: **4**
1st Value:
2nd Value:
Value Percent: **20.000**
Continuous Index:
Within 8" of Joint: **NO**
Remarks:

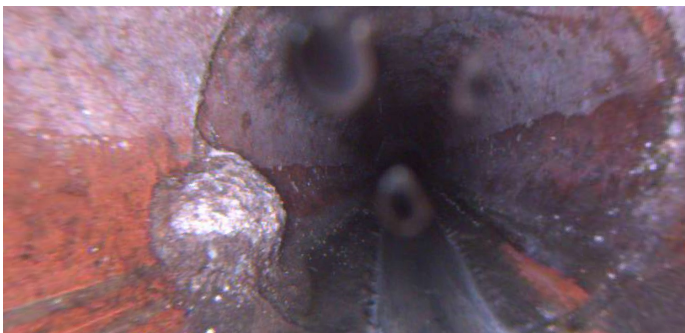
Code: **DAE**
Description: **Deposits Attached Encrustation**

Distance (ft): **27.4**
Structural Grade: **0**
O&M Grade: **2**
Clock Start/From: **8**
Clock To: **9**
1st Value:
2nd Value:
Value Percent: **5.000**
Continuous Index:
Within 8" of Joint: **YES**
Remarks:

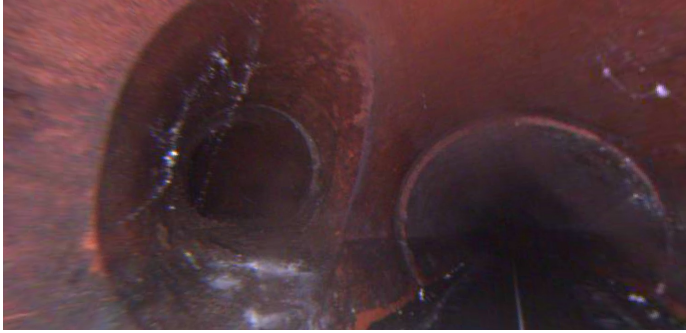
Code: **TF**
Description: **Tap Factory**

Distance (ft): **135.9**
Structural Grade: **0**
O&M Grade: **0**
Clock Start/From: **3**
Clock To:
1st Value: **4.000**
2nd Value:
Value Percent:
Continuous Index:
Within 8" of Joint:
Remarks:

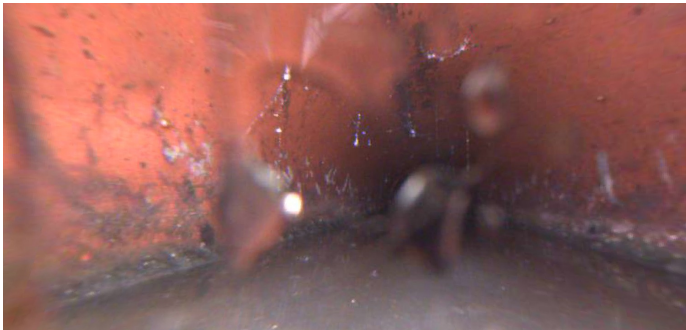
Code: **MWL**
Description: **Water Level**

Distance (ft): **189.6**
Structural Grade: **0**
O&M Grade: **0**
Clock Start/From:
Clock To:
1st Value:
2nd Value:
Value Percent: **30.000**
Continuous Index:
Within 8" of Joint: **NO**
Remarks:

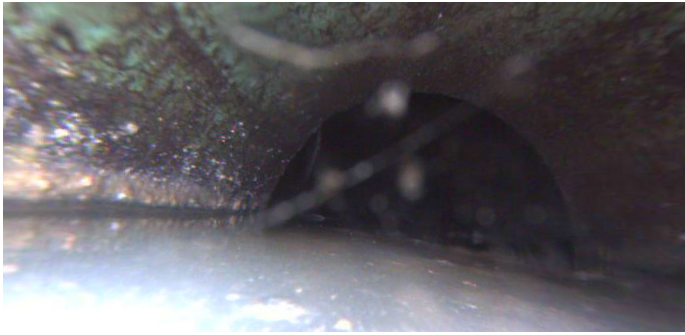
Code: **MMC**
Description: **Material Change**

Distance (ft): **196.5**
Structural Grade: **0**
O&M Grade: **0**
Clock Start/From:
Clock To:
1st Value:
2nd Value:
Value Percent:
Continuous Index:
Within 8" of Joint: **NO**
Remarks: **PVC**

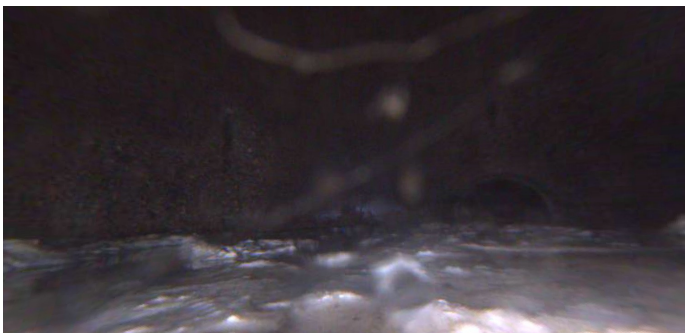
Code: **DAGS**
Description: **Deposits Attached Grease**

Distance (ft): **198.0**
Structural Grade: **0**
O&M Grade: **2**
Clock Start/From: **8**
Clock To: **4**
1st Value:
2nd Value:
Value Percent: **5.000**
Continuous Index: **F01**
Within 8" of Joint: **NO**
Remarks:

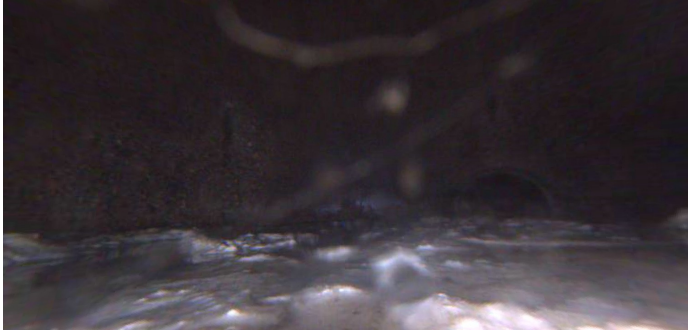
Code:	AMH
Description:	Manhole
Distance (ft):	198.0
Structural Grade:	0
O&M Grade:	0
Clock Start/From:	
Clock To:	
1st Value:	
2nd Value:	
Value Percent:	
Continuous Index:	
Within 8" of Joint:	NO
Remarks:	M-806-004
