Profile/Photo Observation Report

Date:	04/13/2018	Weather:		Coding:	PACP 6.0
Pipe Length (ft):	204.1	Owner:	NA	Pre Clean:	Not Known
P.O.#:		Surveyor:	Jen Costello	PSR:	P-806-003-004
Customer:		Clean Date:	01/01/1900	Shape:	C

Street:	Capitol	Flow Control:	Not Controlled
City:	Hobart, IN	Year Renewed:	
Location:	Light Highway	Tape/Media #:	
Purpose:	Maintenance Related	Dia/Height:	8"
Use:	Sanitary	Material:	VCP
Drain Area:	NA	Lining:	Cured in Place
Category:	NA		
Comment:	flow incorrect.

Location Details:		Direction of Survey:	Upstream
US MH:	M-806-004	DS MH:	M-806-003
		Total Length Surveyed (ft):	198.0

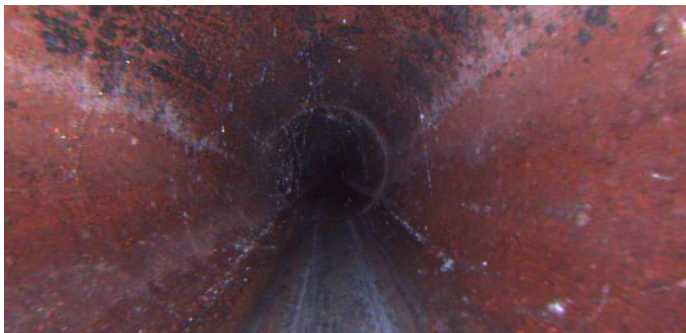
Code: **AMH**
Description: **Manhole**

Distance (ft): **.0**
Structural Grade: **0**
O&M Grade: **0**
Clock Start/From:
Clock To:
1st Value:
2nd Value:
Value Percent:
Continuous Index:
Within 8" of Joint: **NO**
Remarks: **M-806-003**

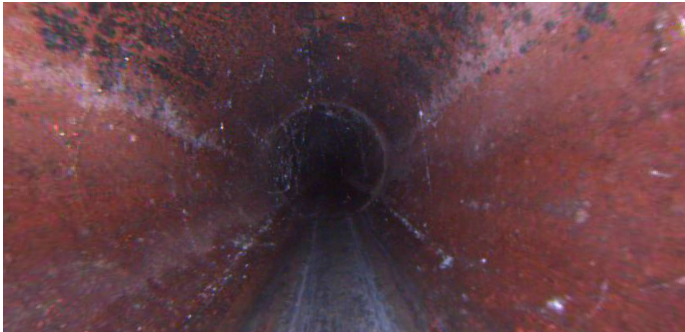
Code:	MWL
Description:	Water Level

Distance (ft):	.0
Structural Grade:	0
O&M Grade:	0
Clock Start/From:	
Clock To:	
1st Value:	
2nd Value:	
Value Percent:	5.000
Continuous Index:	
Within 8" of Joint:	NO
Remarks:

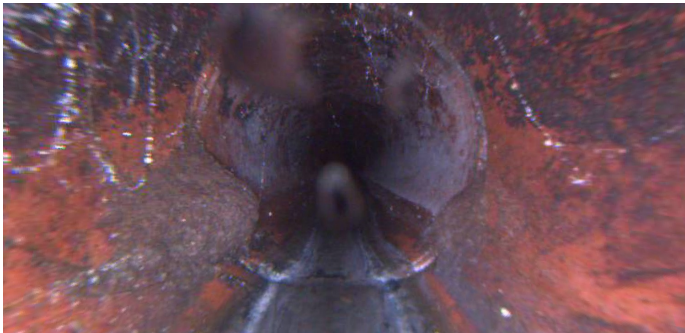
Code:	DAZ
Description:	Deposits Attached Other

Distance (ft):	5.5
Structural Grade:	0
O&M Grade:	2
Clock Start/From:	8
Clock To:	4
1st Value:	
2nd Value:	
Value Percent:	5.000
Continuous Index:	
Within 8" of Joint:	YES
Remarks:

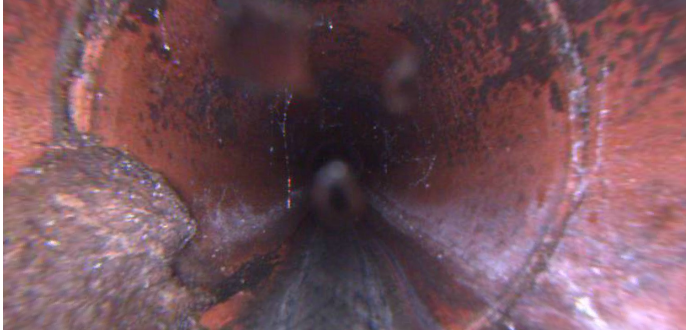
Code: **DAE**
Description: **Deposits Attached Encrustation**

Distance (ft): **9.7**
Structural Grade: **0**
O&M Grade: **2**
Clock Start/From: **8**
Clock To: **9**
1st Value:
2nd Value:
Value Percent: **10.000**
Continuous Index:
Within 8" of Joint: **YES**
Remarks:

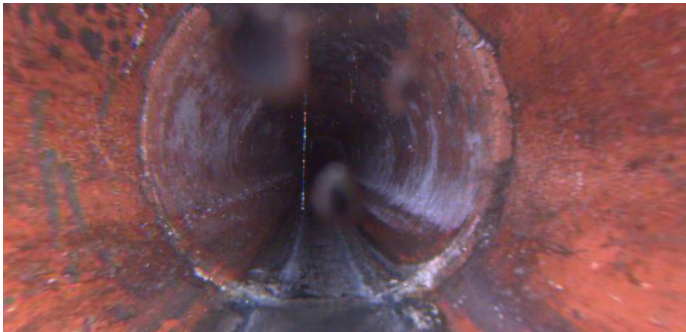
Code: **RFJ**
Description: **Roots Fine Joint**

Distance (ft): **13.5**
Structural Grade: **0**
O&M Grade: **1**
Clock Start/From: **1**
Clock To: **4**
1st Value:
2nd Value:
Value Percent:
Continuous Index:
Within 8" of Joint: **YES**
Remarks:

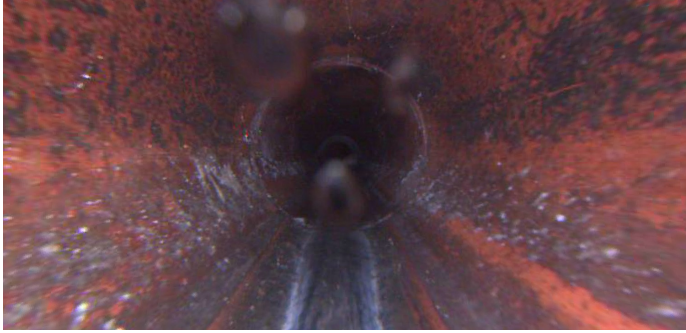
Code: **DAGS**
Description: **Deposits Attached Grease**

Distance (ft): **20.7**
Structural Grade: **0**
O&M Grade: **2**
Clock Start/From: **8**
Clock To: **4**
1st Value:
2nd Value:
Value Percent: **5.000**
Continuous Index: **S01**
Within 8" of Joint: **NO**
Remarks:

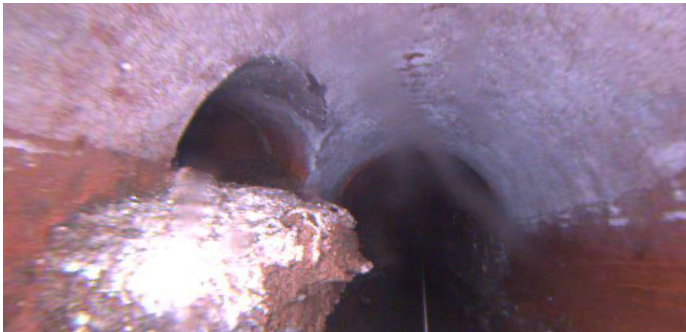
Code: **TFD**
Description: **Tap Factory Defective**

Distance (ft): **27.4**
Structural Grade: **0**
O&M Grade: **2**
Clock Start/From: **3**
Clock To:
1st Value: **4.000**
2nd Value:
Value Percent:
Continuous Index:
Within 8" of Joint:
Remarks: **rml**

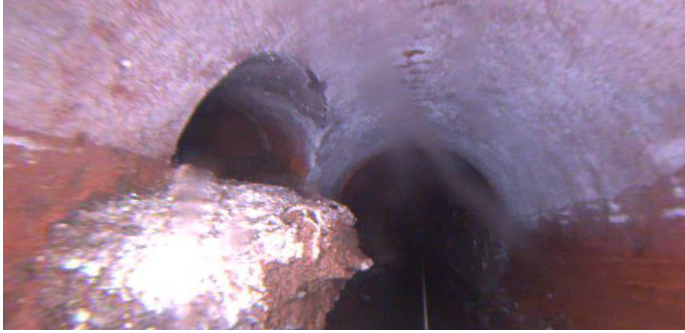
Code: **RML**
Description: **Roots Medium Lateral**

Distance (ft): **27.4**
Structural Grade: **0**
O&M Grade: **3**
Clock Start/From: **3**
Clock To: **4**
1st Value:
2nd Value:
Value Percent: **20.000**
Continuous Index:
Within 8" of Joint: **NO**
Remarks:

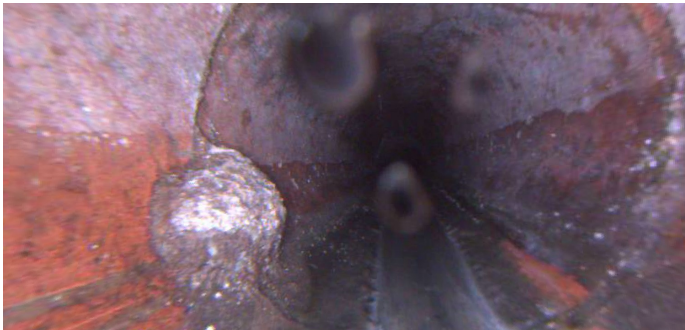
Code: **DAE**
Description: **Deposits Attached Encrustation**

Distance (ft): **27.4**
Structural Grade: **0**
O&M Grade: **2**
Clock Start/From: **8**
Clock To: **9**
1st Value:
2nd Value:
Value Percent: **5.000**
Continuous Index:
Within 8" of Joint: **YES**
Remarks:

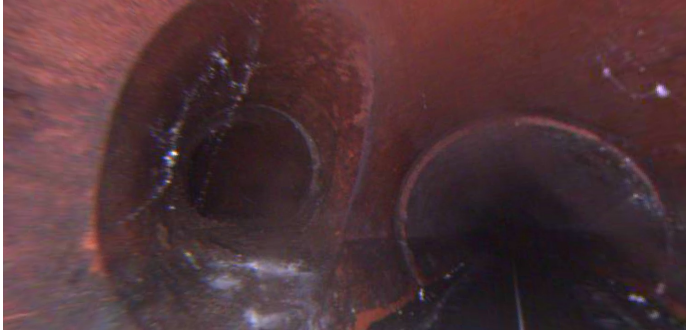
Code: **TF**
Description: **Tap Factory**

Distance (ft): **135.9**
Structural Grade: **0**
O&M Grade: **0**
Clock Start/From: **3**
Clock To:
1st Value: **4.000**
2nd Value:
Value Percent:
Continuous Index:
Within 8" of Joint:
Remarks:

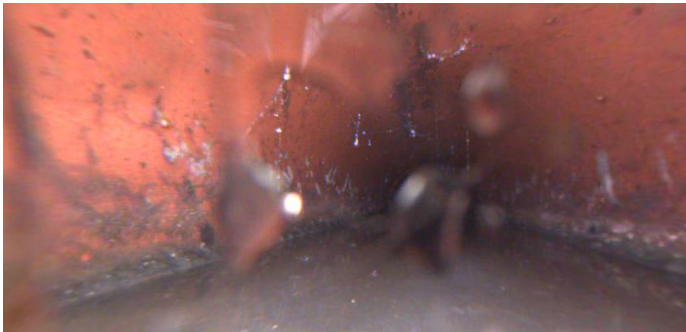
Code: **MWL**
Description: **Water Level**

Distance (ft): **189.6**
Structural Grade: **0**
O&M Grade: **0**
Clock Start/From:
Clock To:
1st Value:
2nd Value:
Value Percent: **30.000**
Continuous Index:
Within 8" of Joint: **NO**
Remarks:

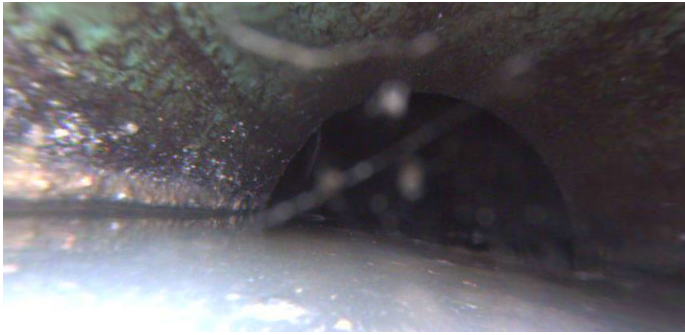
Code: **MMC**
Description: **Material Change**

Distance (ft): **196.5**
Structural Grade: **0**
O&M Grade: **0**
Clock Start/From:
Clock To:
1st Value:
2nd Value:
Value Percent:
Continuous Index:
Within 8" of Joint: **NO**
Remarks: **PVC**

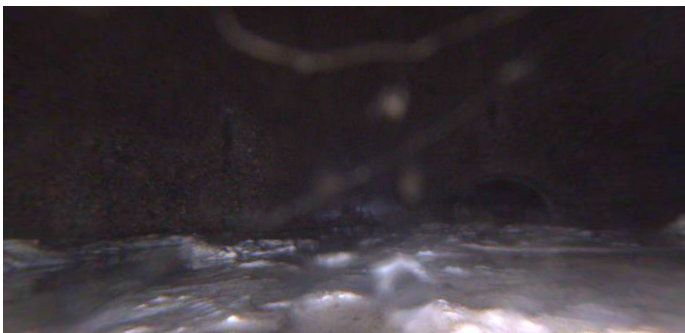
Code: **DAGS**
Description: **Deposits Attached Grease**

Distance (ft): **198.0**
Structural Grade: **0**
O&M Grade: **2**
Clock Start/From: **8**
Clock To: **4**
1st Value:
2nd Value:
Value Percent: **5.000**
Continuous Index: **F01**
Within 8" of Joint: **NO**
Remarks:

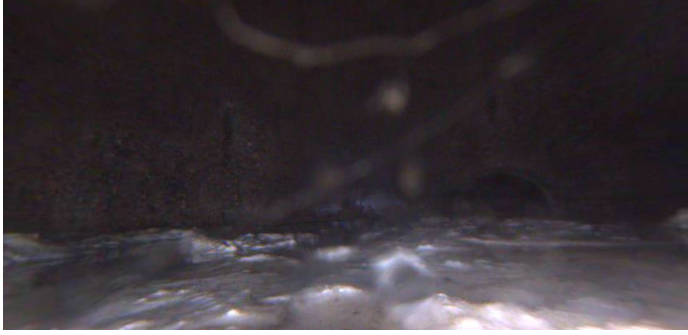
Code:	AMH
Description:	Manhole
Distance (ft):	198.0
Structural Grade:	0
O&M Grade:	0
Clock Start/From:	
Clock To:	
1st Value:	
2nd Value:	
Value Percent:	
Continuous Index:	
Within 8" of Joint:	NO
Remarks:	M-806-004
