Profile/Photo Observation Report

| Street: | LUTHER DR | Flow Control: | Not Controlled |
| City: | Hobart, IN | Year Renewed: | |

| US MH: | M-806-005 | DS MH: | M-806-004 |

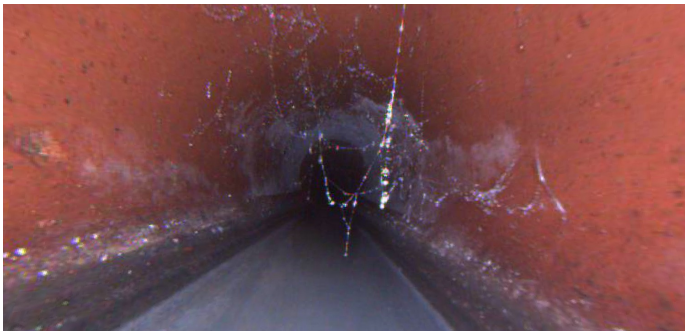
Code: **AMH**
Description: **Manhole**

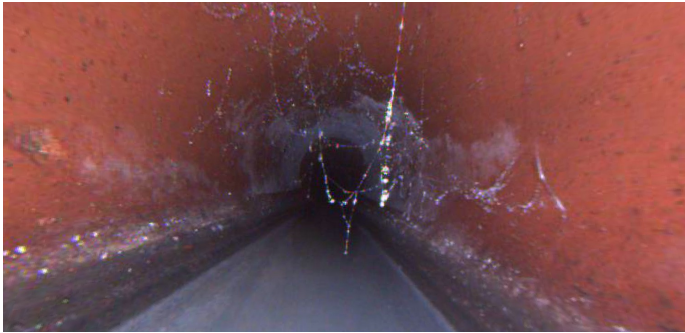
| Code: | MWL |
| Description: | Water Level |

| Value Percent: | 10.000 |

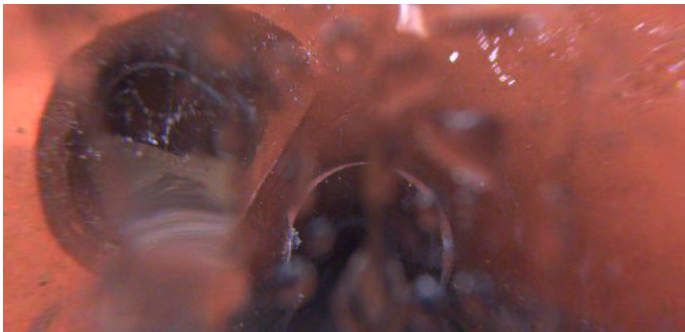
| Code: | TF |
| Description: | Tap Factory |

| Distance (ft): | 16.7 |

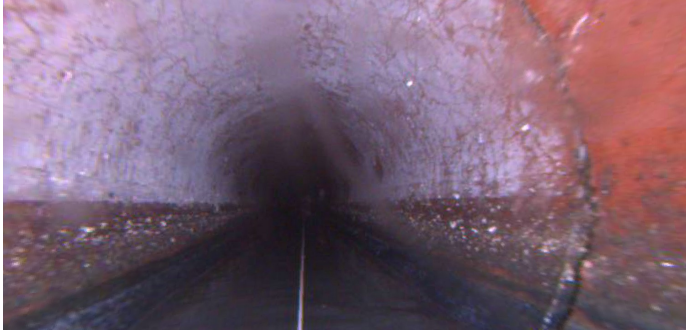
Code: **MGO**
Description: **General Observation**

Distance (ft): **22.4**
Structural Grade: **0**
O&M Grade: **0**
Clock Start/From:
Clock To:
1st Value:
2nd Value:
Value Percent:
Continuous Index:
Within 8" of Joint: **NO**
Remarks: **rear camera**

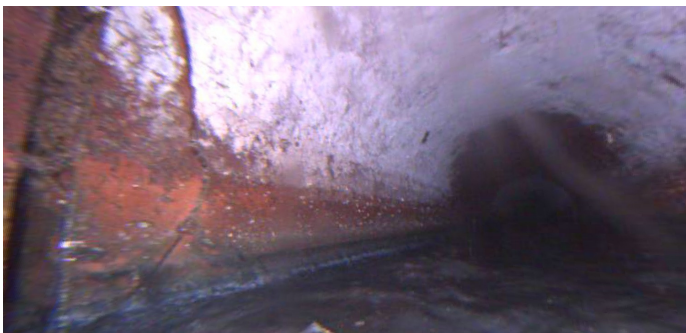
| Position | Code | Observation | Video (sec) | Grade |
|--|---|---|---|---|
| 62.2 | FC | Fracture Circumferential | 183 | S 2 |

Code: **FC**
Description: **Fracture Circumferential**

Distance (ft): **62.2**
Structural Grade: **2**
O&M Grade: **0**
Clock Start/From: **2**
Clock To: **4**
1st Value:
2nd Value:
Value Percent:
Continuous Index:
Within 8" of Joint: **YES**
Remarks:

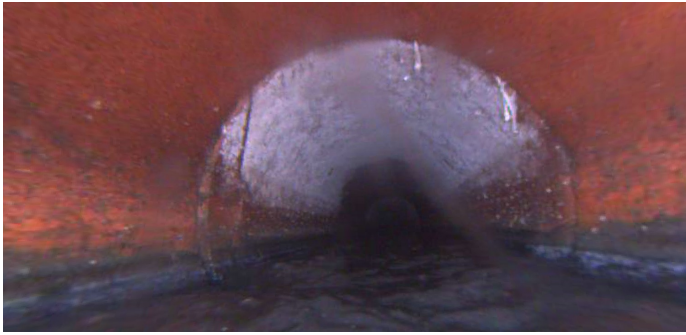
| Position | Code | Observation | Video (sec) | Grade |
|--|---|---|---|---|
| 62.8 | RFJ | Roots Fine Joint | 196 | M 1 |

Code: **RFJ**
Description: **Roots Fine Joint**

Distance (ft): **62.8**
Structural Grade: **0**
O&M Grade: **1**
Clock Start/From: **8**
Clock To: **4**
1st Value:
2nd Value:
Value Percent:
Continuous Index:
Within 8" of Joint: **YES**
Remarks:

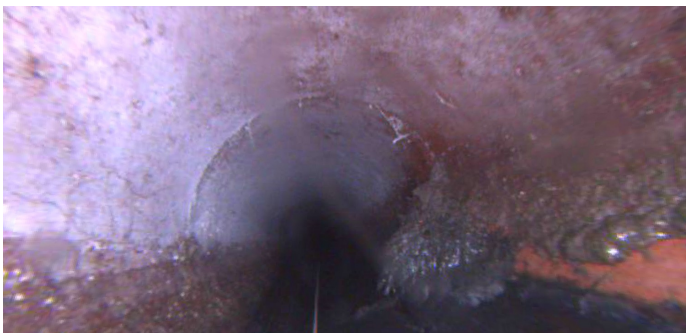
| Position | Code | Observation | Video (sec) | Grade |
|--|---|---|---|---|
| 87.1 | RMJ | Roots Medium Joint | 256 | M 3 |

Code: **RMJ**
Description: **Roots Medium Joint**

Distance (ft): **87.1**
Structural Grade: **0**
O&M Grade: **3**
Clock Start/From: **8**
Clock To: **4**
1st Value:
2nd Value:
Value Percent: **10.000**
Continuous Index:
Within 8" of Joint: **YES**
Remarks:

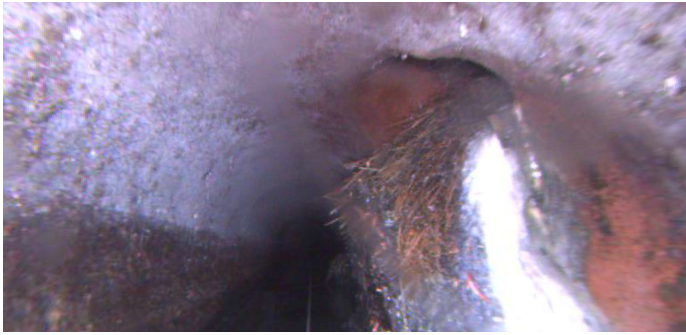
| Position | Code | Observation | Video (sec) | Grade |
|--|---|---|---|---|
| 88.0 | TFD | Tap Factory Defective | 269 | M 2 |

Code: **TFD**
Description: **Tap Factory Defective**

Distance (ft): **88.0**
Structural Grade: **0**
O&M Grade: **2**
Clock Start/From: **10**
Clock To:
1st Value: **4.000**
2nd Value:
Value Percent:
Continuous Index:
Within 8" of Joint:
Remarks: **rml**

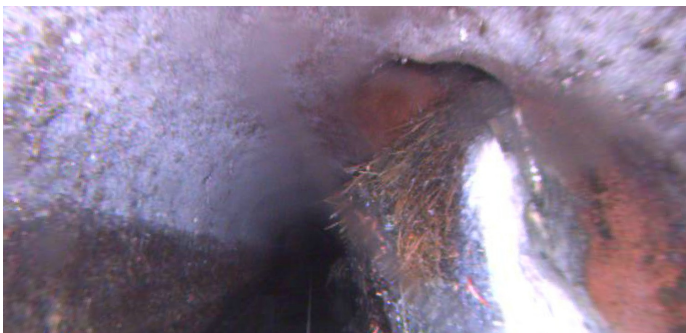
| Position | Code | Observation | Video (sec) | Grade |
|--|---|---|---|---|
| 88.0 | RML | Roots Medium Lateral | 280 | M 3 |

Code: **RML**
Description: **Roots Medium Lateral**

Distance (ft): **88.0**
Structural Grade: **0**
O&M Grade: **3**
Clock Start/From: **10**
Clock To:
1st Value:
2nd Value:
Value Percent: **20.000**
Continuous Index:
Within 8" of Joint: **NO**
Remarks:

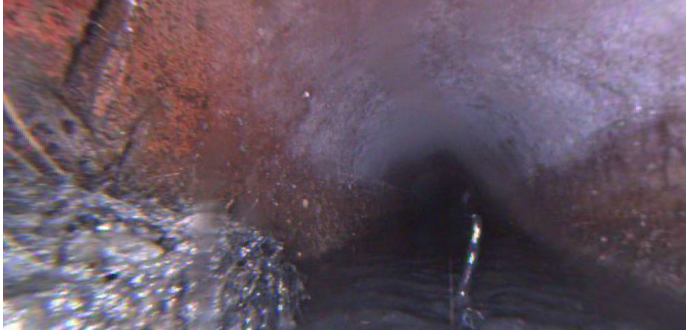
| Position | Code | Observation | Video (sec) | Grade |
|--|---|---|---|---|
| 92.3 | RMJ | Roots Medium Joint | 300 | M 3 |

Code: **RMJ**
Description: **Roots Medium Joint**

Distance (ft): **92.3**
Structural Grade: **0**
O&M Grade: **3**
Clock Start/From: **3**
Clock To: **5**
1st Value:
2nd Value:
Value Percent: **10.000**
Continuous Index:
Within 8" of Joint: **YES**
Remarks:

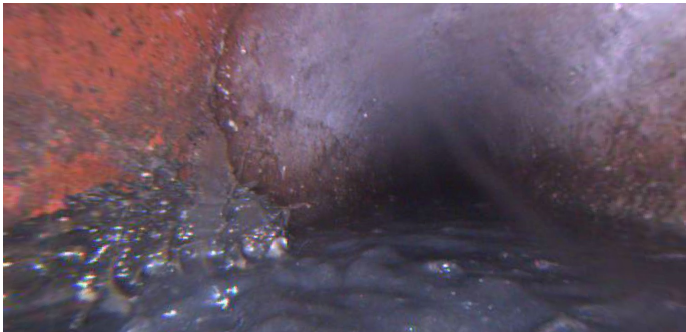
| Position | Code | Observation | Video (sec) | Grade |
|--|---|---|---|---|
| 100.5 | RMJ | Roots Medium Joint | 329 | M 3 |

Code: **RMJ**
Description: **Roots Medium Joint**

Distance (ft): **100.5**
Structural Grade: **0**
O&M Grade: **3**
Clock Start/From: **3**
Clock To: **4**
1st Value:
2nd Value:
Value Percent: **5.000**
Continuous Index:
Within 8" of Joint: **YES**
Remarks:

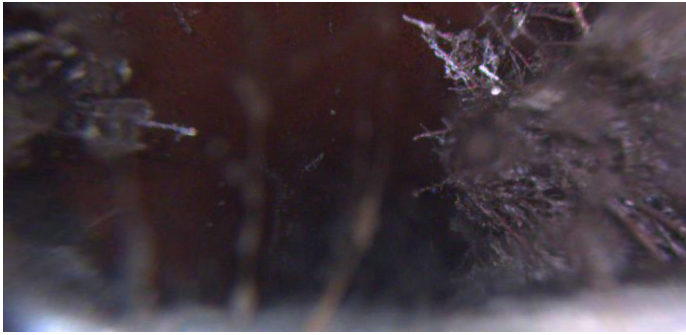
| Comment: | roots at 103'.-flow incorrect. | | |

| Position | Code | Observation | Video (sec) | Grade |
|--|---|---|---|---|
| 104.3 | RMJ | Roots Medium Joint | 350 | M 3 |

Code: **RMJ**
Description: **Roots Medium Joint**

Distance (ft): **104.3**
Structural Grade: **0**
O&M Grade: **3**
Clock Start/From: **8**
Clock To: **4**
1st Value:
2nd Value:
Value Percent: **20.000**
Continuous Index:
Within 8" of Joint: **YES**
Remarks:

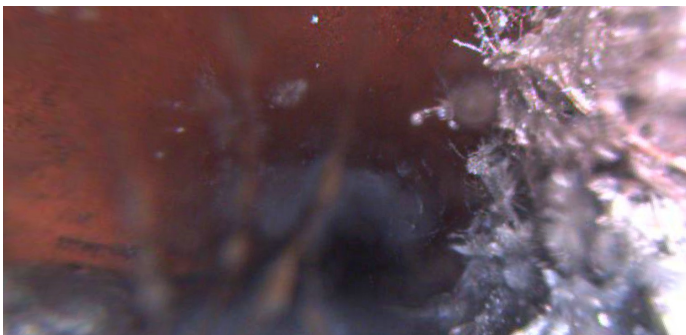
Code: **MSA**
Description: **Abandoned Survey**

Distance (ft): **104.8**
Structural Grade: **0**
O&M Grade: **0**
Clock Start/From:
Clock To:
1st Value:
2nd Value:
Value Percent:
Continuous Index:
Within 8" of Joint: **NO**
Remarks: **roots**
