## Profile/Photo Observation Report

Date:	<b>04/13/2018</b>	Weather:		Coding:	<b>PACP 6.0</b>
Pipe Length (ft):	<b>196.6</b>	Owner:	<b>NA</b>	Pre Clean:	<b>Not Known</b>
P.O.#:		Surveyor:	<b>Jen Costello</b>	PSR:	<b>P-806-004-005</b>
Customer:		Clean Date:	<b>01/01/1900</b>	Shape:	<b>C</b>

Street:	<b>Capitol</b>	Flow Control:	<b>Not Controlled</b>
City:	<b>Hobart, IN</b>	Year Renewed:	
Location:	<b>Light Highway</b>	Tape/Media #:	
Purpose:	<b>Maintenance Related</b>	Dia/Height:	<b>8"</b>
Use:	<b>Sanitary</b>	Material:	<b>VCP</b>
Drain Area:	<b>NA</b>	Lining:	<b>Cured in Place</b>
Category:	<b>NA</b>		
Comment:	<b>roots at 103'.-flow incorrect.</b>		
Location Details:		Direction of Survey:	<b>Downstream</b>
US MH:	<b>M-806-005</b>	DS MH:	<b>M-806-004</b>
		Total Length Surveyed (ft):	<b>104.8</b>

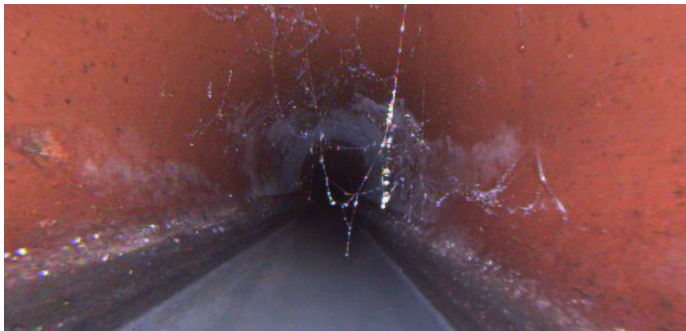
Code: **AMH**  
Description: **Manhole**

Distance (ft): **.0**  
Structural Grade: **0**  
O&M Grade: **0**  
Clock Start/From:  
Clock To:  
1st Value:  
2nd Value:  
Value Percent:  
Continuous Index:  
Within 8" of Joint: **NO**  
Remarks: **M-806-005**

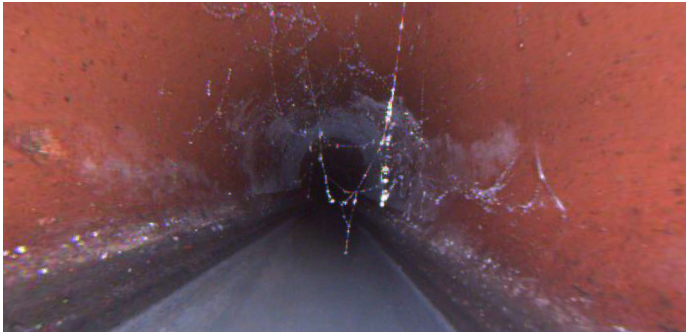
Code: **MWL**  
Description: **Water Level**

Distance (ft): **.0**  
Structural Grade: **0**  
O&M Grade: **0**  
Clock Start/From:  
Clock To:  
1st Value:  
2nd Value:  
Value Percent: **10.000**  
Continuous Index:  
Within 8" of Joint: **NO**  
Remarks:

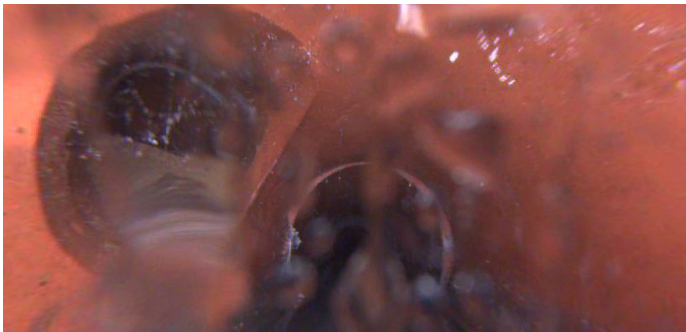
Code: **TF**  
Description: **Tap Factory**

Distance (ft): **16.7**  
Structural Grade: **0**  
O&M Grade: **0**  
Clock Start/From: **10**  
Clock To:  
1st Value: **4.000**  
2nd Value:  
Value Percent:  
Continuous Index:  
Within 8" of Joint:  
Remarks:

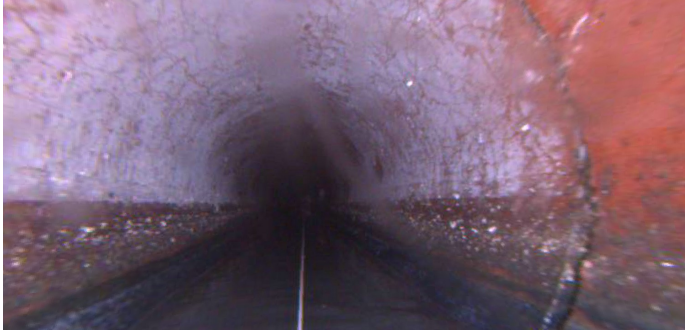
Code: **MGO**  
Description: **General Observation**

Distance (ft): **22.4**  
Structural Grade: **0**  
O&M Grade: **0**  
Clock Start/From:  
Clock To:  
1st Value:  
2nd Value:  
Value Percent:  
Continuous Index:  
Within 8" of Joint: **NO**  
Remarks: **rear camera**

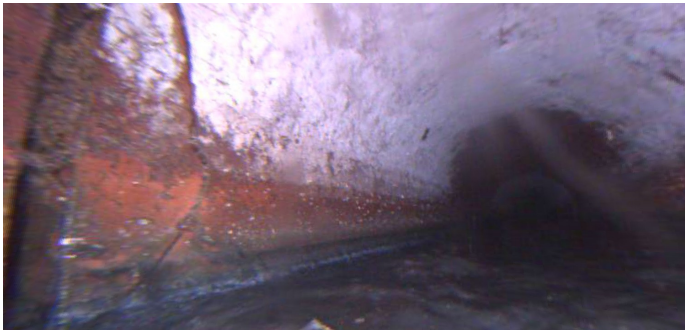
Code: **FC**  
Description: **Fracture Circumferential**

Distance (ft): **62.2**  
Structural Grade: **2**  
O&M Grade: **0**  
Clock Start/From: **2**  
Clock To: **4**  
1st Value:  
2nd Value:  
Value Percent:  
Continuous Index:  
Within 8" of Joint: **YES**  
Remarks:

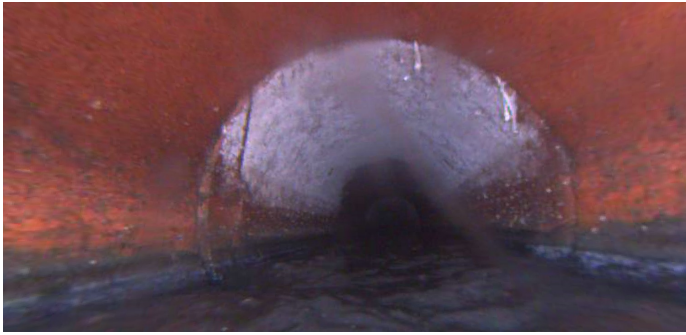
Code: **RFJ**  
Description: **Roots Fine Joint**

Distance (ft): **62.8**  
Structural Grade: **0**  
O&M Grade: **1**  
Clock Start/From: **8**  
Clock To: **4**  
1st Value:  
2nd Value:  
Value Percent:  
Continuous Index:  
Within 8" of Joint: **YES**  
Remarks:

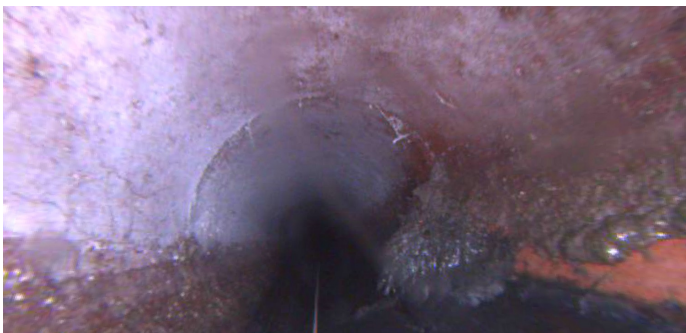
Code: **RMJ**  
Description: **Roots Medium Joint**

Distance (ft): **87.1**  
Structural Grade: **0**  
O&M Grade: **3**  
Clock Start/From: **8**  
Clock To: **4**  
1st Value:  
2nd Value:  
Value Percent: **10.000**  
Continuous Index:  
Within 8" of Joint: **YES**  
Remarks:

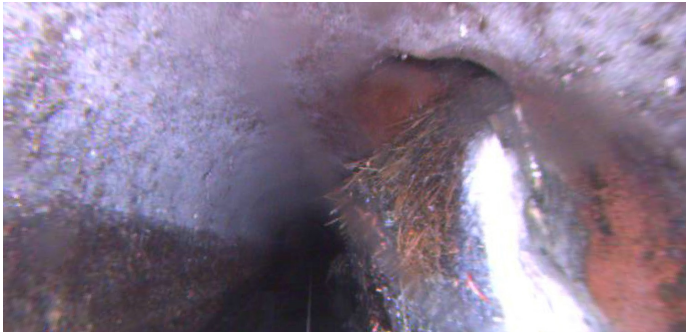
Code: **TFD**  
Description: **Tap Factory Defective**

Distance (ft): **88.0**  
Structural Grade: **0**  
O&M Grade: **2**  
Clock Start/From: **10**  
Clock To:  
1st Value: **4.000**  
2nd Value:  
Value Percent:  
Continuous Index:  
Within 8" of Joint:  
Remarks: **rml**

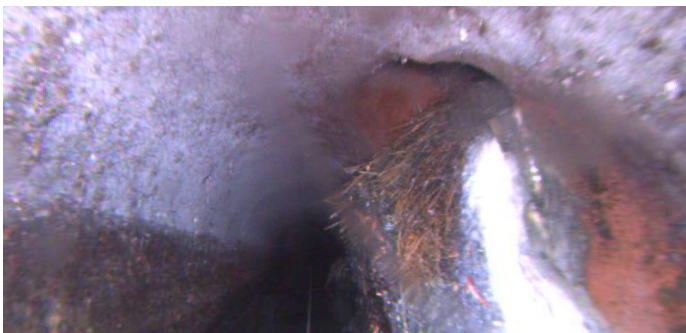
Code: **RML**  
Description: **Roots Medium Lateral**

Distance (ft): **88.0**  
Structural Grade: **0**  
O&M Grade: **3**  
Clock Start/From: **10**  
Clock To:  
1st Value:  
2nd Value:  
Value Percent: **20.000**  
Continuous Index:  
Within 8" of Joint: **NO**  
Remarks:

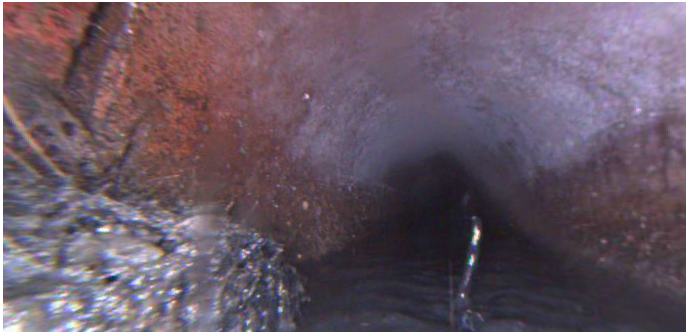
Code: **RMJ**  
Description: **Roots Medium Joint**

Distance (ft): **92.3**  
Structural Grade: **0**  
O&M Grade: **3**  
Clock Start/From: **3**  
Clock To: **5**  
1st Value:  
2nd Value:  
Value Percent: **10.000**  
Continuous Index:  
Within 8" of Joint: **YES**  
Remarks:

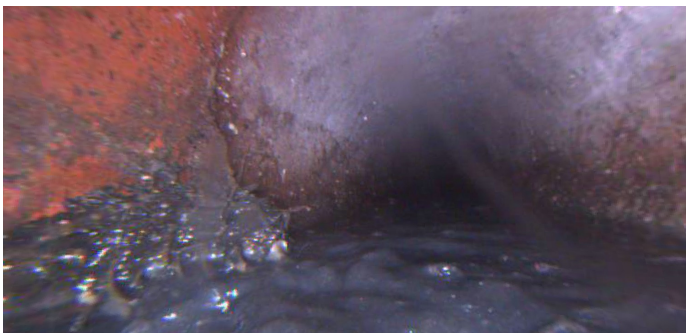
Code: **RMJ**  
Description: **Roots Medium Joint**

Distance (ft): **100.5**  
Structural Grade: **0**  
O&M Grade: **3**  
Clock Start/From: **3**  
Clock To: **4**  
1st Value:  
2nd Value:  
Value Percent: **5.000**  
Continuous Index:  
Within 8" of Joint: **YES**  
Remarks:

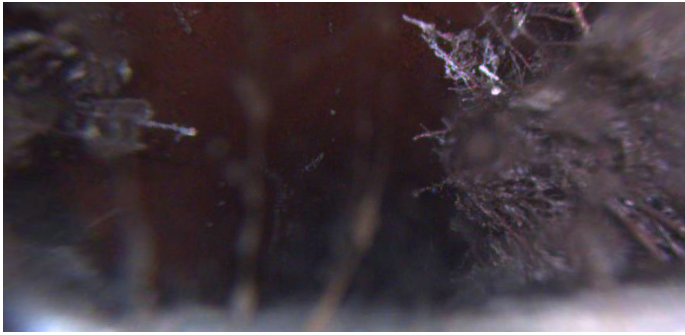
Code: **RMJ**  
Description: **Roots Medium Joint**

Distance (ft): **104.3**  
Structural Grade: **0**  
O&M Grade: **3**  
Clock Start/From: **8**  
Clock To: **4**  
1st Value:  
2nd Value:  
Value Percent: **20.000**  
Continuous Index:  
Within 8" of Joint: **YES**  
Remarks:

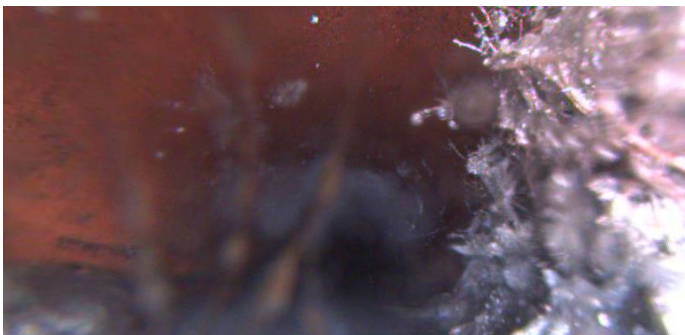
Code: **MSA**  
Description: **Abandoned Survey**

Distance (ft): **104.8**  
Structural Grade: **0**  
O&M Grade: **0**  
Clock Start/From:  
Clock To:  
1st Value:  
2nd Value:  
Value Percent:  
Continuous Index:  
Within 8" of Joint: **NO**  
Remarks: **roots**
