Profile/Photo Observation Report

Street:	LUTHER DR	Flow Control:	Not Controlled
City:	Hobart, IN	Year Renewed:	
Location:	Light Highway	Tape/Media #:	
Purpose:	Maintenance Related	Dia/Height:	10"
Use:	Sanitary	Material:	VCP
Drain Area:	NA	Lining:	Cured in Place
Category:	NA		
Comment:	flow incorrect.

Location Details:		Direction of Survey:	Upstream
US MH:	M-806-006	DS MH:	M-806-005
		Total Length Surveyed (ft):	278.2

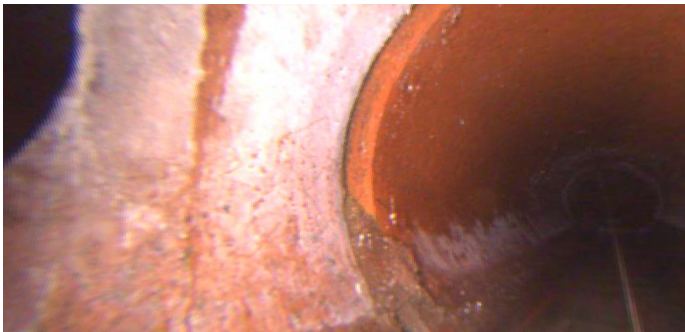
Code:	DAZ
Description:	Deposits Attached Other

Distance (ft):	5.6
Structural Grade:	0
O&M Grade:	2
Clock Start/From:	5
Clock To:	
1st Value:	
2nd Value:	
Value Percent:	5.000
Continuous Index:	
Within 8" of Joint:	YES
Remarks:

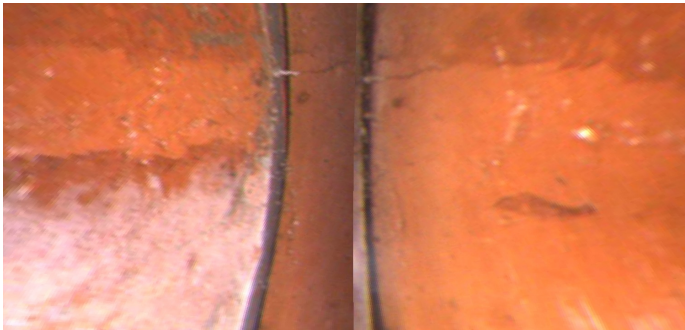
Code: **CM**
Description: **Crack Multiple**

Distance (ft): **6.8**
Structural Grade: **3**
O&M Grade: **0**
Clock Start/From: **10**
Clock To: **11**
1st Value:
2nd Value:
Value Percent:
Continuous Index: **S01**
Within 8" of Joint: **YES**
Remarks: **wandering**

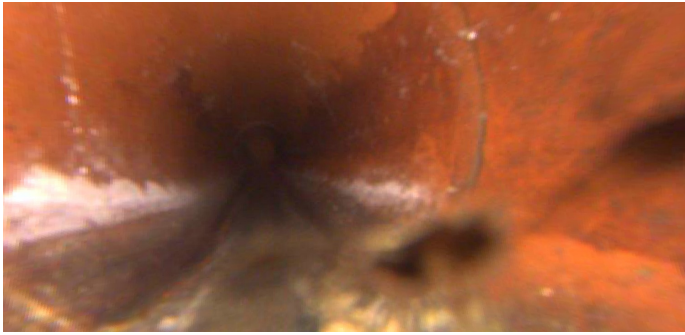
Code: **DSZ**
Description: **Deposits Settled Other**

Distance (ft): **14.4**
Structural Grade: **0**
O&M Grade: **2**
Clock Start/From: **6**
Clock To:
1st Value:
2nd Value:
Value Percent: **5.000**
Continuous Index:
Within 8" of Joint: **NO**
Remarks: **debris**

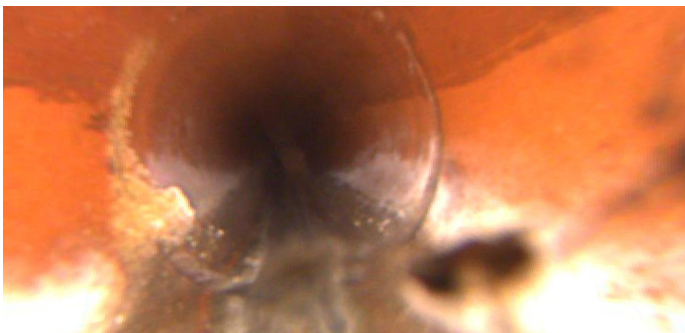
Code: **DAE**
Description: **Deposits Attached Encrustation**

Distance (ft): **30.4**
Structural Grade: **0**
O&M Grade: **2**
Clock Start/From: **8**
Clock To:
1st Value:
2nd Value:
Value Percent: **5.000**
Continuous Index:
Within 8" of Joint: **YES**
Remarks:

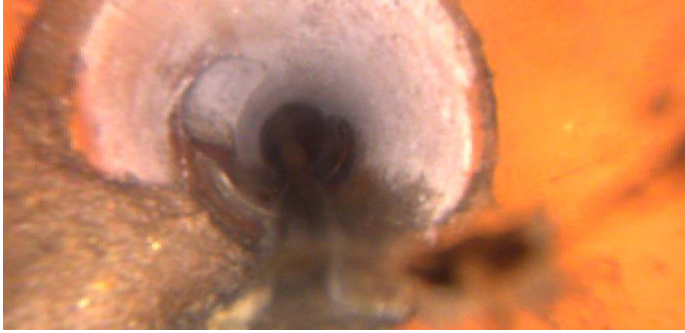
Code: **DAZ**
Description: **Deposits Attached Other**

Distance (ft): **43.0**
Structural Grade: **0**
O&M Grade: **2**
Clock Start/From: **7**
Clock To: **9**
1st Value:
2nd Value:
Value Percent: **5.000**
Continuous Index:
Within 8" of Joint: **YES**
Remarks:

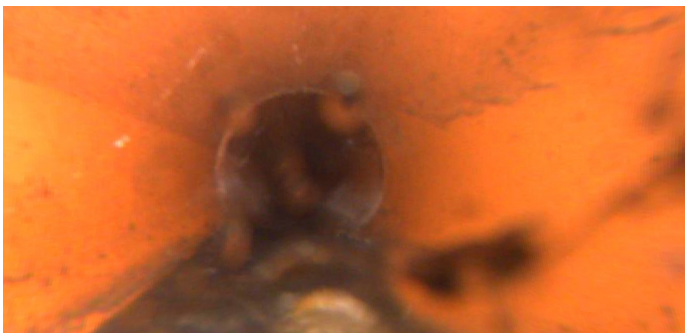
Code: **DSZ**
Description: **Deposits Settled Other**

Distance (ft): **89.2**
Structural Grade: **0**
O&M Grade: **2**
Clock Start/From: **6**
Clock To:
1st Value:
2nd Value:
Value Percent: **5.000**
Continuous Index: **S02**
Within 8" of Joint: **NO**
Remarks: **debris**

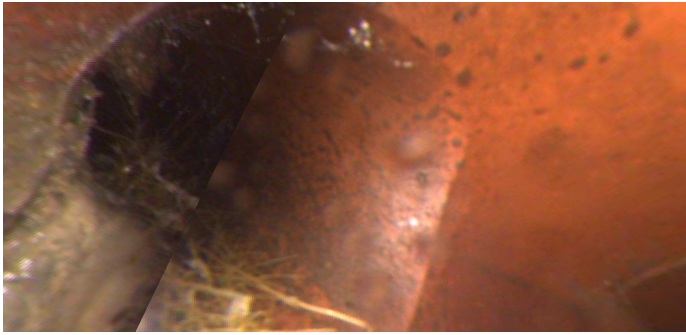
Code: **RFL**
Description: **Roots Fine Lateral**

Distance (ft): **117.7**
Structural Grade: **0**
O&M Grade: **1**
Clock Start/From: **8**
Clock To:
1st Value:
2nd Value:
Value Percent:
Continuous Index:
Within 8" of Joint: **NO**
Remarks:

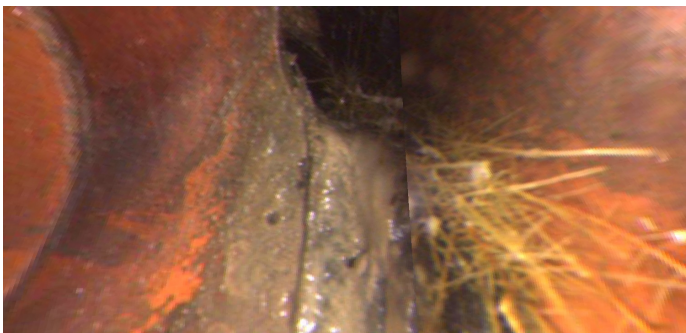
Code: **DAGS**
Description: **Deposits Attached Grease**

Distance (ft): **117.7**
Structural Grade: **0**
O&M Grade: **2**
Clock Start/From: **7**
Clock To: **10**
1st Value:
2nd Value:
Value Percent: **5.000**
Continuous Index:
Within 8" of Joint: **NO**
Remarks:

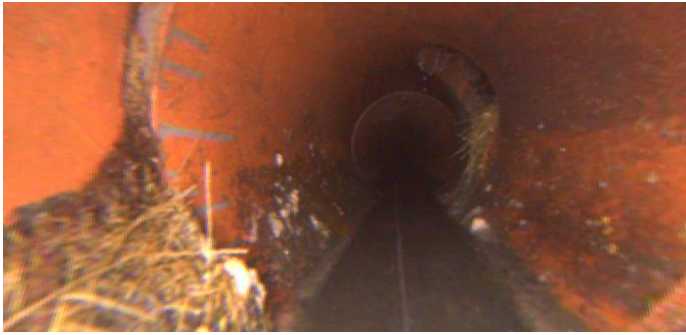
Code: **RMJ**
Description: **Roots Medium Joint**

Distance (ft): **119.4**
Structural Grade: **0**
O&M Grade: **3**
Clock Start/From: **4**
Clock To:
1st Value:
2nd Value:
Value Percent: **5.000**
Continuous Index:
Within 8" of Joint: **YES**
Remarks:

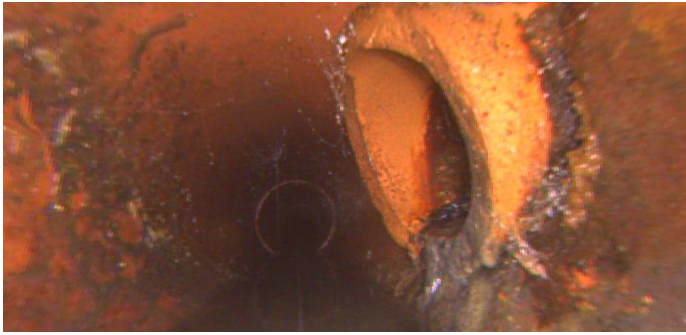
Code: **TBI**
Description: **Tap Break-in Intruding**

Distance (ft): **263.4**
Structural Grade: **0**
O&M Grade: **2**
Clock Start/From: **10**
Clock To:
1st Value: **4.000**
2nd Value: **2.000**
Value Percent:
Continuous Index:
Within 8" of Joint:
Remarks:

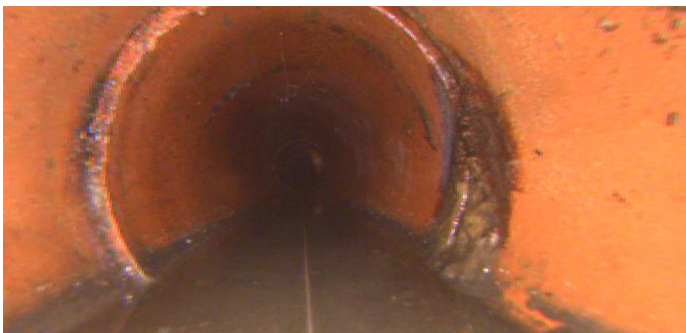
Code: **RFJ**
Description: **Roots Fine Joint**

Distance (ft): **268.8**
Structural Grade: **0**
O&M Grade: **1**
Clock Start/From: **7**
Clock To: **9**
1st Value:
2nd Value:
Value Percent:
Continuous Index:
Within 8" of Joint: **YES**
Remarks:

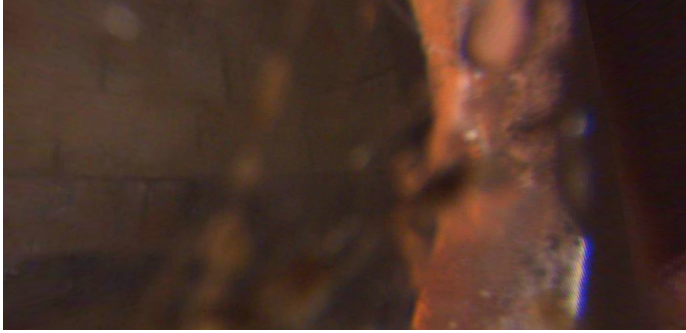
Code: **DSZ**
Description: **Deposits Settled Other**

Distance (ft): **276.1**
Structural Grade: **0**
O&M Grade: **2**
Clock Start/From: **6**
Clock To:
1st Value:
2nd Value:
Value Percent: **5.000**
Continuous Index: **F02**
Within 8" of Joint: **NO**
Remarks: **debris**

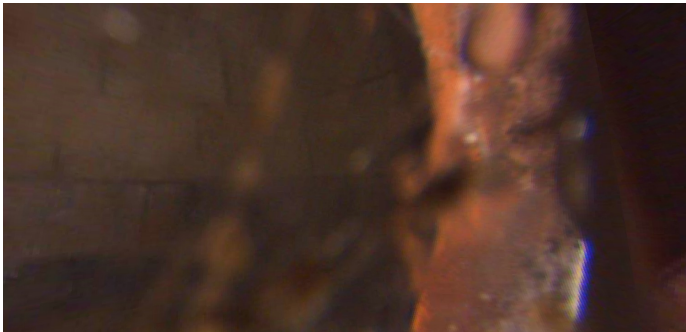
Code: **CM**
Description: **Crack Multiple**

Distance (ft): **276.1**
Structural Grade: **3**
O&M Grade: **0**
Clock Start/From: **10**
Clock To: **11**
1st Value:
2nd Value:
Value Percent:
Continuous Index: **F01**
Within 8" of Joint: **YES**
Remarks: **wandering**
