Profile/Photo Observation Report

Date:	04/20/2018	Weather:		Coding:	PACP 6.0
Pipe Length (ft):	274.7	Owner:	NA	Pre Clean:	Not Known
P.O.#:		Surveyor:	Byrd Fitzgerald	PSR:	P-806-005-006
Customer:		Clean Date:	01/01/1900	Shape:	C

Street:	Capitol	Flow Control:	Not Controlled
City:	Hobart, IN	Year Renewed:	
Location:	Light Highway	Tape/Media #:	
Purpose:	Maintenance Related	Dia/Height:	10"
Use:	Sanitary	Material:	VCP
Drain Area:	NA	Lining:	Cured in Place
Category:	NA		
Comment:	flow incorrect.

Location Details:		Direction of Survey:	Upstream
US MH:	M-806-006	DS MH:	M-806-005
		Total Length Surveyed (ft):	278.2

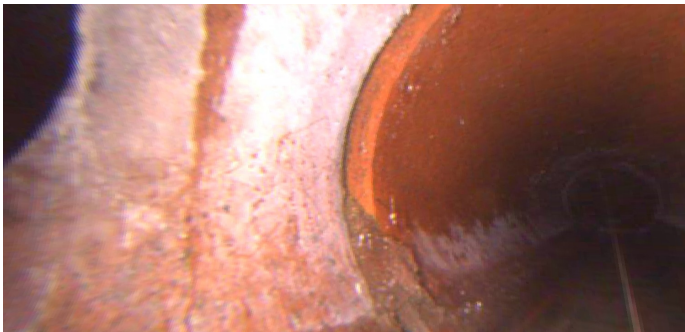
Code:	DAZ
Description:	Deposits Attached Other

Distance (ft):	5.6
Structural Grade:	0
O&M Grade:	2
Clock Start/From:	5
Clock To:	
1st Value:	
2nd Value:	
Value Percent:	5.000
Continuous Index:	
Within 8" of Joint:	YES
Remarks:

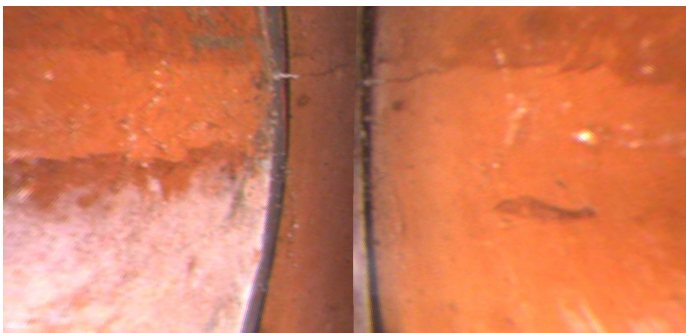
Code: **CM**
Description: **Crack Multiple**

Distance (ft): **6.8**
Structural Grade: **3**
O&M Grade: **0**
Clock Start/From: **10**
Clock To: **11**
1st Value:
2nd Value:
Value Percent:
Continuous Index: **S01**
Within 8" of Joint: **YES**
Remarks: **wandering**

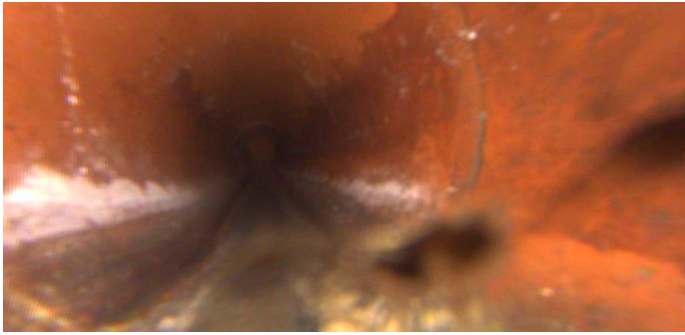
Code: **DSZ**
Description: **Deposits Settled Other**

Distance (ft): **14.4**
Structural Grade: **0**
O&M Grade: **2**
Clock Start/From: **6**
Clock To:
1st Value:
2nd Value:
Value Percent: **5.000**
Continuous Index:
Within 8" of Joint: **NO**
Remarks: **debris**

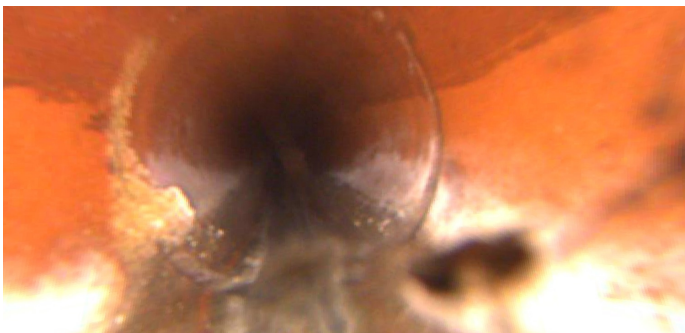
Code: **DAE**
Description: **Deposits Attached Encrustation**

Distance (ft): **30.4**
Structural Grade: **0**
O&M Grade: **2**
Clock Start/From: **8**
Clock To:
1st Value:
2nd Value:
Value Percent: **5.000**
Continuous Index:
Within 8" of Joint: **YES**
Remarks:

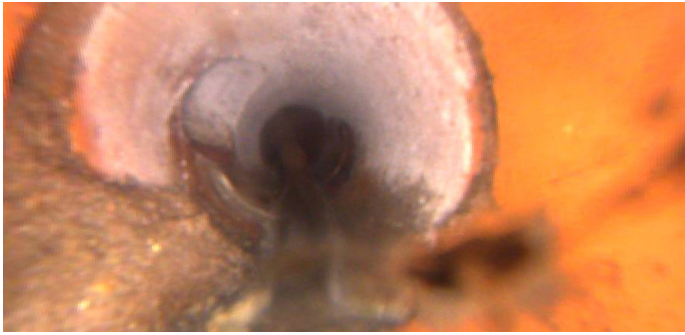
Code: **DAZ**
Description: **Deposits Attached Other**

Distance (ft): **43.0**
Structural Grade: **0**
O&M Grade: **2**
Clock Start/From: **7**
Clock To: **9**
1st Value:
2nd Value:
Value Percent: **5.000**
Continuous Index:
Within 8" of Joint: **YES**
Remarks:

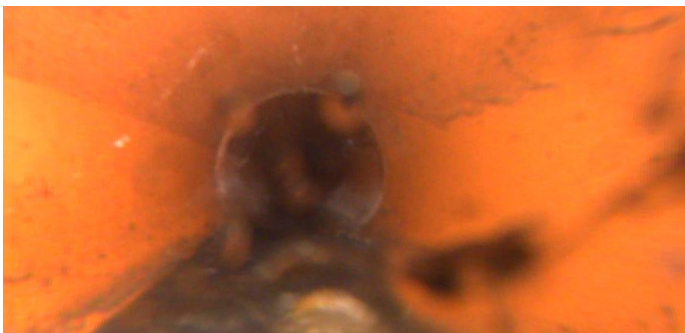
Code: **DSZ**
Description: **Deposits Settled Other**

Distance (ft): **89.2**
Structural Grade: **0**
O&M Grade: **2**
Clock Start/From: **6**
Clock To:
1st Value:
2nd Value:
Value Percent: **5.000**
Continuous Index: **S02**
Within 8" of Joint: **NO**
Remarks: **debris**

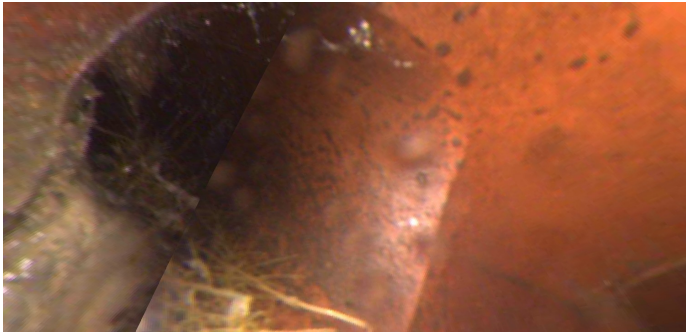
Code: **RFL**
Description: **Roots Fine Lateral**

Distance (ft): **117.7**
Structural Grade: **0**
O&M Grade: **1**
Clock Start/From: **8**
Clock To:
1st Value:
2nd Value:
Value Percent:
Continuous Index:
Within 8" of Joint: **NO**
Remarks:

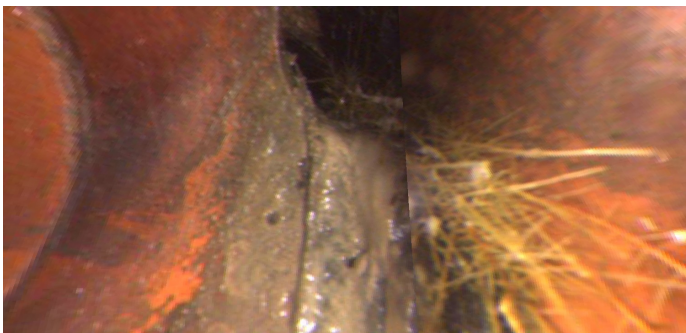
Code: **DAGS**
Description: **Deposits Attached Grease**

Distance (ft): **117.7**
Structural Grade: **0**
O&M Grade: **2**
Clock Start/From: **7**
Clock To: **10**
1st Value:
2nd Value:
Value Percent: **5.000**
Continuous Index:
Within 8" of Joint: **NO**
Remarks:

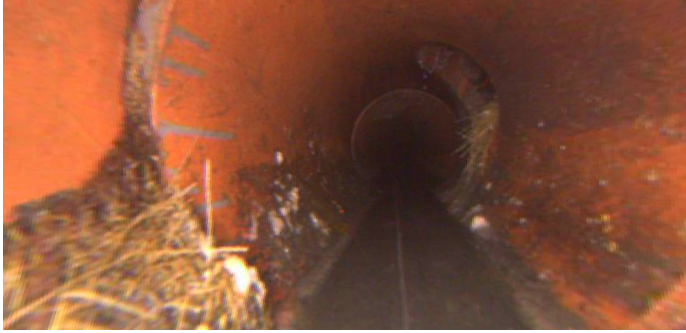
Code: **RMJ**
Description: **Roots Medium Joint**

Distance (ft): **119.4**
Structural Grade: **0**
O&M Grade: **3**
Clock Start/From: **4**
Clock To:
1st Value:
2nd Value:
Value Percent: **5.000**
Continuous Index:
Within 8" of Joint: **YES**
Remarks:

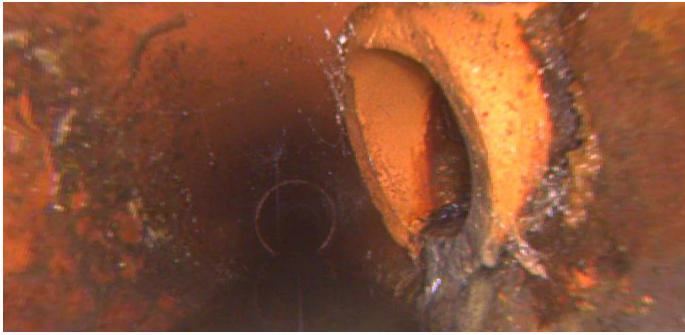
Code: **TBI**
Description: **Tap Break-in Intruding**

Distance (ft): **263.4**
Structural Grade: **0**
O&M Grade: **2**
Clock Start/From: **10**
Clock To:
1st Value: **4.000**
2nd Value: **2.000**
Value Percent:
Continuous Index:
Within 8" of Joint:
Remarks:

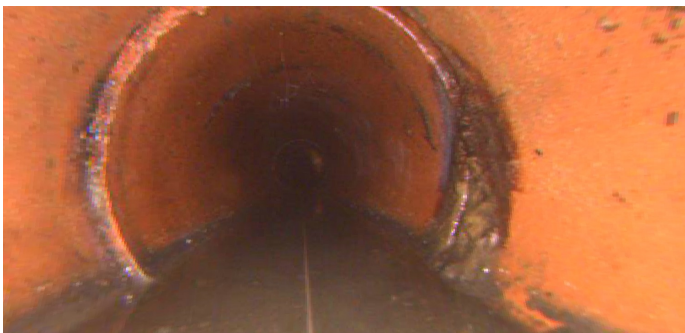
Code: **RFJ**
Description: **Roots Fine Joint**

Distance (ft): **268.8**
Structural Grade: **0**
O&M Grade: **1**
Clock Start/From: **7**
Clock To: **9**
1st Value:
2nd Value:
Value Percent:
Continuous Index:
Within 8" of Joint: **YES**
Remarks:

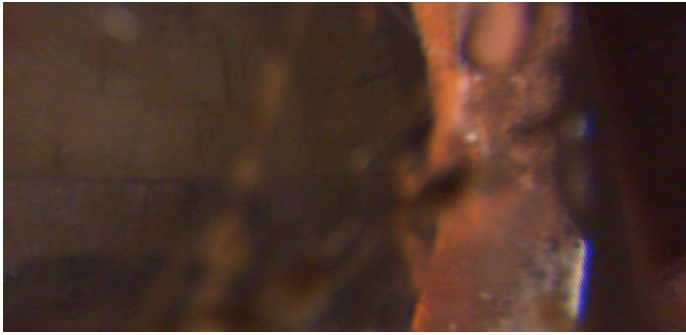
Code: **DSZ**
Description: **Deposits Settled Other**

Distance (ft): **276.1**
Structural Grade: **0**
O&M Grade: **2**
Clock Start/From: **6**
Clock To:
1st Value:
2nd Value:
Value Percent: **5.000**
Continuous Index: **F02**
Within 8" of Joint: **NO**
Remarks: **debris**

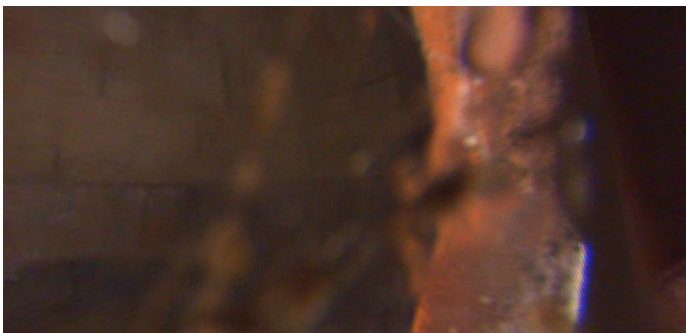
Code: **CM**
Description: **Crack Multiple**

Distance (ft): **276.1**
Structural Grade: **3**
O&M Grade: **0**
Clock Start/From: **10**
Clock To: **11**
1st Value:
2nd Value:
Value Percent:
Continuous Index: **F01**
Within 8" of Joint: **YES**
Remarks: **wandering**
