## Profile/Photo Observation Report

Street:	<b>Capitol</b>	Flow Control:	<b>Not Controlled</b>
City:	<b>Hobart, IN</b>	Year Renewed:	
Location:	<b>Light Highway</b>	Tape/Media #:	
Purpose:	<b>Maintenance Related</b>	Dia/Height:	<b>10"</b>
Use:	<b>Sanitary</b>	Material:	<b>VCP</b>
Drain Area:	<b>NA</b>	Lining:	<b>Cured in Place</b>
Category:	<b>NA</b>		
Comment:	<b>may be 12" pipe.</b>

Location Details:		Direction of Survey:	<b>Upstream</b>
US MH:	<b>M-806-006</b>	DS MH:	<b>M-806-027</b>
		Total Length Surveyed (ft):	<b>12.3</b>

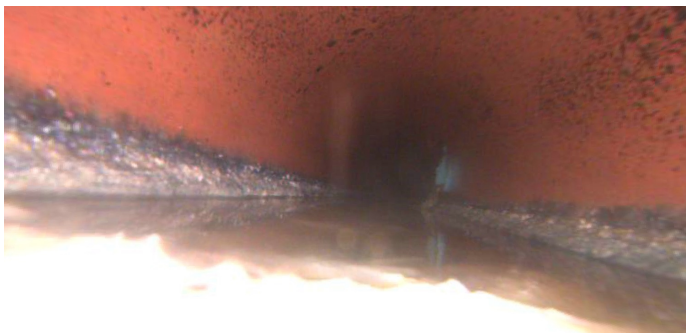
Code: **AMH**  
Description: **Manhole**

Distance (ft): **.0**  
Structural Grade: **0**  
O&M Grade: **0**  
Clock Start/From:  
Clock To:  
1st Value:  
2nd Value:  
Value Percent:  
Continuous Index:  
Within 8" of Joint: **NO**  
Remarks: **M-806-027**

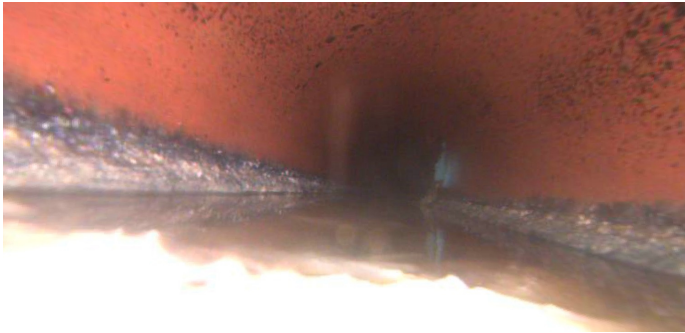
Code:	<b>MWL</b>
Description:	<b>Water Level</b>

Distance (ft):	<b>.0</b>
Structural Grade:	<b>0</b>
O&M Grade:	<b>0</b>
Clock Start/From:	
Clock To:	
1st Value:	
2nd Value:	
Value Percent:	<b>40.000</b>
Continuous Index:	
Within 8" of Joint:	<b>NO</b>
Remarks:

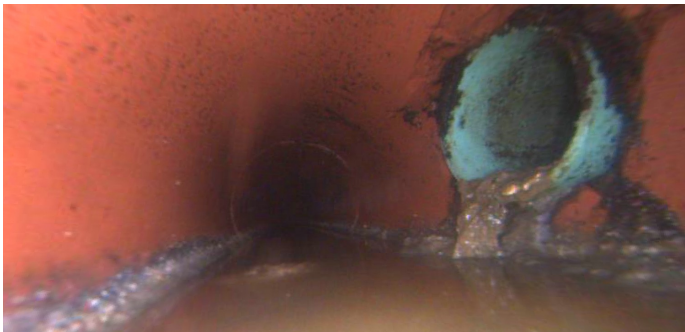
Code:	<b>TBI</b>
Description:	<b>Tap Break-in Intruding</b>

Distance (ft):	<b>3.0</b>
Structural Grade:	<b>0</b>
O&M Grade:	<b>2</b>
Clock Start/From:	<b>3</b>
Clock To:	
1st Value:	<b>4.000</b>
2nd Value:	<b>1.000</b>
Value Percent:	
Continuous Index:	
Within 8" of Joint:	
Remarks:

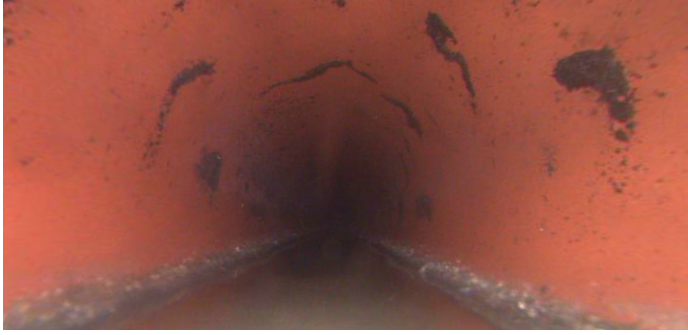
Code:	<b>MSA</b>
Description:	<b>Abandoned Survey</b>
Distance (ft):	<b>12.3</b>
Structural Grade:	<b>0</b>
O&M Grade:	<b>0</b>
Clock Start/From:	
Clock To:	
1st Value:	
2nd Value:	
Value Percent:	
Continuous Index:	
Within 8" of Joint:	<b>NO</b>
Remarks:	<b>unknown</b>
