Profile/Photo Observation Report

Date:	04/20/2018	Weather:		Coding:	PACP 6.0
Pipe Length (ft):	137.6	Owner:	NA	Pre Clean:	Not Known
P.O.#:		Surveyor:	Byrd Fitzgerald	PSR:	P-806-006-027
Customer:		Clean Date:	01/01/1900	Shape:	C

Street:	LUTHER DR & E 8TH ST	Flow Control:	Not Controlled
City:	Hobart, IN	Year Renewed:	
Location:	Light Highway	Tape/Media #:	
Purpose:	Maintenance Related	Dia/Height:	12"
Use:	Sanitary	Material:	VCP
Drain Area:	NA	Lining:	Cured in Place
Category:	NA		
Comment:	2nd attempt

Location Details:		Direction of Survey:	Upstream
US MH:	M-806-006	DS MH:	M-806-027
		Total Length Surveyed (ft):	103.6

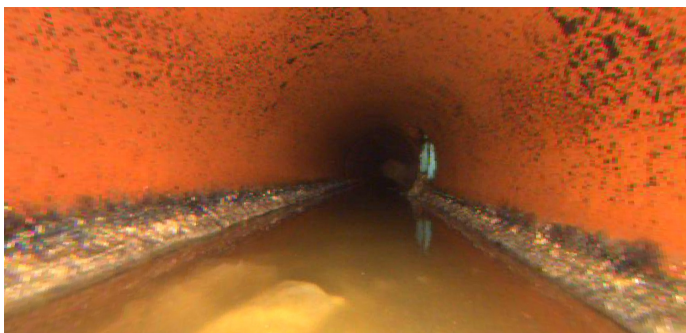
Code: **AMH**
Description: **Manhole**

Distance (ft): **.0**
Structural Grade: **0**
O&M Grade: **0**
Clock Start/From:
Clock To:
1st Value:
2nd Value:
Value Percent:
Continuous Index:
Within 8" of Joint: **NO**
Remarks: **M-806-027**

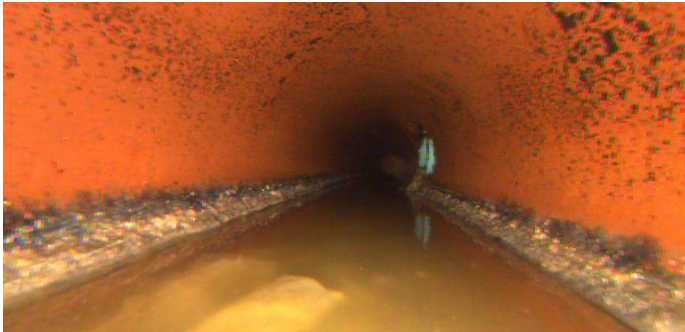
Code:	MWL
Description:	Water Level

Distance (ft):	.0
Structural Grade:	0
O&M Grade:	0
Clock Start/From:	
Clock To:	
1st Value:	
2nd Value:	
Value Percent:	5.000
Continuous Index:	
Within 8" of Joint:	NO
Remarks:

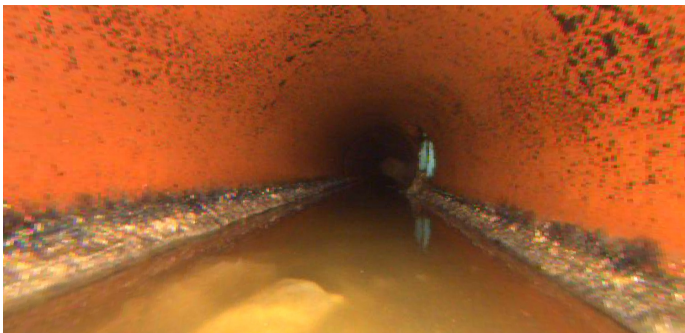
Code:	DSZ
Description:	Deposits Settled Other

Distance (ft):	.0
Structural Grade:	0
O&M Grade:	2
Clock Start/From:	6
Clock To:	
1st Value:	
2nd Value:	
Value Percent:	5.000
Continuous Index:	S01
Within 8" of Joint:	NO
Remarks:	tissue

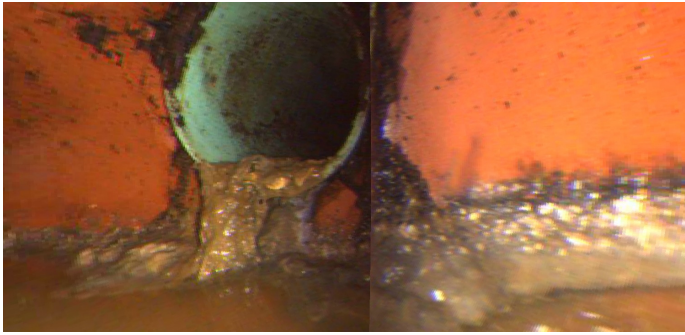
Code: **TB**
Description: **Tap Break-in**

Distance (ft): **3.5**
Structural Grade: **0**
O&M Grade: **0**
Clock Start/From: **3**
Clock To:
1st Value: **4.000**
2nd Value:
Value Percent:
Continuous Index:
Within 8" of Joint:
Remarks:

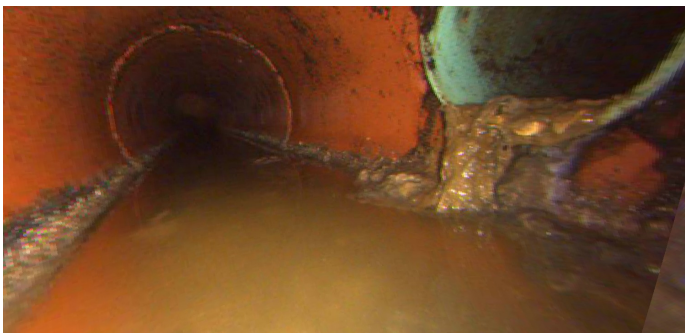
Code: **DAZ**
Description: **Deposits Attached Other**

Distance (ft): **3.5**
Structural Grade: **0**
O&M Grade: **2**
Clock Start/From: **4**
Clock To:
1st Value:
2nd Value:
Value Percent: **5.000**
Continuous Index:
Within 8" of Joint: **NO**
Remarks:

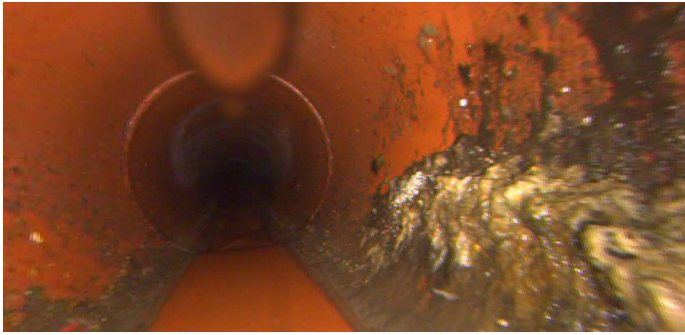
Code: **DAGS**
Description: **Deposits Attached Grease**

Distance (ft): **32.2**
Structural Grade: **0**
O&M Grade: **2**
Clock Start/From: **7**
Clock To: **5**
1st Value:
2nd Value:
Value Percent: **5.000**
Continuous Index:
Within 8" of Joint: **NO**
Remarks:

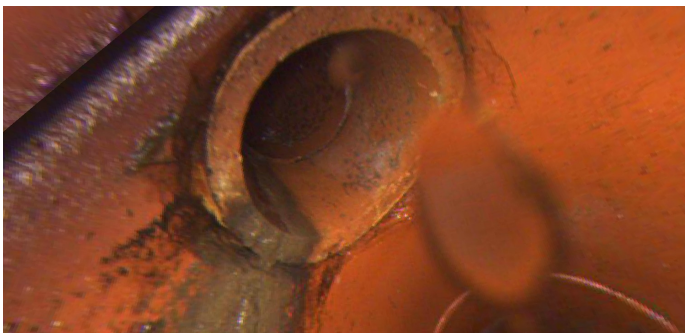
Code: **TB**
Description: **Tap Break-in**

Distance (ft): **32.2**
Structural Grade: **0**
O&M Grade: **0**
Clock Start/From: **11**
Clock To:
1st Value: **4.000**
2nd Value:
Value Percent:
Continuous Index:
Within 8" of Joint:
Remarks:

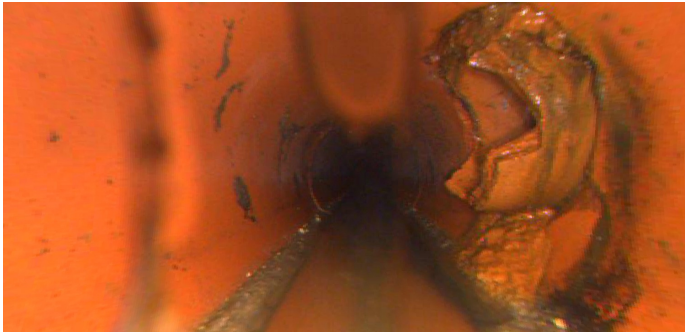
Code: **TBI**
Description: **Tap Break-in Intruding**

Distance (ft): **48.3**
Structural Grade: **0**
O&M Grade: **2**
Clock Start/From: **2**
Clock To:
1st Value: **4.000**
2nd Value: **1.000**
Value Percent:
Continuous Index:
Within 8" of Joint:
Remarks:

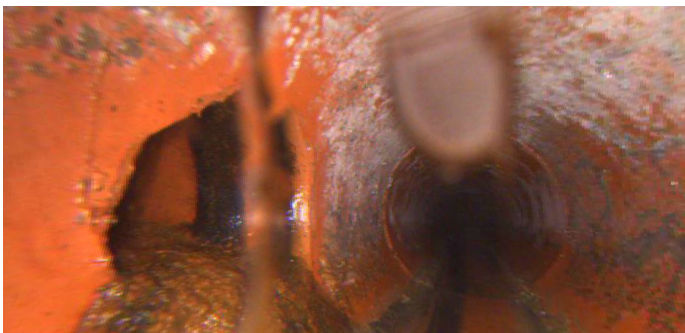
Code: **TBD**
Description: **Tap Break-in Defective**

Distance (ft): **62.4**
Structural Grade: **0**
O&M Grade: **3**
Clock Start/From: **9**
Clock To:
1st Value: **4.000**
2nd Value:
Value Percent:
Continuous Index:
Within 8" of Joint:
Remarks: **blocked by dae**

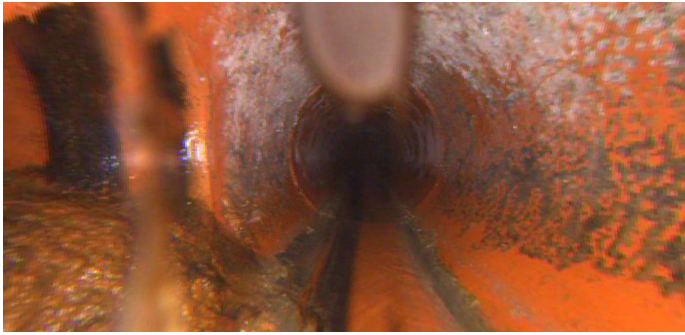
Code: **DAE**
Description: **Deposits Attached Encrustation**

Distance (ft): **62.4**
Structural Grade: **0**
O&M Grade: **2**
Clock Start/From: **8**
Clock To:
1st Value:
2nd Value:
Value Percent: **5.000**
Continuous Index:
Within 8" of Joint: **NO**
Remarks:

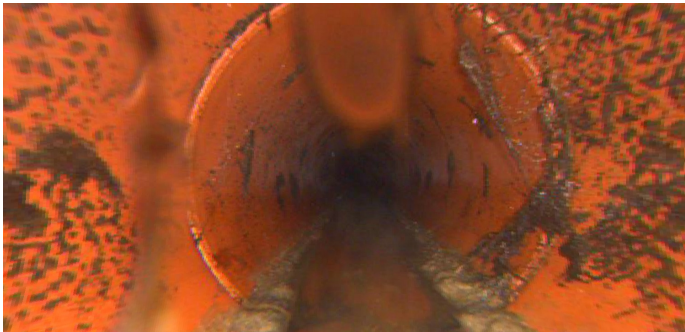
Code: **RFJ**
Description: **Roots Fine Joint**

Distance (ft): **69.2**
Structural Grade: **0**
O&M Grade: **1**
Clock Start/From: **1**
Clock To: **5**
1st Value:
2nd Value:
Value Percent:
Continuous Index:
Within 8" of Joint: **YES**
Remarks:

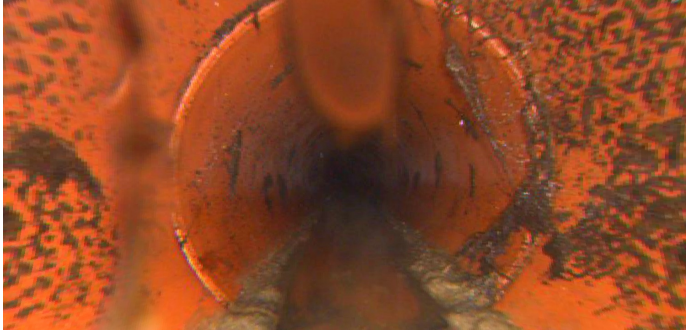
Code: **DSZ**
Description: **Deposits Settled Other**

Distance (ft): **69.2**
Structural Grade: **0**
O&M Grade: **2**
Clock Start/From: **6**
Clock To:
1st Value:
2nd Value:
Value Percent: **5.000**
Continuous Index: **F01**
Within 8" of Joint: **NO**
Remarks: **tissue**

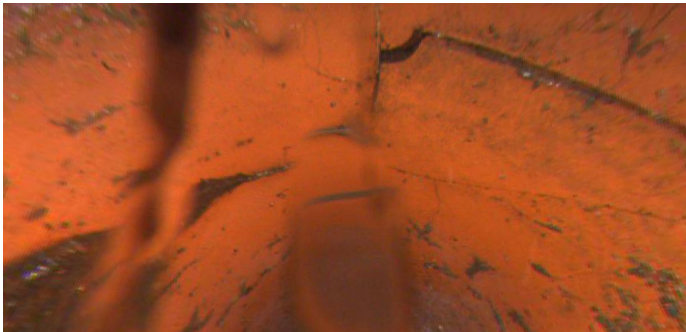
Code: **CM**
Description: **Crack Multiple**

Distance (ft): **78.3**
Structural Grade: **3**
O&M Grade: **0**
Clock Start/From: **11**
Clock To: **2**
1st Value:
2nd Value:
Value Percent:
Continuous Index:
Within 8" of Joint:
Remarks:

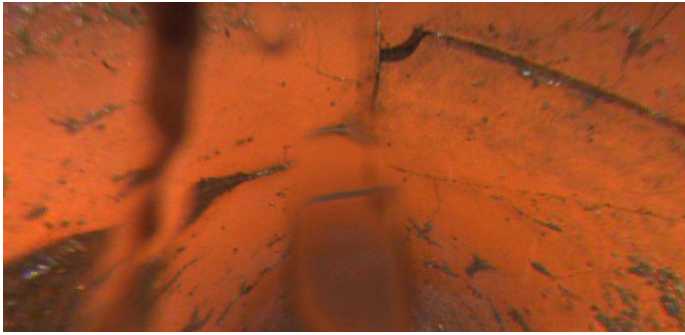
Code: **FC**
Description: **Fracture Circumferential**

Distance (ft): **78.3**
Structural Grade: **2**
O&M Grade: **0**
Clock Start/From: **7**
Clock To: **5**
1st Value:
2nd Value:
Value Percent:
Continuous Index:
Within 8" of Joint:
Remarks:

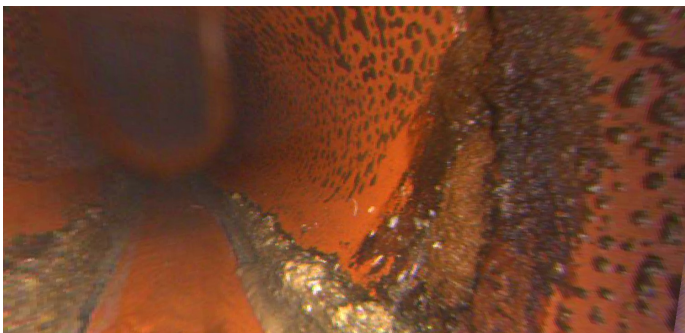
Code: **DAE**
Description: **Deposits Attached Encrustation**

Distance (ft): **97.9**
Structural Grade: **0**
O&M Grade: **2**
Clock Start/From: **7**
Clock To: **5**
1st Value:
2nd Value:
Value Percent: **5.000**
Continuous Index:
Within 8" of Joint: **YES**
Remarks:

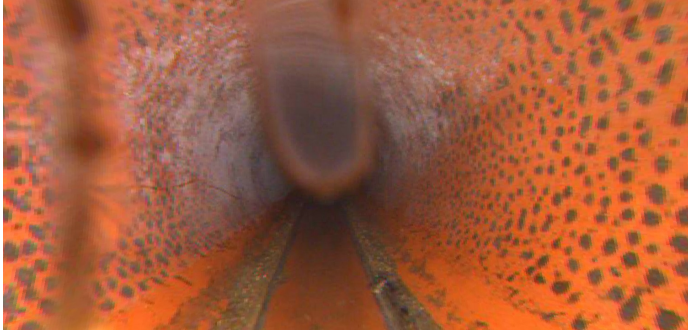
Code:	MSA
Description:	Abandoned Survey
Distance (ft):	103.6
Structural Grade:	0
O&M Grade:	0
Clock Start/From:	
Clock To:	
1st Value:	
2nd Value:	
Value Percent:	
Continuous Index:	
Within 8" of Joint:	NO
Remarks:	no blockage
