Profile/Photo Observation Report

Date:	04/20/2018	Weather:		Coding:	PACP 6.0
Pipe Length (ft):	137.6	Owner:	NA	Pre Clean:	Not Known
P.O.#:		Surveyor:	Byrd Fitzgerald	PSR:	P-806-006-027
Customer:		Clean Date:	01/01/1900	Shape:	C

Street:	Capitol	Flow Control:	Not Controlled
City:	Hobart, IN	Year Renewed:	
Location:	Light Highway	Tape/Media #:	
Purpose:	Maintenance Related	Dia/Height:	12"
Use:	Sanitary	Material:	VCP
Drain Area:	NA	Lining:	Cured in Place
Category:	NA		
Comment:	2nd attempt

Location Details:		Direction of Survey:	Upstream
US MH:	M-806-006	DS MH:	M-806-027
		Total Length Surveyed (ft):	103.6

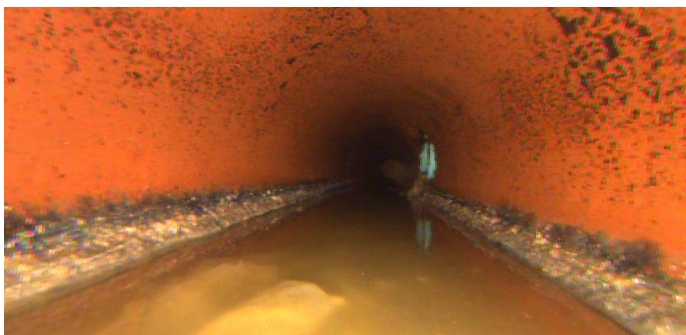
Code: **AMH**
Description: **Manhole**

Distance (ft): **.0**
Structural Grade: **0**
O&M Grade: **0**
Clock Start/From:
Clock To:
1st Value:
2nd Value:
Value Percent:
Continuous Index:
Within 8" of Joint: **NO**
Remarks: **M-806-027**

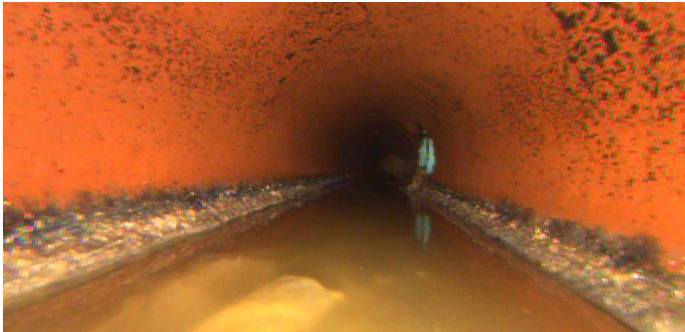
Code:	MWL
Description:	Water Level

Distance (ft):	.0
Structural Grade:	0
O&M Grade:	0
Clock Start/From:	
Clock To:	
1st Value:	
2nd Value:	
Value Percent:	5.000
Continuous Index:	
Within 8" of Joint:	NO
Remarks:

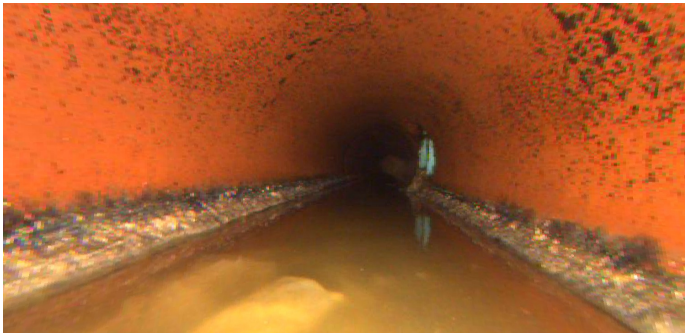
Code:	DSZ
Description:	Deposits Settled Other

Distance (ft):	.0
Structural Grade:	0
O&M Grade:	2
Clock Start/From:	6
Clock To:	
1st Value:	
2nd Value:	
Value Percent:	5.000
Continuous Index:	S01
Within 8" of Joint:	NO
Remarks:	tissue

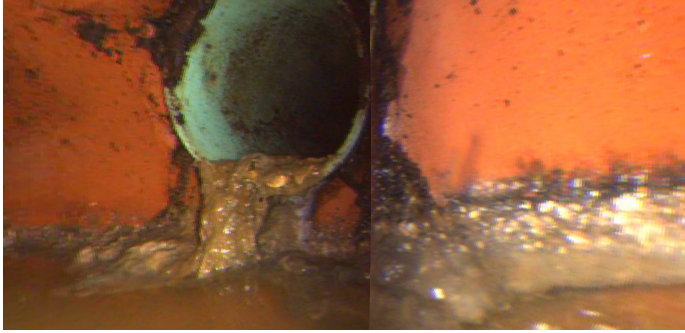
Code: **TB**
Description: **Tap Break-in**

Distance (ft): **3.5**
Structural Grade: **0**
O&M Grade: **0**
Clock Start/From: **3**
Clock To:
1st Value: **4.000**
2nd Value:
Value Percent:
Continuous Index:
Within 8" of Joint:
Remarks:

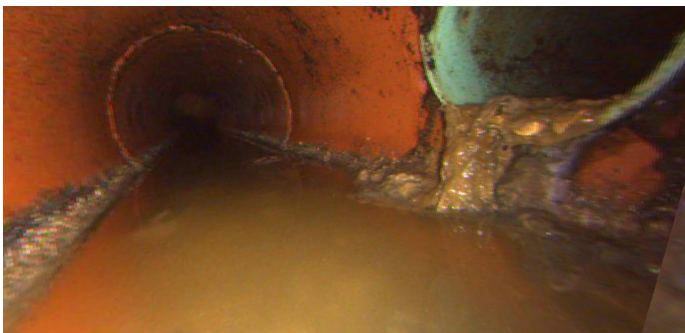
Code: **DAZ**
Description: **Deposits Attached Other**

Distance (ft): **3.5**
Structural Grade: **0**
O&M Grade: **2**
Clock Start/From: **4**
Clock To:
1st Value:
2nd Value:
Value Percent: **5.000**
Continuous Index:
Within 8" of Joint: **NO**
Remarks:

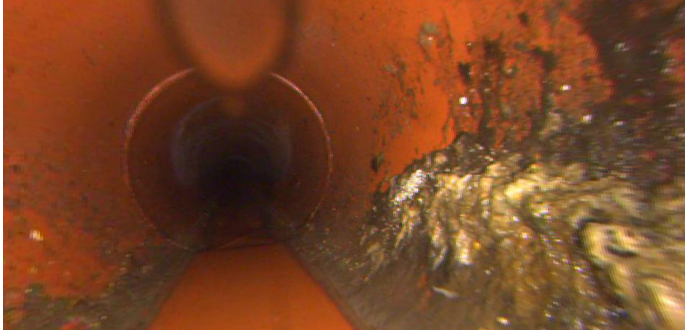
Code: **DAGS**
Description: **Deposits Attached Grease**

Distance (ft): **32.2**
Structural Grade: **0**
O&M Grade: **2**
Clock Start/From: **7**
Clock To: **5**
1st Value:
2nd Value:
Value Percent: **5.000**
Continuous Index:
Within 8" of Joint: **NO**
Remarks:

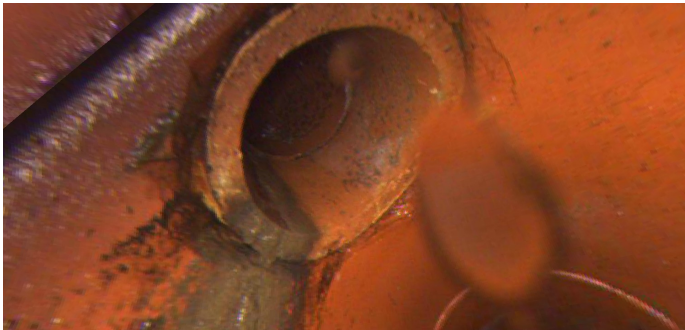
Code: **TB**
Description: **Tap Break-in**

Distance (ft): **32.2**
Structural Grade: **0**
O&M Grade: **0**
Clock Start/From: **11**
Clock To:
1st Value: **4.000**
2nd Value:
Value Percent:
Continuous Index:
Within 8" of Joint:
Remarks:

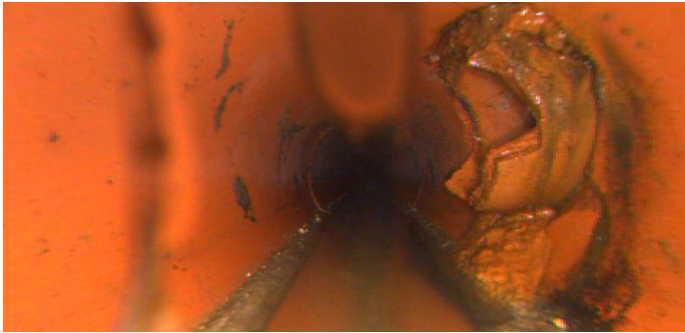
Code: **TBI**
Description: **Tap Break-in Intruding**

Distance (ft): **48.3**
Structural Grade: **0**
O&M Grade: **2**
Clock Start/From: **2**
Clock To:
1st Value: **4.000**
2nd Value: **1.000**
Value Percent:
Continuous Index:
Within 8" of Joint:
Remarks:

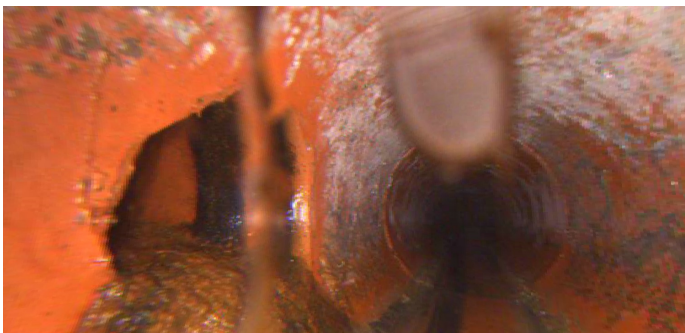
Code: **TBD**
Description: **Tap Break-in Defective**

Distance (ft): **62.4**
Structural Grade: **0**
O&M Grade: **3**
Clock Start/From: **9**
Clock To:
1st Value: **4.000**
2nd Value:
Value Percent:
Continuous Index:
Within 8" of Joint:
Remarks: **blocked by dae**

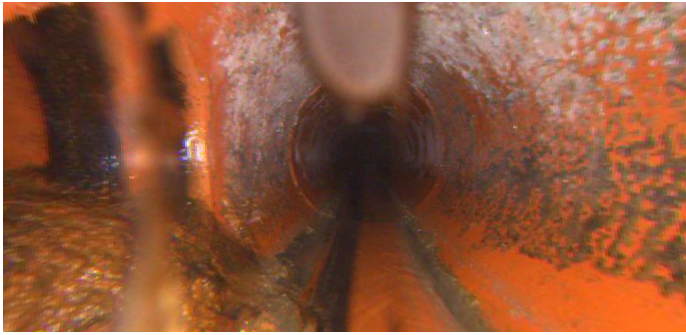
Code: **DAE**
Description: **Deposits Attached Encrustation**

Distance (ft): **62.4**
Structural Grade: **0**
O&M Grade: **2**
Clock Start/From: **8**
Clock To:
1st Value:
2nd Value:
Value Percent: **5.000**
Continuous Index:
Within 8" of Joint: **NO**
Remarks:

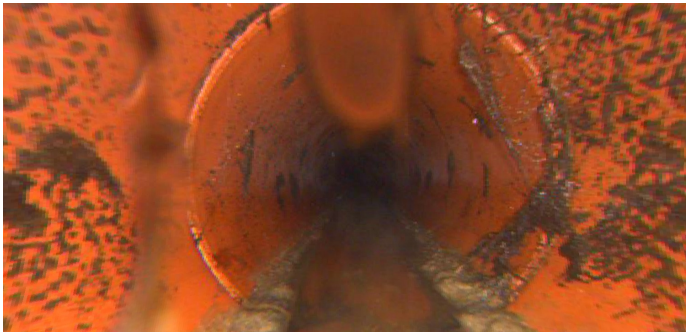
Code: **RFJ**
Description: **Roots Fine Joint**

Distance (ft): **69.2**
Structural Grade: **0**
O&M Grade: **1**
Clock Start/From: **1**
Clock To: **5**
1st Value:
2nd Value:
Value Percent:
Continuous Index:
Within 8" of Joint: **YES**
Remarks:

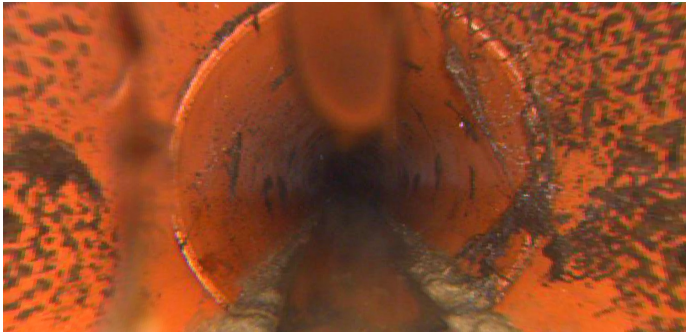
Code: **DSZ**
Description: **Deposits Settled Other**

Distance (ft): **69.2**
Structural Grade: **0**
O&M Grade: **2**
Clock Start/From: **6**
Clock To:
1st Value:
2nd Value:
Value Percent: **5.000**
Continuous Index: **F01**
Within 8" of Joint: **NO**
Remarks: **tissue**

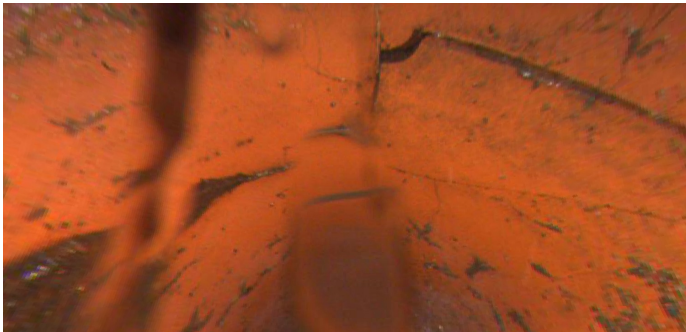
Code: **CM**
Description: **Crack Multiple**

Distance (ft): **78.3**
Structural Grade: **3**
O&M Grade: **0**
Clock Start/From: **11**
Clock To: **2**
1st Value:
2nd Value:
Value Percent:
Continuous Index:
Within 8" of Joint:
Remarks:

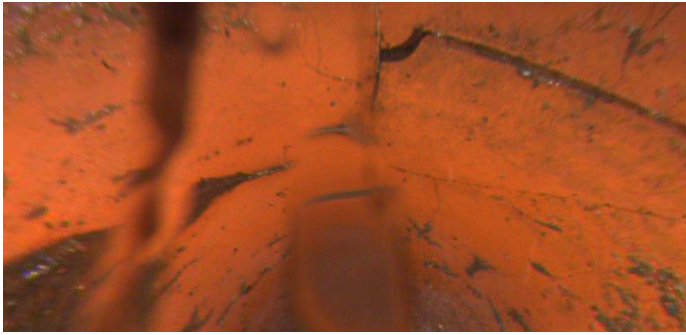
Code: **FC**
Description: **Fracture Circumferential**

Distance (ft): **78.3**
Structural Grade: **2**
O&M Grade: **0**
Clock Start/From: **7**
Clock To: **5**
1st Value:
2nd Value:
Value Percent:
Continuous Index:
Within 8" of Joint:
Remarks:

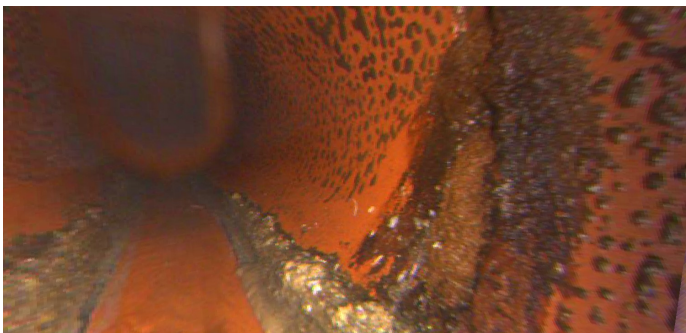
Code: **DAE**
Description: **Deposits Attached Encrustation**

Distance (ft): **97.9**
Structural Grade: **0**
O&M Grade: **2**
Clock Start/From: **7**
Clock To: **5**
1st Value:
2nd Value:
Value Percent: **5.000**
Continuous Index:
Within 8" of Joint: **YES**
Remarks:

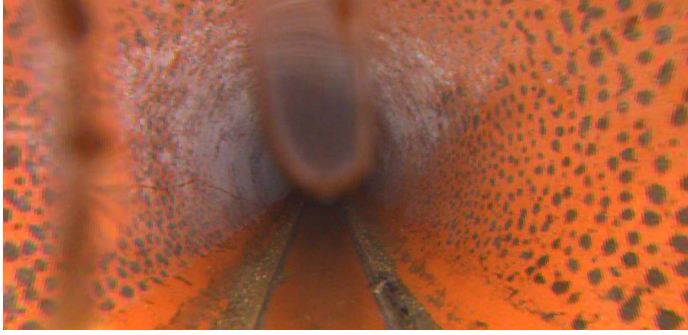
Code:	MSA
Description:	Abandoned Survey
Distance (ft):	103.6
Structural Grade:	0
O&M Grade:	0
Clock Start/From:	
Clock To:	
1st Value:	
2nd Value:	
Value Percent:	
Continuous Index:	
Within 8" of Joint:	NO
Remarks:	no blockage
